DAILY FIELD REPORT

Project	Bedford Beverly Brownfield Site	Report No.	3
BCP Site	BCP Site No. C224384	Date	9/22/2023
Location	2359 and 2360 Bedford Avenue, Brooklyn, NY	File No.	0205432
Client	Bedford Beverly Acquisitions LLC	Temperature	59-70 °F
Contractor	Haley & Aldrich, Lakewood Environmental Solutions	Wind Direction	NE to SW, 5-12 mph
Weather	Sunny	Personnel on Site	S. Sotomayor, C. Evertz
Humidity	69%	Time on Site	6:45am to 3:00pm

Haley & Aldrich of New York (Haley & Aldrich) was present to document implementation of the NYSDEC-approved April 2023 Remedial Investigation Work Plan (RIWP) prepared by Haley & Aldrich. Site Observations are summarized below.

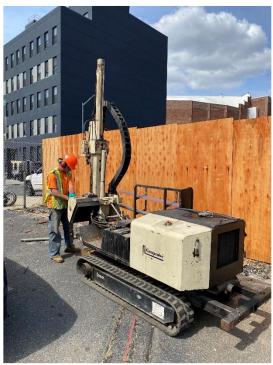
Photo 1: View of contractor advancing waste characterization borings, facing west.

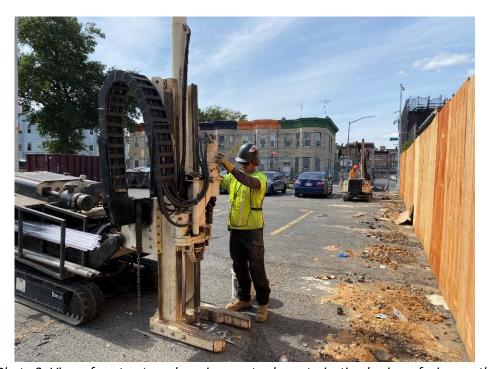
Photo 2: View of contractor advancing waste characterization borings, facing south.
