Project	Bedford Beverly Brownfield	Report No.	9
	Site		
BCP Site	BCP Site No. C224384	Date	10/17/2023
Location	2359 and 2360 Bedford	File No.	0205432
	Avenue, Brooklyn, NY		
Client	Bedford Beverly Acquisitions	Temperature	50-64 °F
	LLC, Star Demolition (Star),		
	Maman Contracting (Maman)		
Contractor	Haley & Aldrich	Wind Direction	N to S, 14 mph
Weather	Mostly Sunny	Personnel on	D. Djombalic
		Site	
Humidity	78%	Time on Site	7:00am to 2:30pm

Haley & Aldrich of New York (Haley & Aldrich) was present to document implementation of the Remedial Action Work Plan (RAWP) prepared by Haley & Aldrich currently under review by NYSDEC and the NYSDEC-approved Change of Use dated 17 August 2023 to begin support of excavation work. Site observations are summarized below.

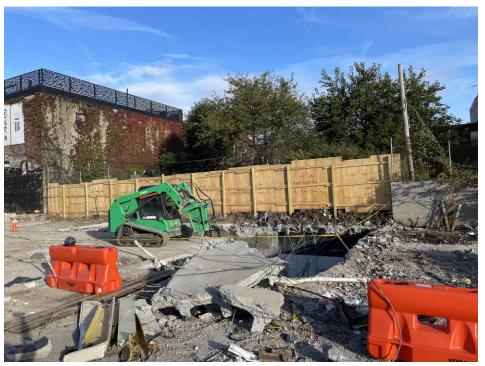
Photo 1: View of demolition work, facing north.

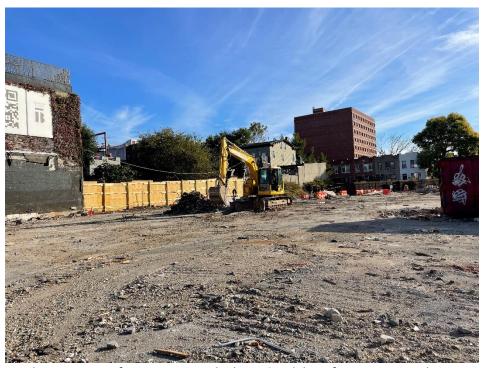
Photo 2: View of contractor stockpiling C&D debris, facing east-northeast.
