Project	Bedford Beverly Brownfield	Report No.	10	
	Site			
BCP Site	BCP Site No. C224384	Date	10/18/2023	
Location	2359 and 2360 Bedford	File No.	0205432	
	Avenue, Brooklyn, NY			
Client	Bedford Beverly Acquisitions	Temperature	51-65 °F	
	LLC, Star Demolition (Star),			
	Maman Contracting (Maman)			
Contractor	Haley & Aldrich	Wind Direction	N to S, 10 mph	
Weather	Mostly Cloudy	Personnel on	D. Djombalic	
		Site		
Humidity	84%	Time on Site	6:45am to 2:30pm

Haley & Aldrich of New York (Haley & Aldrich) was present to document implementation of the Remedial Action Work Plan (RAWP) prepared by Haley & Aldrich currently under review by NYSDEC and the NYSDEC-approved Change of Use dated 17 August 2023 to begin support of excavation work. Site observations are summarized below.

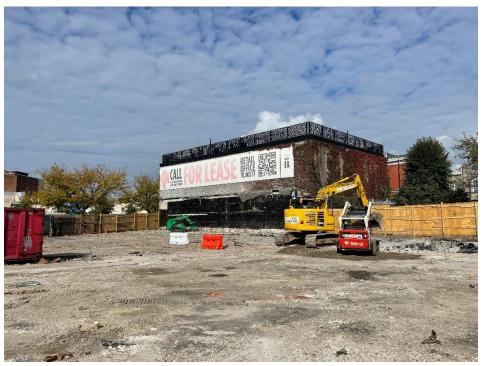
Photo 1: View of demolition work, facing northwest.

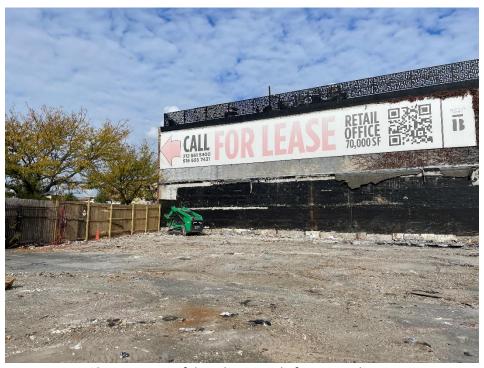
Photo 2: View of demolition work, facing northwest.
