Project	Bedford Beverly Brownfield	Report No.	18	
	Site			
BCP Site	BCP Site No. C224384	Date	10/30/2023	
Location	2359 and 2360 Bedford	File No.	0205432	
	Avenue, Brooklyn, NY			
Client	Bedford Beverly Acquisitions	Temperature	49-68 °F	
	LLC, Star Demolition (Star),			
	Maman Contracting (Maman),			
	International Concrete			
Contractor	Haley & Aldrich	Wind Direction	E to W, 29 mph	
Weather	Mostly rainy	Personnel on	D. Djombalic	
		Site		
Humidity	100%	Time on Site	7:30am to 4:30pm

Haley & Aldrich of New York (Haley & Aldrich) was present to document implementation of the Remedial Action Work Plan (RAWP) prepared by Haley & Aldrich currently under review by NYSDEC and the NYSDEC-approved Change of Use dated 17 August 2023 to begin support of excavation work. Site observations are summarized below.

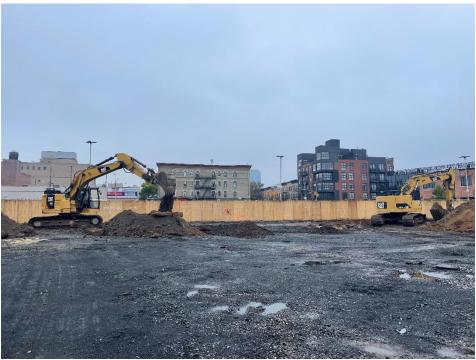
Photo 1: View of excavation for SOE installation along the perimeter of Lot 14, facing north.

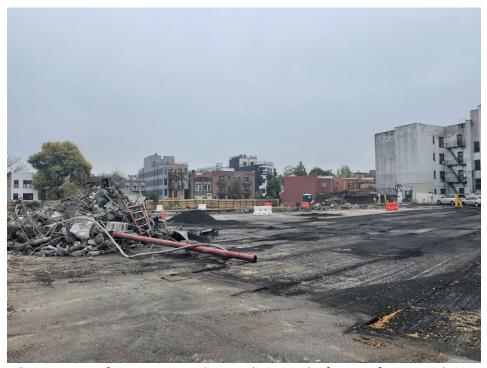
Photo 2: View of contractor conducting demo work of Lot 53, facing southeast.
