Project	Bedford Beverly Brownfield	Report No.	23
Project	•	Report No.	25
	Site		
BCP Site	BCP Site No. C224384	Date	11/06/2023
Location	2359 and 2360 Bedford	File No.	0205432
	Avenue, Brooklyn, NY		
Client	Bedford Beverly Acquisitions	Temperature	44-56 °F
	LLC, Star Demolition (Star),		
	Maman Contracting (Maman),		
	International Concrete		
Contractor	Haley & Aldrich	Wind Direction	NNE to SSW, 21 mph
Weather	Mostly Sunny	Personnel on	D. Djombalic
		Site	
Humidity	69%	Time on Site	7:15am to 3:30pm

Haley & Aldrich of New York (Haley & Aldrich) was present to document implementation of the Remedial Action Work Plan (RAWP) prepared by Haley & Aldrich currently under review by NYSDEC and the NYSDEC-approved Change of Use dated 17 August 2023 to begin support of excavation work. Site observations are summarized below.

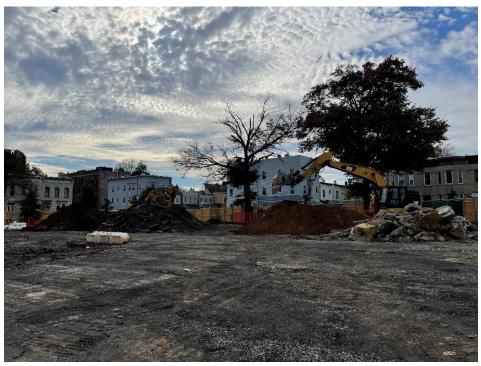
Photo 1: View of excavation for SOE installation along the perimeter of Lot 14, facing southwest.

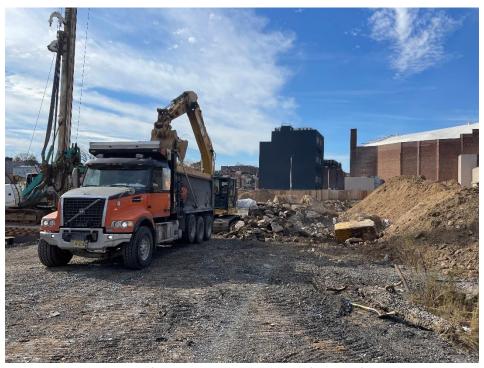
Photo 2: View of contractor loading C&D of Lot 14, facing west.
