Project	Bedford Beverly Brownfield	Report No.	25
l roject	Site	neport ito:	
BCP Site	BCP Site No. C224384	Date	11/08/2023
Location	2359 and 2360 Bedford Avenue, Brooklyn, NY	File No.	0205432
Client	Bedford Beverly Acquisitions LLC, Star Demolition (Star), Maman Contracting (Maman), International Concrete	Temperature	43-53 °F
Contractor	Haley & Aldrich	Wind Direction	N to S, 25 mph
Weather	Sunny	Personnel on Site	D. Djombalic & Z. Simmel
Humidity	63%	Time on Site	6:50am to 3:40pm

Haley & Aldrich of New York (Haley & Aldrich) was present to document implementation of the Remedial Action Work Plan (RAWP) prepared by Haley & Aldrich currently under review by NYSDEC and the NYSDEC-approved Change of Use dated 17 August 2023 to begin support of excavation work. Site observations are summarized below.

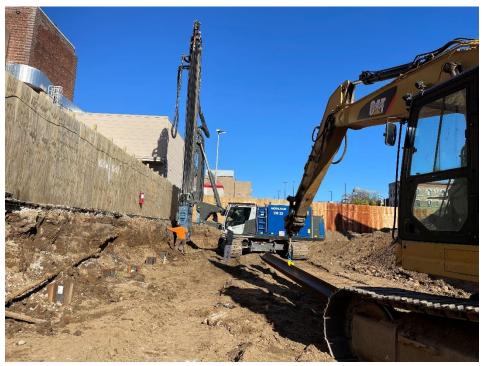
Photo 1: View of contractor installing H piles in Lot 14, facing west.

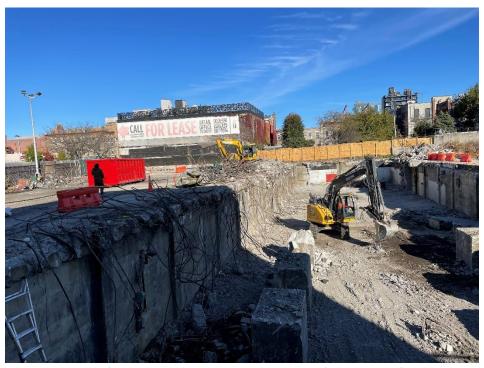
Photo 2: View of contractor stockpiling demo debris from Lot 53, facing north.
