Project	Bedford Beverly Brownfield	Report No.	27
	Site		
BCP Site	BCP Site No. C224384	Date	11/10/2023
Location	2359 and 2360 Bedford	File No.	0205432
	Avenue, Brooklyn, NY		
Client	Bedford Beverly Acquisitions	Temperature	45-54 °F
	LLC, Star Demolition (Star),		
	Maman Contracting (Maman),		
	International Concrete		
Contractor	Haley & Aldrich	Wind Direction	W to E, 20 mph
Weather	Mostly Cloudy	Personnel on	D. Djombalic & E. Nunez
		Site	
Humidity	70%	Time on Site	6:50am to 3:10pm

Haley & Aldrich of New York (Haley & Aldrich) was present to document implementation of the Remedial Action Work Plan (RAWP) prepared by Haley & Aldrich currently under review by NYSDEC and the NYSDEC-approved Change of Use dated 17 August 2023 to begin support of excavation work. Site observations are summarized below.

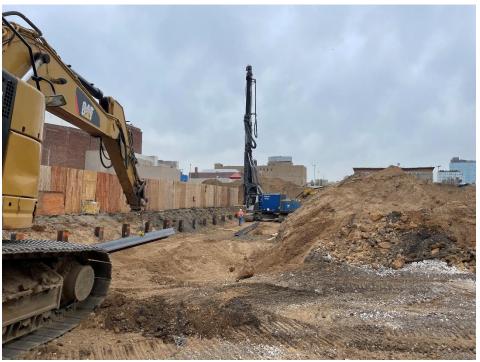
Photo 1: View of contractor installing H piles in Lot 14, facing north-northwest.

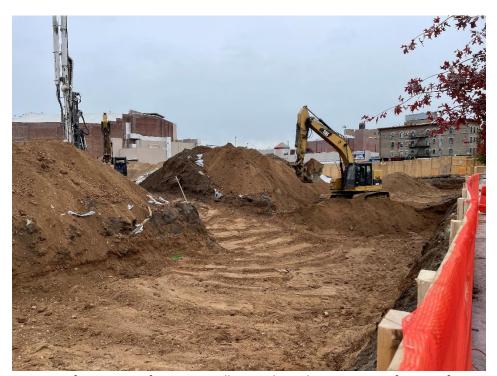
Photo 2: View of excavation for SOE installation along the perimeter of Lot 14, facing north.
