Project	Bedford Beverly Brownfield	Report No.	28
	Site		
BCP Site	BCP Site No. C224384	Date	11/13/2023
Location	2359 and 2360 Bedford	File No.	0205432
	Avenue, Brooklyn, NY		
Client	Bedford Beverly Acquisitions	Temperature	32-49 °F
	LLC, Star Demolition (Star),		
	Maman Contracting (Maman),		
	International Concrete		
Contractor	Haley & Aldrich	Wind Direction	N to S, 4 mph
Weather	Sunny	Personnel on	N. Mooney & E. Nunez
		Site	
Humidity	76%	Time on Site	6:50am to 3:30pm

Haley & Aldrich of New York (Haley & Aldrich) was present to document implementation of the Remedial Action Work Plan (RAWP) prepared by Haley & Aldrich currently under review by NYSDEC and the NYSDEC-approved Change of Use dated 17 August 2023 to begin support of excavation work. Site observations are summarized below.

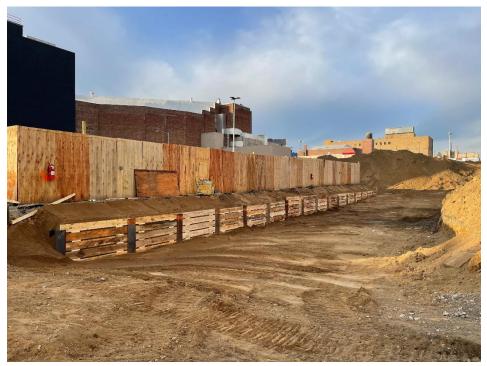
Photo 1: View of H piles and lagging installed in Lot 14, facing north-northwest.

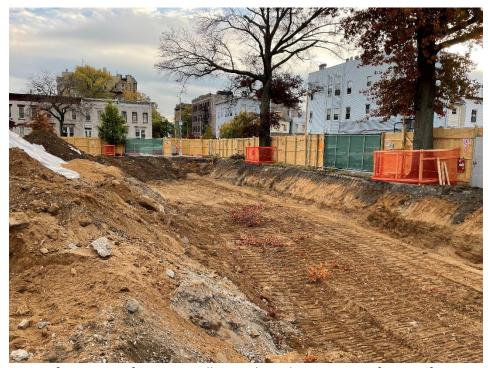
Photo 2: View of excavation for SOE installation along the perimeter of Lot 14, facing southwest.
