Project	Bedford Beverly Brownfield	Report No.	31
	Site		
BCP Site	BCP Site No. C224384	Date	11/16/2023
Location	2359 and 2360 Bedford	File No.	0205432
	Avenue, Brooklyn, NY		
Client	Bedford Beverly Acquisitions	Temperature	43-65 °F
	LLC, Star Demolition (Star),		
	Maman Contracting (Maman),		
	International Concrete		
Contractor	Haley & Aldrich	Wind Direction	SW to NE, 3 mph
Weather	Sunny	Personnel on	D. Djombalic & E. Nunez
		Site	
Humidity	45%	Time on Site	6:50am to 3:30pm

Haley & Aldrich of New York (Haley & Aldrich) was present to document implementation of the Remedial Action Work Plan (RAWP) prepared by Haley & Aldrich currently under review by NYSDEC and the NYSDEC-approved Change of Use dated 17 August 2023 to begin support of excavation work. Site observations are summarized below.

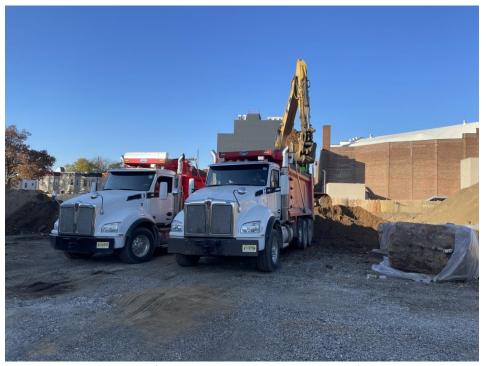
Photo 1: View of contractor loading soil in Lot 14, facing west.

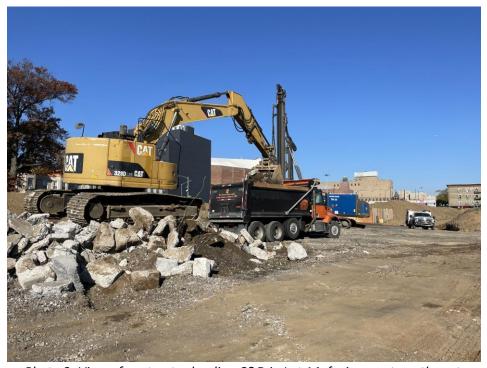
Photo 2: View of contractor loading C&D in Lot 14, facing west-southwest.
