Project	Bedford Beverly Brownfield	Report No.	35
-	Site		
BCP Site	BCP Site No. C224384	Date	11/22/2023
Location	2359 and 2360 Bedford	File No.	0205432
	Avenue, Brooklyn, NY		
Client	Bedford Beverly Acquisitions	Temperature	48-56 °F
	LLC, Star Demolition (Star),		
	Maman Contracting (Maman),		
	International Concrete		
Contractor	Haley & Aldrich	Wind Direction	SW to NE, 7 mph
Weather	Rainy	Personnel on	D. Djombalic & A. Vaculik
		Site	
Humidity	82%	Time on Site	5:45am to 4:30pm

Haley & Aldrich of New York (Haley & Aldrich) was present to document implementation of the Remedial Action Work Plan (RAWP) prepared by Haley & Aldrich currently under review by NYSDEC and the NYSDEC-approved Change of Use dated 17 August 2023 to begin support of excavation work. Site observations are summarized below.

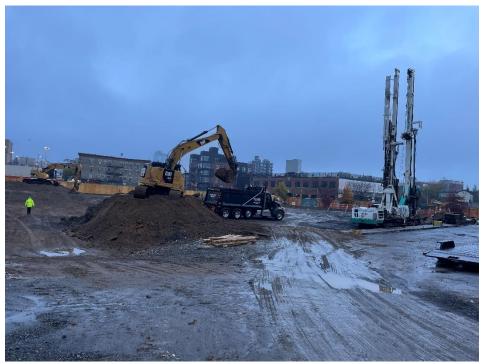
Photo 1: View of contractor loading soil in Lot 14, facing north.

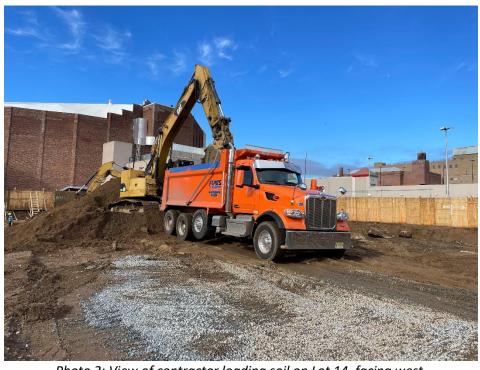
Photo 2: View of contractor loading soil on Lot 14, facing west.
