SITE OBSERVATION REPORT

PROJECT No.: 170381202

250 Water Street

Langan was present to document remediation activities in accordance with the NYSDEC-approved November 2021 Remedial Action Work Plan (RAWP) at the 250 Water Street site (NYSDEC Brownfield Cleanup Program [BCP] Site No C231127).

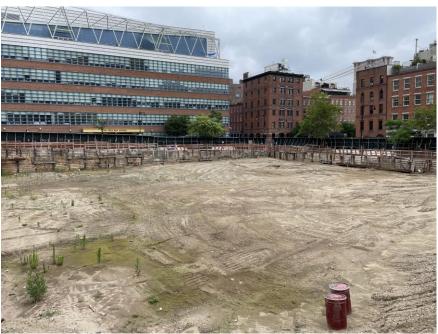
Photo 1: General view of the site (facing east)
