**Review Avenue Development Sites I & II**  
37-30 & 37-80 Review Avenue  
Long Island City, New York 11101  
Photographic Log for Remedial Action

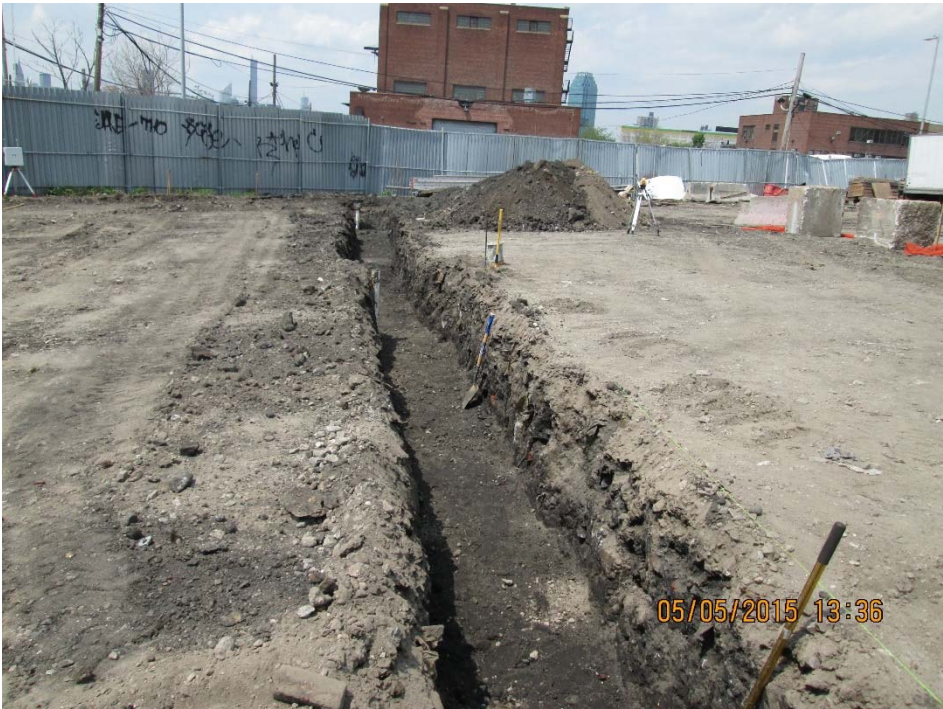
Photograph 1: TF-4 trench on RAD II

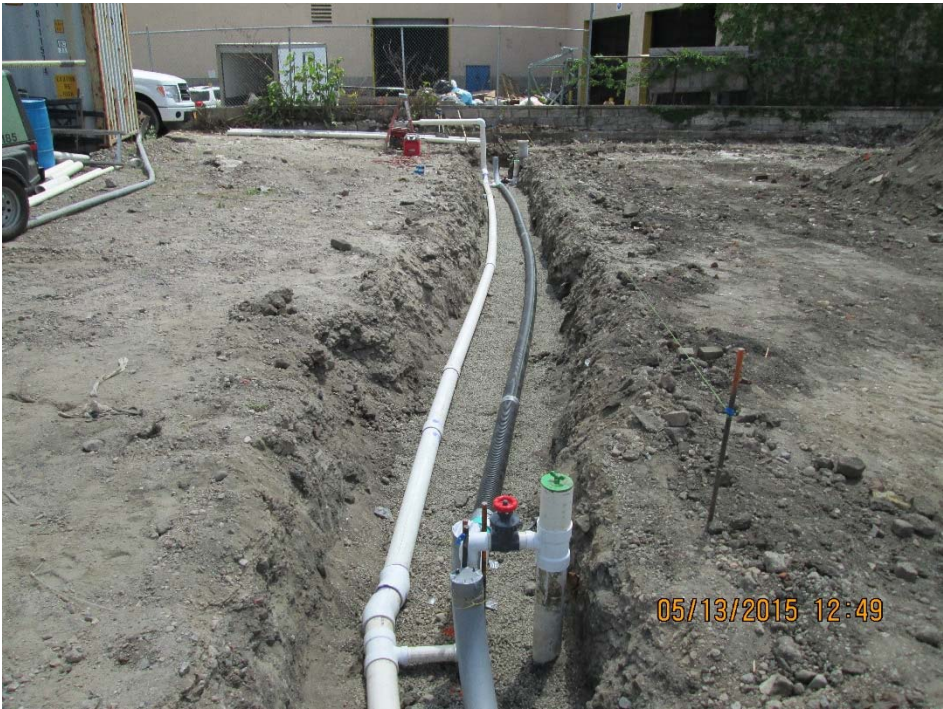
Photograph 2: VER piping in TF-3 trench on RAD II

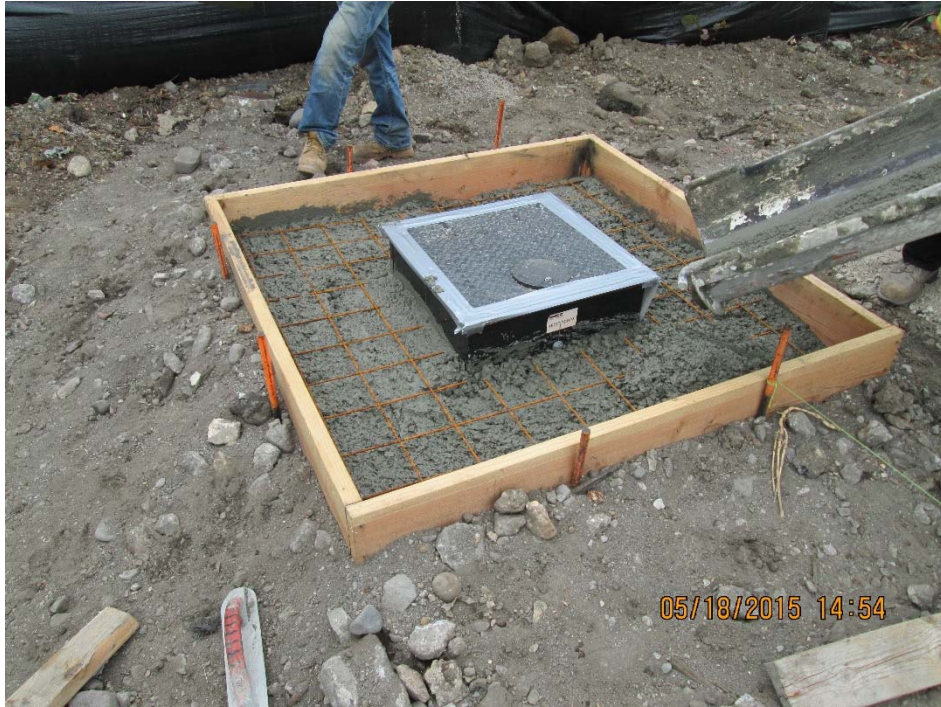
Photograph 3: Construction of well vault pad

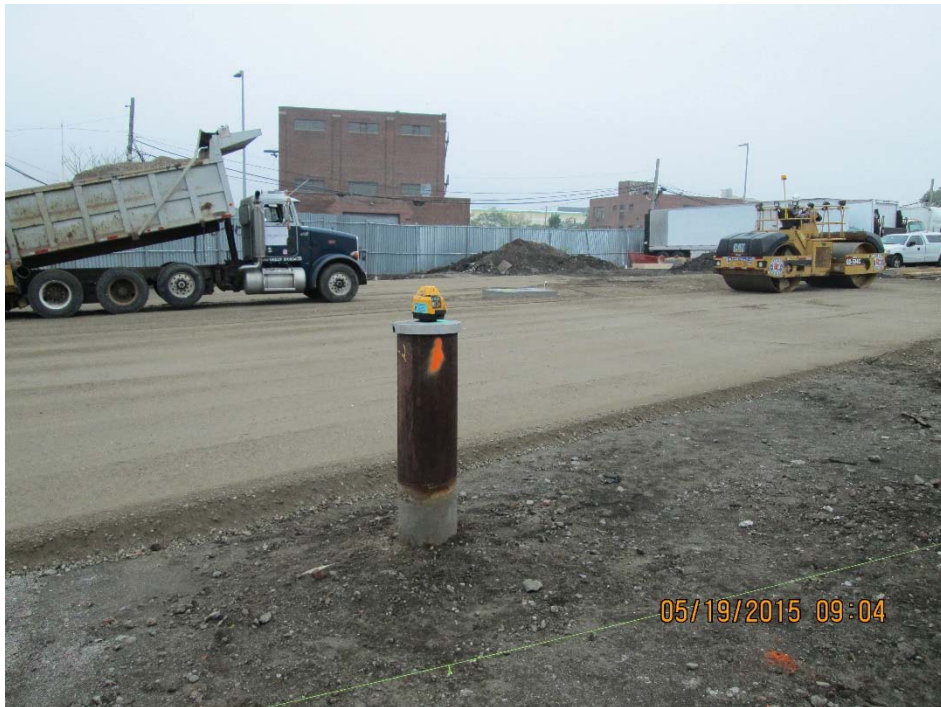
Photograph 4: Compacting DGA on RAD II

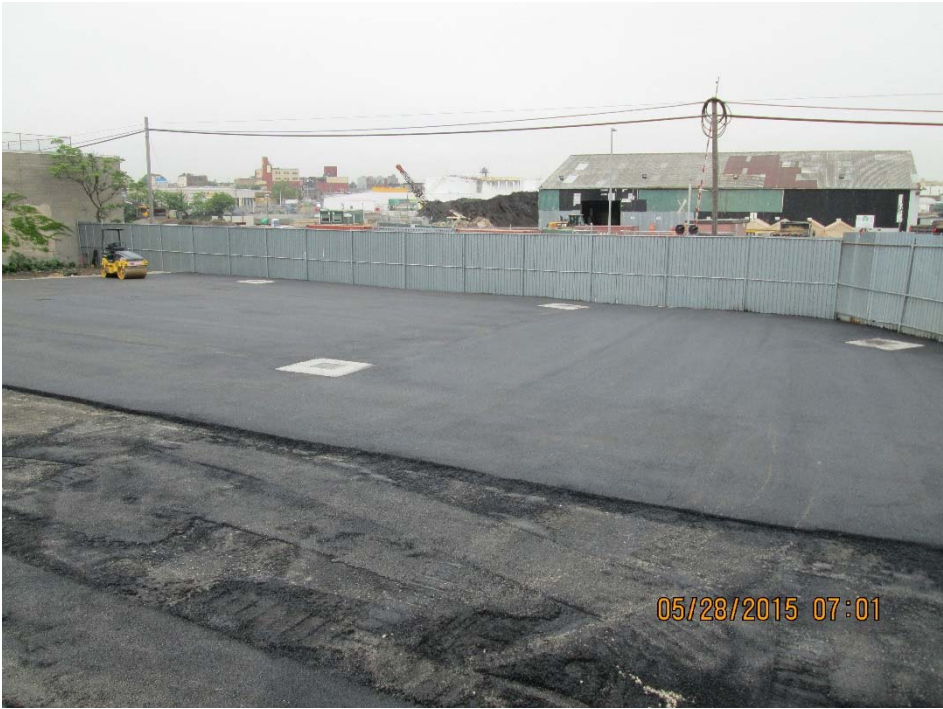
Photograph 5: New asphalt on RAD II

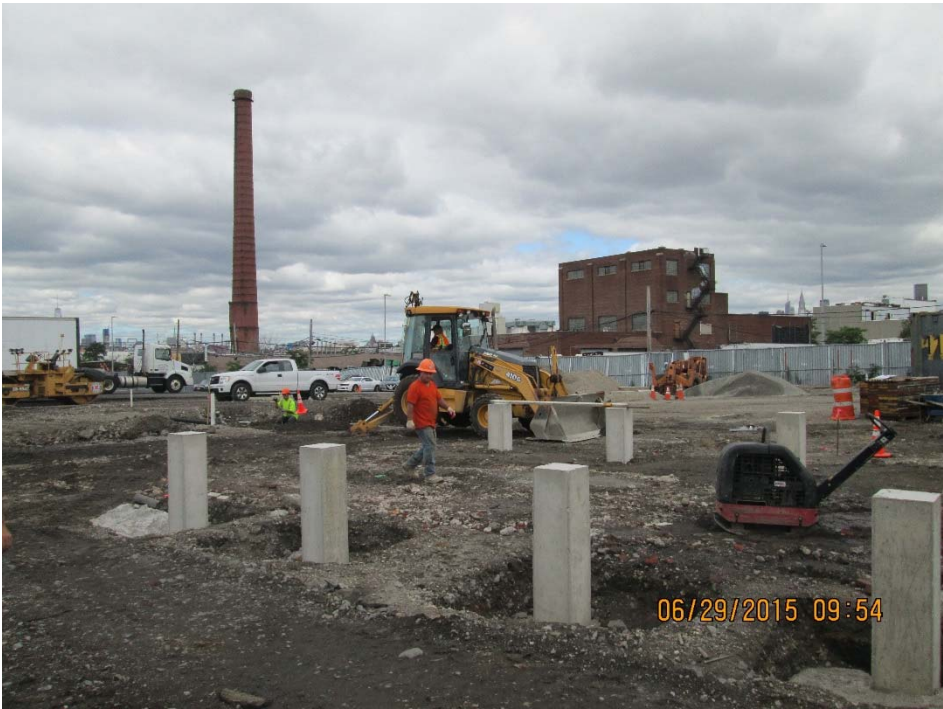
Photograph 6: Footings for equipment trailers

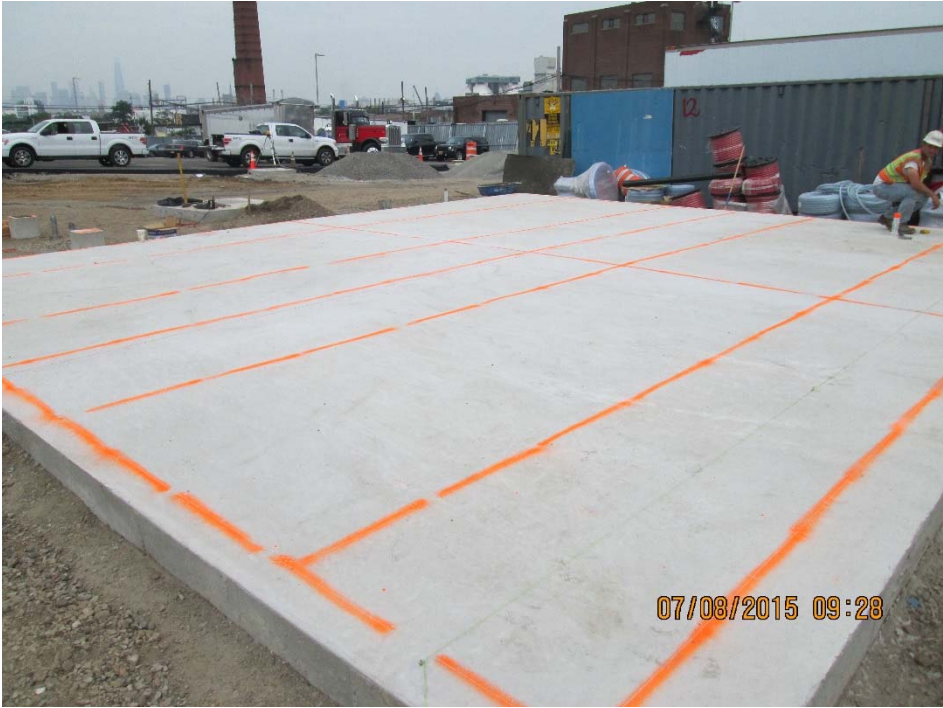
Photograph 7: Concrete pad for storage tanks

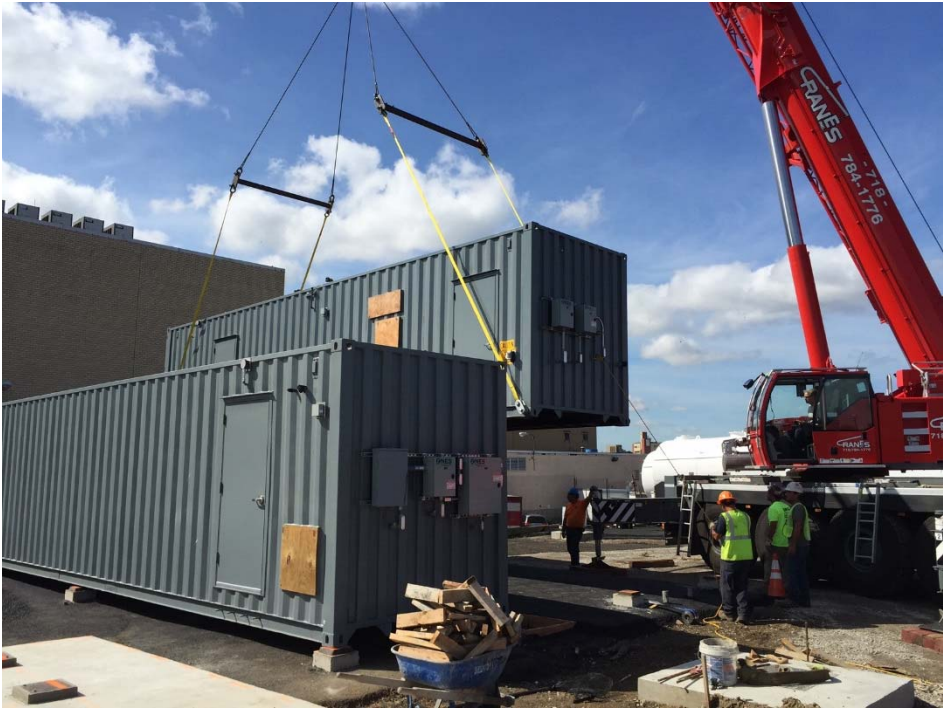
Photograph 8: Equipment trailers

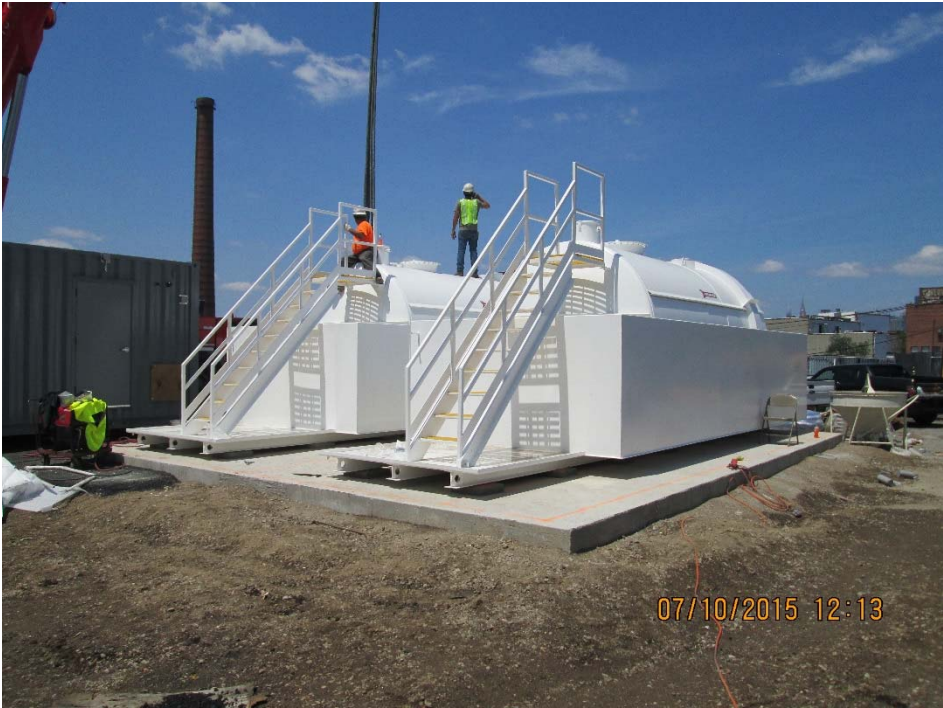
Photograph 9: Storage tanks

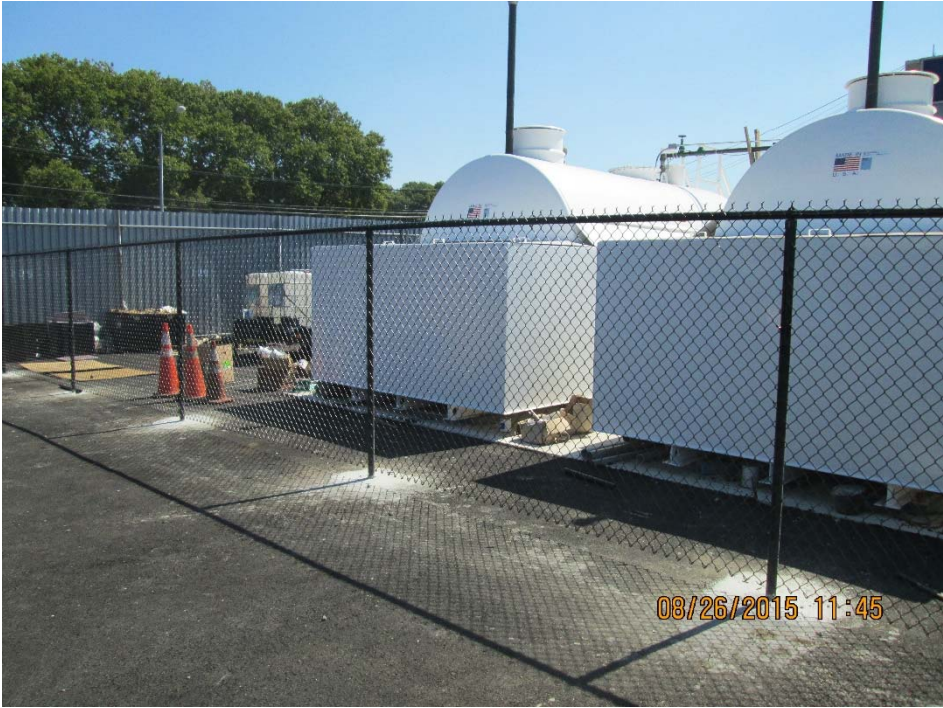
Photograph 10: Security fence around treatment area

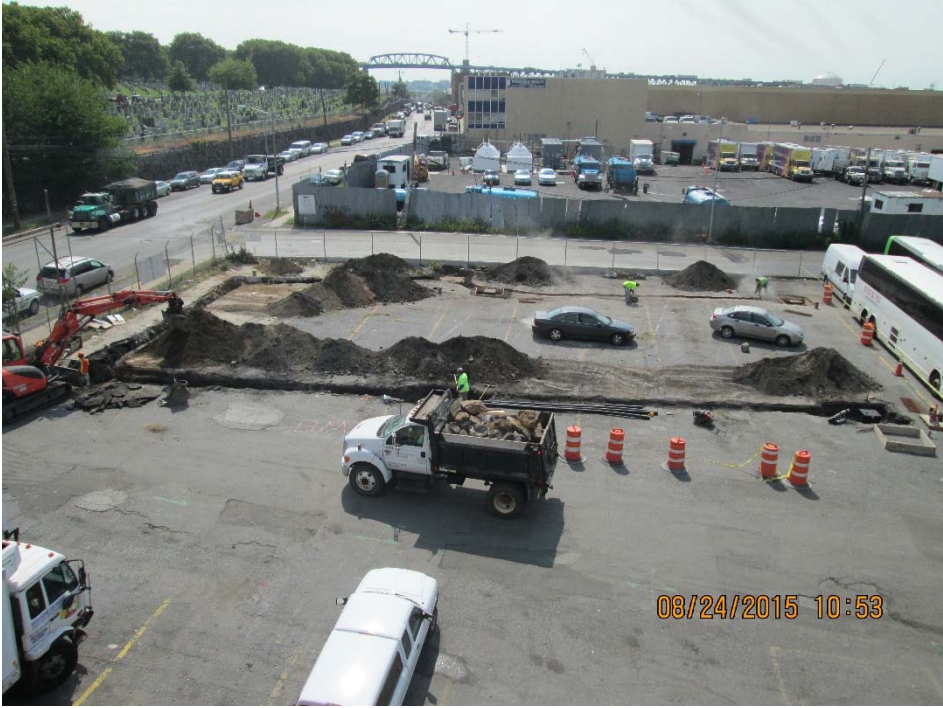
Photograph 11: Trenching operations on RAD I

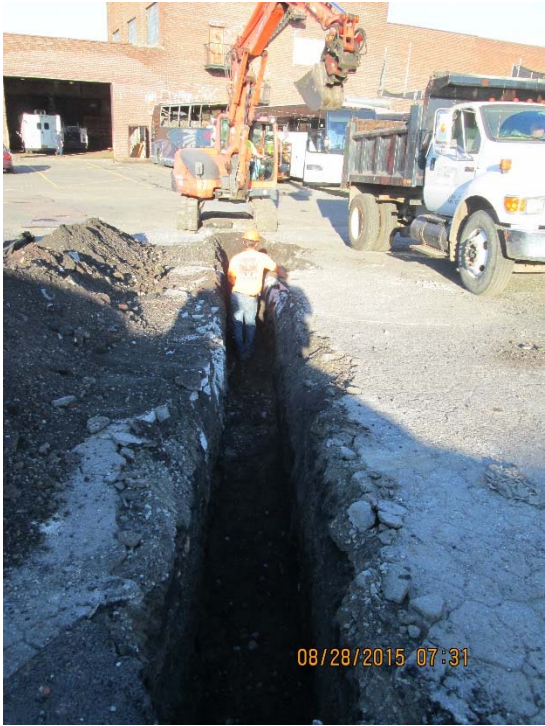
Photograph 12: Excavating trench on RAD I

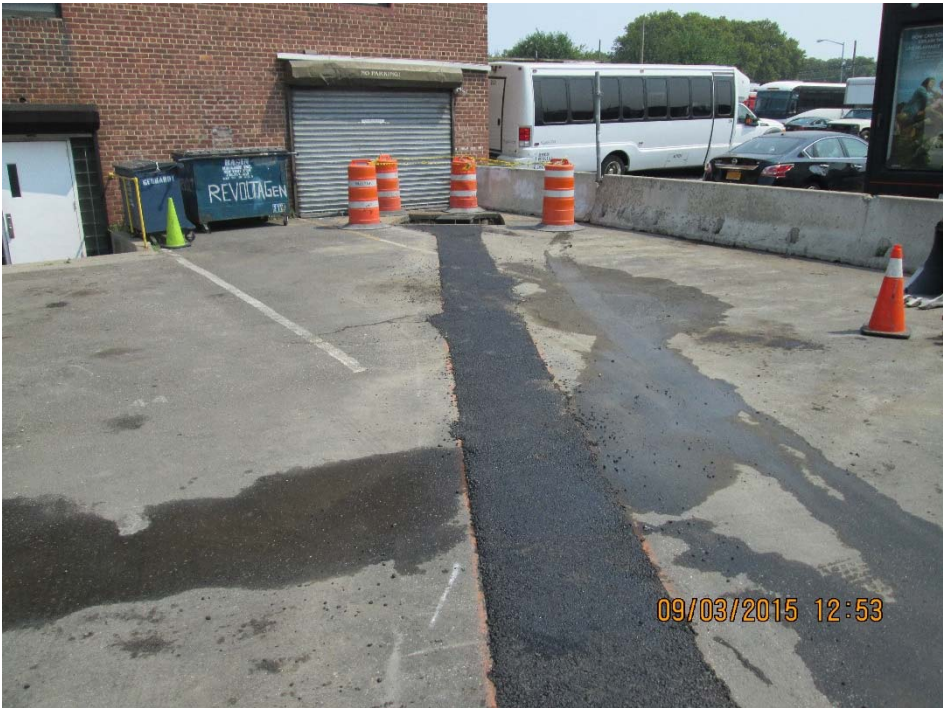
Photograph 13: Trench restoration on RAD I

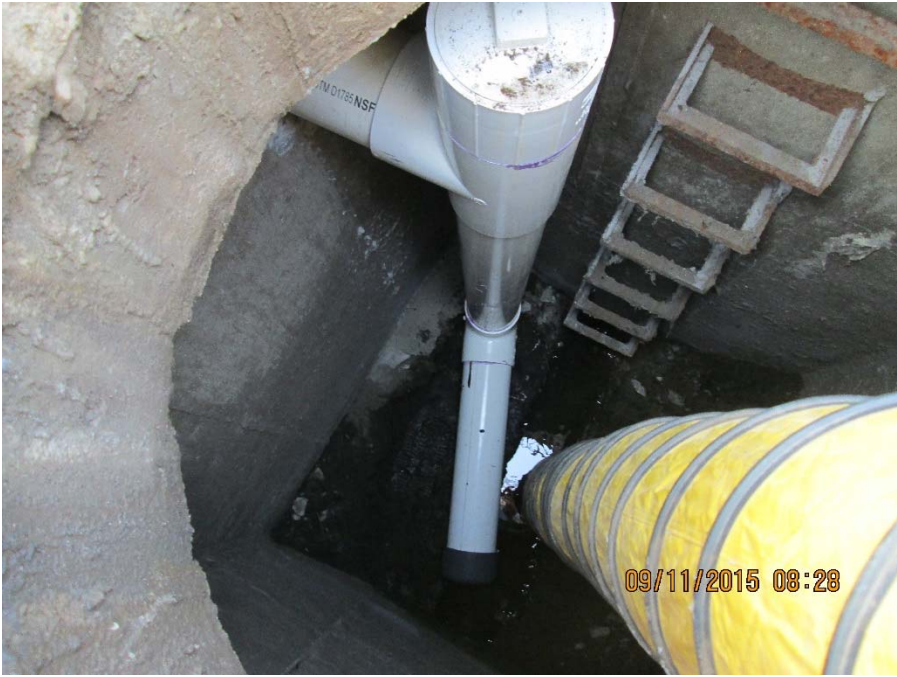
Photograph 14: Installation of force main sewer discharge pipe

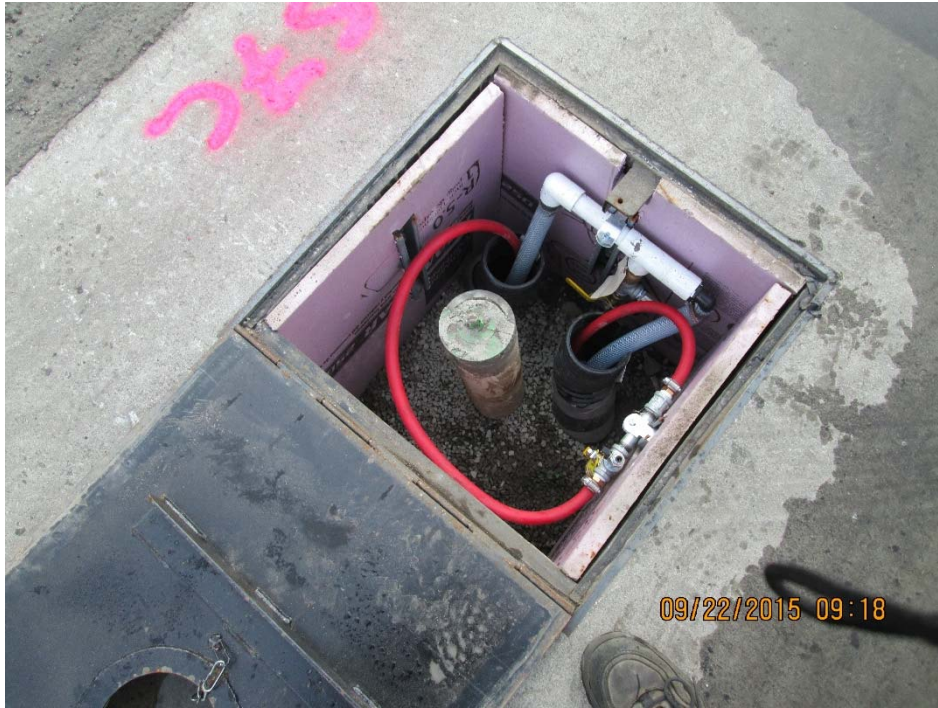
Photograph 15: Construction of recovery well piping

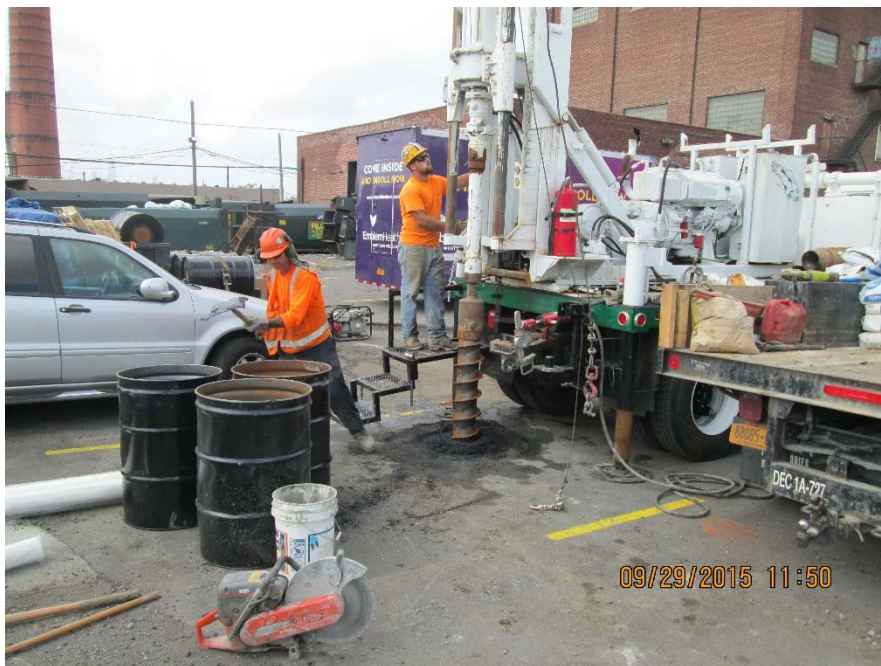
Photograph 16: Monitoring well installation
