**RE: 2016 Offsite Sub-Slab Depressurization Systems Annual Inspection Report
DeWalt Service Center, 56-15 Queens Boulevard in Woodside, New York
BCP Site No. C241129**

This report documents the annual inspection of offsite sub-slab depressurization (SSD) systems installed in connection with the above referenced site. At the request of the New York State Department of Environmental Conservation (NYSDEC) and the New York State Department of Health (NYSDOH), SSD systems have been installed at the following six offsite properties to mitigate risks associated with volatile organic compounds (VOCs) in soil vapor:

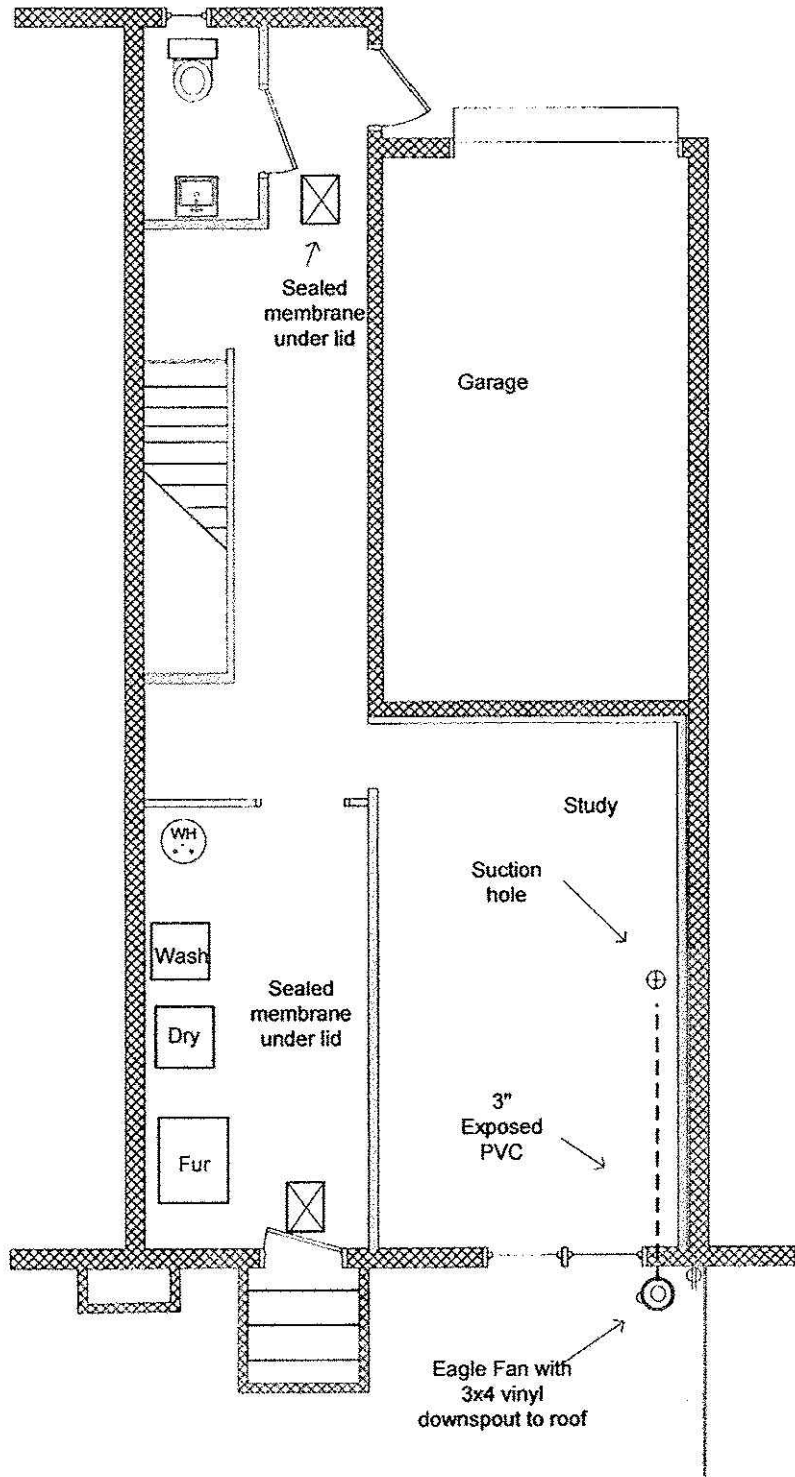
FIGURE 2

An inspection of the SSD system was performed on December 20, 2016. The manometer located on the PVC vacuum pipe indicated that the system was adequately pressurized. Penetration seals at the vacuum points and foundation wall were observed to be in good condition with no evidence of leakage. All PVC pipe joints were noted to be tightly sealed. The exterior fan was on and functioning properly. The exhaust pipe was in good condition and was not obstructed. No new air intakes were identified in the vicinity of the SSD system exhaust pipe.

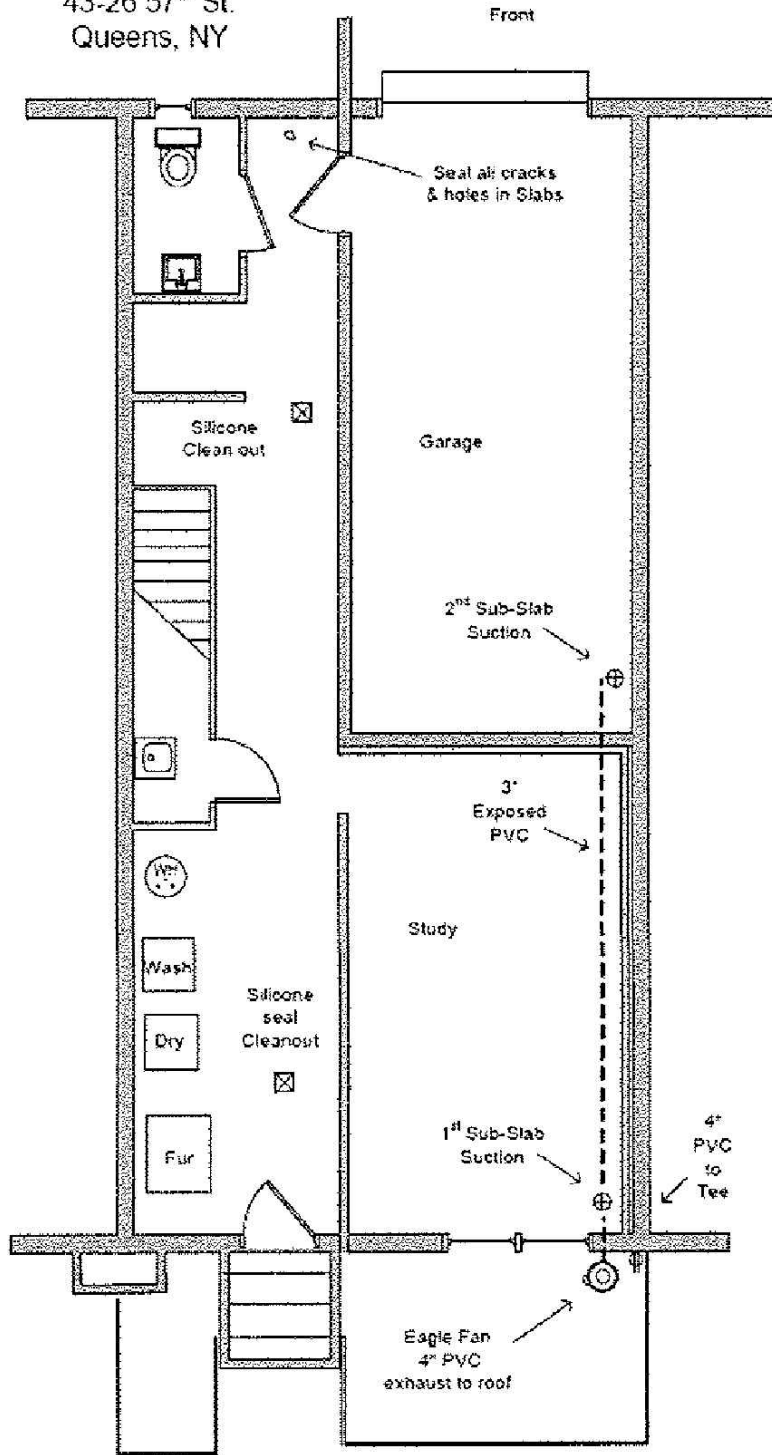
FIGURE 3

An inspection of the SSD system was performed on April 13, 2016. The manometer located on the PVC vacuum pipe indicated that the system was adequately pressurized. Penetration seals at the vacuum points and foundation wall were observed to be in good condition. All PVC pipe joints were noted to be tightly sealed. The exterior fan was on and functioning properly. The

exhaust pipe was in good condition and was not obstructed. No new air intakes were identified in the vicinity of the exhaust pipe.

The SSD system was found to be in good condition, operating properly, and did not require any repairs.

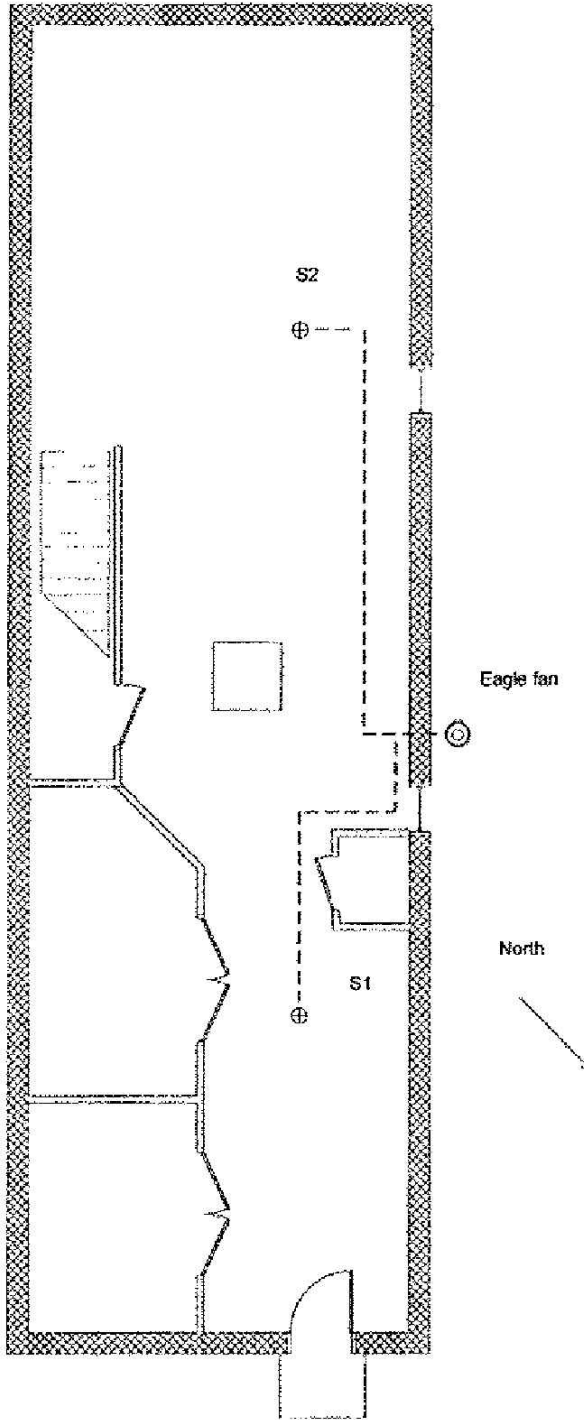
FIGURE 4

An inspection of the SSD system was performed on April 13, 2016. The manometer located on the PVC vacuum pipe indicated that the system was adequately pressurized. Seals observed at the vacuum point and at the foundation wall were noted to be in good condition. All PVC pipe joints were noted to be tightly sealed. The exterior fan was on and functioning properly. The exhaust pipe was in good condition and was not obstructed. No new air intakes were identified in the vicinity of the exhaust pipe.

The SSD system was found to be in good condition, operating properly, and did not require any repairs.

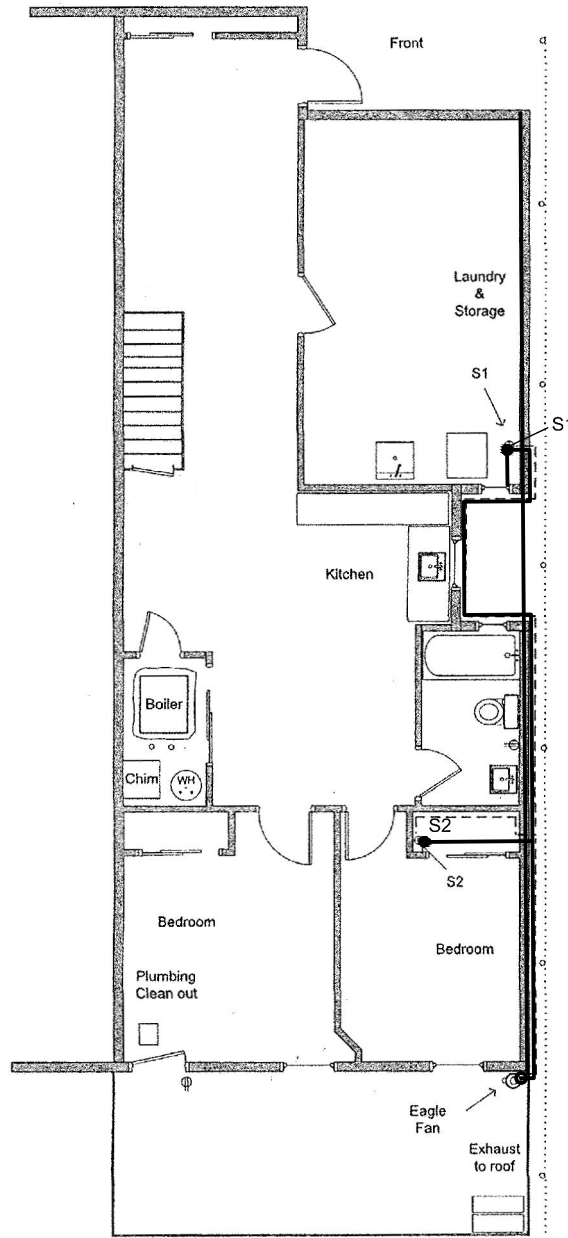
FIGURE 5

Accessible portions of the SSD system were inspected on April 13, 2016. The manometer is located within an area leased as tenant space and was not accessible by property owner. The fan was in operation and appeared to be functioning properly. All visible pipe joints were noted to be tightly sealed. The exhaust pipe was observed to be in good condition and was not obstructed. No new air intakes were identified in the vicinity of the exhaust pipe.

Accessible portions of the SSD system were found to be in good condition, operating properly, and did not require any repairs.

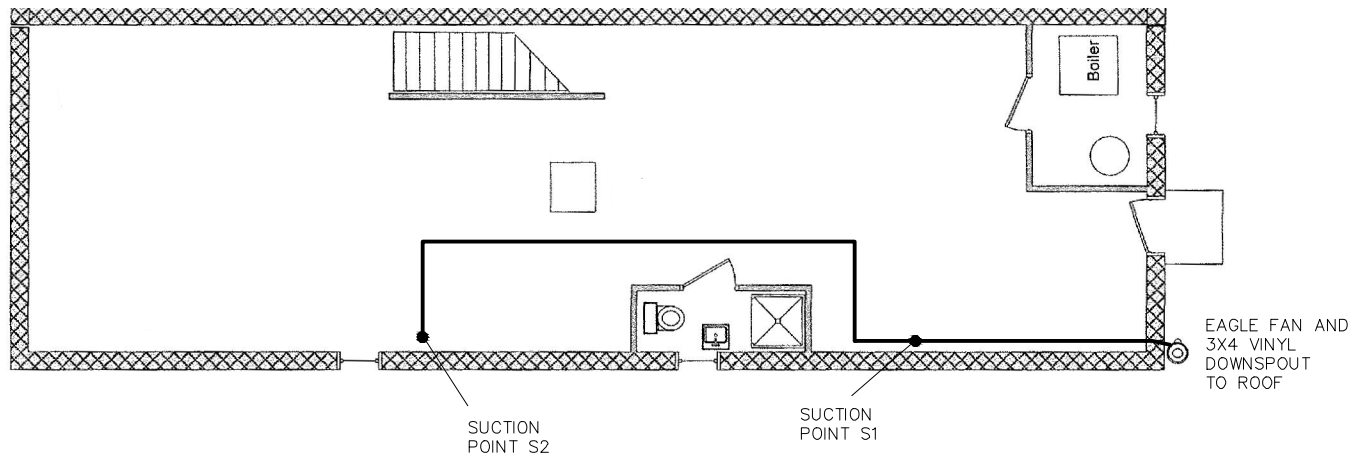
FIGURE 6

An inspection of the SSD system was performed on April 14, 2016. The manometer located on the PVC vacuum pipe indicated that the system was adequately pressurized. Seals observed at the vacuum point and at the foundation wall were noted to be in good condition. All PVC pipe joints were noted to be tightly sealed. The exterior fan was on and functioning properly. The exhaust pipe was in good condition and was not obstructed. No new air intakes were identified in the vicinity of the SSD system exhaust pipe.

The SSD system was found to be in good condition, operating properly, and did not require any repairs.

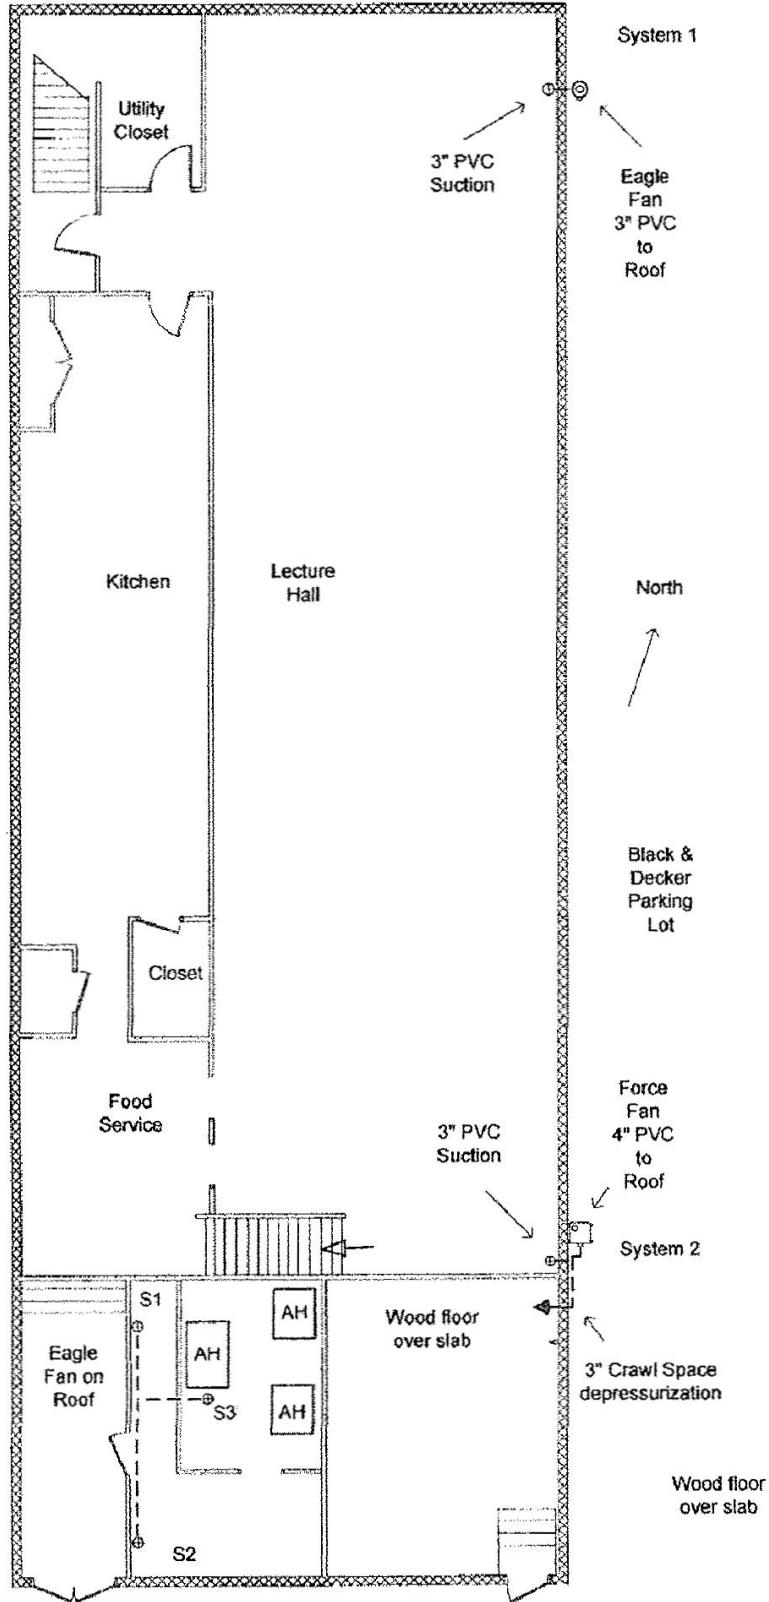
FIGURE 7

An inspection of the three SSD systems was performed on April 13, 2016. The manometers for SSD Systems 1, 2, and 3 indicated that the systems were adequately pressurized. Penetration seals at the foundation walls and vacuum points were noted to be in good condition. The exterior fans for Systems 1, 2, and 3 were on and functioning properly. The exhaust pipes were in good condition and were not obstructed. No new air intakes were identified in the vicinity of the SSD system exhaust pipes.

The SSD systems were found to be in good condition, operating properly, and did not require any repairs.
