ENGINEERING REPORT

Prepared for
Corporation of the Presiding Bishop of The Church of Jesus Christ of Latter-day Saints
c/o Latham & Watkins LLP
885 Third Ave
New York, NY 10022-4834

December 21, 2012

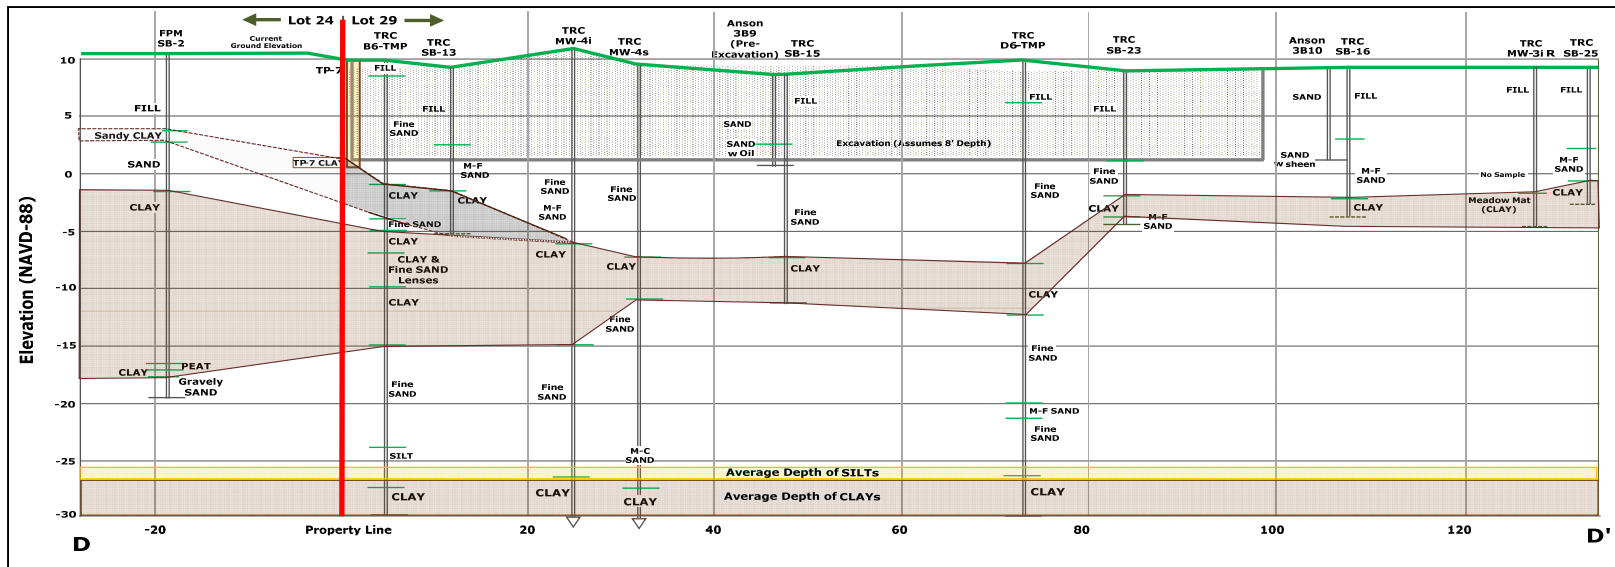
Figure 8 Cross-Section D-D'

Cross-Section D – D' demonstrates the sloping clay layer on Lot 24 that extends from high levels on Lot 24 towards lower levels on Lot 29. On the basis of this, and the influence of the former Norton Creek channel on all cross-sections, I can now conclude that the intermediate clay layer slopes from Lot 24 to Lot 29 at most if not all locations near the property line between Lot 29 and Lot 24.

In Cross-Section D-D' the intermediate clay layer is shown to slope from higher elevations on Lot 24 to lower elevations on Lot 29. This is contrary to the interpretation made by Davis that the intermediate clay slopes in the opposite direction. The reason for Davis' erroneous interpretation is that she did not evaluate all of the boring logs available when she developed her cross-section (Figure 14 of her report) and, instead, made her conclusion based on an inadequate set of information that ignored appropriate data. Additionally, of the two boring logs that she used, one of them, FPM B-3, was projected 15 feet from an area where the clay was higher in elevation, while other more appropriate borings directly on the cross-sectional line were ignored, (including TRC TMP B-6, TRC SB-13, TRC MW-4i, TRC MW-4s, and TRC SB-15). The result was an incorrect interpretation of the slope of the clay by Davis.

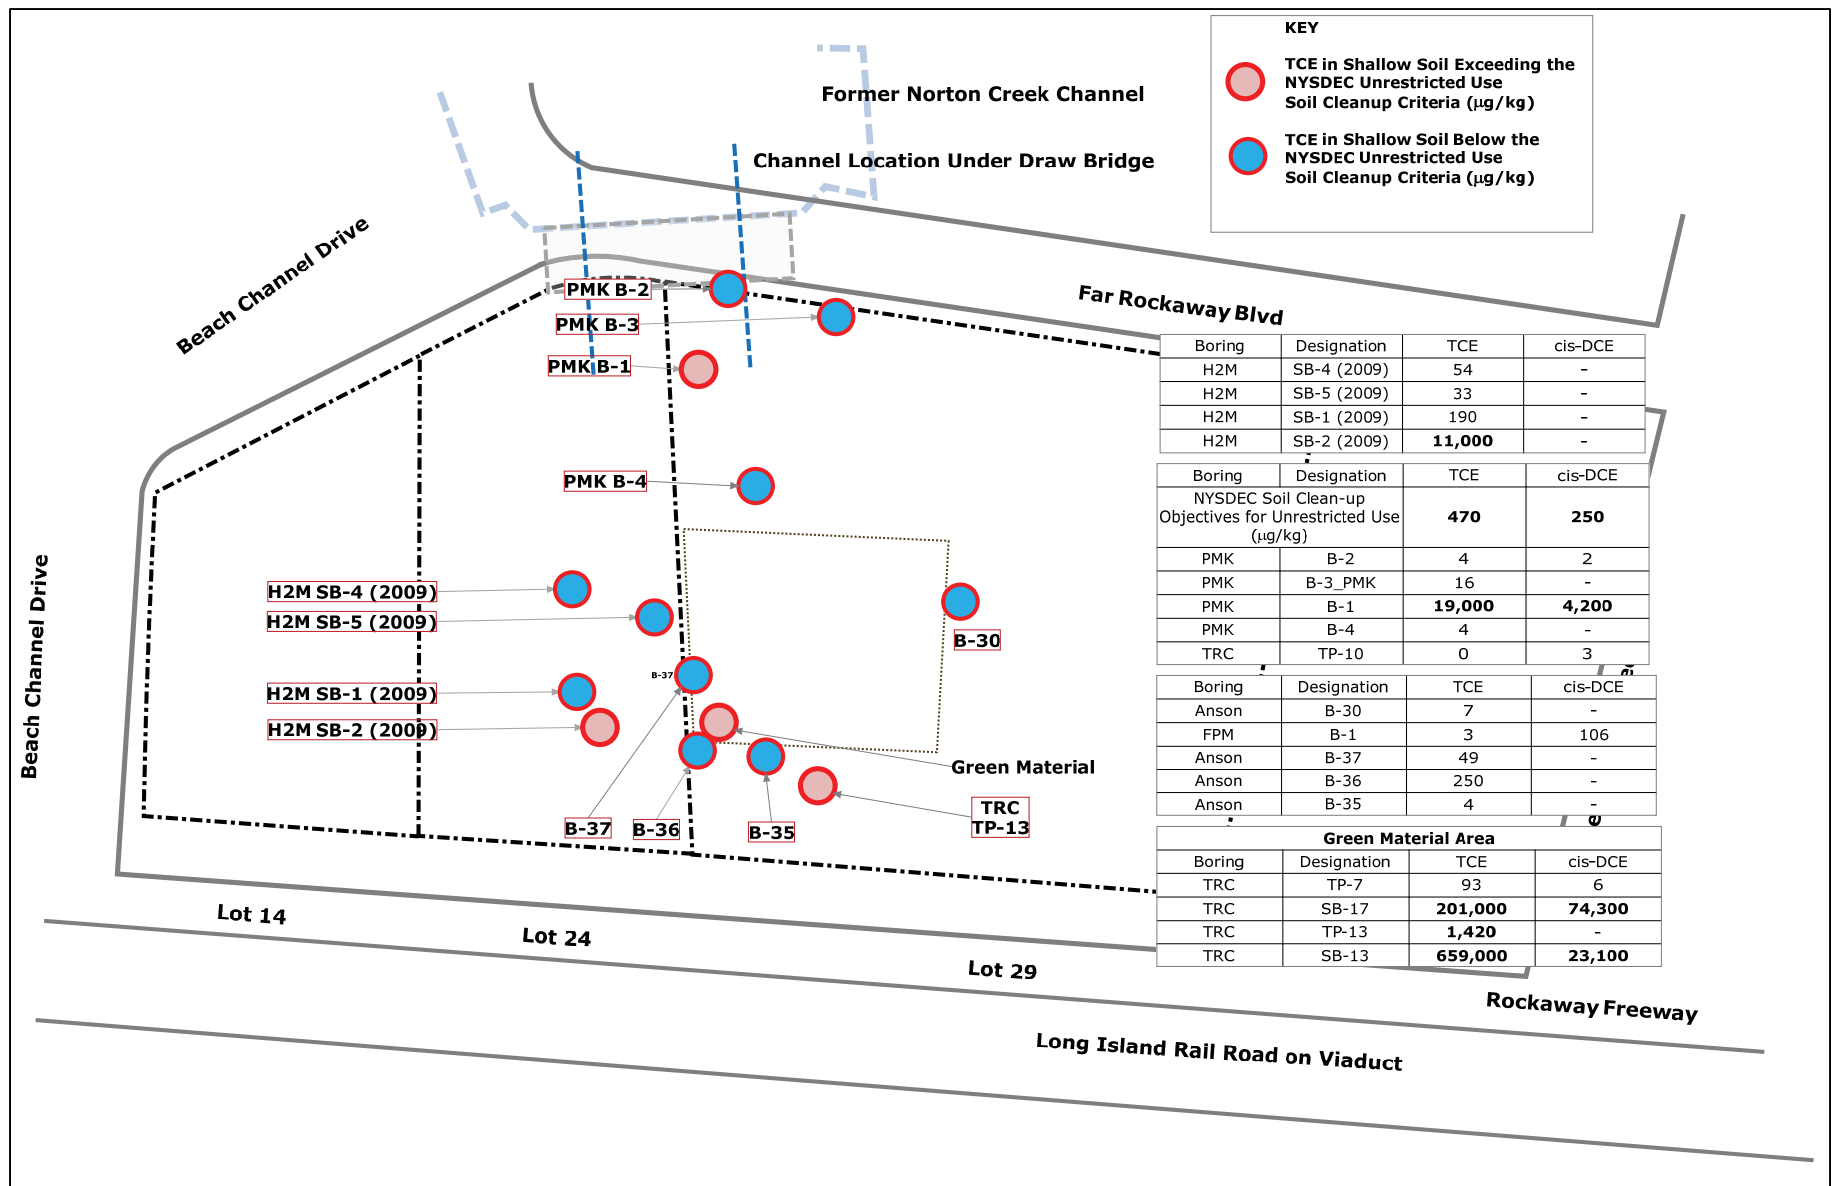
Figure 12 Occurrences of TCE and cis-DCE in Shallow Soil

Lot 24 has several locations where TCE was detected in shallow samples above groundwater. The location with the highest concentration of TCE is at the H2M boring SB – 2 collected in 2009. In this boring, 11,000 µg/kg of TCE were found at a depth of 2.5 feet. TCE was also found in other H2M borings above groundwater, including SB – 1, SB – 4 and SB – 5 at concentrations ranging from 33 to 190 µg/kg. These detections of TCE at dispersed locations and at shallow depths are consistent with the placement of fill laden with TCE as the source of the contamination, which is the most reasonable explanation for the TCE detections on Lot 24, or with a spill of TCE on the ground surface. Figure 11 shows the wide distribution of TCE detections in shallow soil.

The TCE soil concentration at 2 ½ feet below ground in boring SB – 2 is upgradient of groundwater contamination and upslope along the intermediate clay layer. I therefore conclude that there are multiple, independent sources of TCE contamination, some of which are located on Lot 24 and unrelated to the sources of contamination on Lot 29.

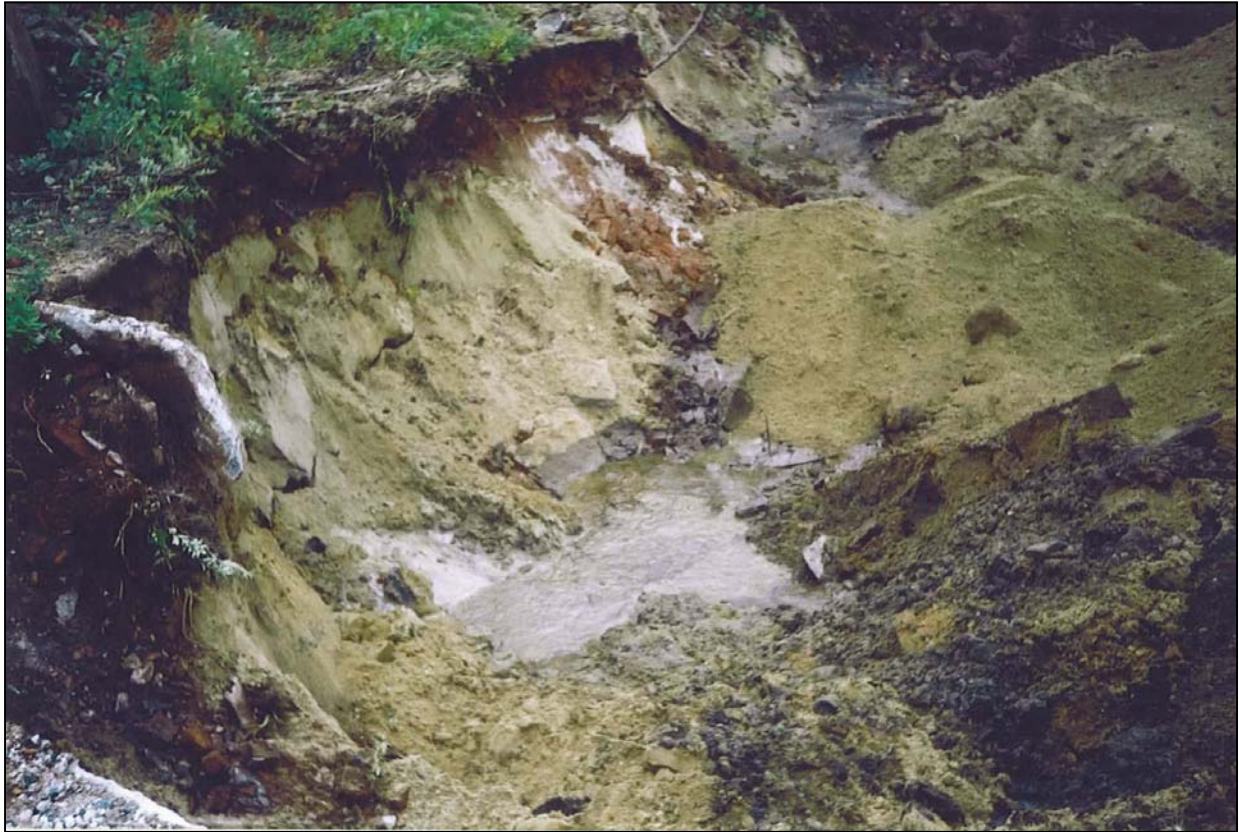
Figure 13 Photograph of Green Material (Anson 00000006)

The green material was identified in the southwest corner of the foundation during excavation of petroleum contaminated soil. The green material was encountered at as little as two to three feet below ground surface. (Tegins Tr. 62:9-79:8). It extended beneath the foundation of the building according to Tegins, but not onto Lot 24. Tegins stated that the foundation material separated the green soil from the petroleum soils to a large degree, indicating that it was located within the foundations of the former building.

The green material was distinct from other soils encountered, allowing Anson to identify it by visual observation for removal purposes, and to investigate its extent without relying on chemical testing. For example, without the benefit of chemical testing to delineate the contamination, Tegins writes in a memo to the Church (See LDS00003466-LDS00003468 at LDS00003468):

“So in conclusion, I believe that we got all of the green stuff out of the unsaturated soils adjacent to the pit and we even excavated some of the green stuff that was below the water table.”

The green material does not appear to have been from the flow of TCE oil or other TCE laden liquid into previously clean soil. TCE oil means TCE undissolved in water and in a liquid form, which would constitute a DNAPL. For one, some of the green material is located at a depth of two to three feet below grade, which is above both the bottom of the foundation walls and the top of groundwater. Therefore, to contaminate clean soil, a liquid such as TCE oil would have to be introduced from above the green material within the confines of the building. The liquid delivering TCE to the soil would not flow in under the foundations and upwards to where the green material was found.

The green material already containing TCE was most likely placed in the ground during building construction. The green material extended under the spread footing of the building. The majority, if not all of the green material was located within the foundation (between foundation walls). In order for the green material to be located under a building floor and foundation and assuming that it was not created by a discharge from within the building (for which no evidence exists), it would have to have been placed there at the time of or prior to construction.

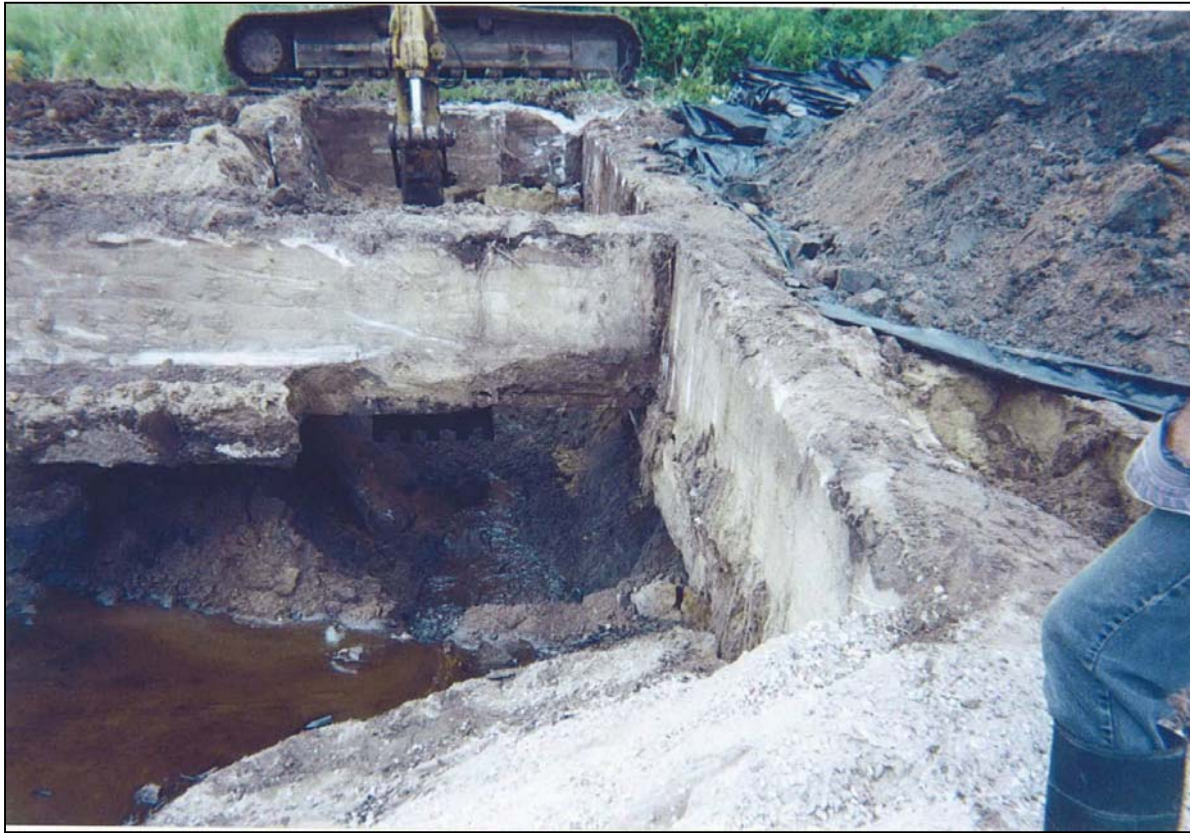
Figure 14 Foundations in the vicinity of the green material (Anson 00000027)

The green material appears to have been placed when the building was reconstructed in the 1960s as part of the expansion of building space on Lot 29. The foundation beneath the area where the green material was found is comprised of poured concrete walls on spread footings. The imprint of the forms used to fashion the concrete and create the walls are still apparent on the walls. The foundations are in good shape and appear relatively new, (see, for example, Figure 14 that shows the foundation wall and spread footing hanging in the air). Although a building first appears on Lot 29 in the 1924 Sanborn map, the age of the building appears inconsistent with the foundation encountered during the excavation of the contaminated soil in the area. Although not impossible, it is unlikely that a foundation built in the 1920s or earlier would be in as good shape as the foundation encountered by Anson. Therefore, it appears that the building under which the green material was found was reconstructed at the time an

additional building was constructed to the east. The construction of the foundations of these buildings occurred in the 1960s, and as part of or prior to this construction, TCE-laden fill was apparently deposited on Lot 29.

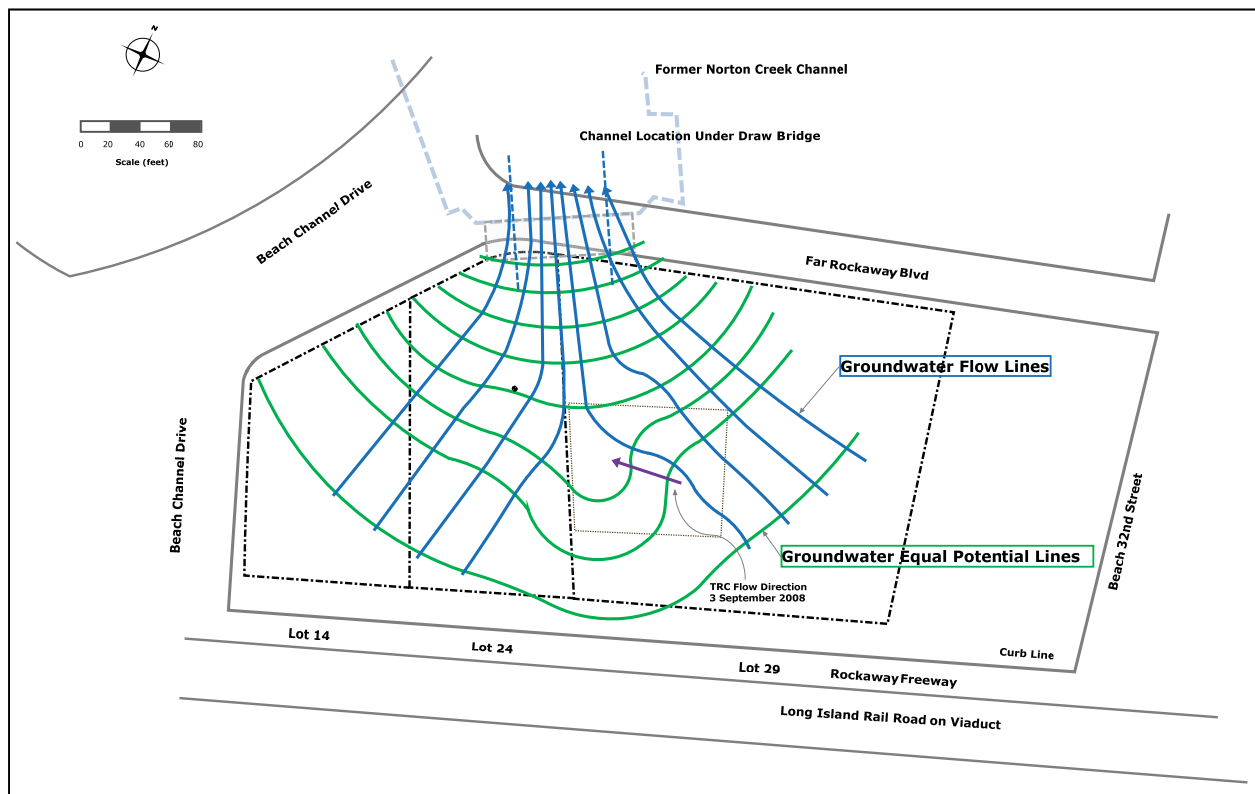
Figure 17 Flow of Groundwater at the Site

The result was a path for groundwater of higher hydraulic conductivity sands and gravels following the route of the former Norton Creek channel. This path of preferential flow bends the flow lines of groundwater on Lots 24 and 29, directing them toward the discharge point at Norton Bay. The resulting groundwater flow is shown in Figure 17. In Figure 17 the equal potential contours (green lines) and the groundwater flow lines (blue lines) are also shown.

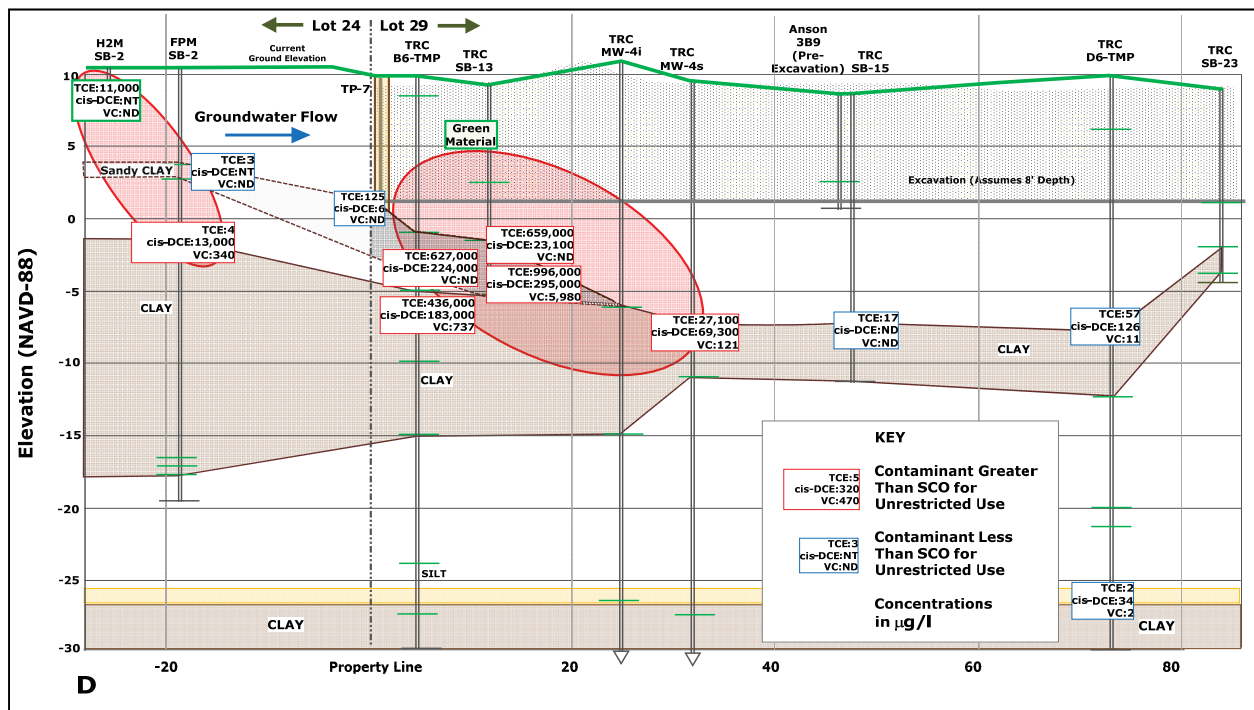
Figure 18 TCE Concentrations on Cross-Section D-D'

Figure 18 is the Cross-Section D – D' showing the concentrations of TCE detected at various locations in relationship to the organic clays under the ground. As can be seen, the occurrence of TCE at H2M SB-2 is too shallow to have been caused by the green material, or any other contaminants on Lot 29 even if there had been a flow from Lot 29 to Lot 24. The sample elevation is too high for this to occur. Additionally, there are samples below NYSDEC Soil Cleanup Objective for Unrestricted Use [6 NYCRR(375)(6)(a)] in between the green material on Lot 29 and the TCE contamination at SB-2 on Lot 24. The situation is the same at the other areas on Lot 24 where TCE was detected in shallow soil. The TCE contamination at these locations on Lot 24 did not come from Lot 29. Rather, the TCE in these areas came from the additional independent sources on Lot 24, including and in particular the contamination at the 2 ½ foot depth in boring SB-2.

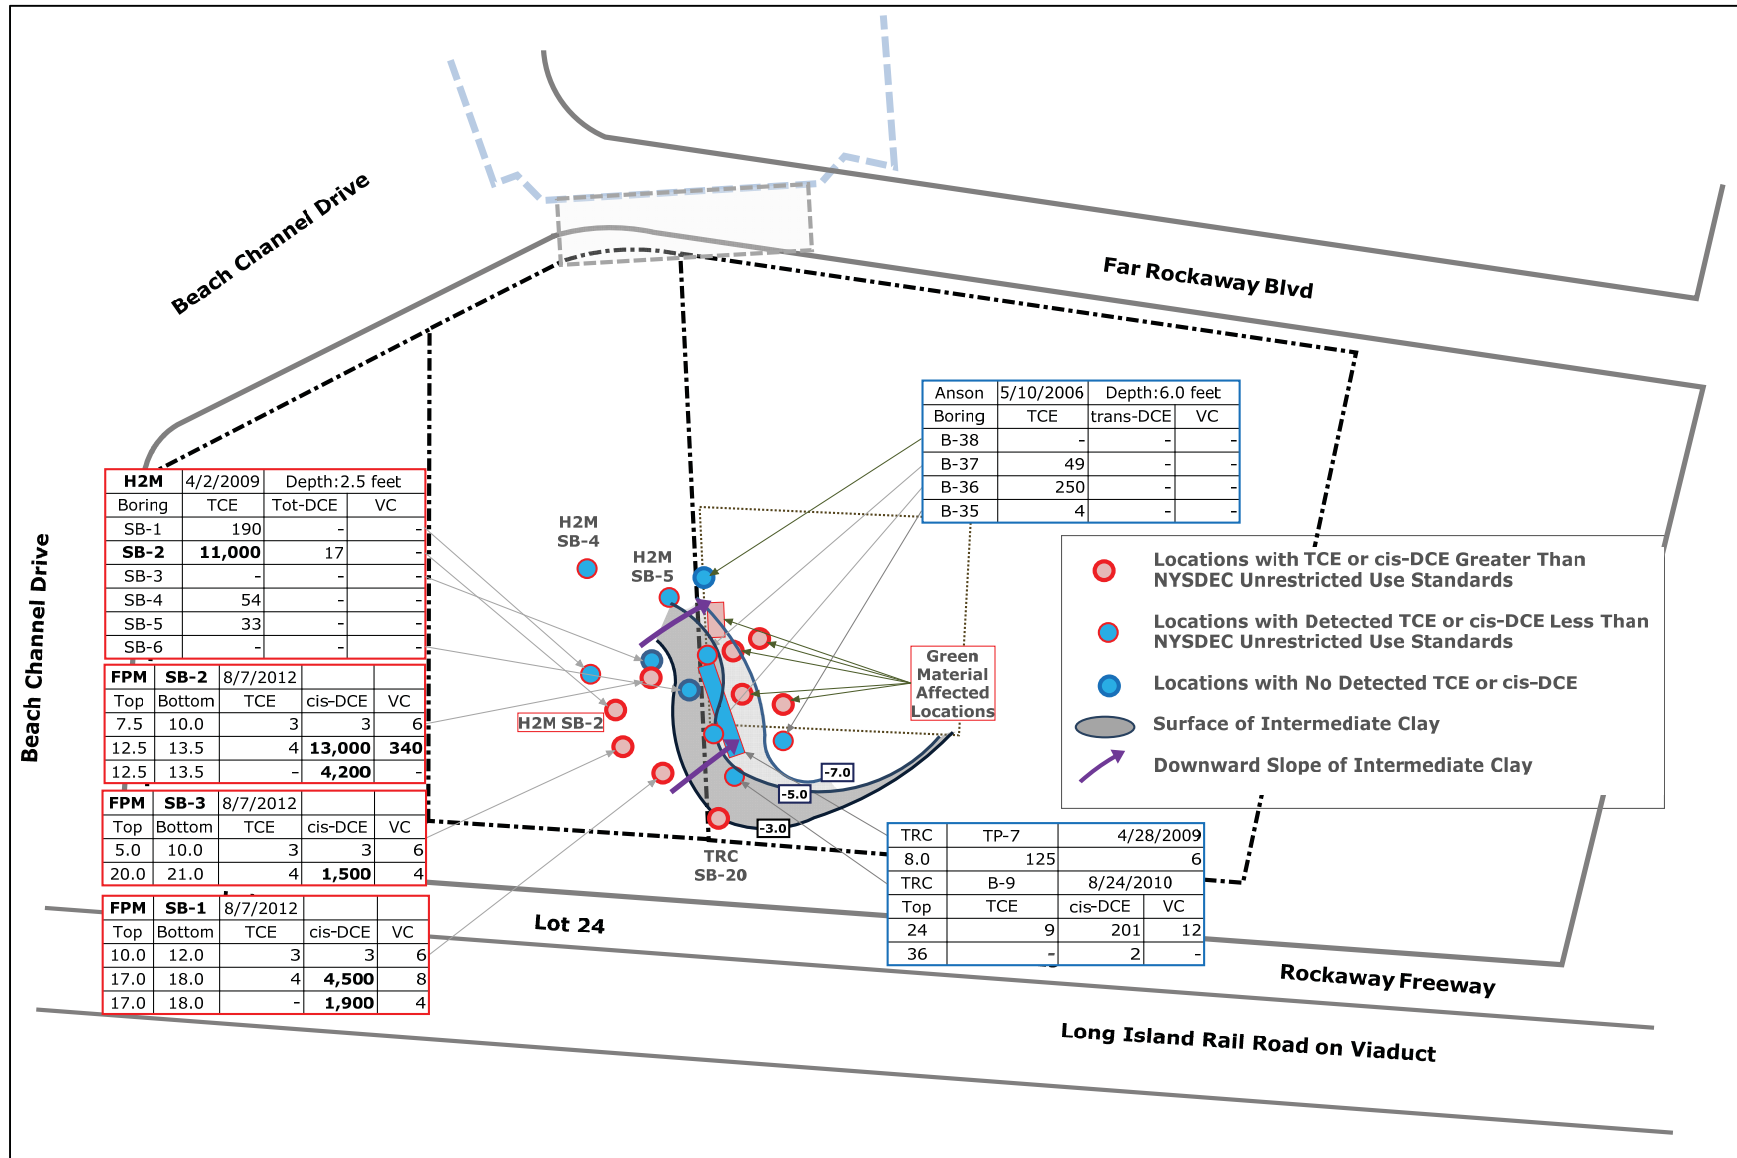
Figure 19 Relationship of Clay to Contamination on Lots 24 and 29

The clay layer and groundwater flow directions affect the fate and transport of contaminants in the fill placed on Lot 24 in other locations as well. On Figure 19 is plotted the significant contamination in the vicinity of the property line between Lot 29 and Lot 24. Also shown on the figure is the area where the clay is the thickest and able to prevent flow from Lot 29 towards Lot 24.

The plan view in Figure 19 also shows a number of samples located between the green material area and the additional source areas on Lot 24 that are within NYSDEC standards or contain no TCE at all. These borings include the following locations: TP-7, B-37, B-36, and TRC B-9. In other words, there are samples with low levels of TCE in between the samples containing elevated TCE on Lot 29 and those containing elevated TCE on lot 24. This up down up concentration pattern is inconsistent with a flow of contamination from Lot 29 to Lot 24. However, it is evidence that the contaminants on Lot 29 are not the source of the contaminants on Lot 24, with only minor possible exceptions.

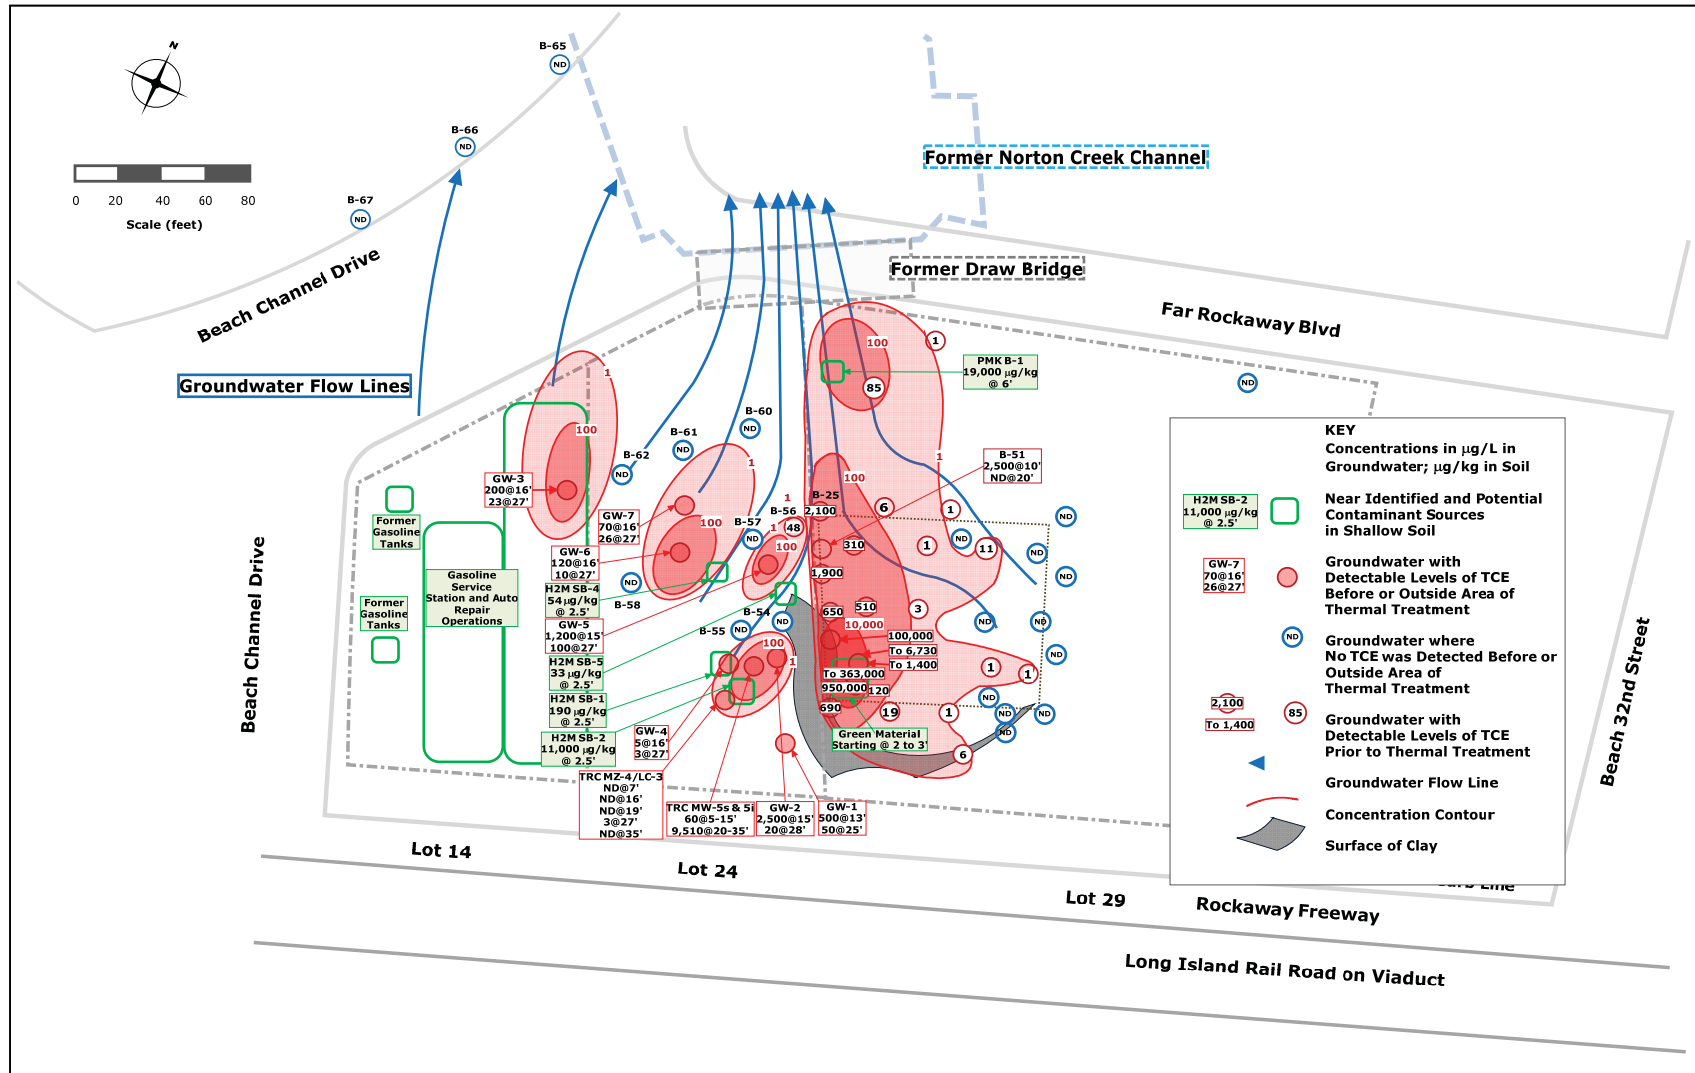
Figure 20 Distribution of TCE in Shallow Groundwater

In Figure 20, I plot the distribution of TCE in shallow groundwater using all available data prior to or outside the influence of the in situ thermal treatment. The contamination from the area where the green material was found is clearly shown by this plot to be flowing to the north-northwest and consistent with the groundwater flow in that direction on Lot 29. Similarly, the shallow soil contamination on Lot 24 is shown to be affecting groundwater downgradient of these sources. In particular, boring H2M SB-2 can be seen to be upgradient of the TCE in MW-5s, MW-5i, GW-2, GW-4, and TRC MZ-4/LC-3.

Taking a closer look at the distribution of groundwater contamination stemming from the location of boring H2M SB-2, one can see the groundwater contamination, including cis-1,2-DCE, spreading both vertically and laterally in the direction of groundwater flow. For example, cis-1,2-DCE was at a concentration of 17,000 µg/l in MZ-4/LC-3 on 11/13/2008 and 36,000 µg/l in MW-5i on 12/2/2008, both dates are before the thermal treatment on Lot 29. The high levels of cis-DCE in boring FPM SB-2/GW-2 results from the continuing migration of contaminants near boring H2M SB-2 on Lot 24, and not from the area of the thermal treatment on Lot 29.

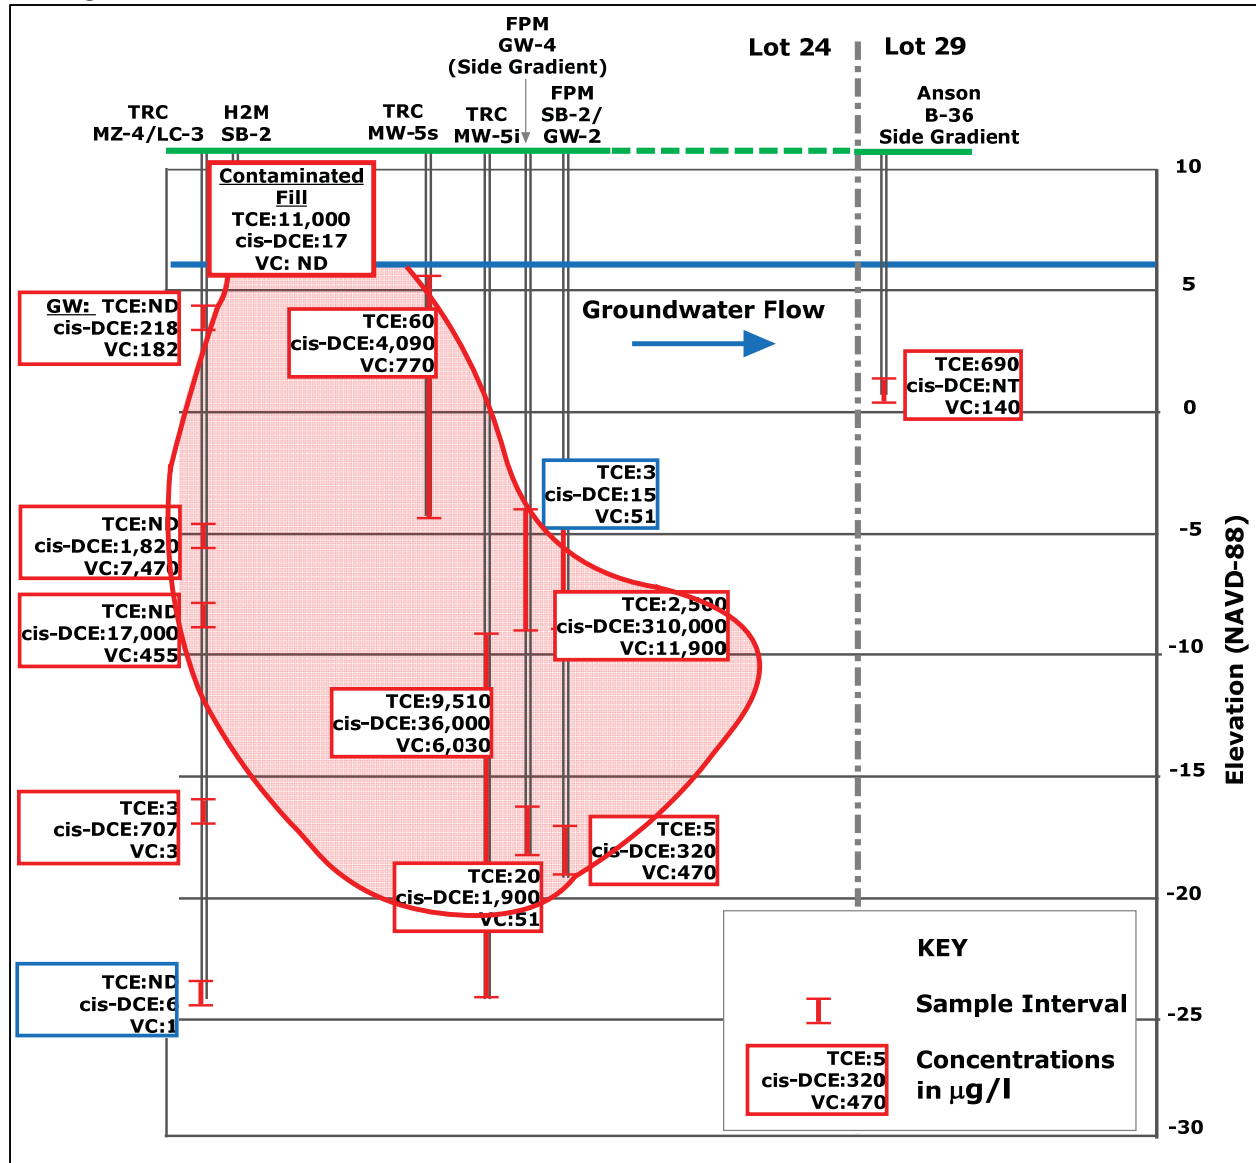
Figure 21 Distribution of cis-1,2-DCE in Shallow Groundwater

Figure 21 shows the distribution of contamination from a shallow source on Lot 24 near boring H2M SB-2.

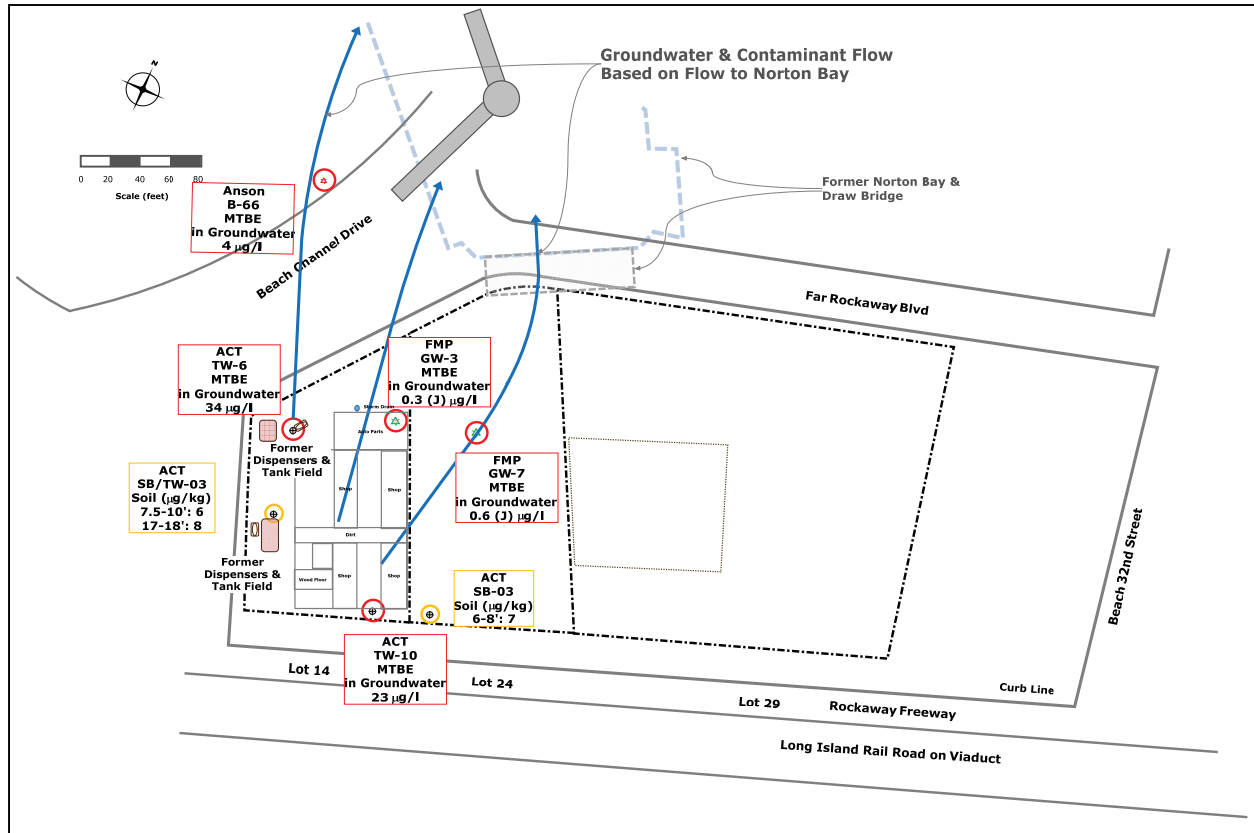
Figure 22 Flow of MTBE in Groundwater

The detections of MTBE, a gasoline additive, in groundwater stemming from the former gasoline service station on Lot 14 is consistent with the direction of groundwater flow identified above. MTBE has been found on the former gasoline service station in both soil and groundwater. The highest levels of MTBE in groundwater were found at two locations, TW – 1 and TW – 6, at concentrations of 23 µg/l and 34 µg/l, respectively. MTBE is detected in three additional downgradient wells at lower concentrations as a result of the flow from the more contaminated areas on the former gasoline service station property. The locations of these additional MTBE detections are consistent with a groundwater flow from the former gasoline service station towards the discharge point at Norton’s Bay.
