**Re: *Quarterly Inspection Report
Former Union Wire Die Corp.
39-40 30th Street, Queens, New York
NYSDEC BCP Number: C241163***

FORMER UNION WIRE DIE CORP.
NYSDEC BCP Number C241163
Project Status Report
Quarter 1 2019

Report Date: March 26, 2019

Reporting Period: 1st Quarter of 2019

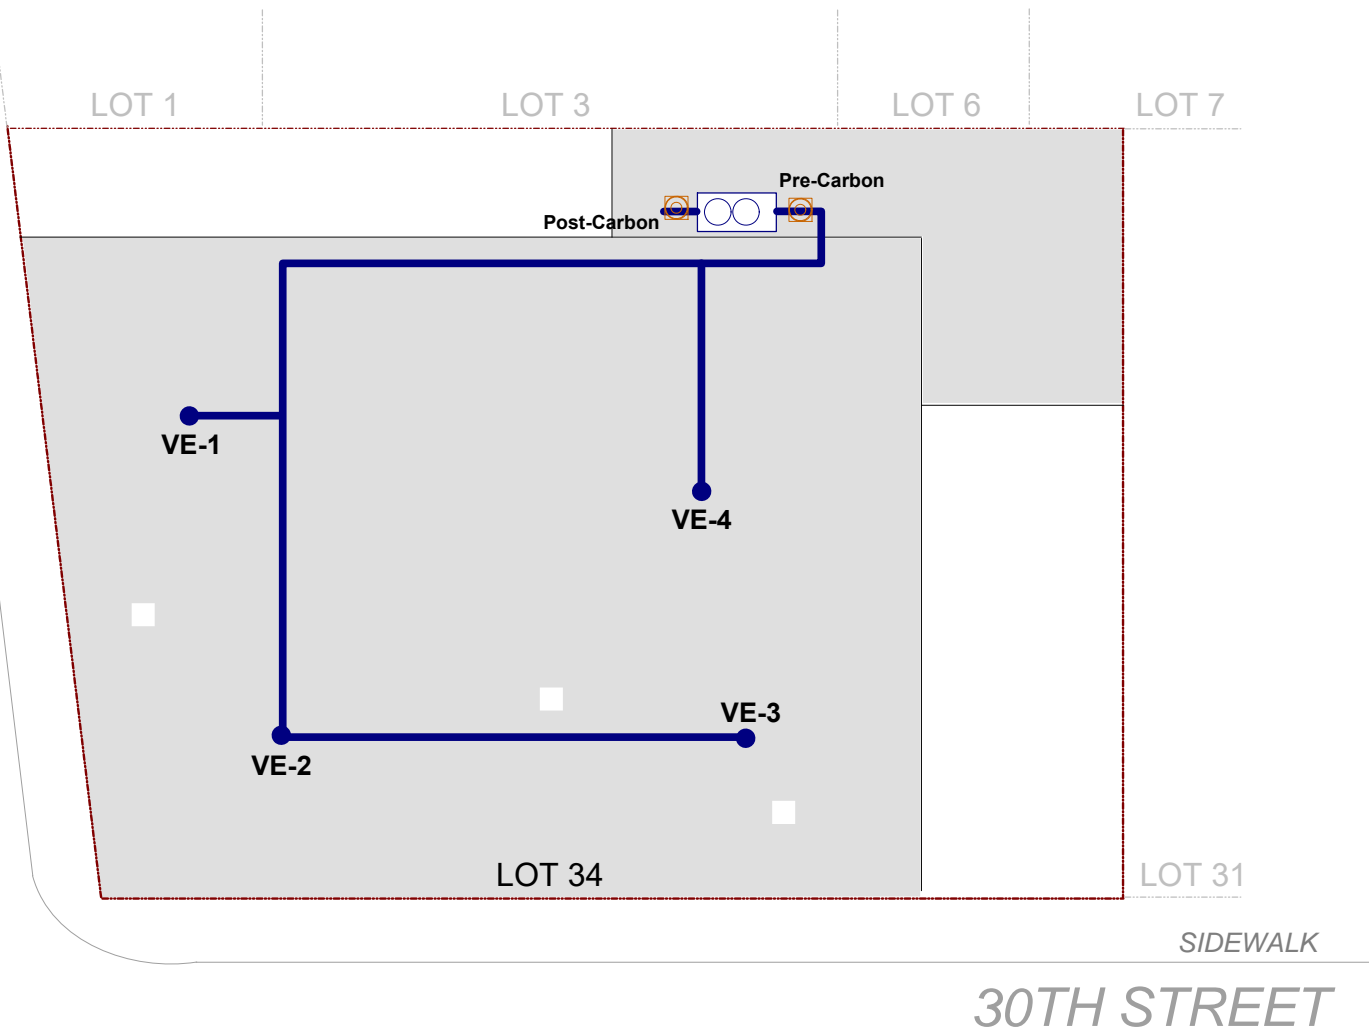
Figure
3

Site Name: REDEVELOPMENT PROJECT
Site Address: 39-40 30TH STREET, QUEENS, NY
Drawing Title: SVE SYSTEM SAMPLING LOCATIONS
