Daily Report for June 1, 2020

**Far Rockaway Project
20-02 Mott Avenue
Far Rockaway, NY
BCP #C241224**

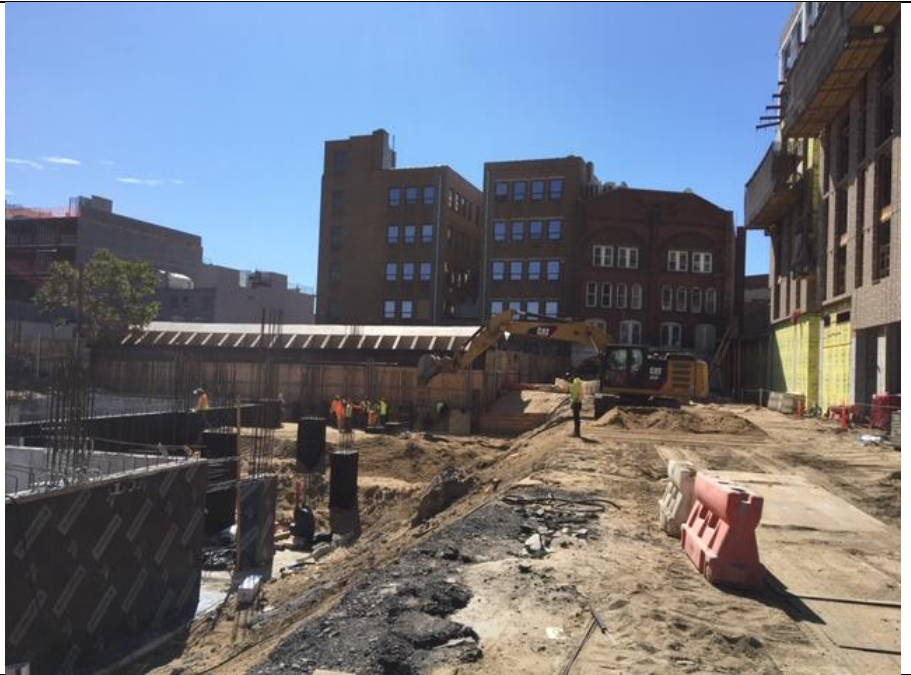
Photo 1- View of backfilling with clean fill in grid D5 and D5.

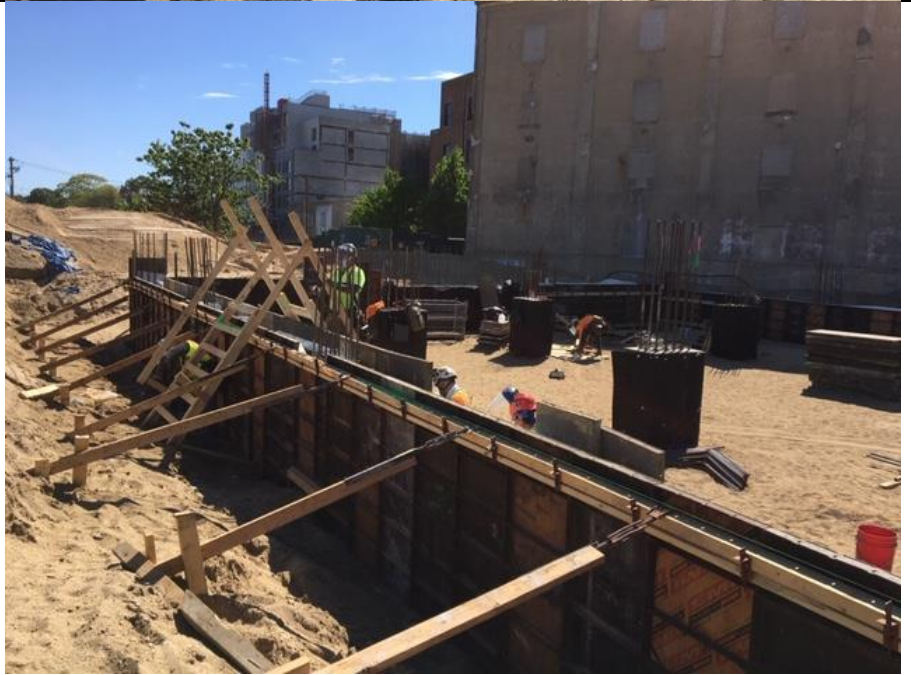
Photo 2- View of formwork and rebar installation in C7 and C8.

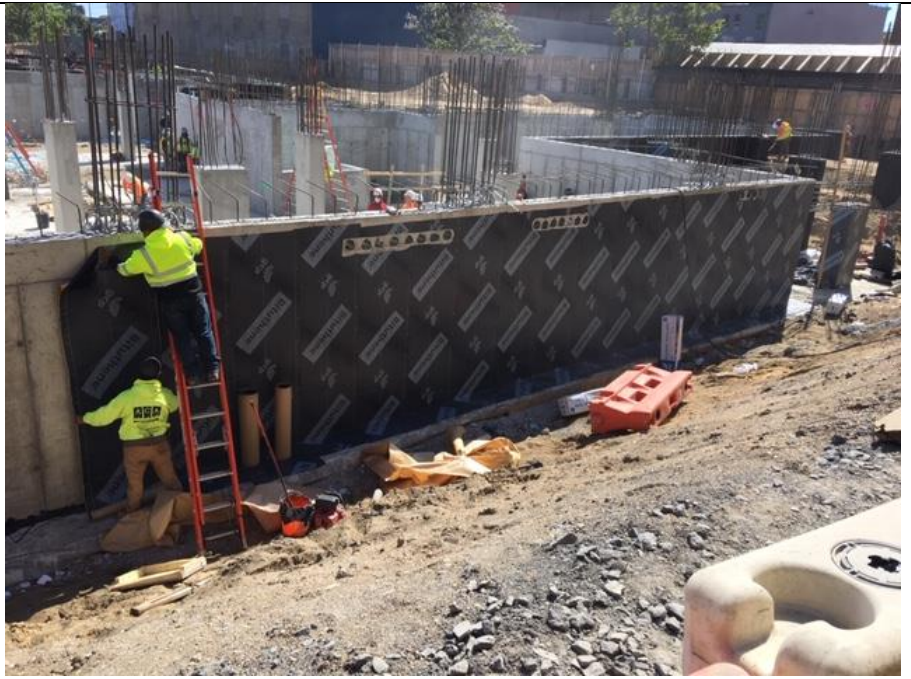
Photo 3- View
of installing
Bituthene in
C5.

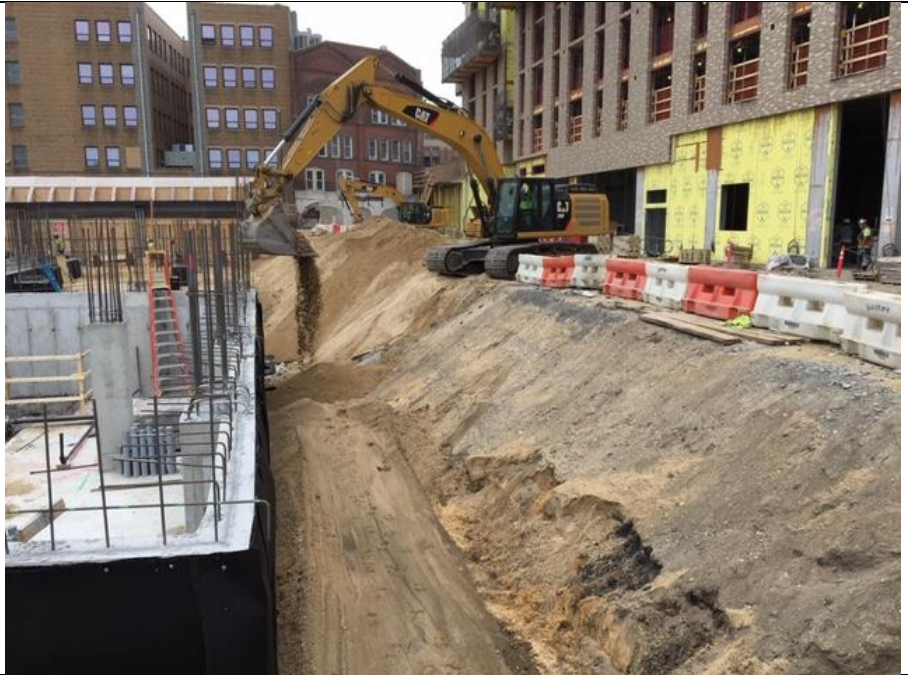
Photo 1- View of backfilling with clean fill in grid D5 and D5.

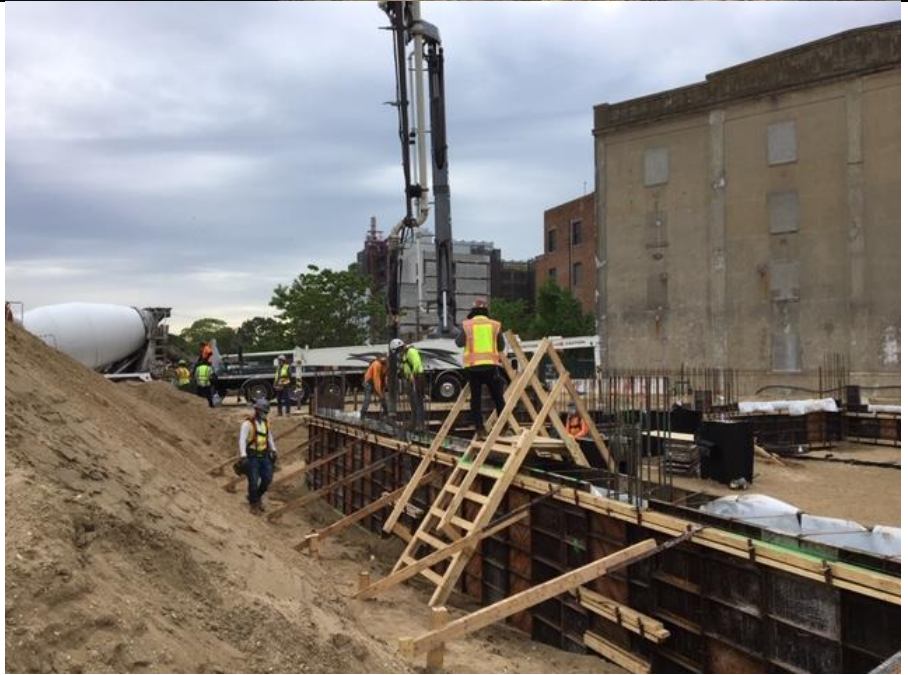
Photo 2- View of pouring concrete in C7 and C8.

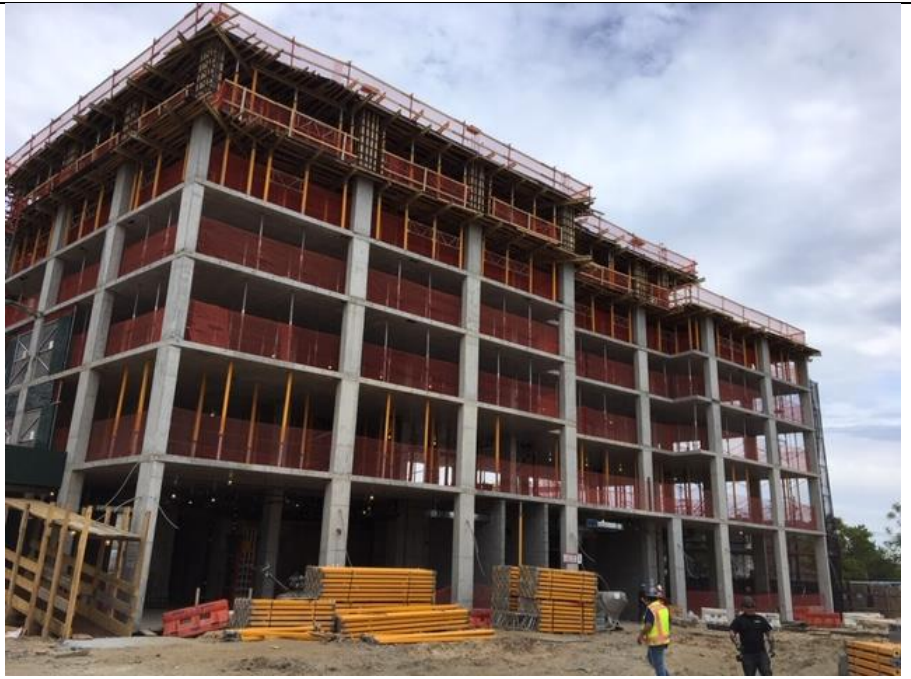
Photo 3- View of formwork and rebar installation in A3, A4, B3, and B4.

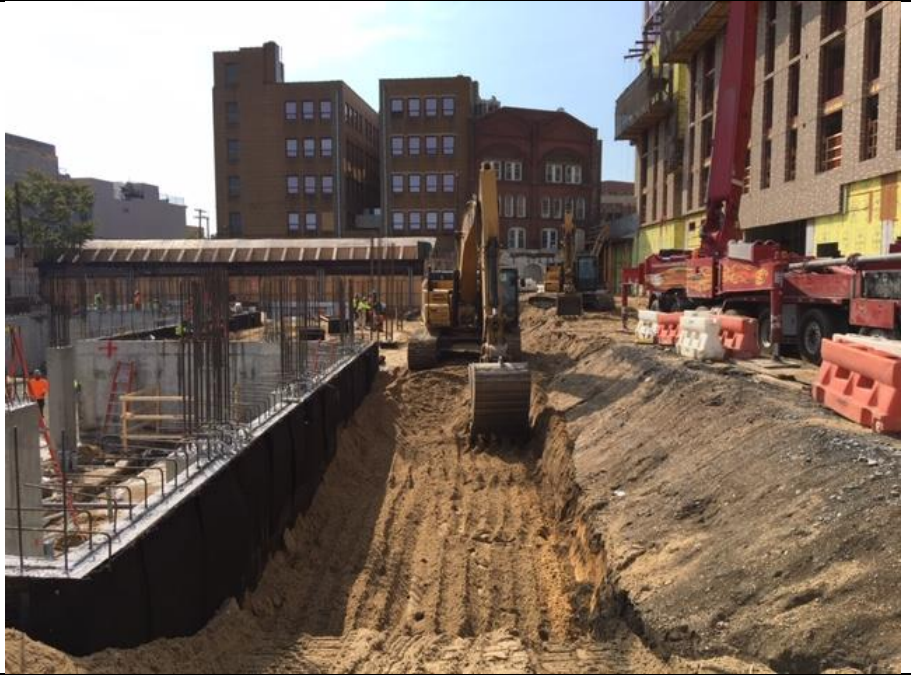
Photo 1- View of backfilling with clean fill in grid D5 and D5.

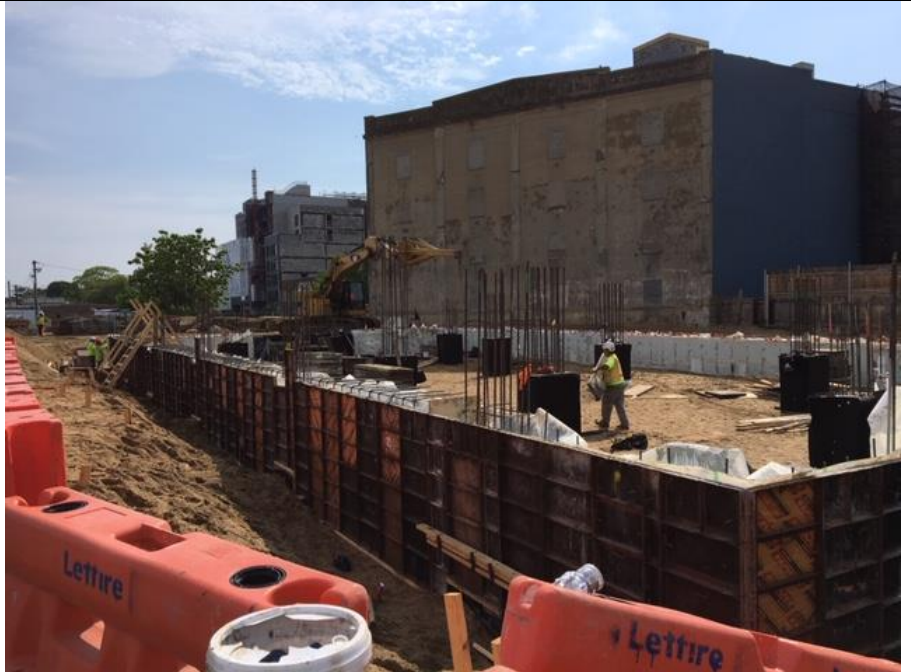
Photo 2- View of formwork and rebar installation in C7 and C8.

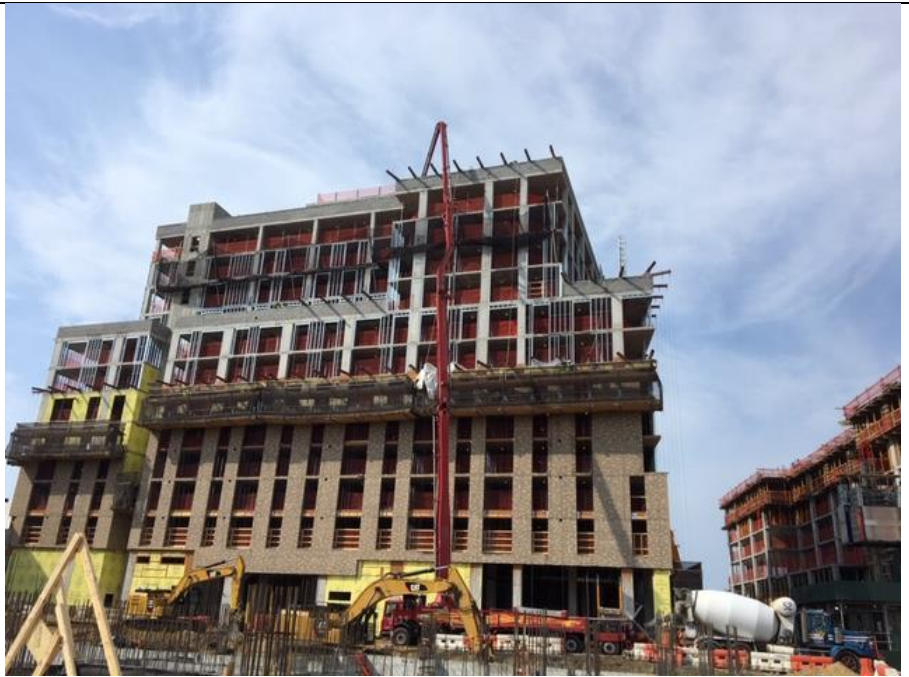
Photo 3- View of pouring concrete, formwork and rebar installation in D3, D4, E3, and E4.

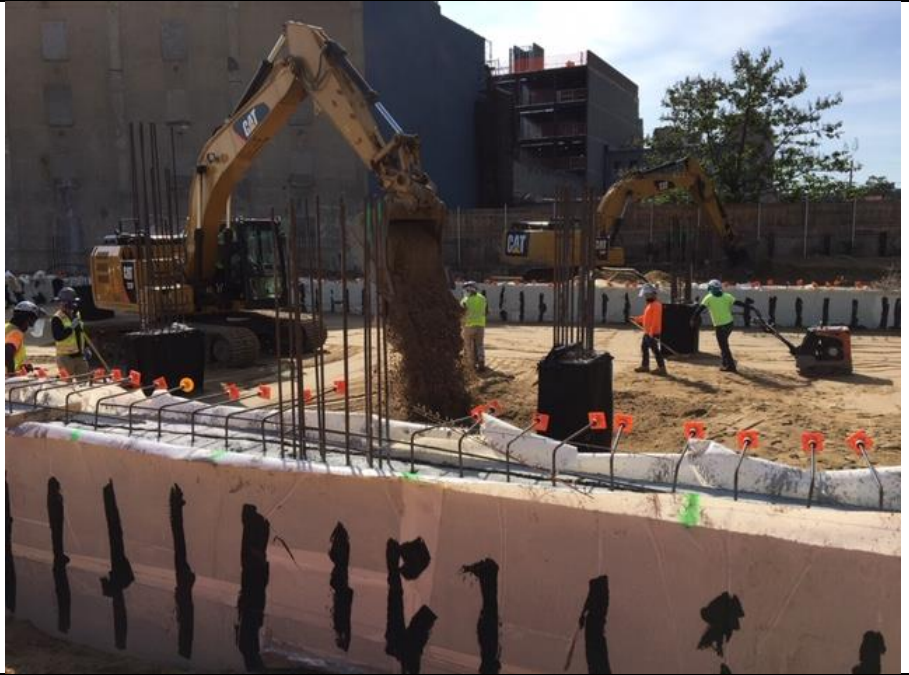
Photo 1- View of backfilling with clean fill in grid C7, C8, D7, and D8.

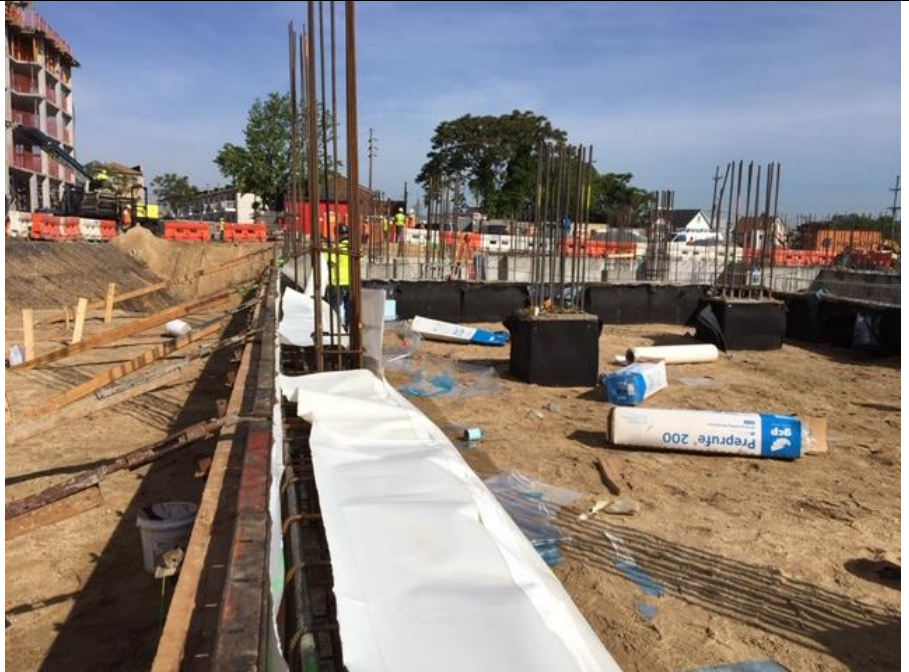
Photo 2- View of Preprufe 200 installation in C5 and D5.

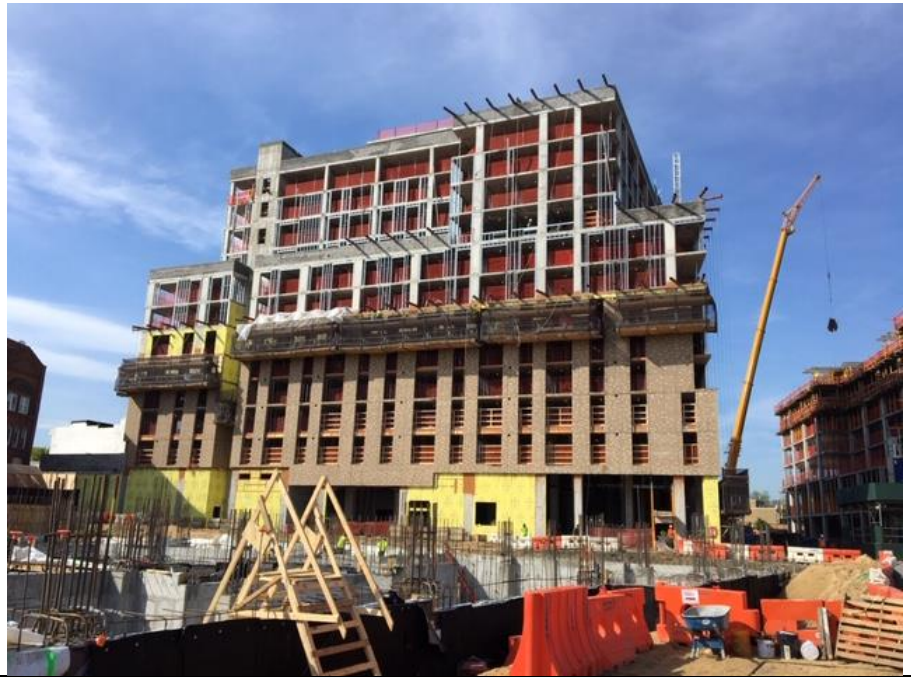
Photo 3- View of formwork and rebar installation in D3, D4, E3, and E4.

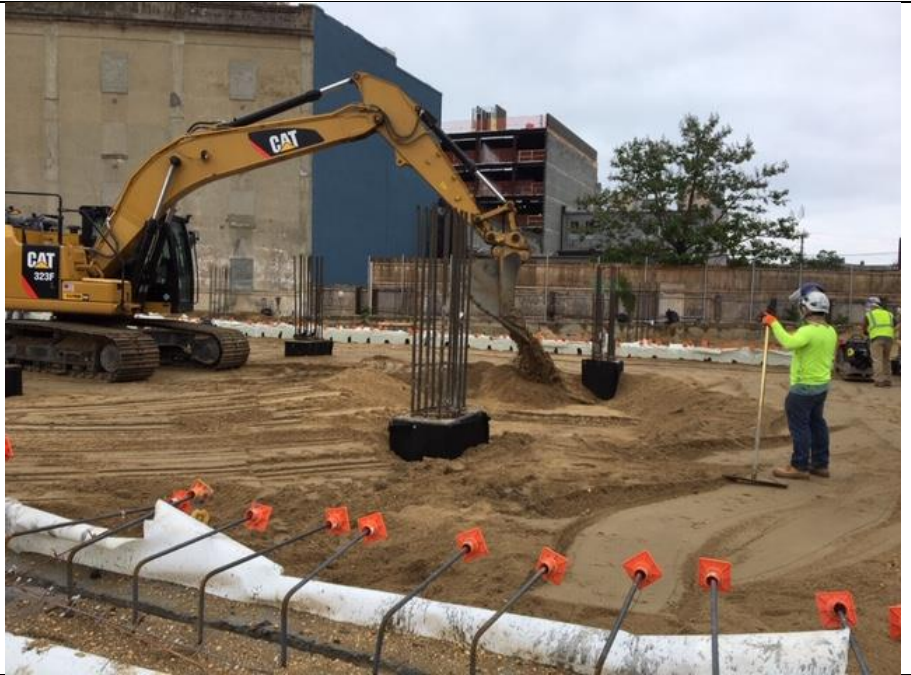
Photo 1- View of backfilling with clean fill in grid C7, C8, D7, and D8.

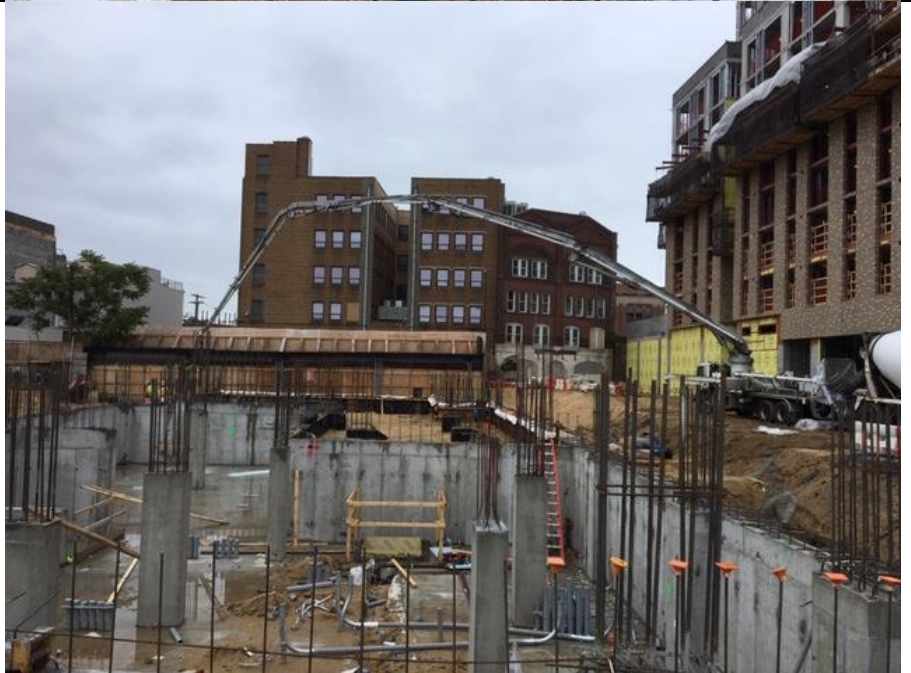
Photo 2- View of pouring concrete in D5 and D6.

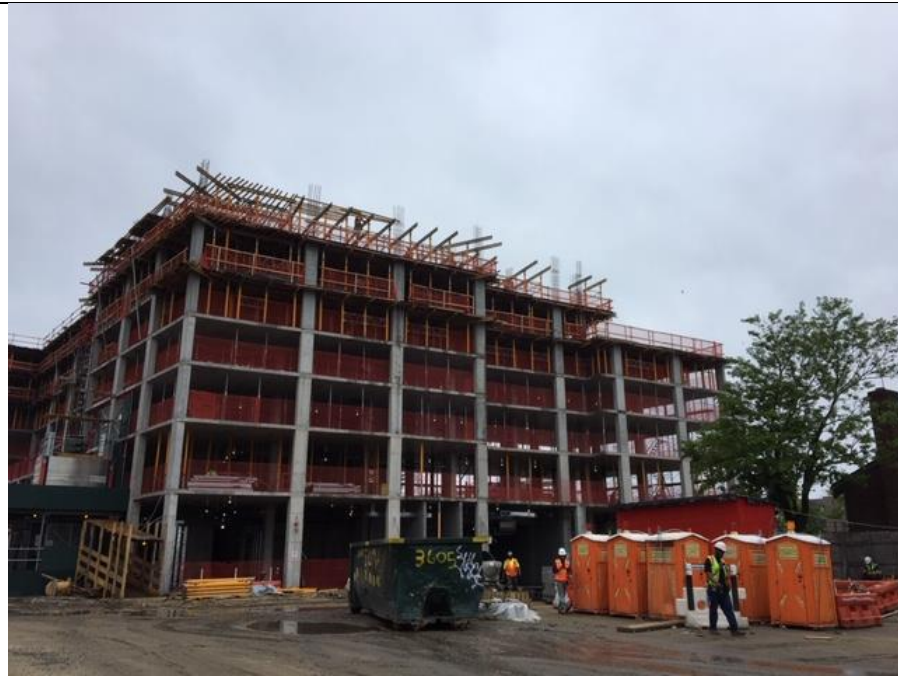
Photo 3- View of formwork and rebar installation in A3, A4, B3, and B4.

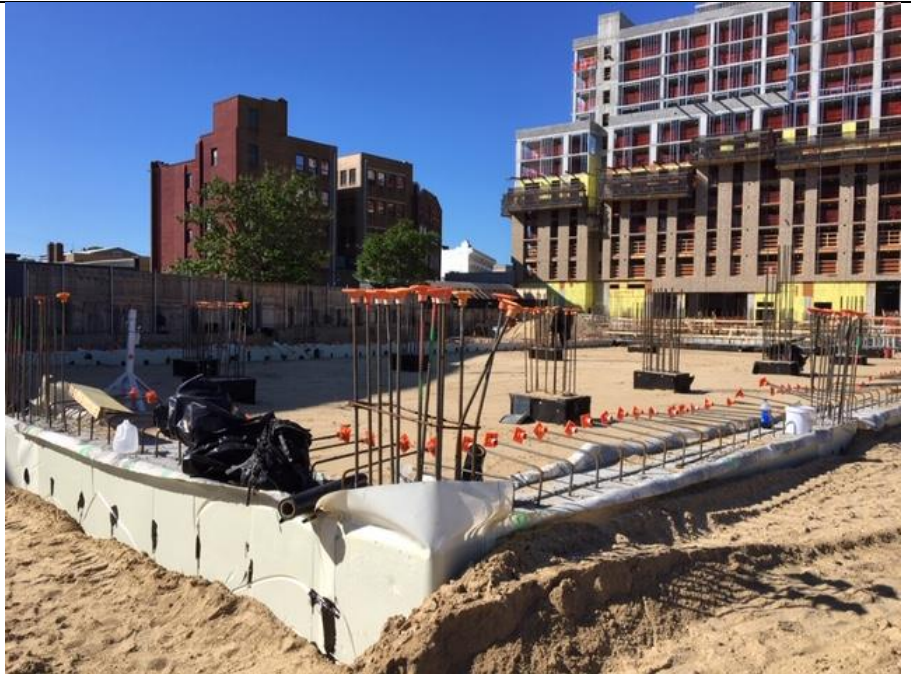
Photo 1- View of backfilled area with clean fill in C7, C8, D7, and D8.

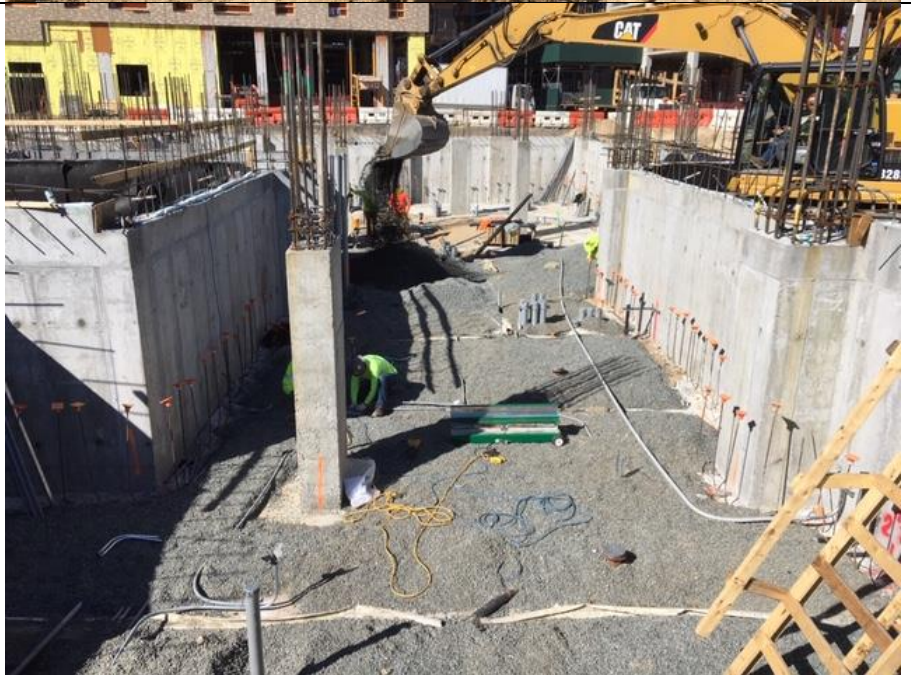
Photo 2- View of utility work and spreading stone in C5, C6, and D5.

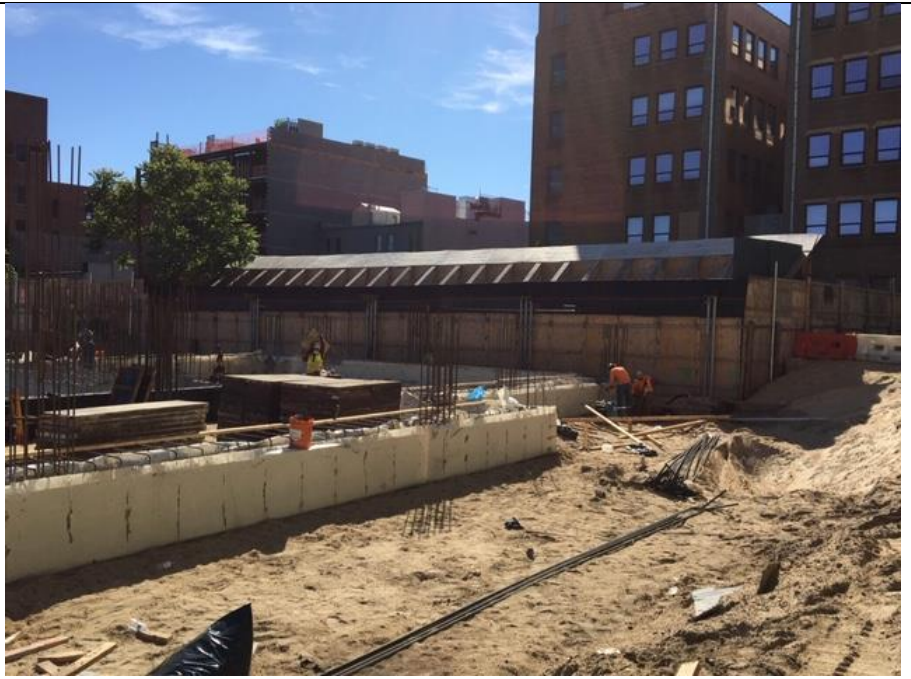
Photo 3- View
of formwork in
C5 and D5.

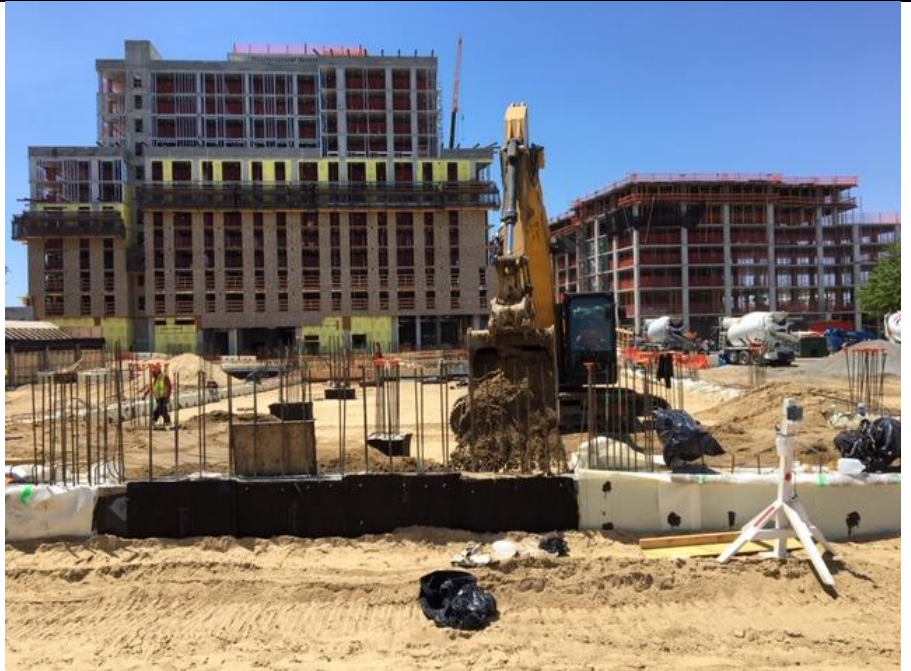
Photo 1- View of backfilling area with clean fill in C7, C8, D7, and D8.

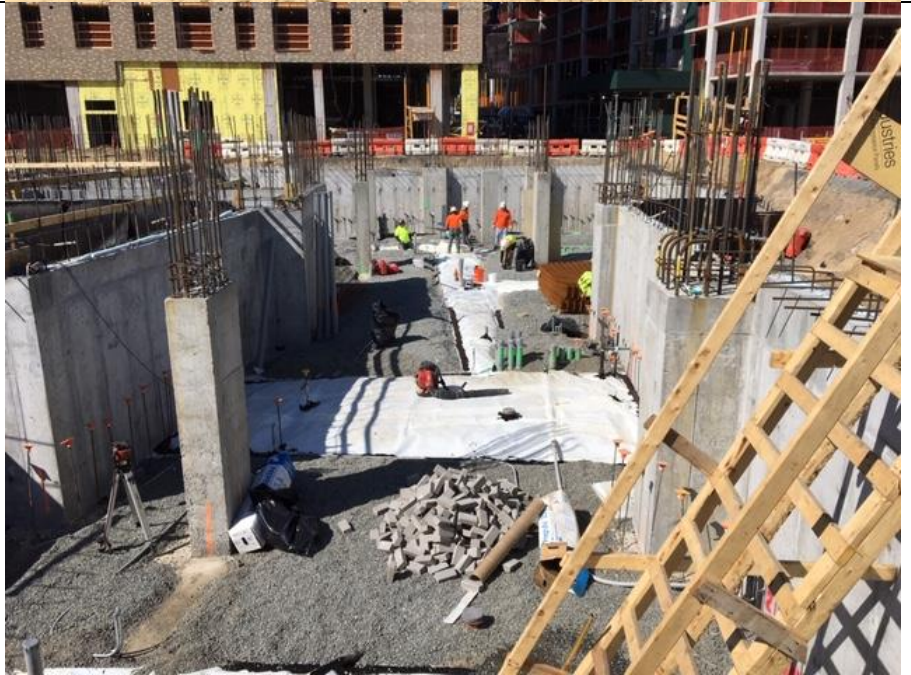
Photo 2- View of utility work and Preprufe 200 installation in C5, C6, and D5.

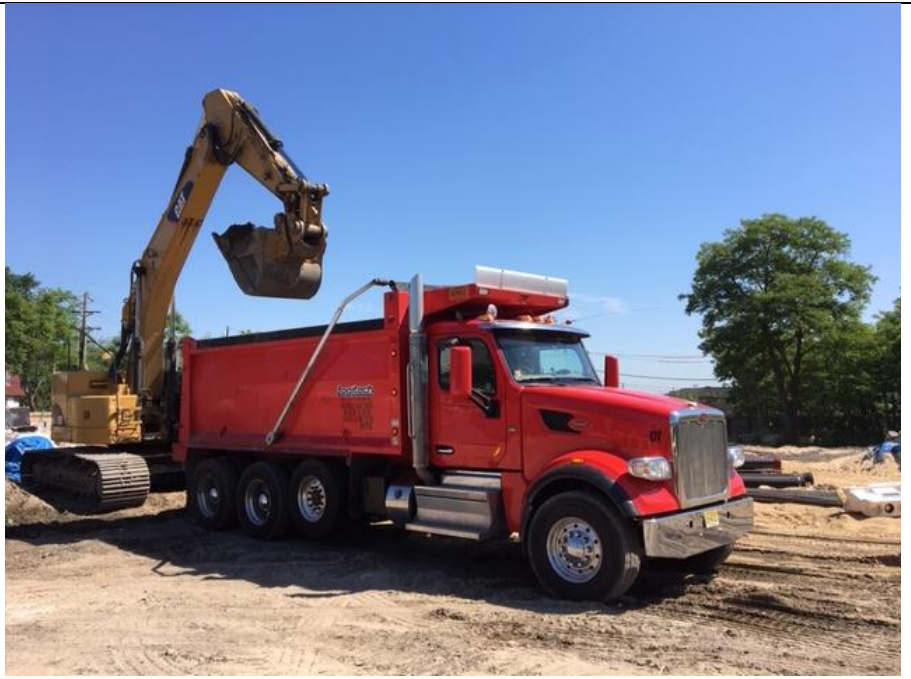
Photo 3- View of loading out soil for export offsite.

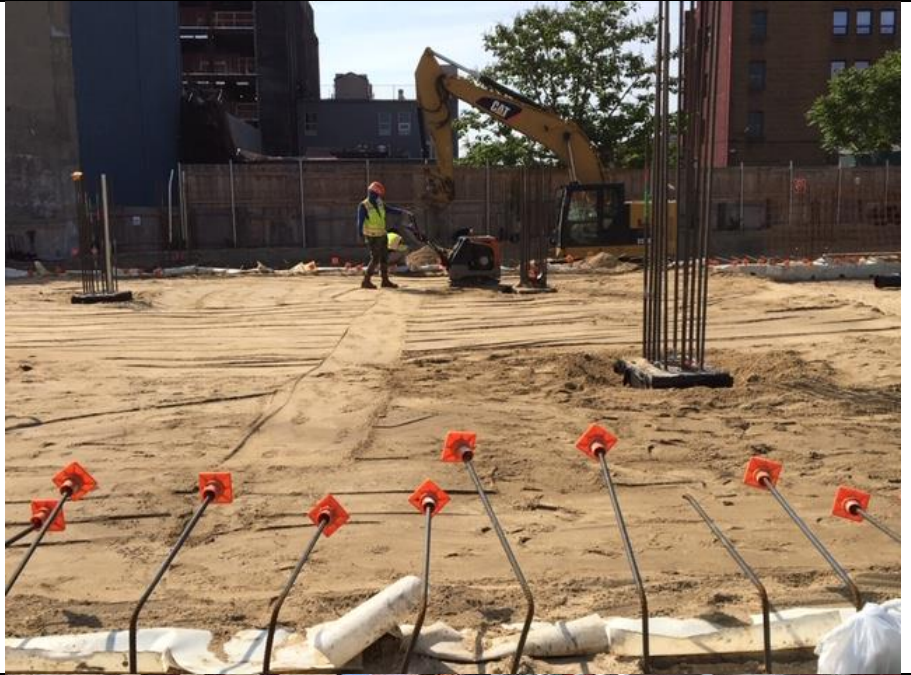
Photo 1- View of backfilling area with clean fill in C7, C8, D7, and D8.

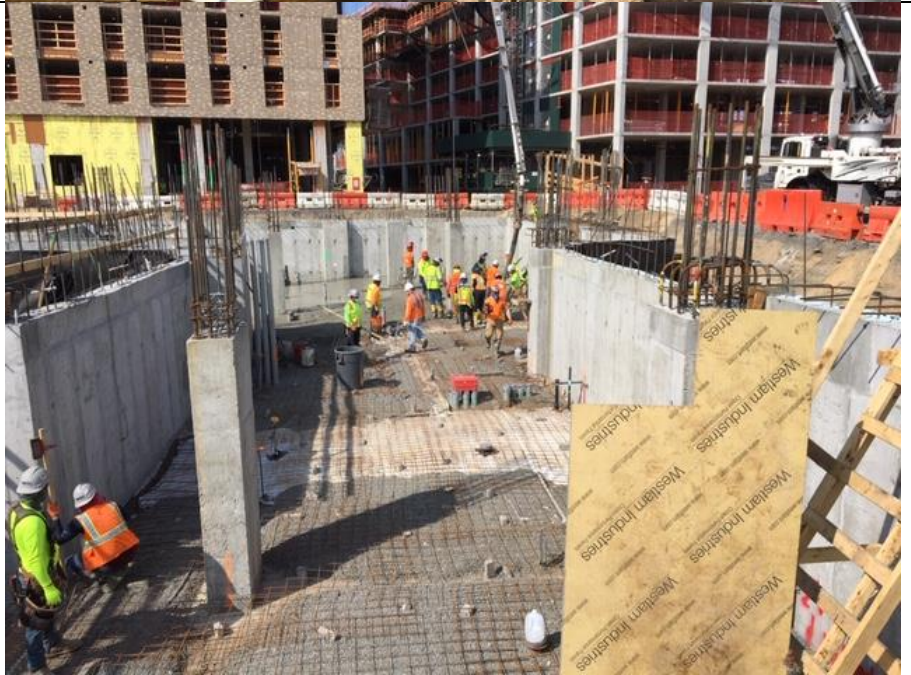
Photo 2- View of pouring concrete in C5, C6, and D5.

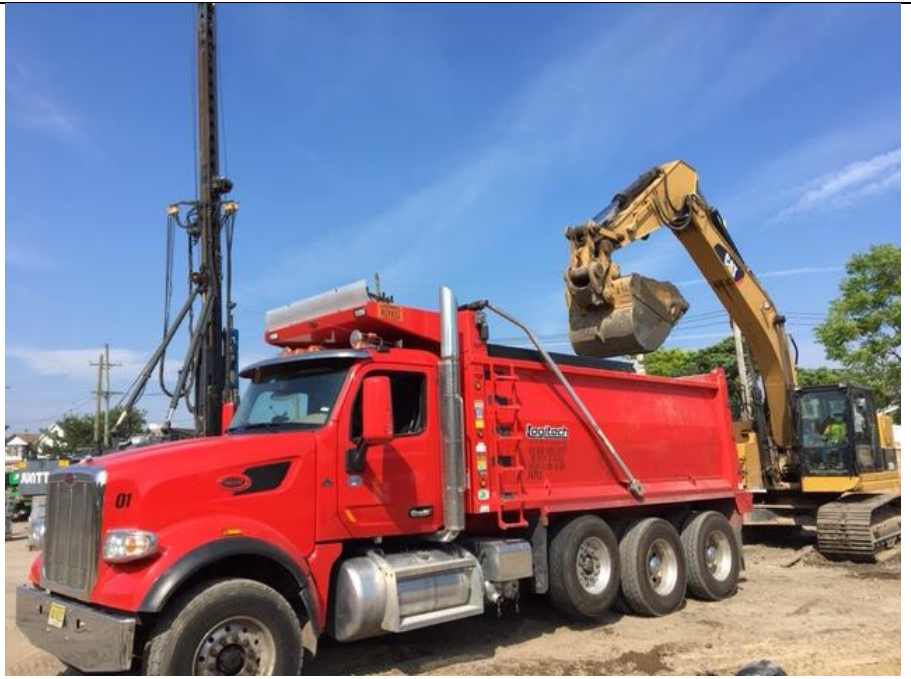
Photo 3- View of loading out soil for export offsite.

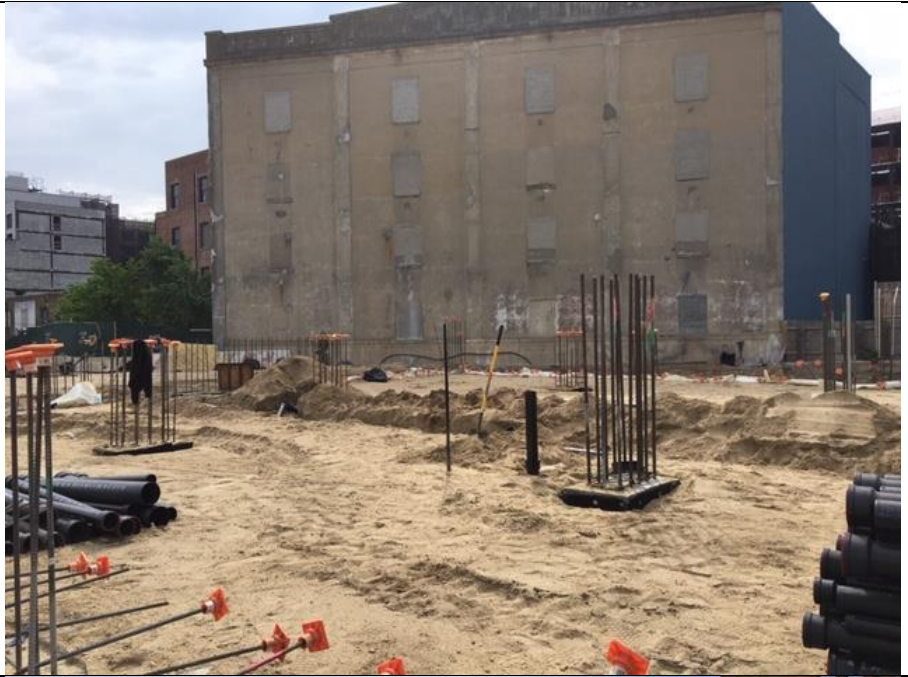
Photo 1- View of trenching for utility installation in C7, C8, D7, and D8.

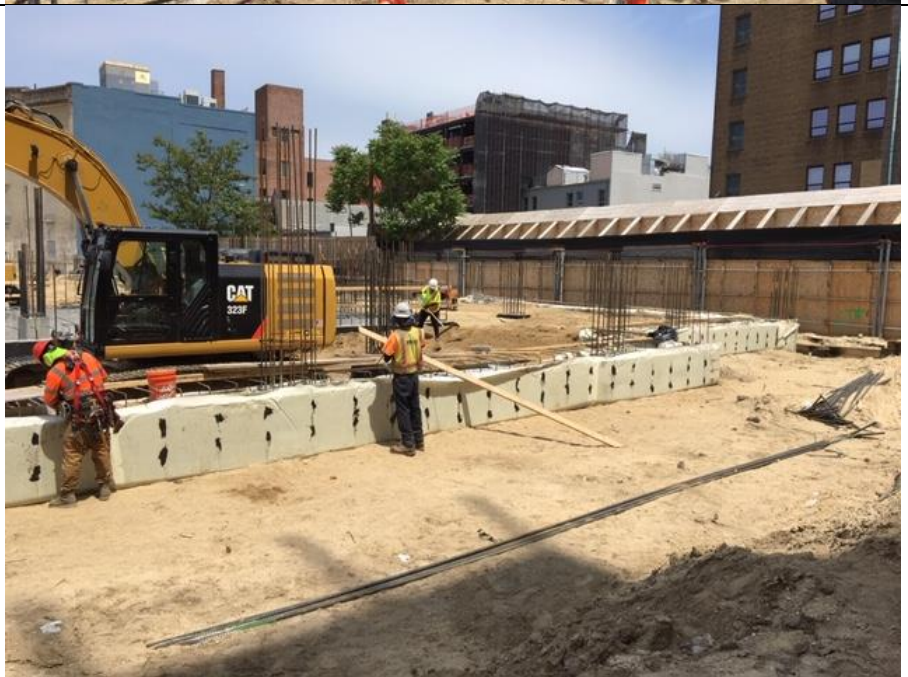
Photo 2- View of backfilling in C5, C6, and D5.

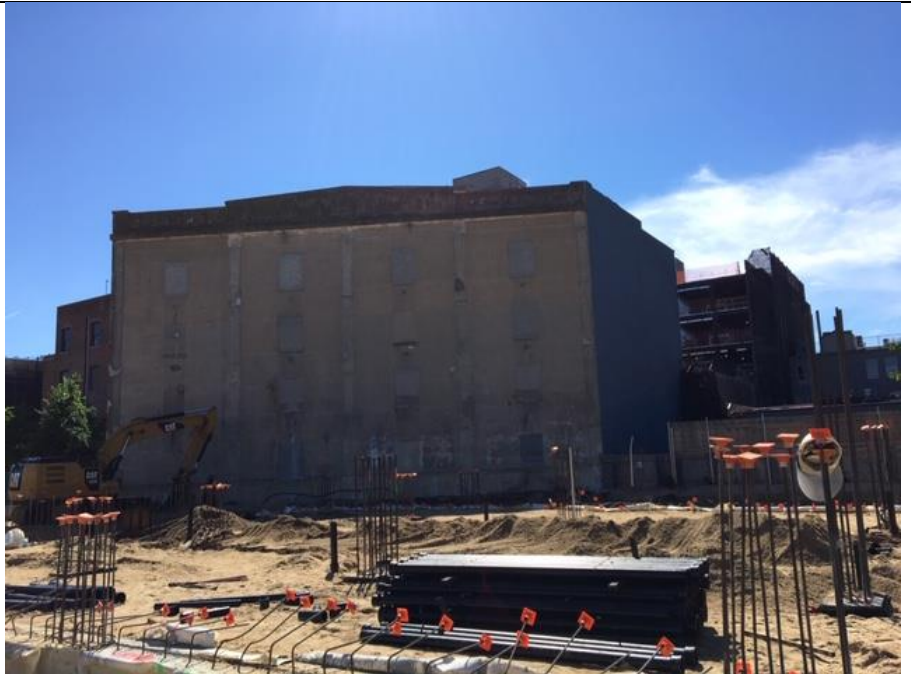
Photo 1- View of trenching for utility installation in C7, C8, D7, and D8.

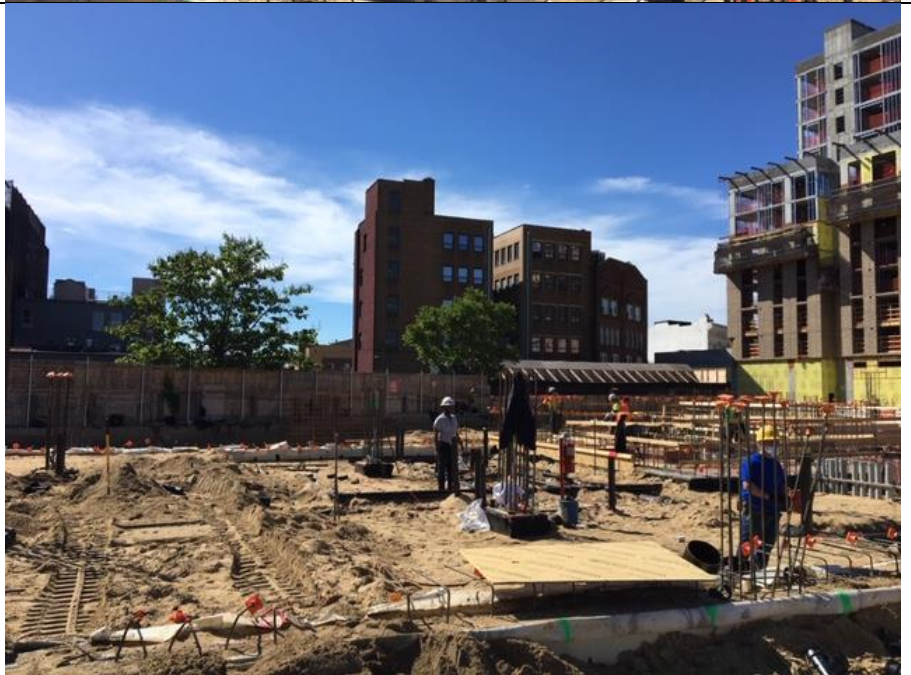
Photo 2- View of utility installation in C6 and C7.

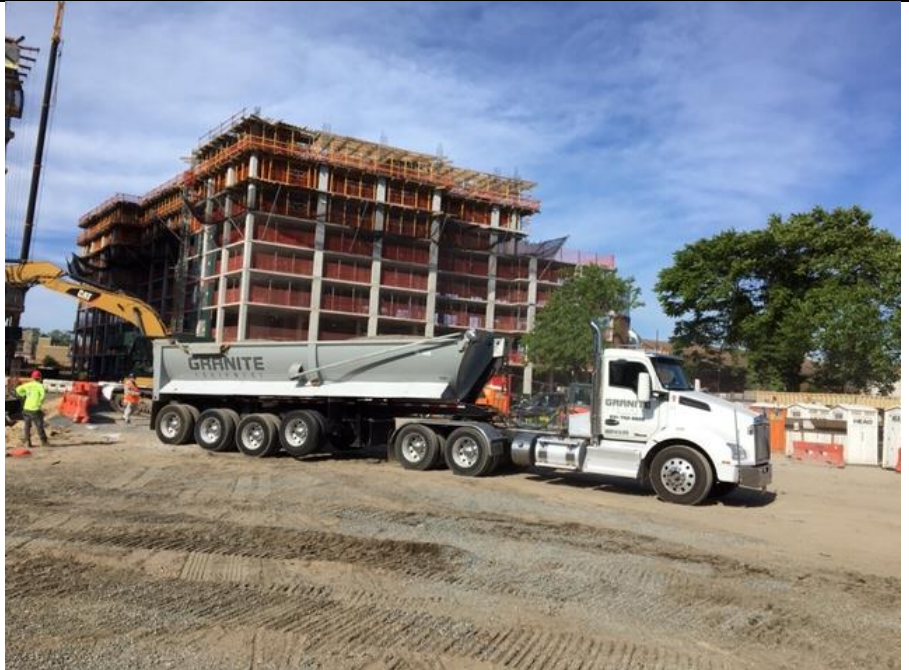
Photo 1- View of importing gravel.

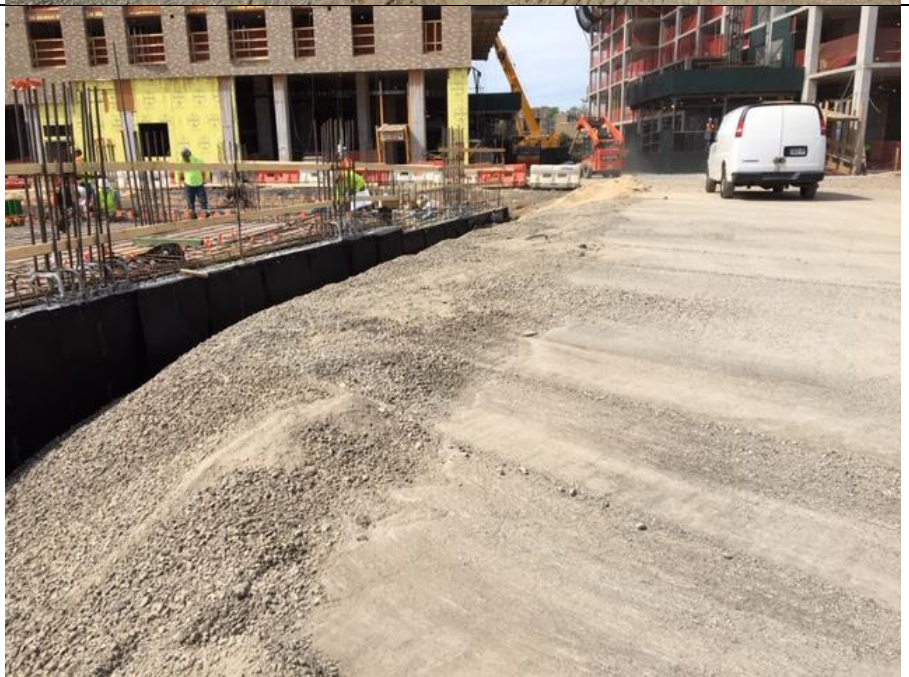
Photo 2- View of backfilling with gravel in C5 and D5.

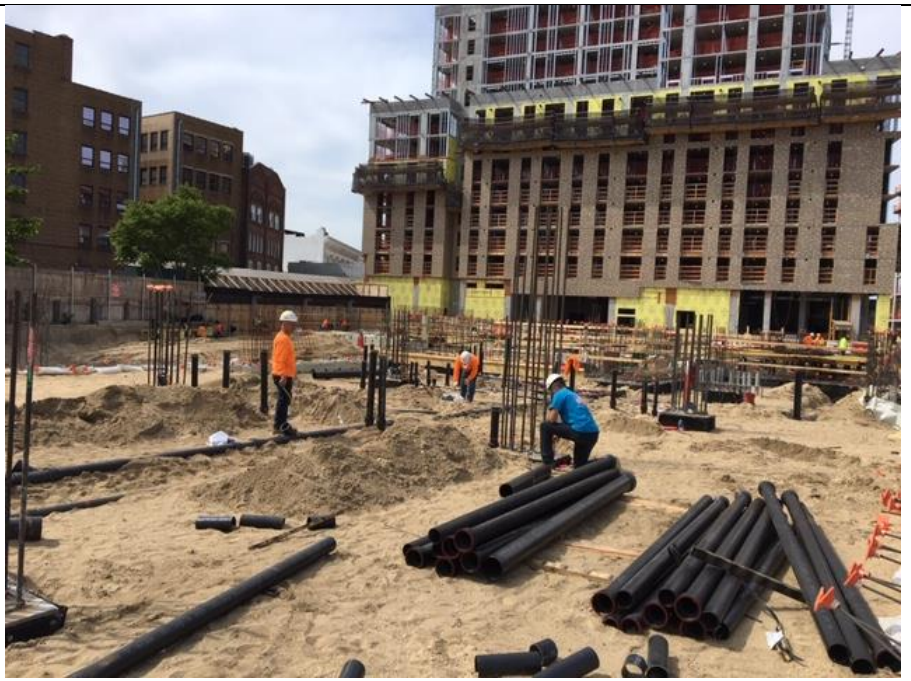
Photo 3- View of formwork, utility installation and trench work in C7 and C8.

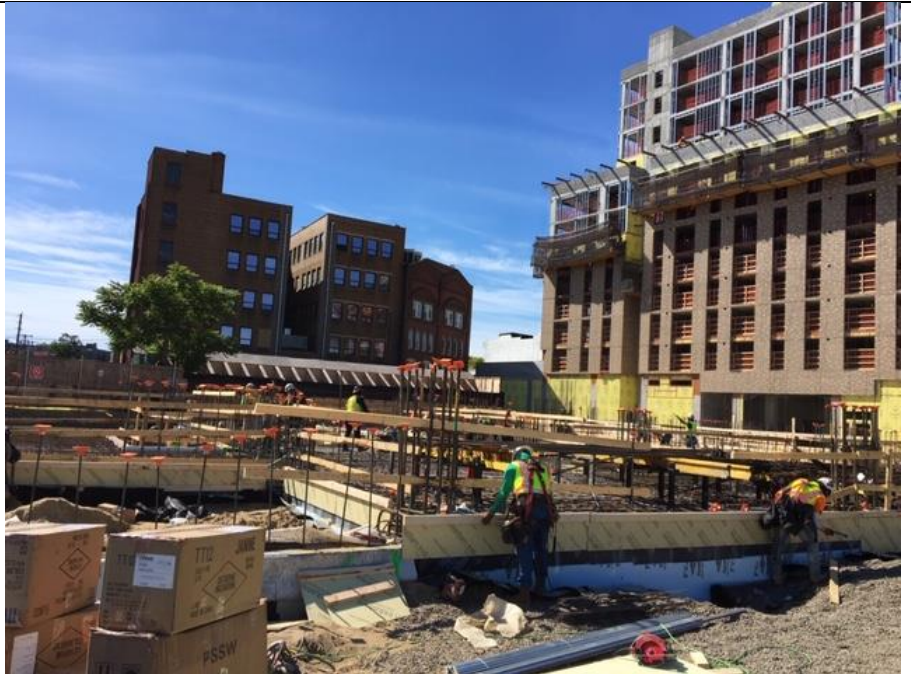
Photo 1- View of formwork, rebar, and utility installation.

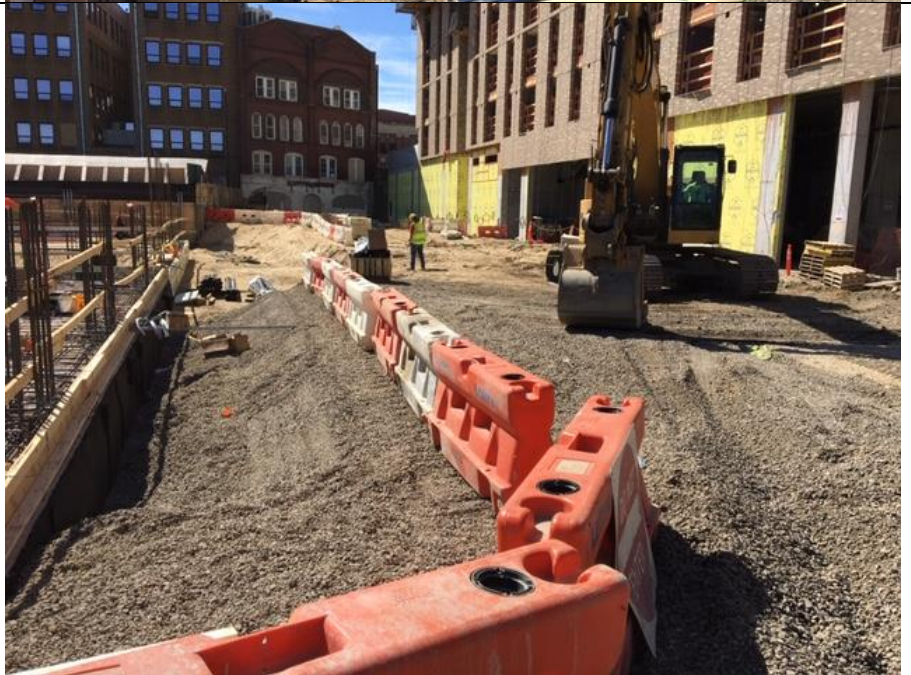
Photo 2- View of backfilling with gravel in C5 and D5.

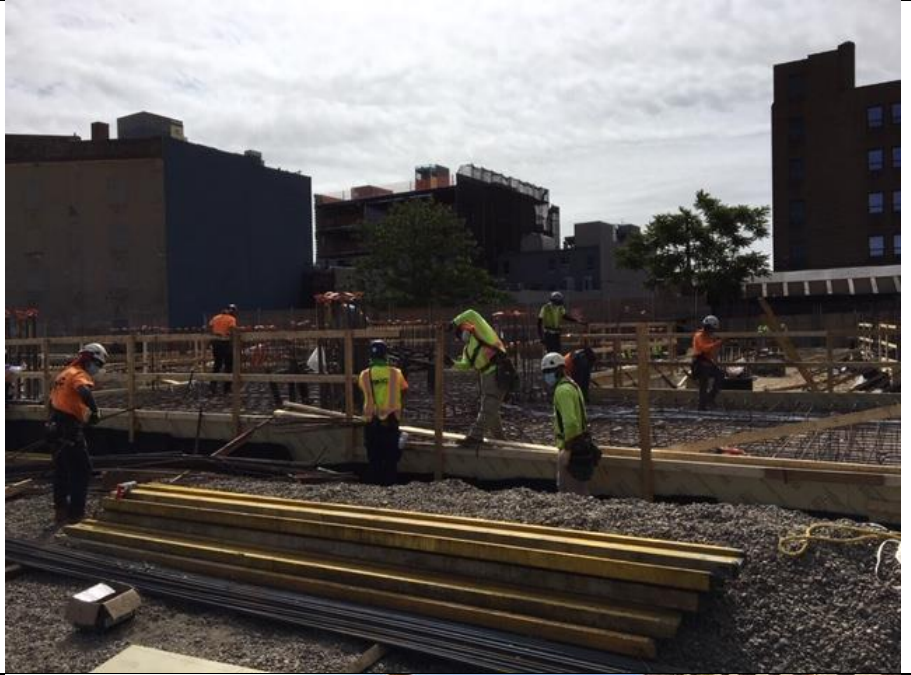
Photo 1- View of formwork, rebar, and utility installation in C6 and C7.

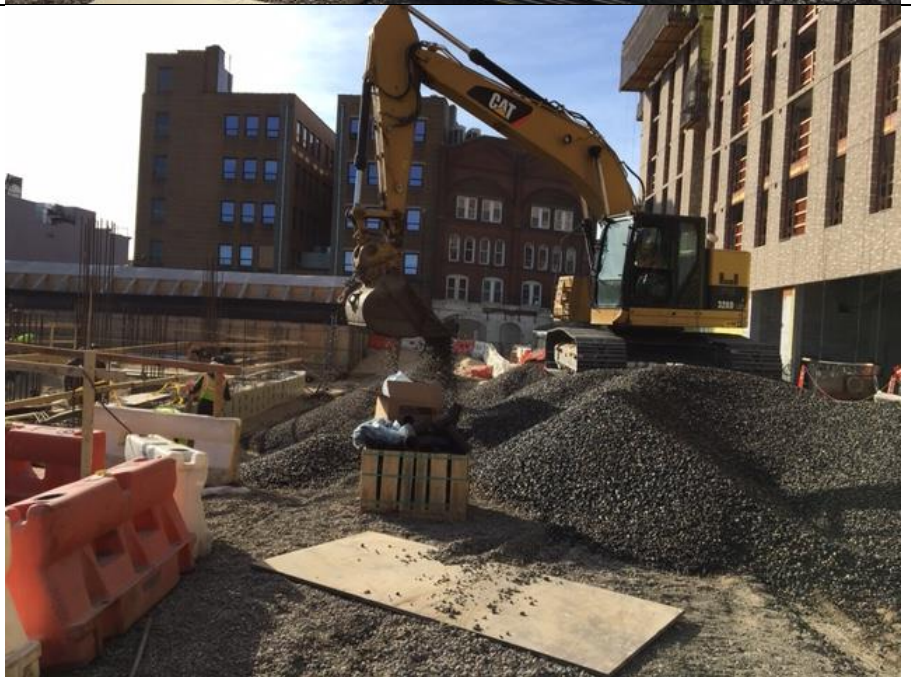
Photo 2- View of backfilling with gravel in C5 and D5.

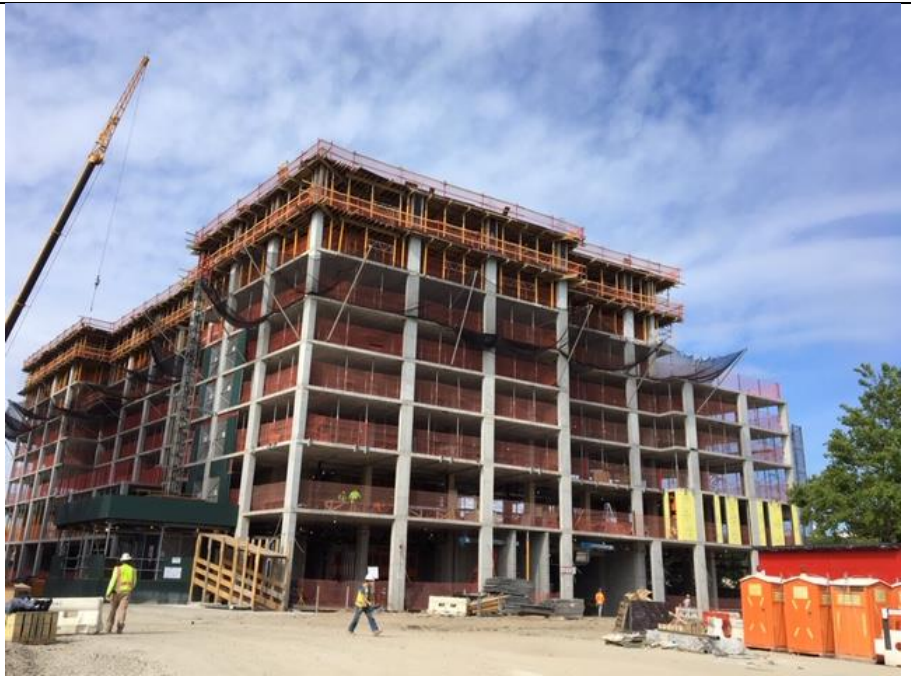
Photo 3- View of formwork, rebar, and utility installation in A4, A4, B3, and B4.
