Daily Report for June 1, 2020

**Far Rockaway Project
20-02 Mott Avenue
Far Rockaway, NY
BCP #C241224**

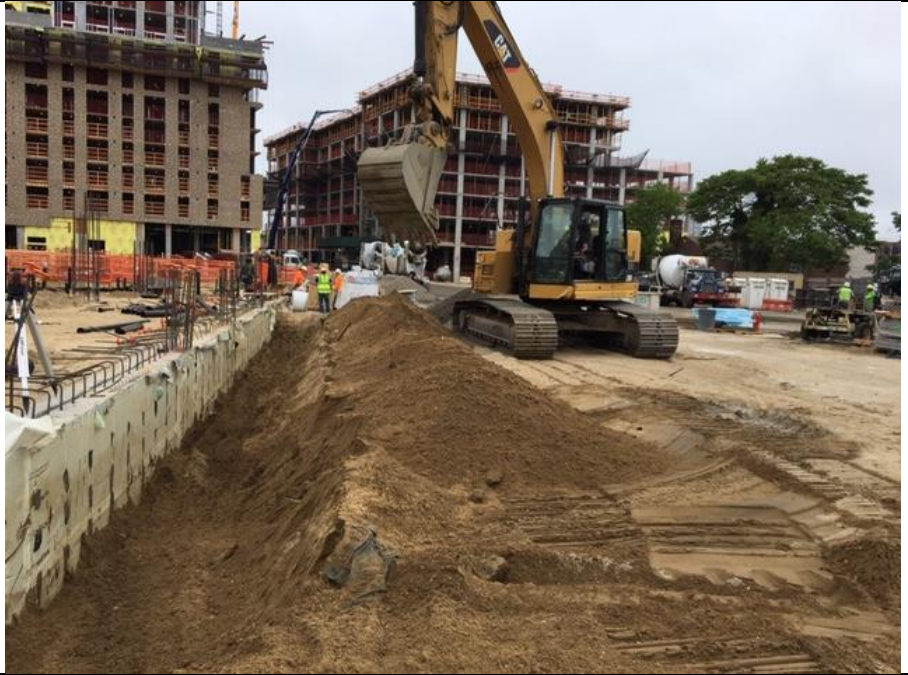
Photo 1- View of trenching soil in C6-C8.

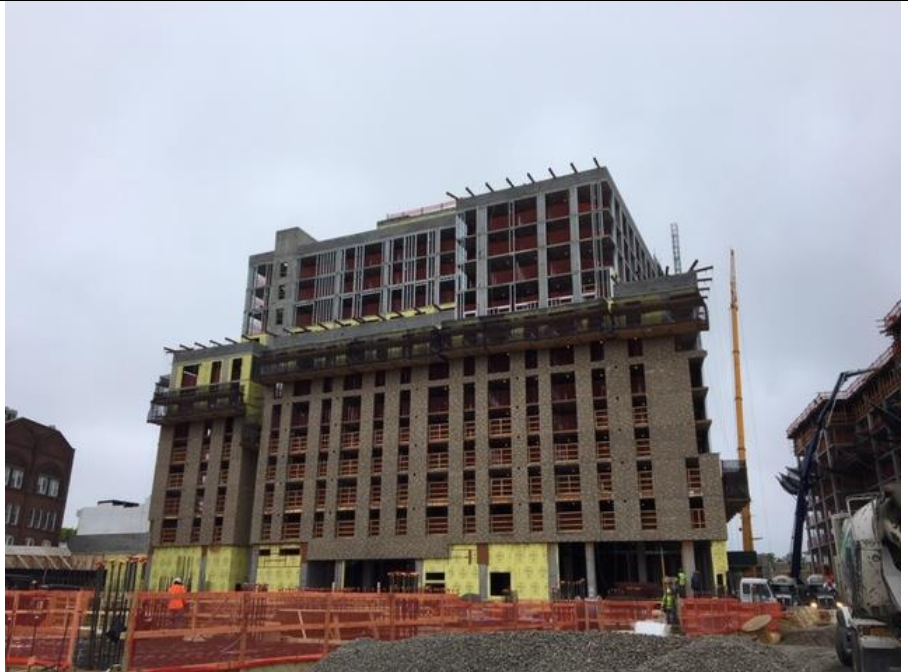
Photo 2- View of formwork, rebar, and utilities installation in D3, D4, E3, and E4.

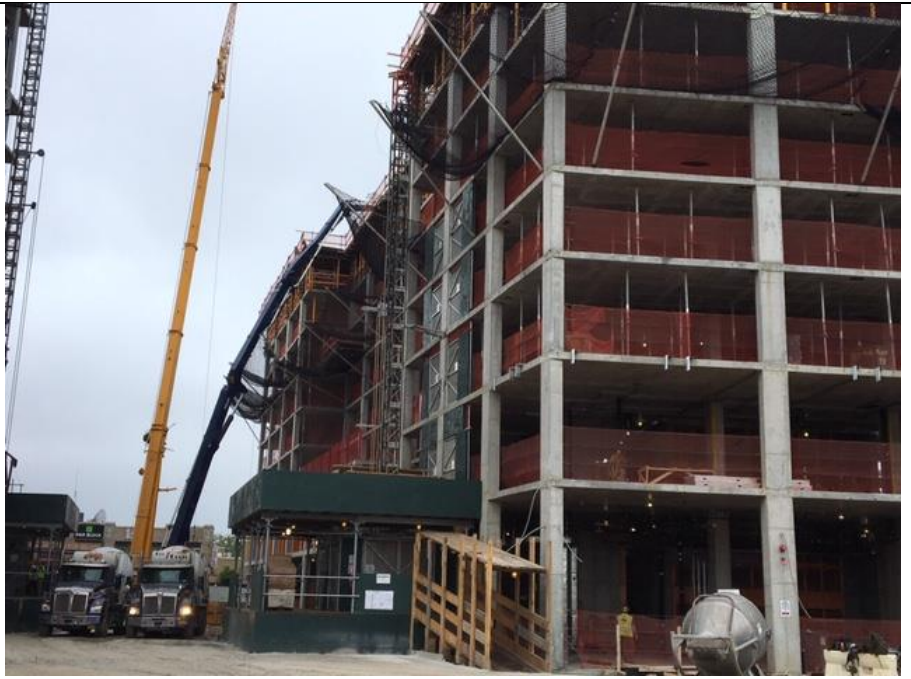
Photo 3- View
of pouring
concrete for
Building C.

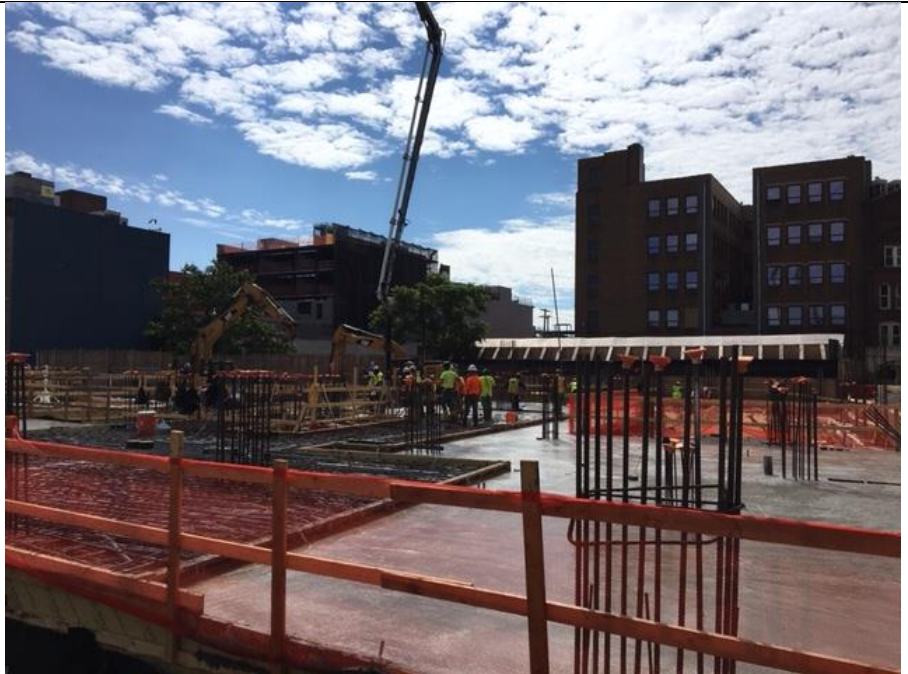
Photo 1- View of pouring concrete in C5, C6, D5, and D6.

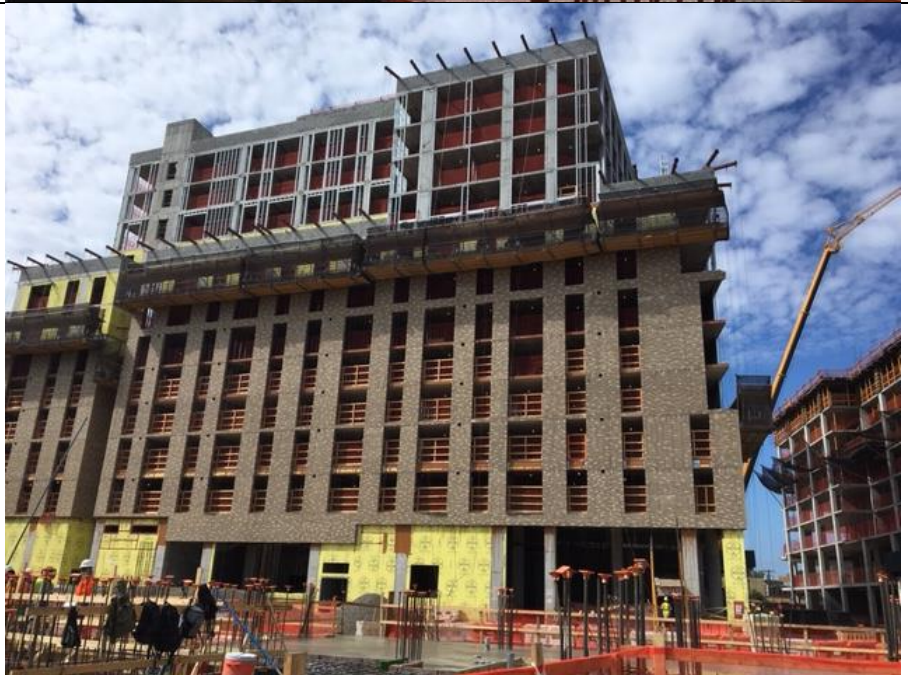
Photo 2- View of formwork, rebar, and utilities installation in D3, D4, E3, and E4.

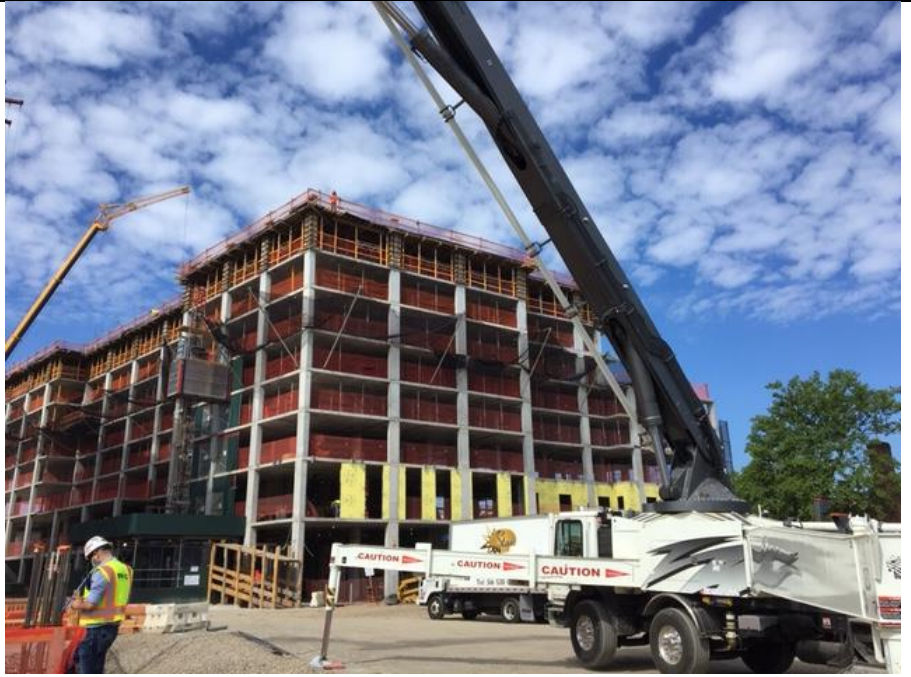
Photo 3- View of formwork, rebar and utilities installation in A3, A4, B3, and B4.

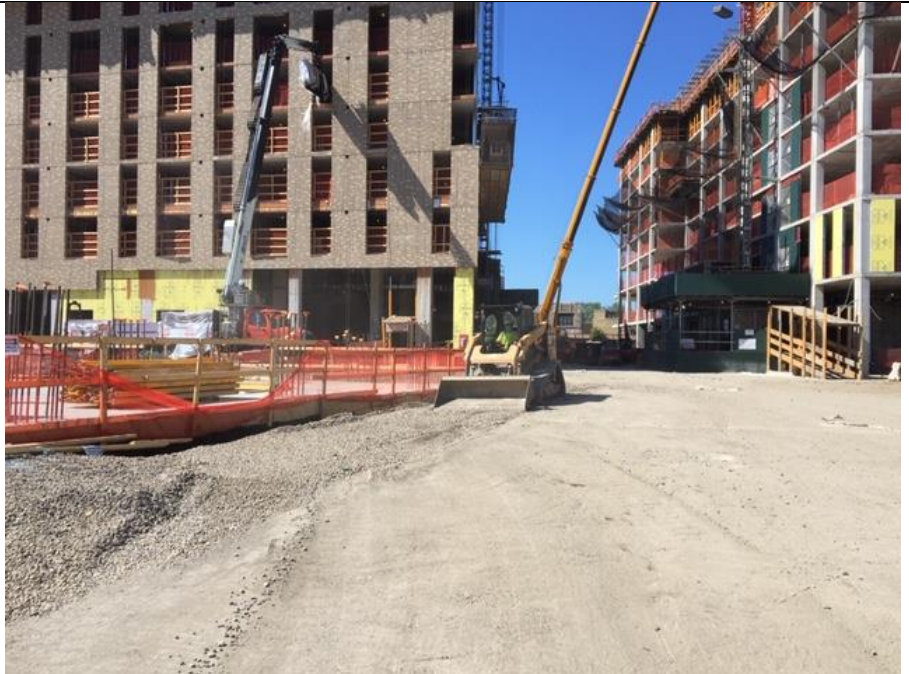
Photo 1- View of grading stone in C5 and C6.

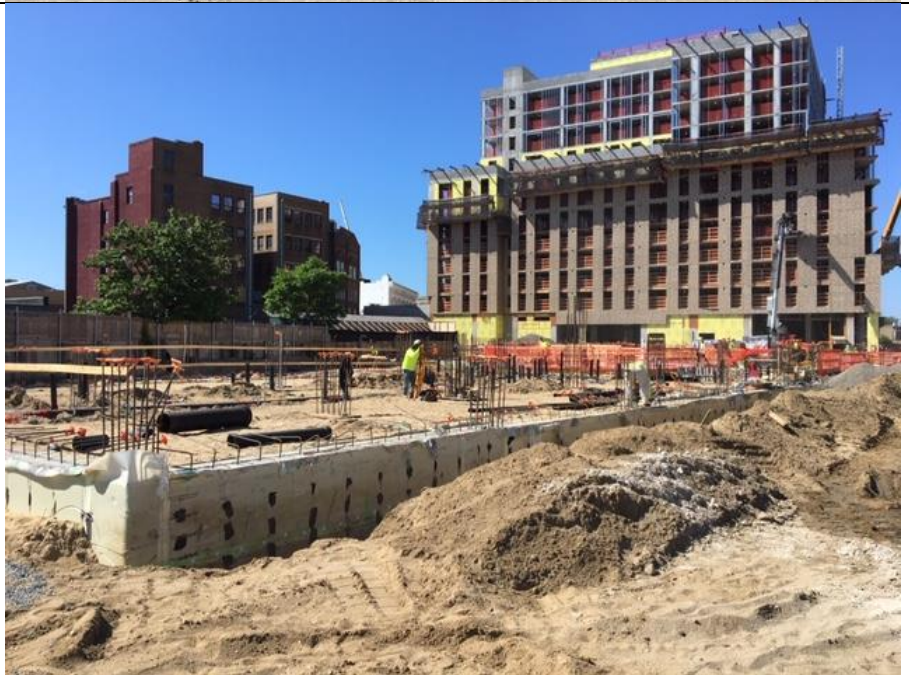
Photo 2- View of formwork, rebar, and utilities installation in D3, D4, E3, and E4.

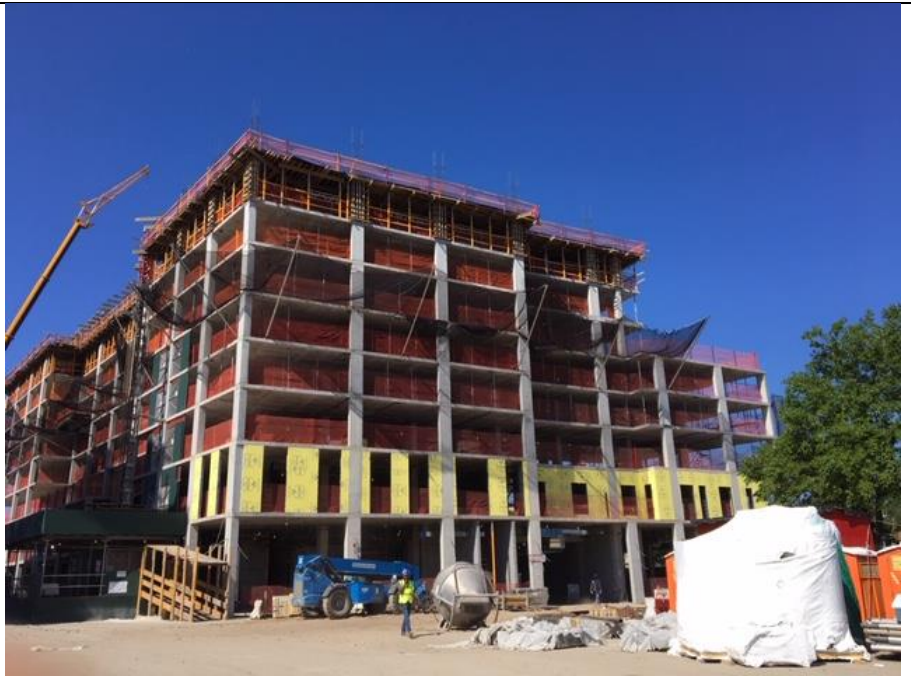
Photo 3- View of formwork, rebar and utilities installation in A3, A4, B3, and B4.

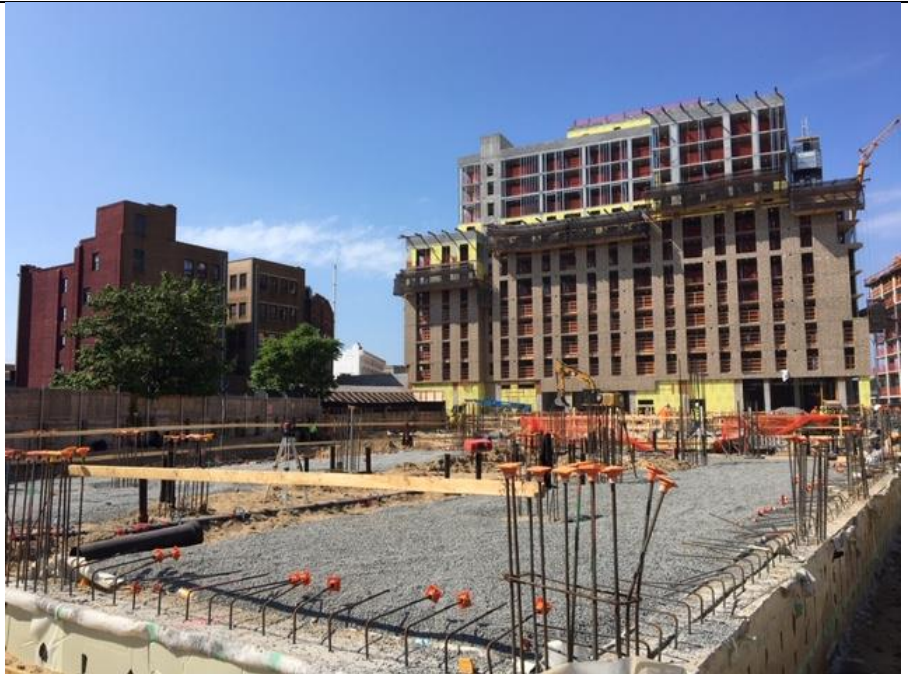
Photo 1- View of grading stone in C7 and C8.

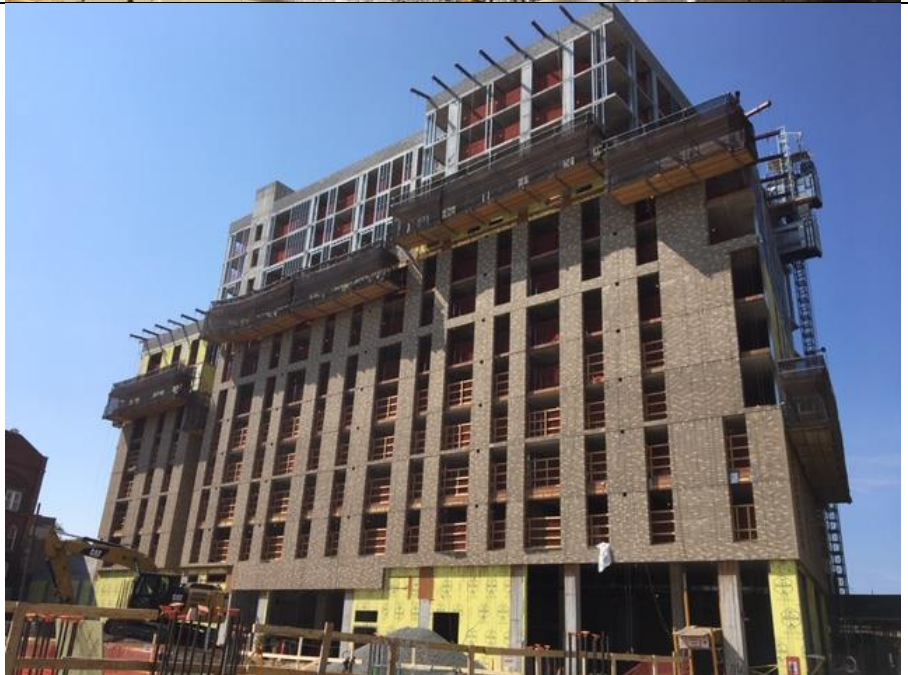
Photo 2- View of formwork, rebar, and utilities installation in D3, D4, E3, and E4.

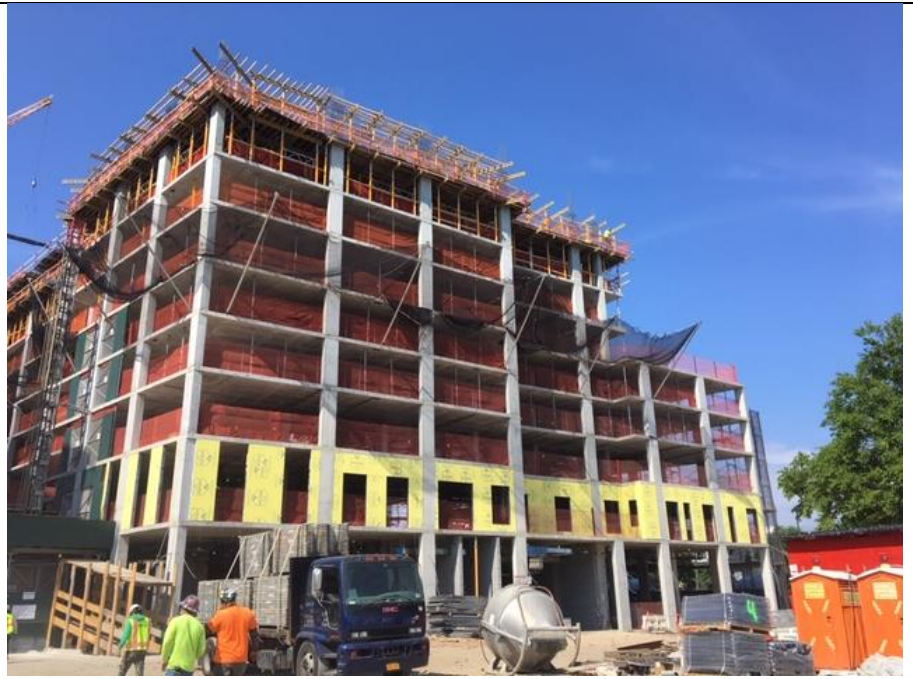
Photo 3- View of formwork, rebar and utilities installation in A3, A4, B3, and B4.

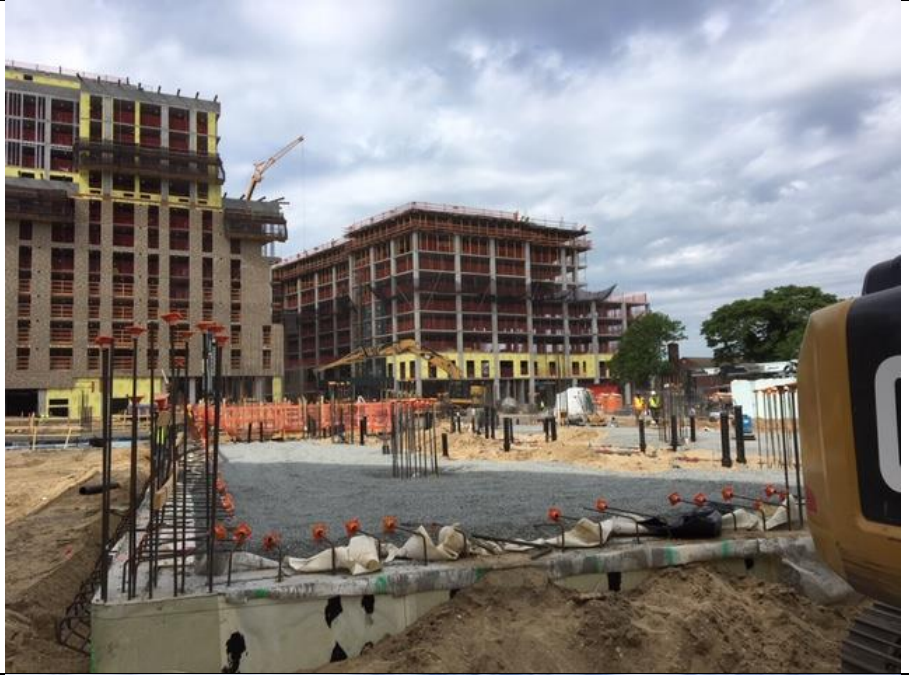
Photo 1- View of graded stone in C7 and C8.

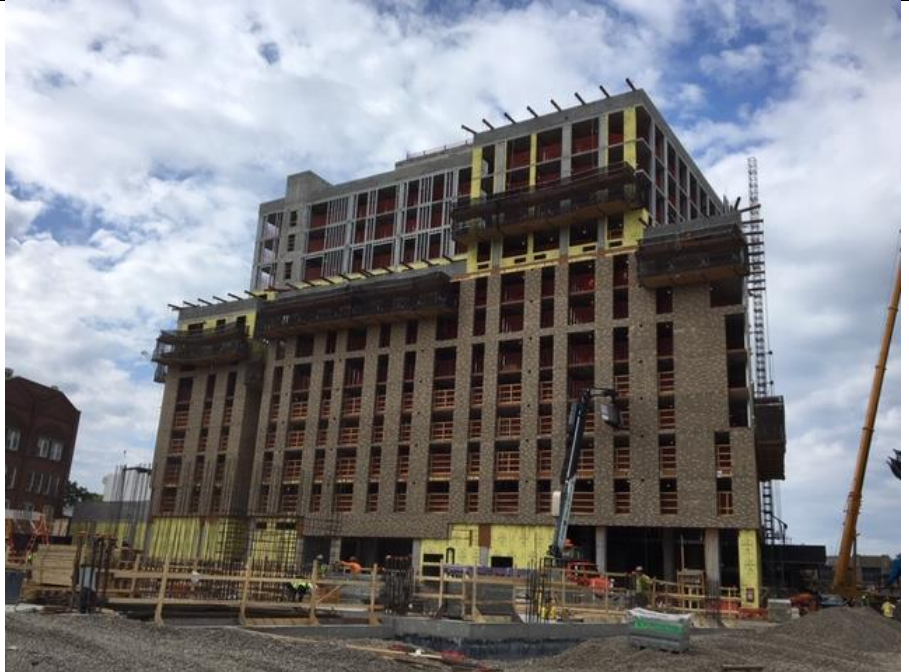
Photo 2- View of formwork, rebar, and utilities installation in D3, D4, E3, and E4.

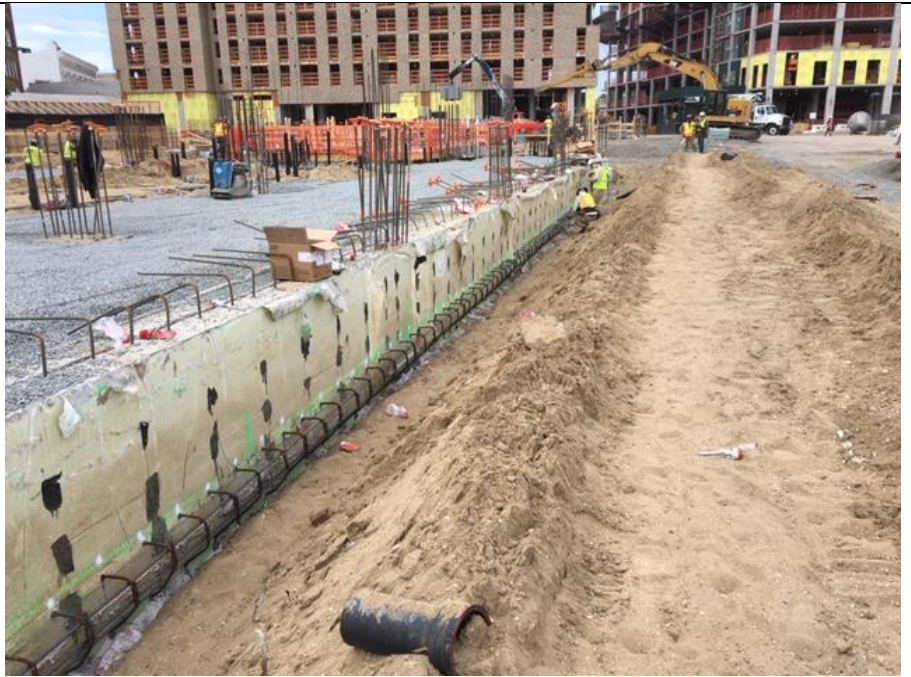
Photo 3- View
of rebar
installation in
C6 and C7.

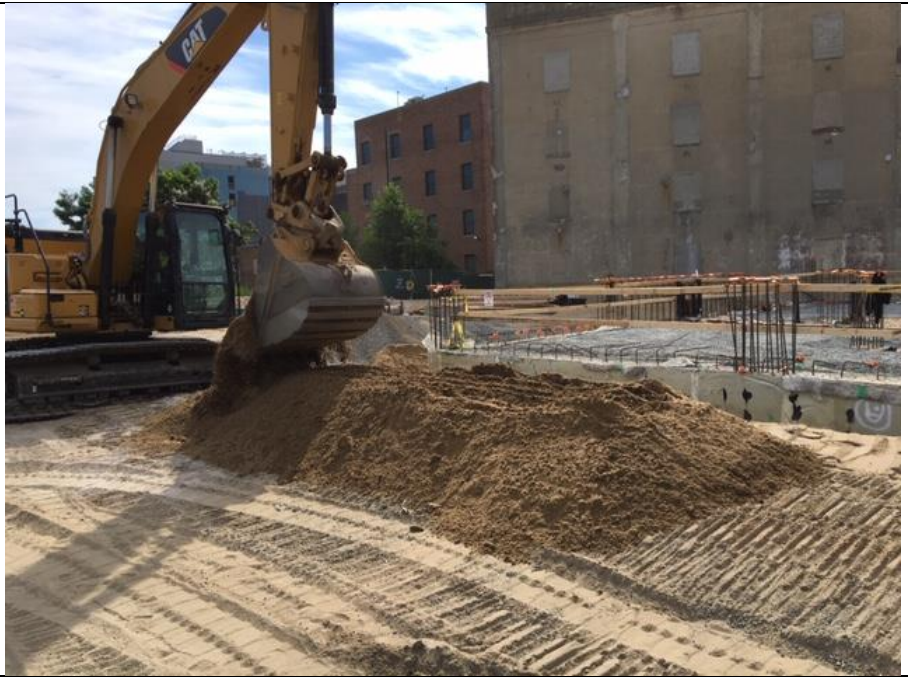
Photo 1- View of graded soil in C7 and C8.

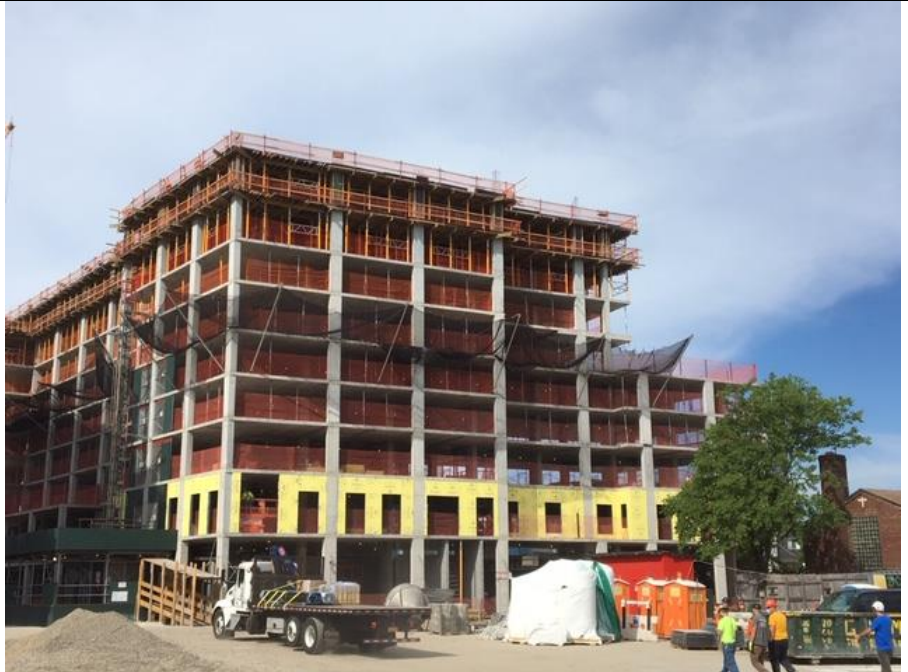
Photo 2- View of formwork, rebar, and utilities installation in A3, A4, B3, and B4.

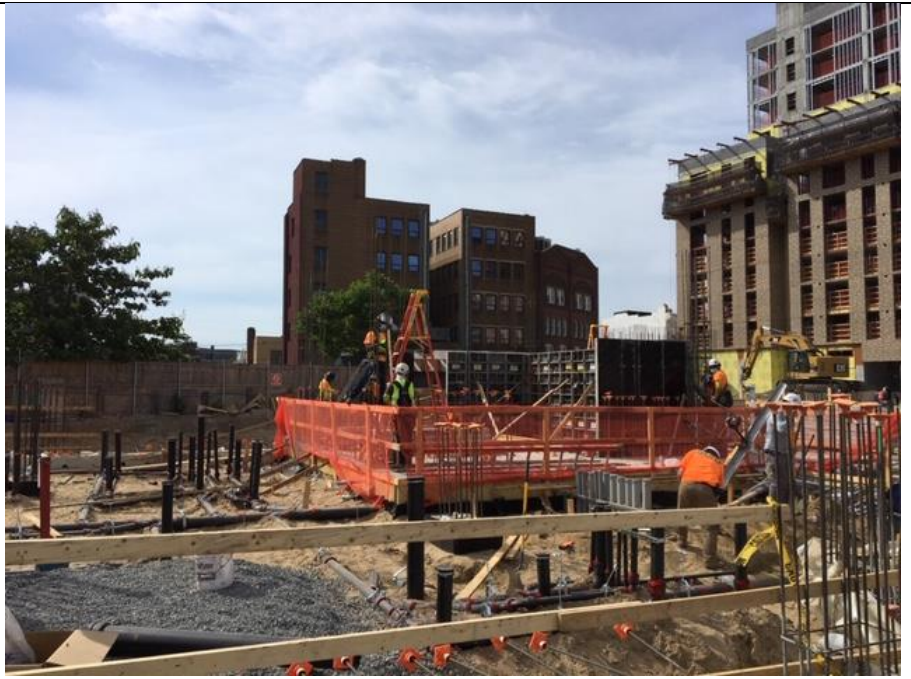
Photo 3- View
of rebar and
formwork
installation in
C5 and C6.

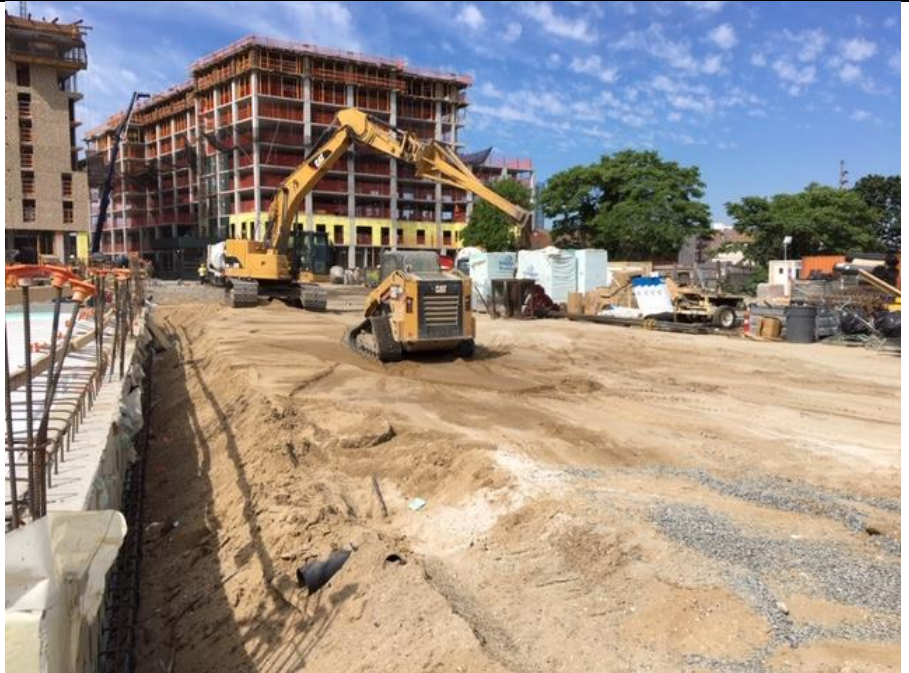
Photo 1- View of grading soil in C7 and C8.

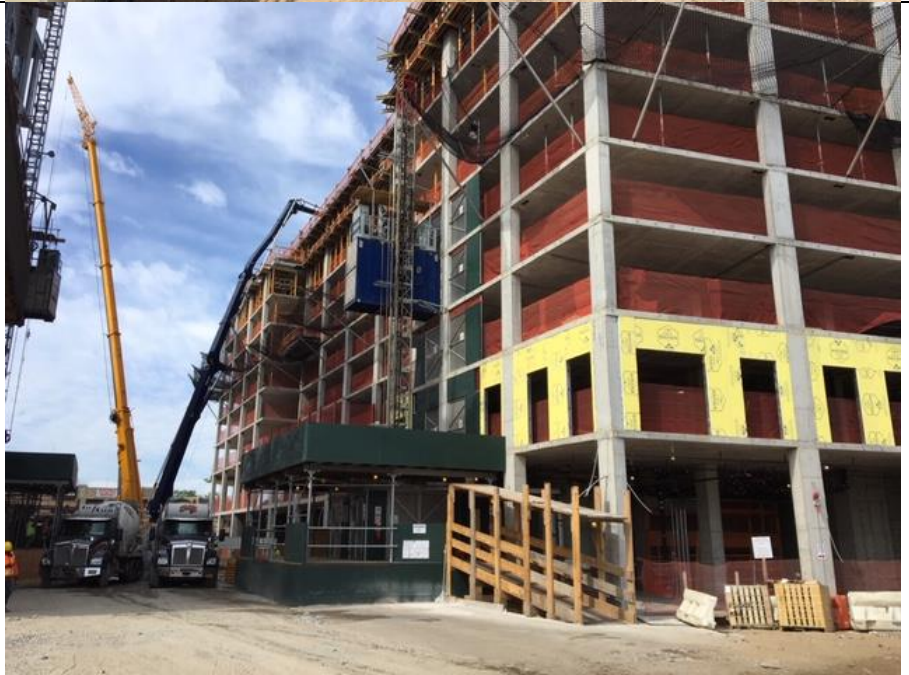
Photo 2- View of pouring concrete in A3, A4, B3, and B4.

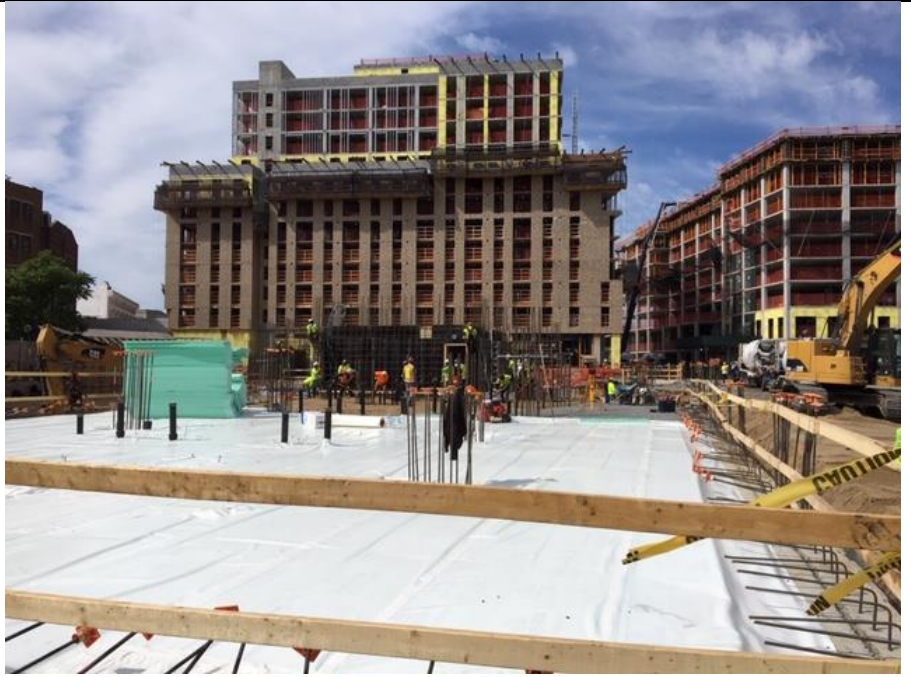
Photo 3- View
of installed
Preprufe 200 in
C7 and C8.

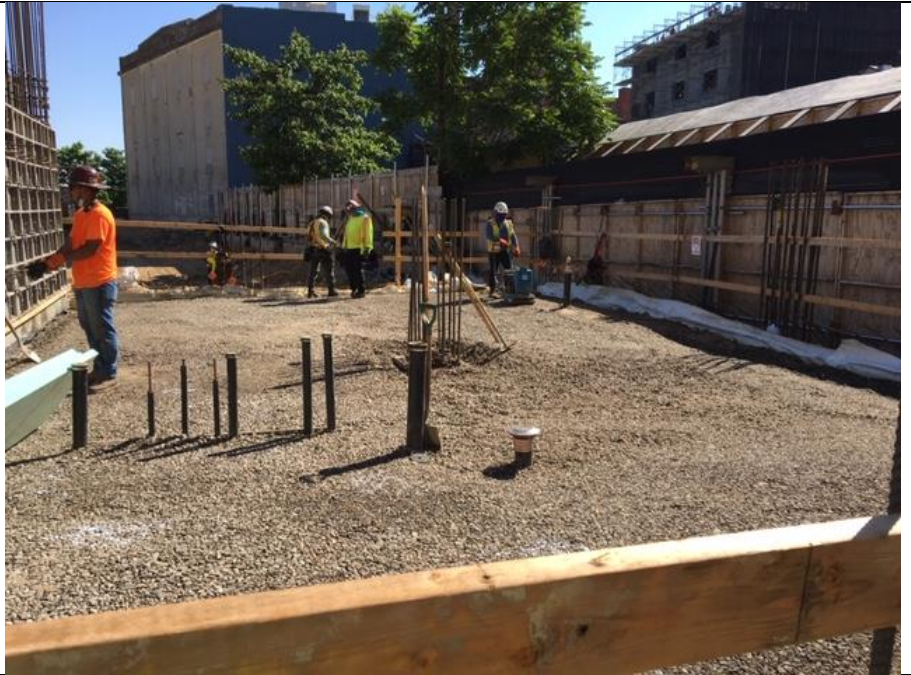
Photo 1- View of grading stone in C5 and D5.

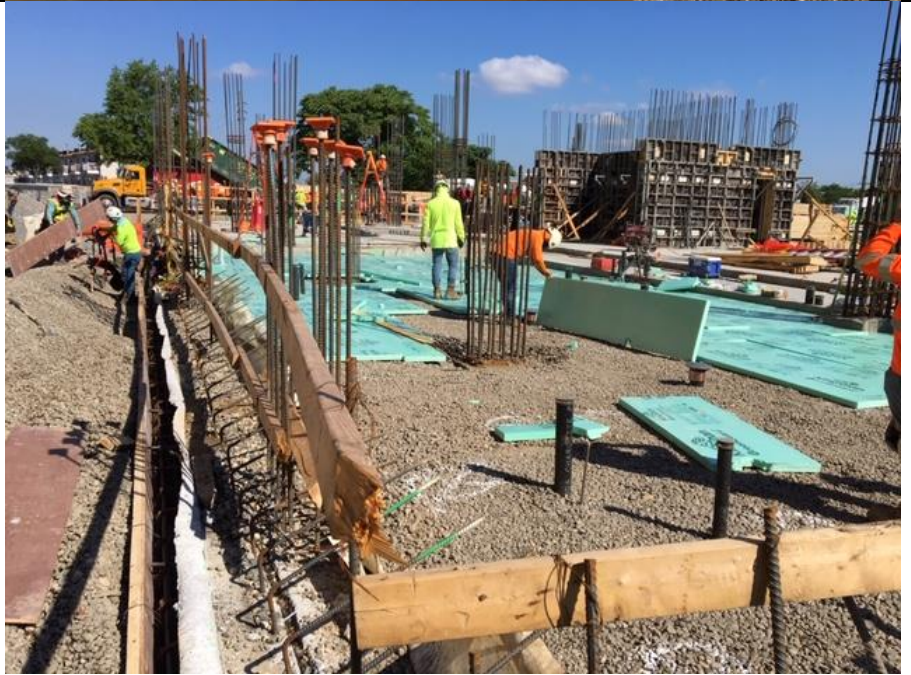
Photo 2- View of installing formwork, rebar, and waterproofing installation in C5 and D5.

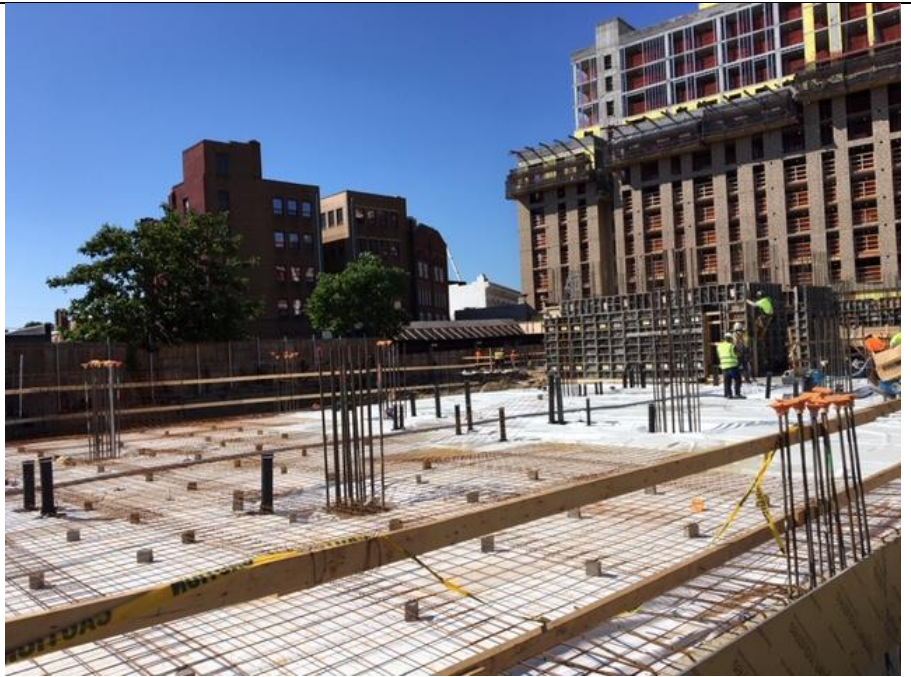
Photo 3- View
of installed
Preprufe 200 in
C7 and C8.

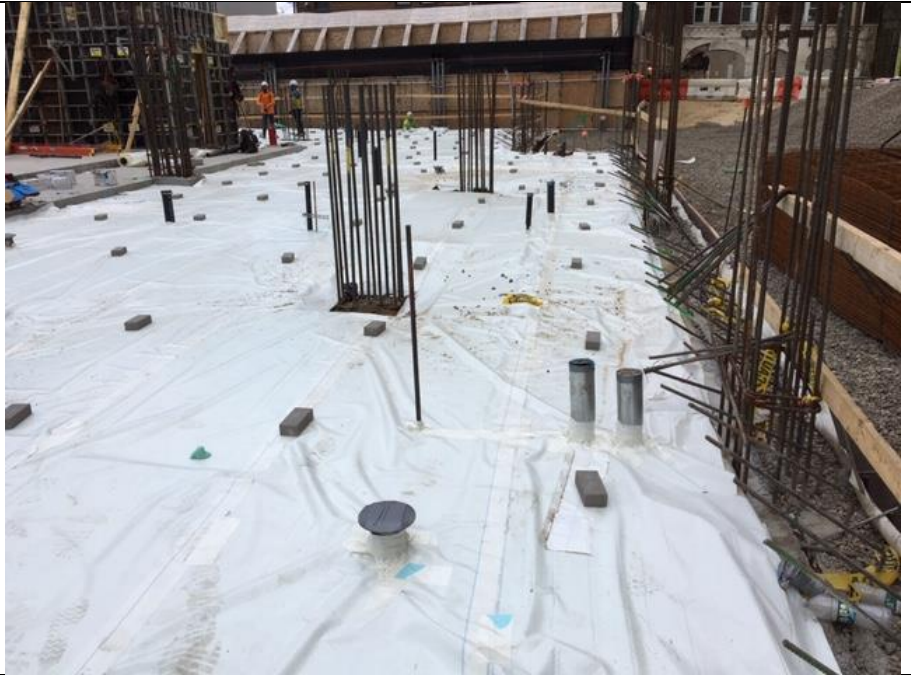
Photo 1- View
of installed
Preprufe 200 in
C5 and D5.

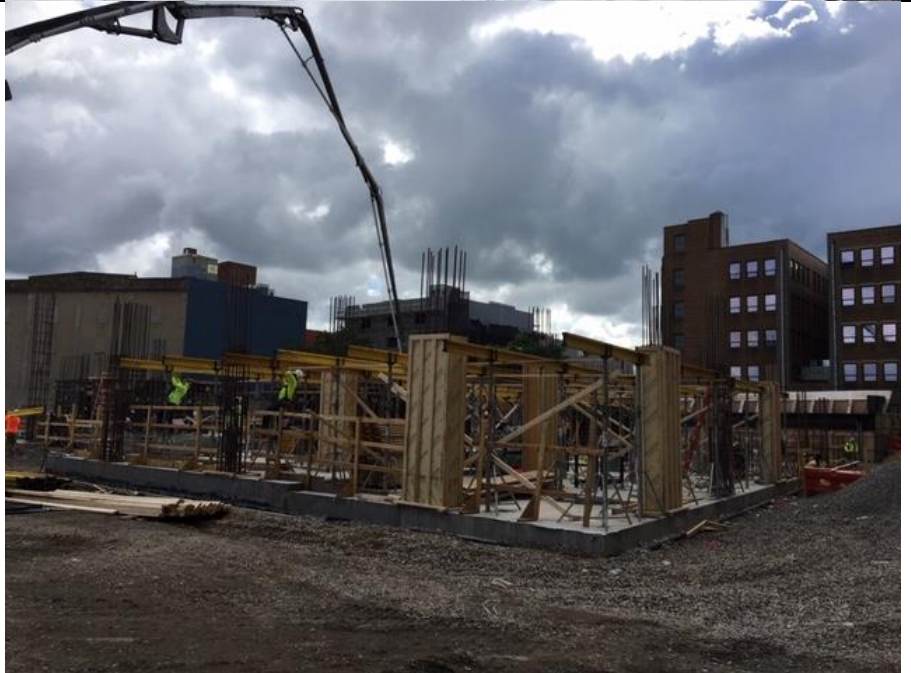
Photo 2- View
of pouring
concrete in D5
and D6.

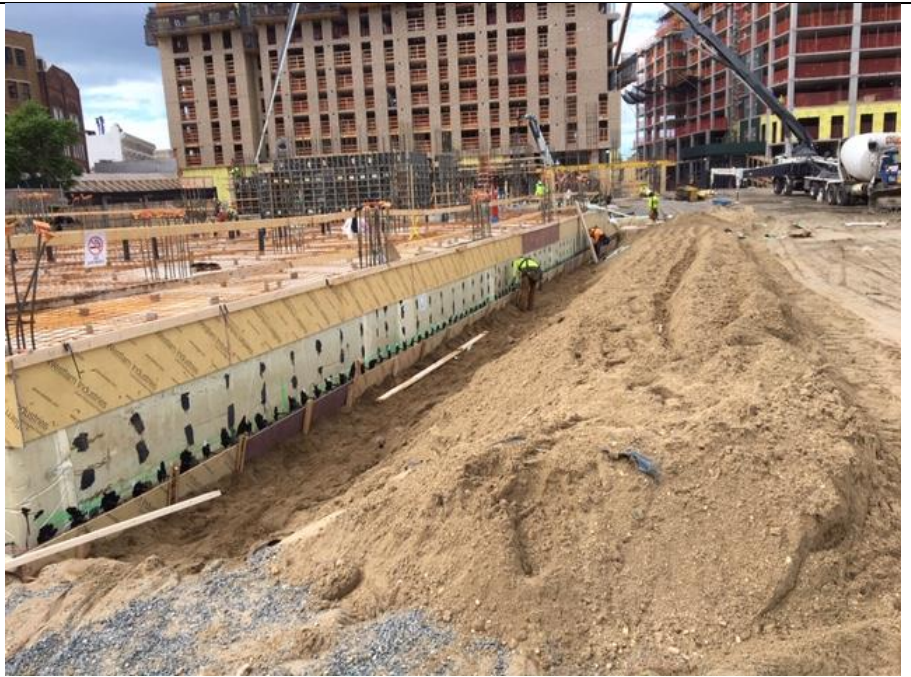
Photo 3- View
of rebar and
formwork in C7
and C8.
