### Daily Report for February 1, 2021

Far Rockaway Project 20-02 Mott Avenue Far Rockaway, NY BCP #C241224

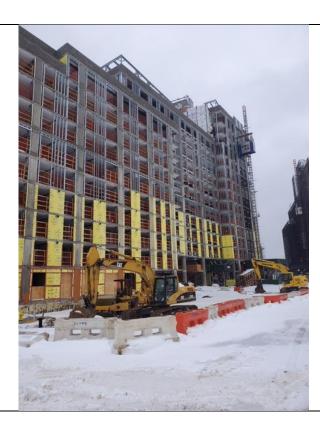
Photo 3- View of formwork and utility installation grids C6-C8.

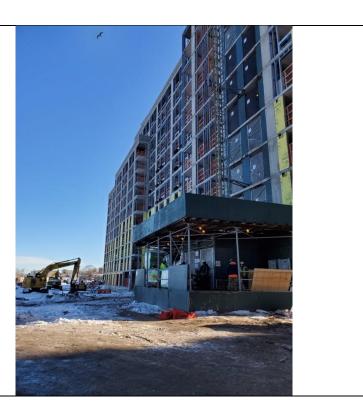
Photo 3- View of utility and formwork installation in C6-C8.

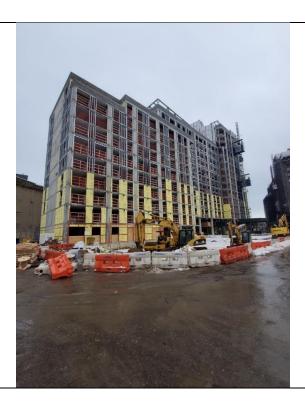
Photo 3- View of utility and formwork installation in C6-C8.
