Langan Project No:	100849501	Project:	990 Rossville	e Ave	Date:		11/18/2021
NYSDEC BCP Site No:	C243043			Time:		8:	00 – 11:45

Langan Engineering, Environmental, Surveying, Landscape Architecture and Geology, D.P.C.

Site Activities

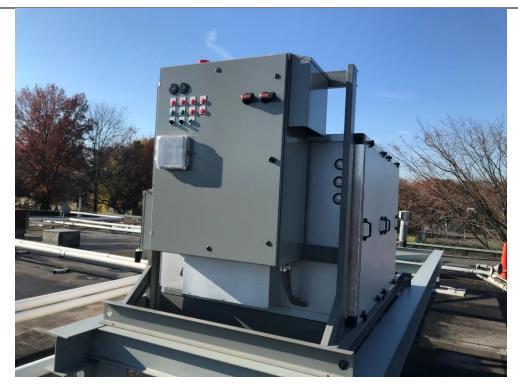
Photo 1 – View of process equipment mounted steel dunnage system with control panel visible, facing west.

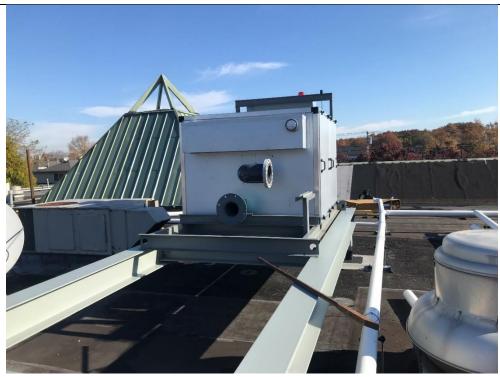
Photo 2 – View of the process equipment, facing east.

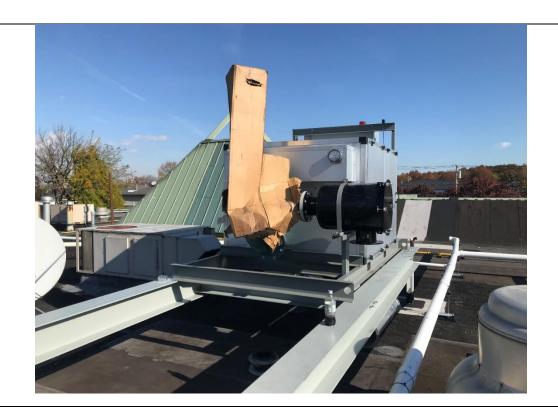
Photo 3 – View of process equipment with discharge stack and inline filter attached, facing east. Note packaging (including plastic interior) remains on discharge stack to protect from weather until rain-cover can be attached.

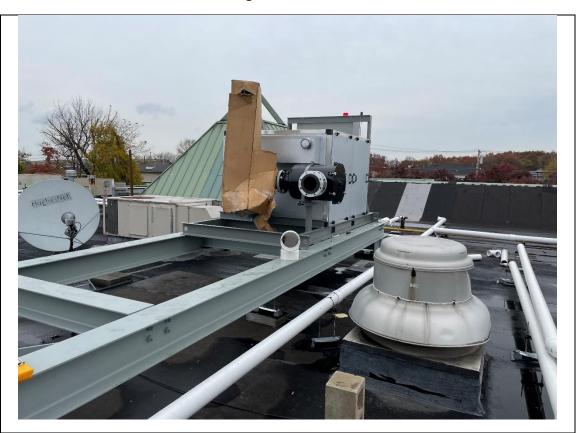
Photo 1 – View of process equipment with discharge stack (covered due to rain), inline filter, and flanged flex connector attached, facing east.

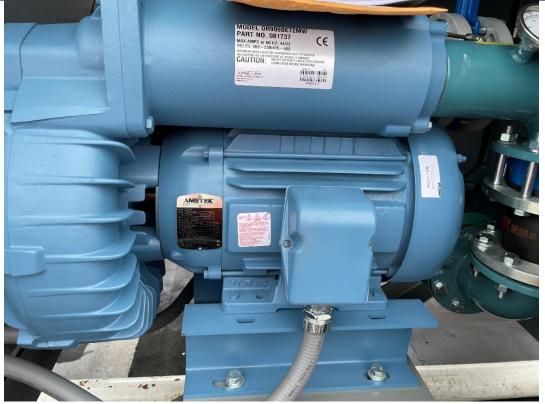
Photo 2 – Interior view of process equipment with one of the two regenerative blowers visible.

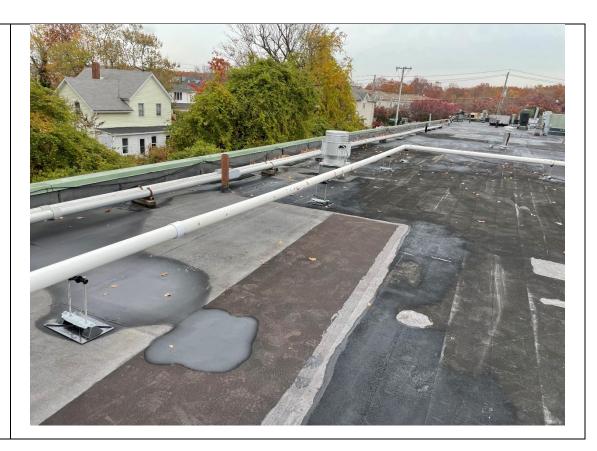
Photo 3 – View of newly installed subheader line (associated with VEP-18, VEP-19, VEP-21, VEP-25 and VEP-26) running towards the main header, facing north.

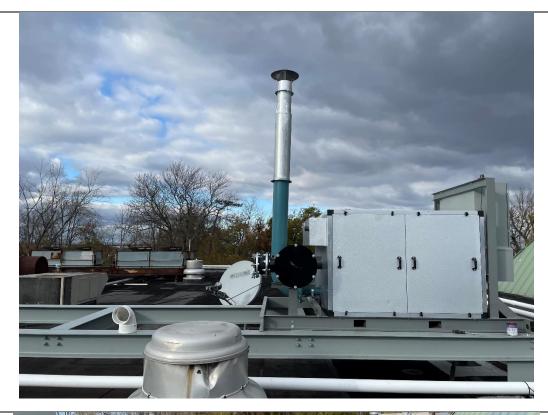
Photo 1 – View of process equipment with completed noloss stack head and associated rain-cap, facing north.

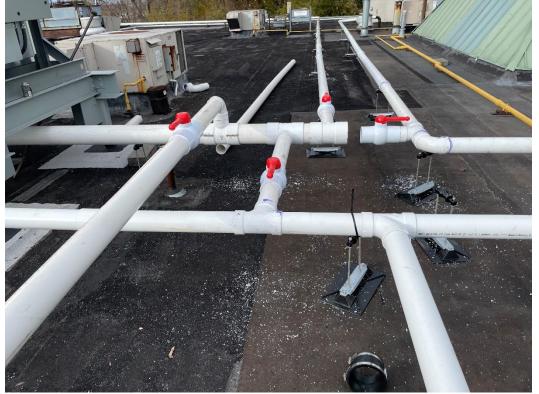
Photo 2 – View of subheader lines manifolding to main header line with dedicated gate valves, facing north.

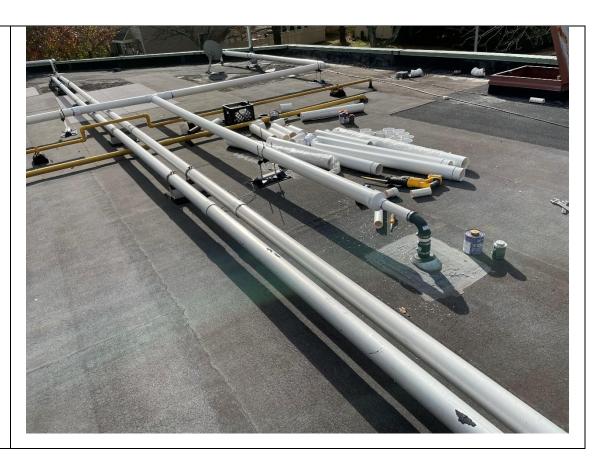
Photo 3 – View of VEP-11 connected to the 4-inch PVC subheader line, facing south.

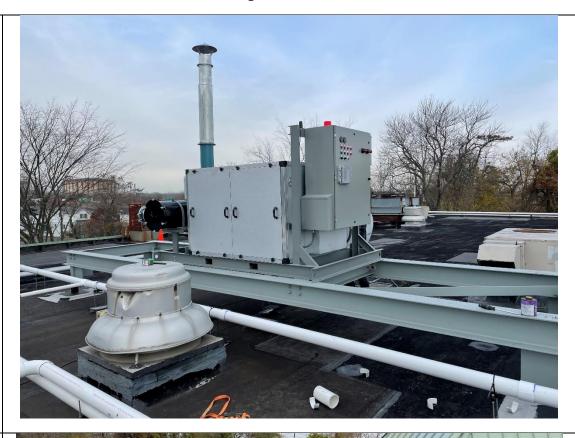
Photo 1 – View of process equipment following repositioning to the center of the steel dunnage system, facing northwest.

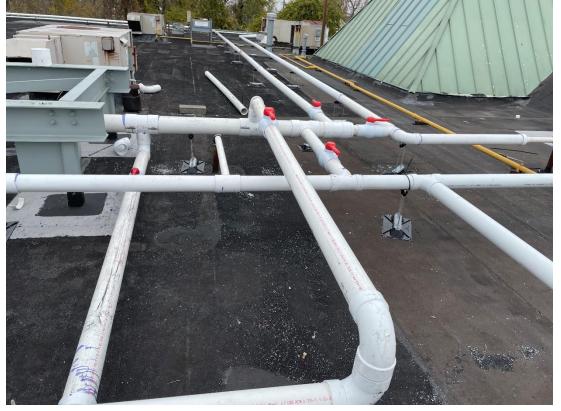
Photo 2 – Completed subheader lines manifolding to the main header line (with dedicated gate valves visible), facing north.

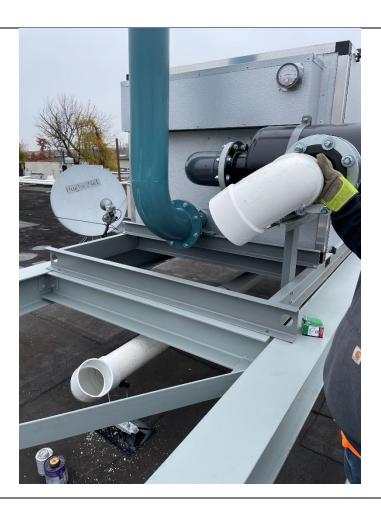
Photo 3 – View of the connection point between the main header line and processing equipment, facing east.
