MONTHLY STATUS REPORT

BCP No.:	C314121	PVE Project No.:	560909	Date:	1/29/2020
Project Name:	3532 North Road, Dutchess County, Poughkeepsie, New York

Consultant: PVE	Consultant On-Site: Trevor Treglia
General Contractor: Saber Development	General Contractor Contact: Richard DeCola

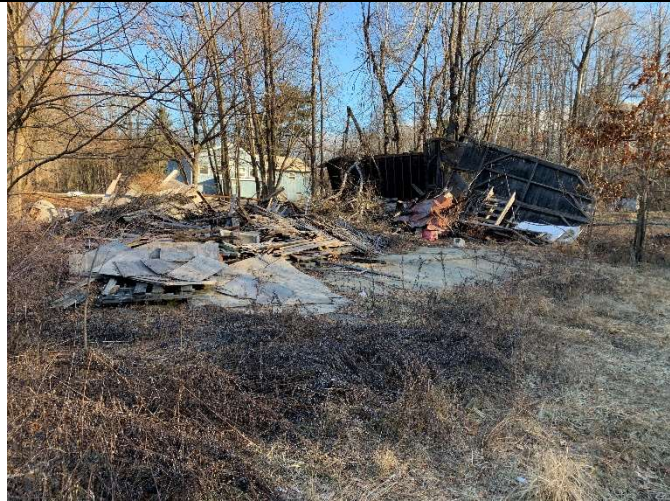
Photo 1 –

Auto Garage East (Collapsed).

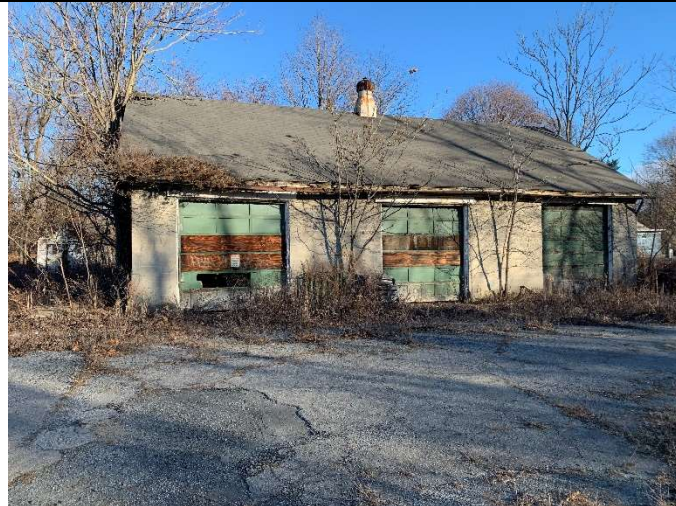
Photo 2 –

Auto Garage West.

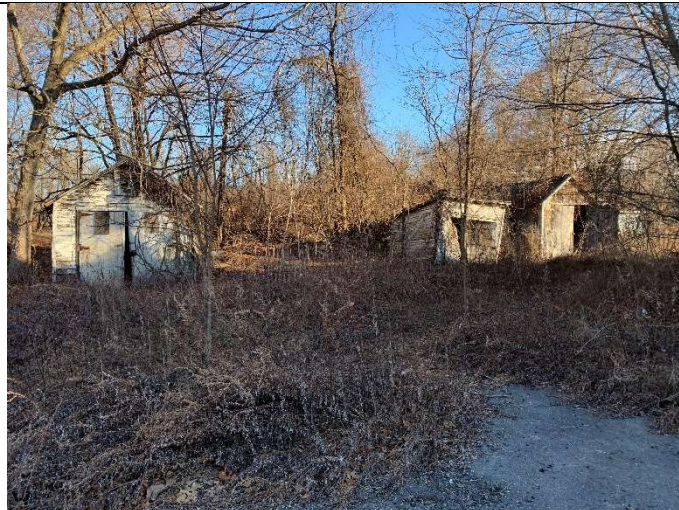
Photo 3 –

Three (3) structures behind Auto
Garage East and West

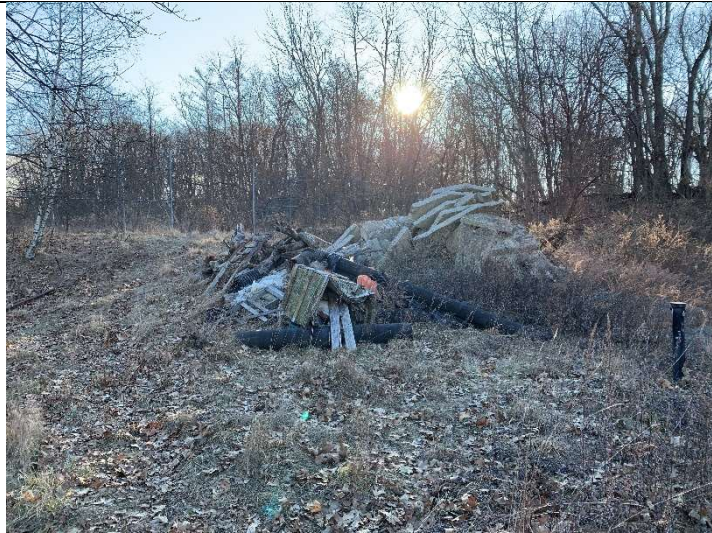
Photo 4 –

Pile of debris outside fenced area.
Just south of Auto Garage East.

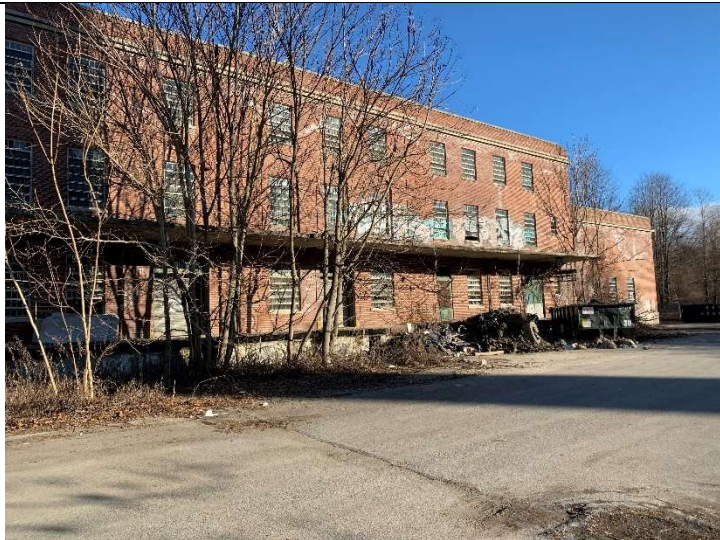
Photo 5 –

Bakery/Storage structure. Piles of
debris along southern side of
structure.

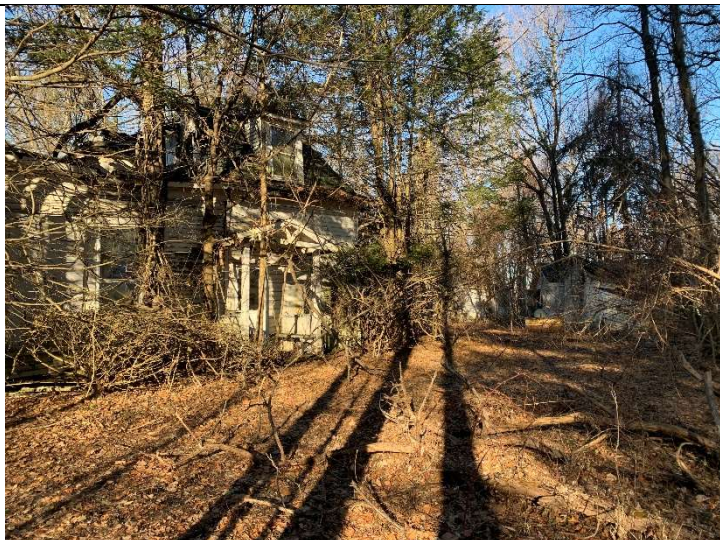
Photo 6 –

Residential structure with shed
(pictured right) directly west of the
Bakery/Storage structure. Severe
deterioration of both structures.

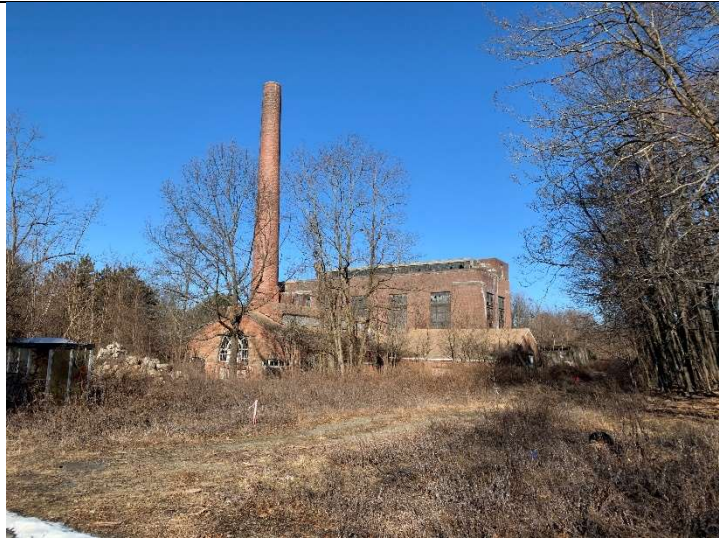
Photo 7 –

Powerhouse.

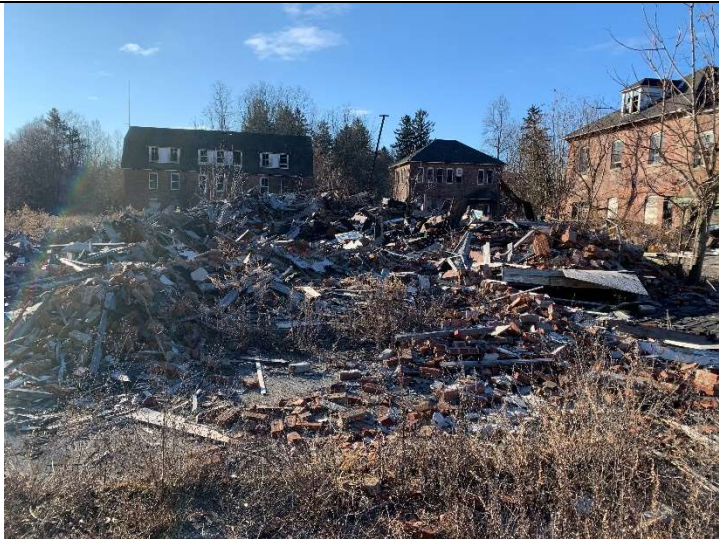
Photo 8 –

Engineer's Office (Demolished).

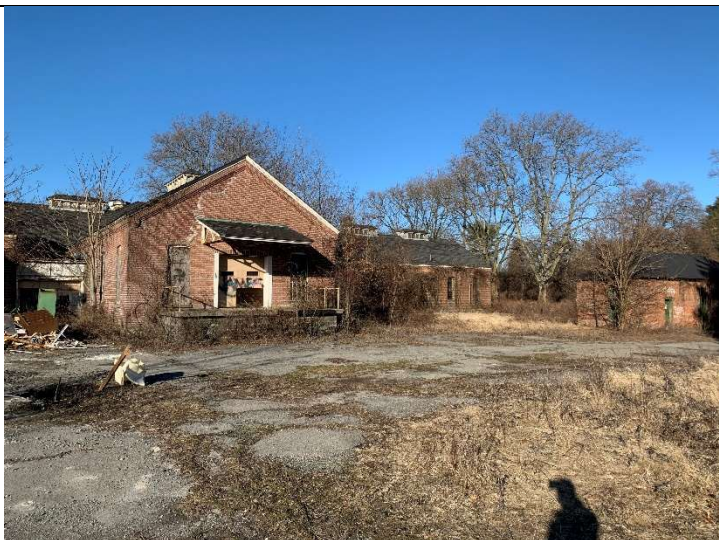
Photo 9 –

Carwash with shed (pictured right).

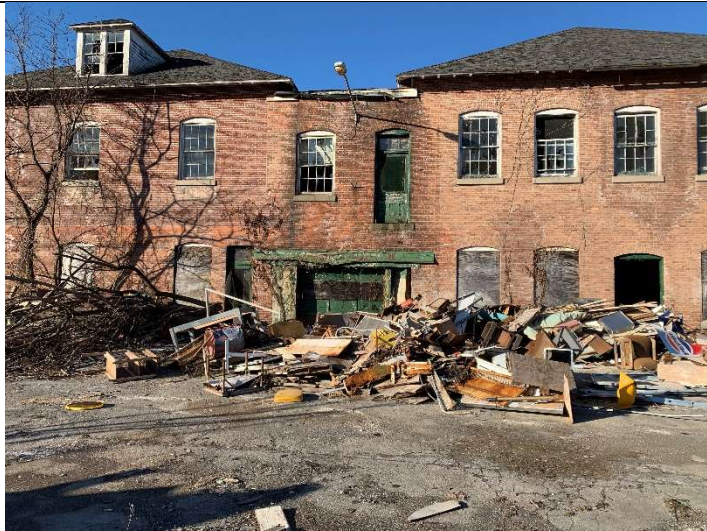
Photo 10 –

Maintenance Building with piles of debris along east side of structure.

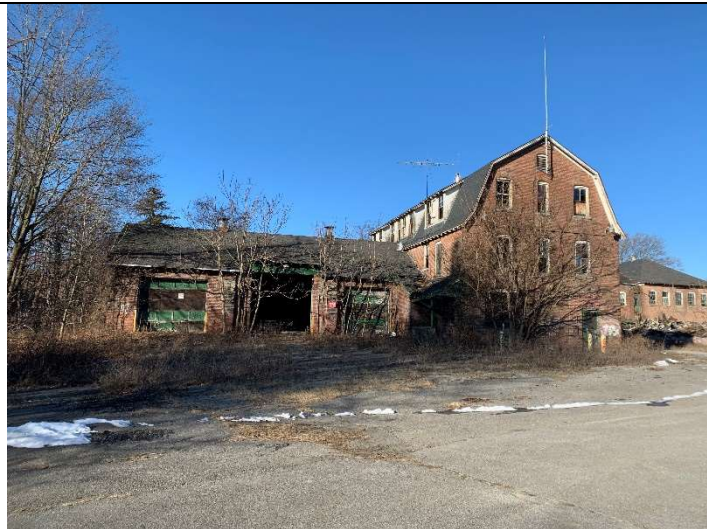
Photo 11 –

Fire House.

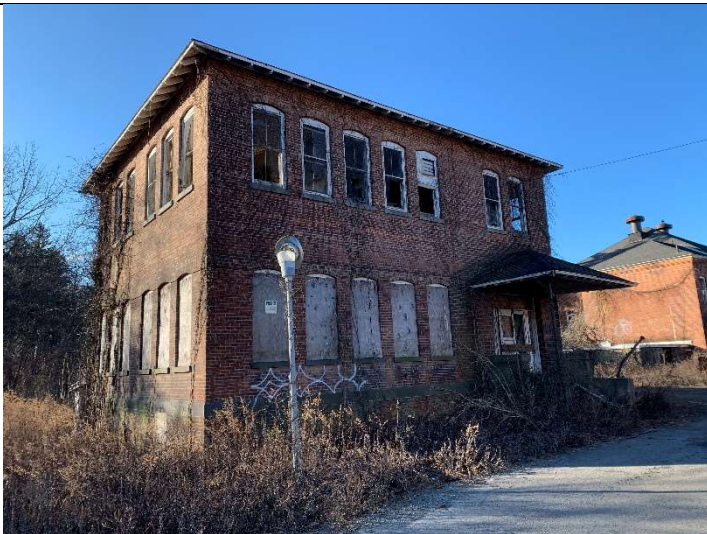
Photo 12 –

Mortuary Building.

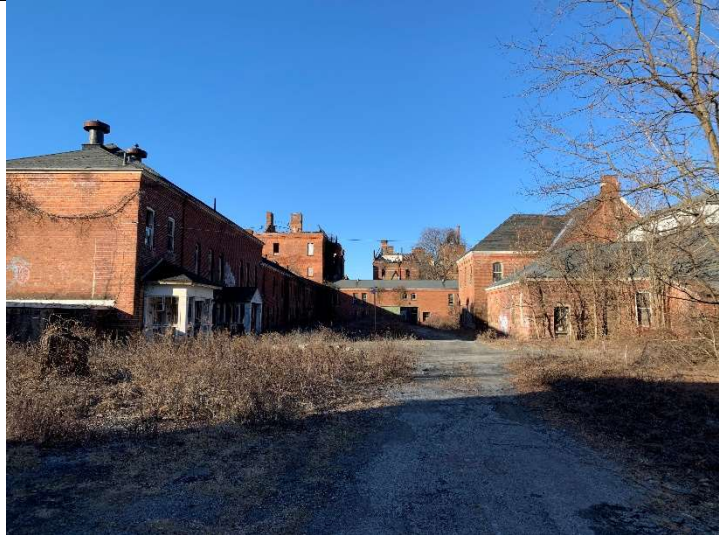
Photo 13 –

Structures west of the Mortuary Building, facing west.

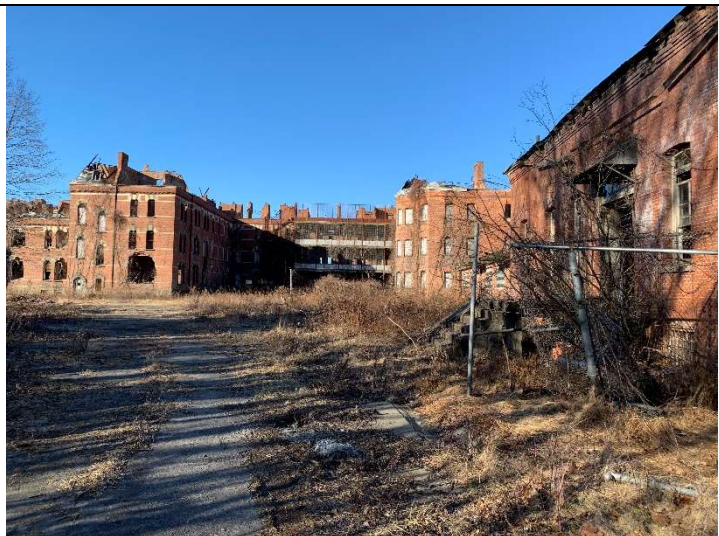
Photo 14 –

Structures in southwest corner of BCP boundary / behind Mortuary Building. North view.

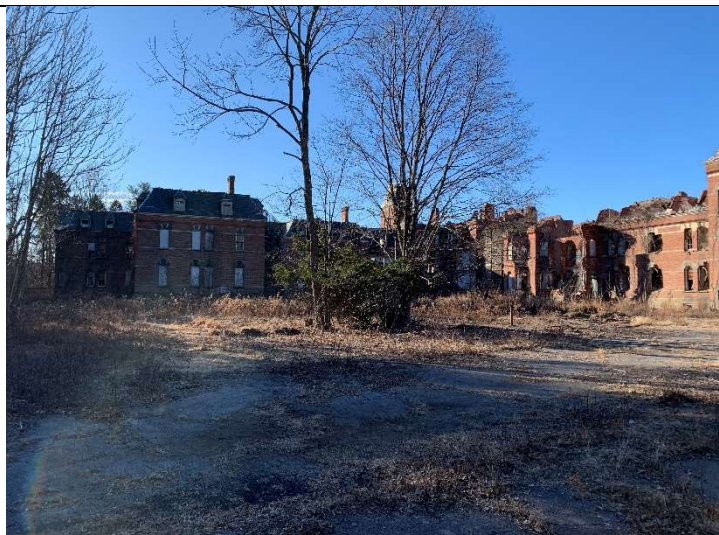
Photo 15 –

Structures in southwest corner of BCP boundary / behind Mortuary Building. South view.

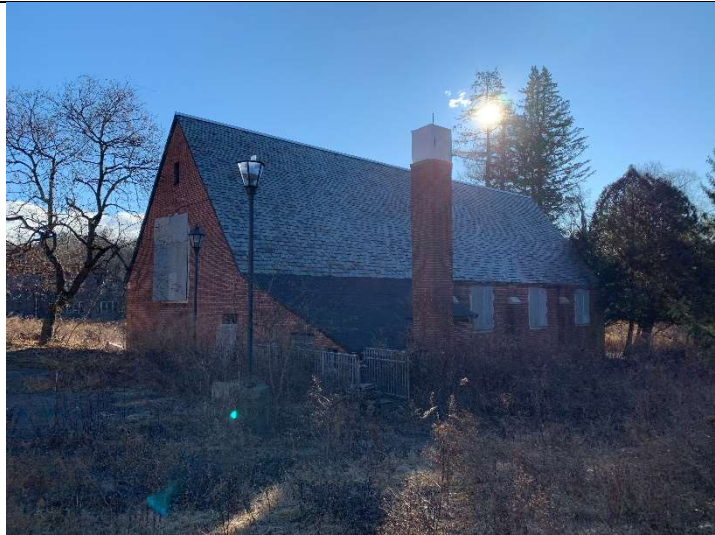
Photo 16 –

Rectory south of the Recreational Hall building.

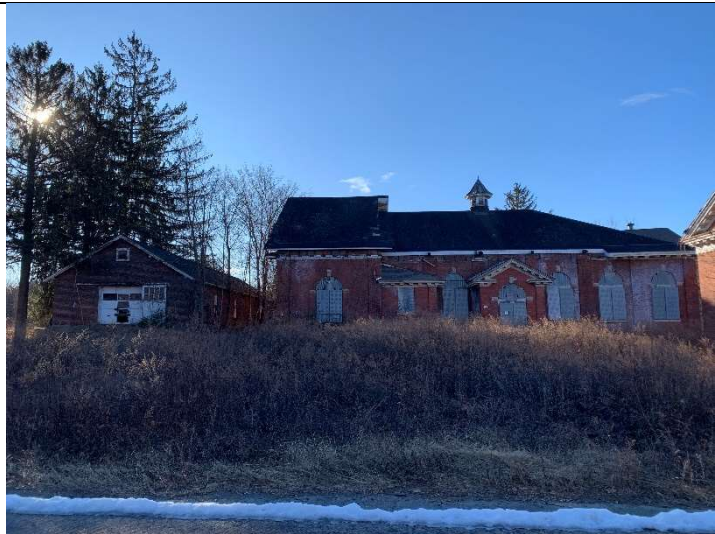
Photo 17 –

Recreational Hall.

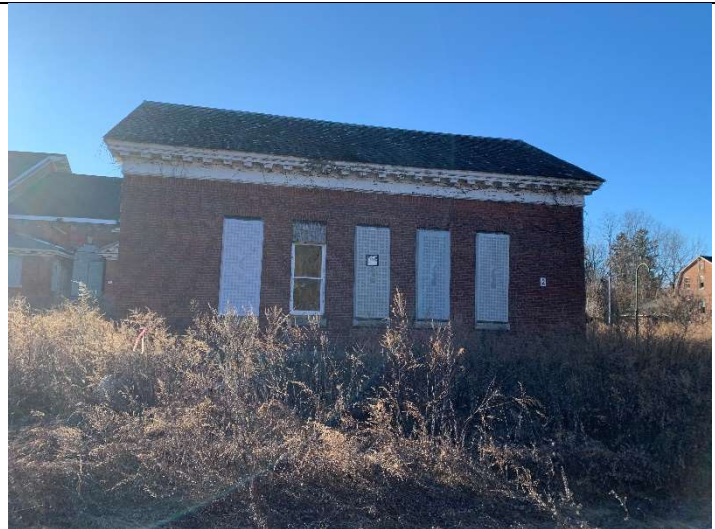
Photo 18 –

Library.

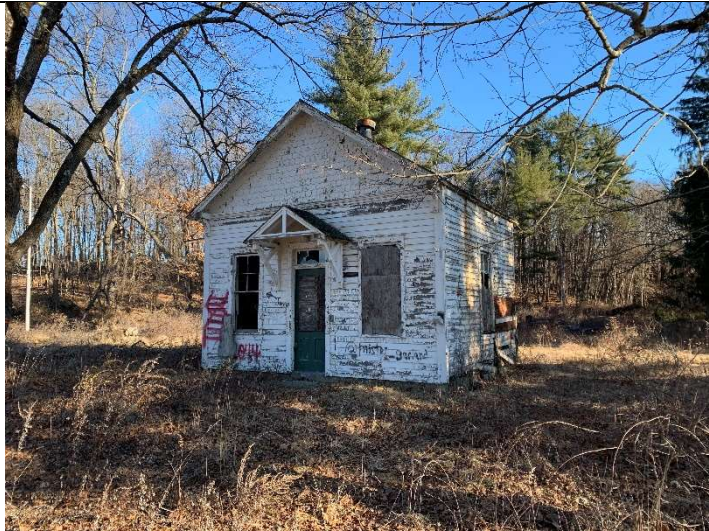
Photo 19 –

Small structure east of the Library.

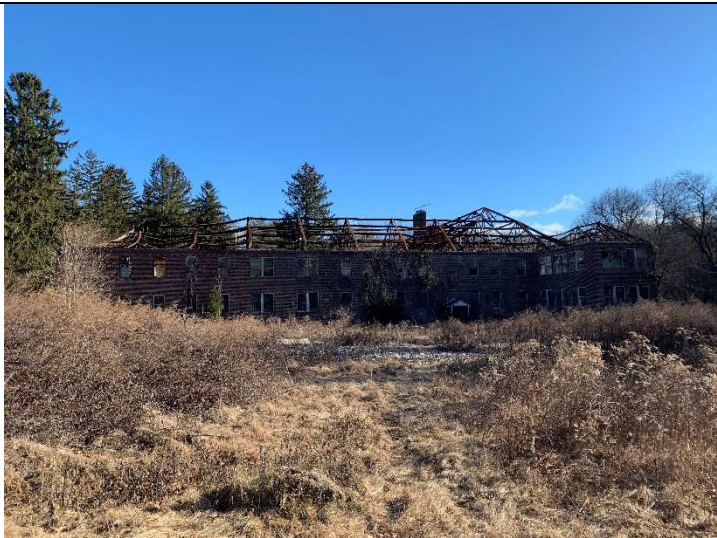
Photo 20 –

Brookside structure, severe deterioration of roof.

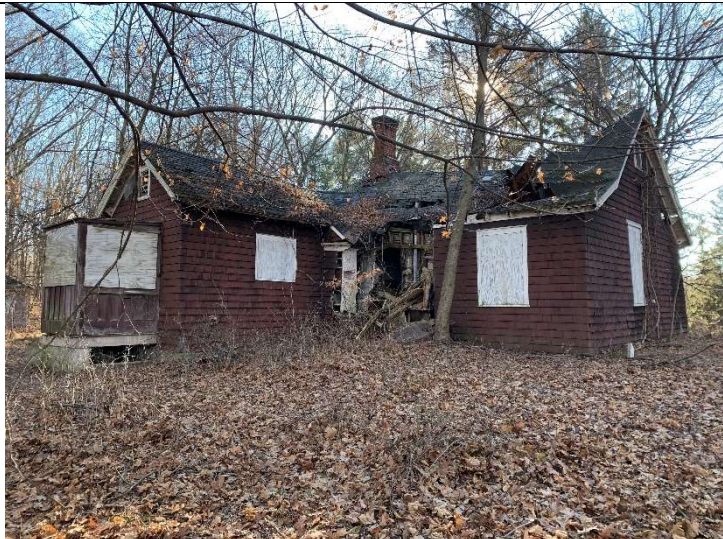
Photo 21 –

Staff House, severe deterioration of roof and interior floor.

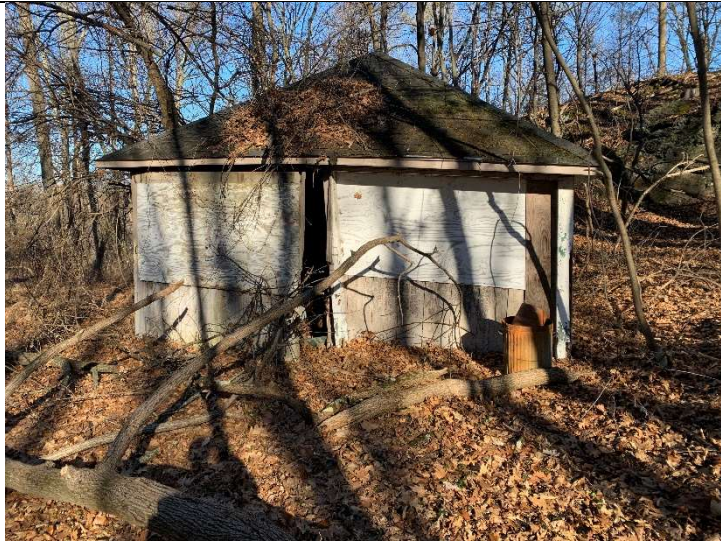
Photo 22 –

Small structure just east of the Staff House.
