MONTHLY STATUS REPORT

BCP No.:	C314121	PVE Project No.:	560909	Date:	7/27/2021
Project Name:	3532 North Road, Dutchess County, Poughkeepsie, New York

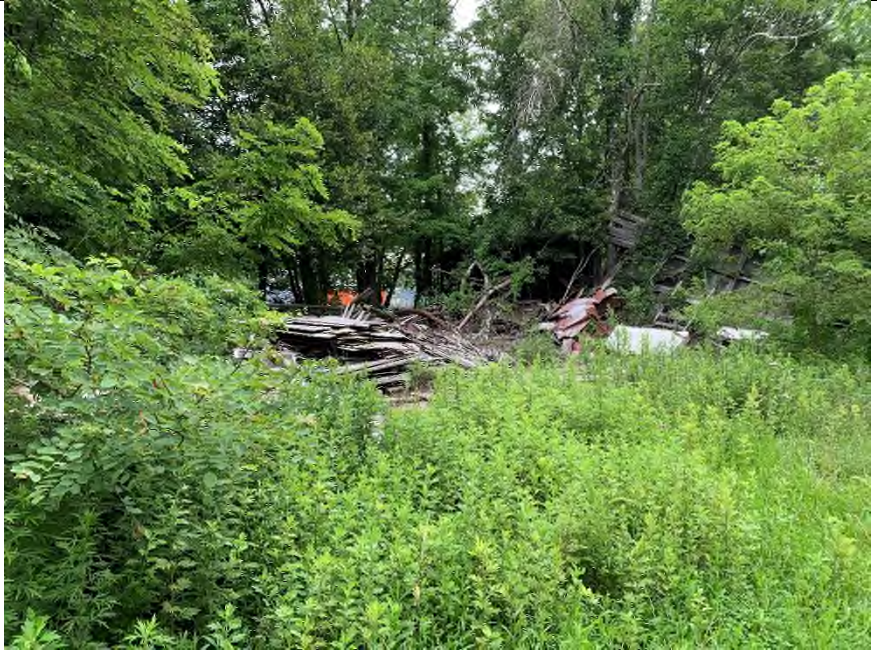
Photo 1 –

Auto Garage East (Collapsed).

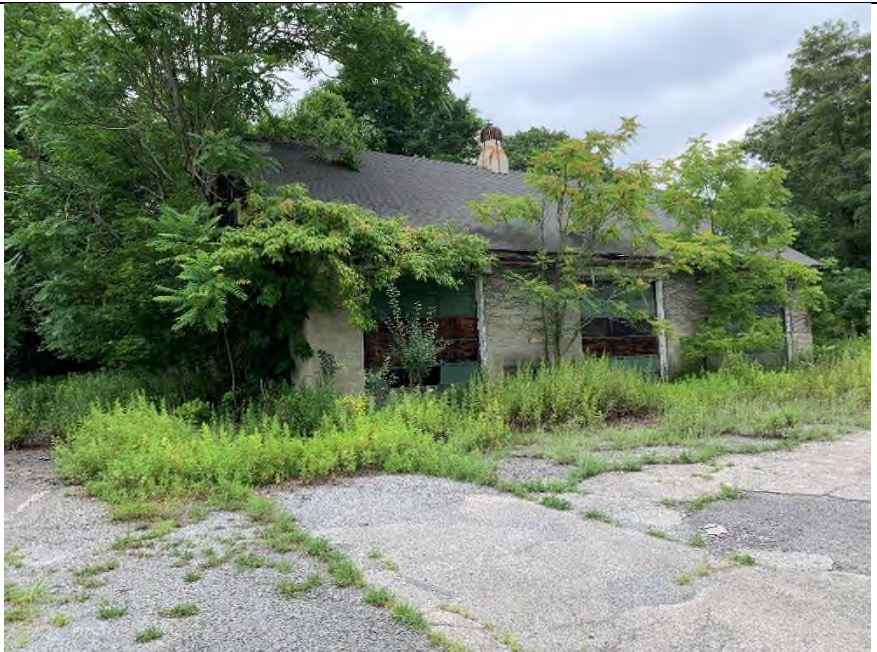
Photo 2 –

Auto Garage West.

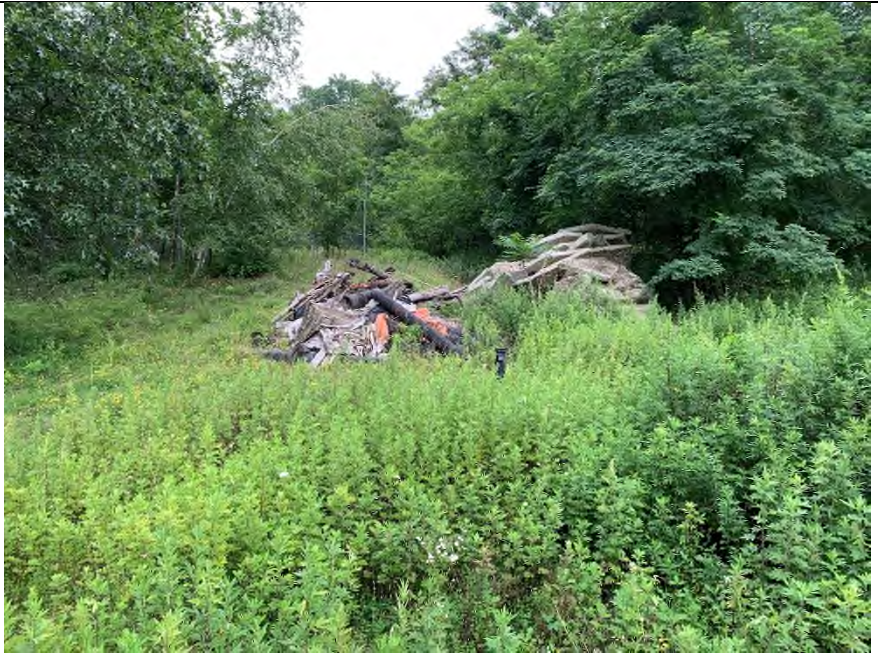
Photo 3 –

Pile of debris located south of Auto Garage East.

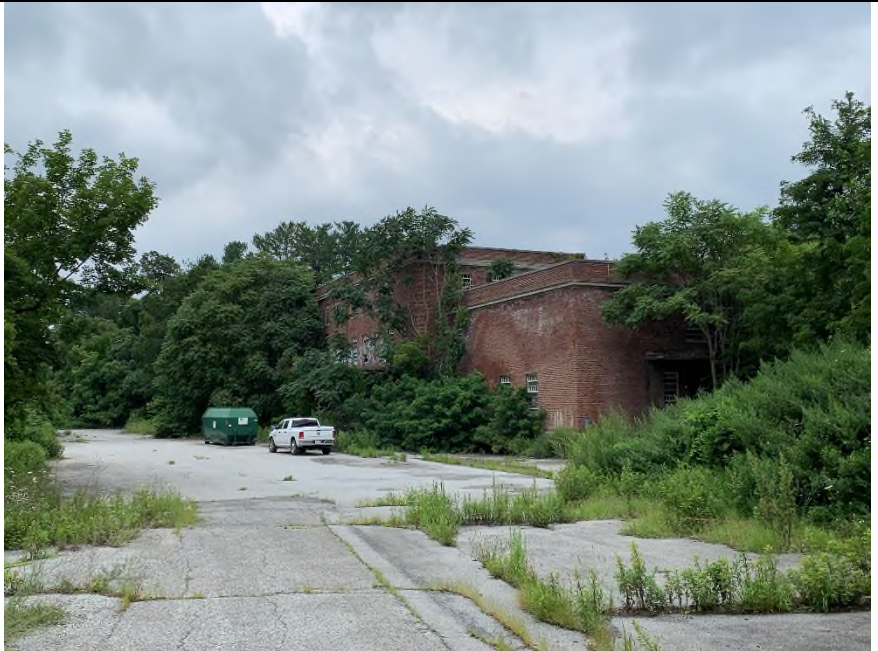
Photo 4 –

Bakery/Storage structure.
Dumpster located south of structure.

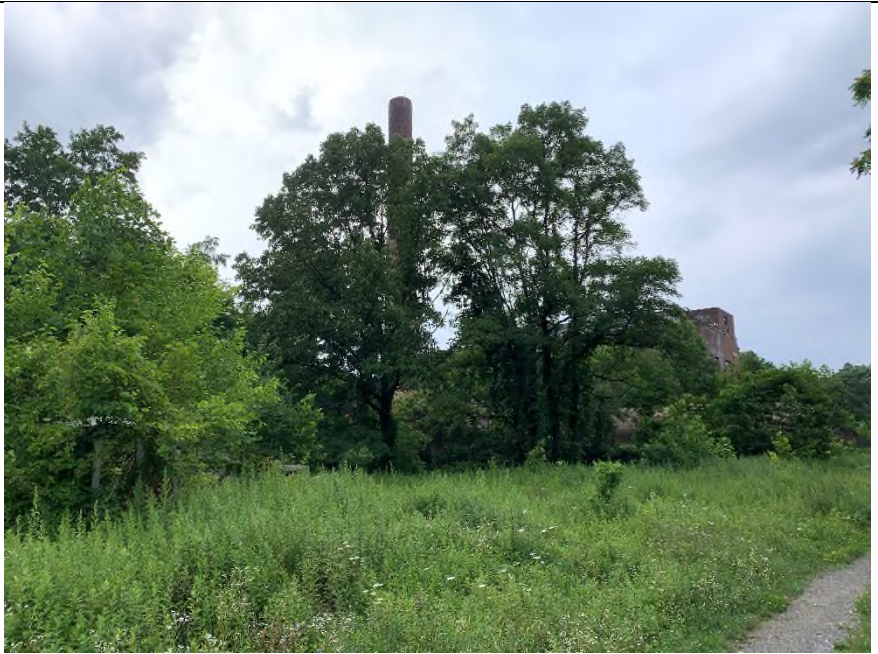
Photo 5 –

Powerhouse.

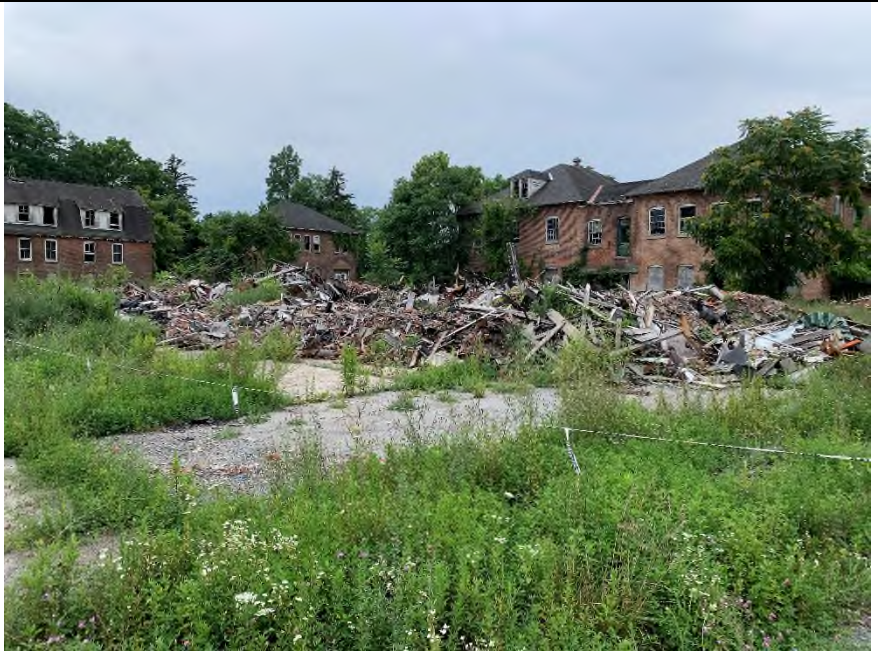
Photo 6 –

Engineer's Office (Demolished).

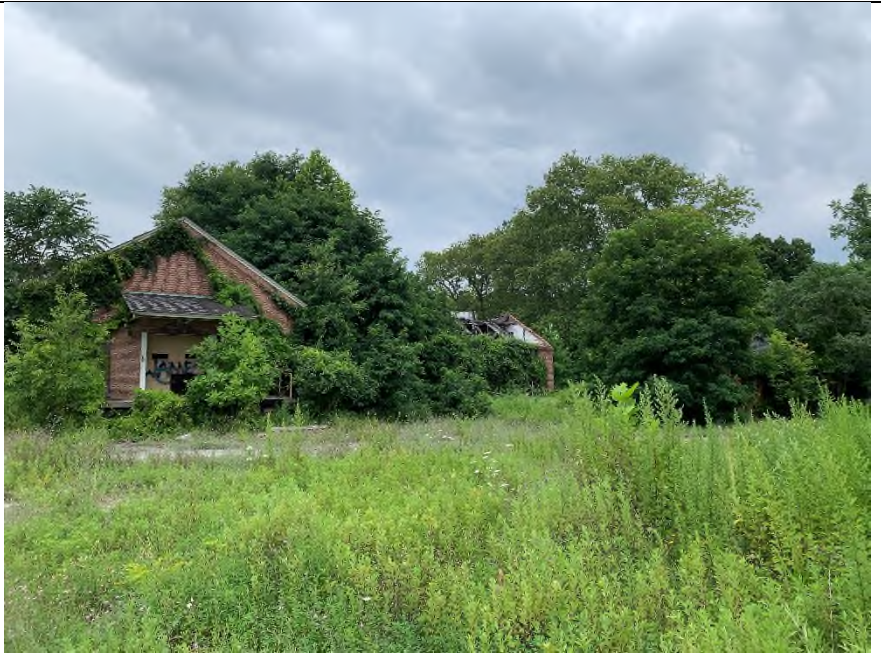
Photo 7 –

Carwash (pictured left) with shed (pictured right).

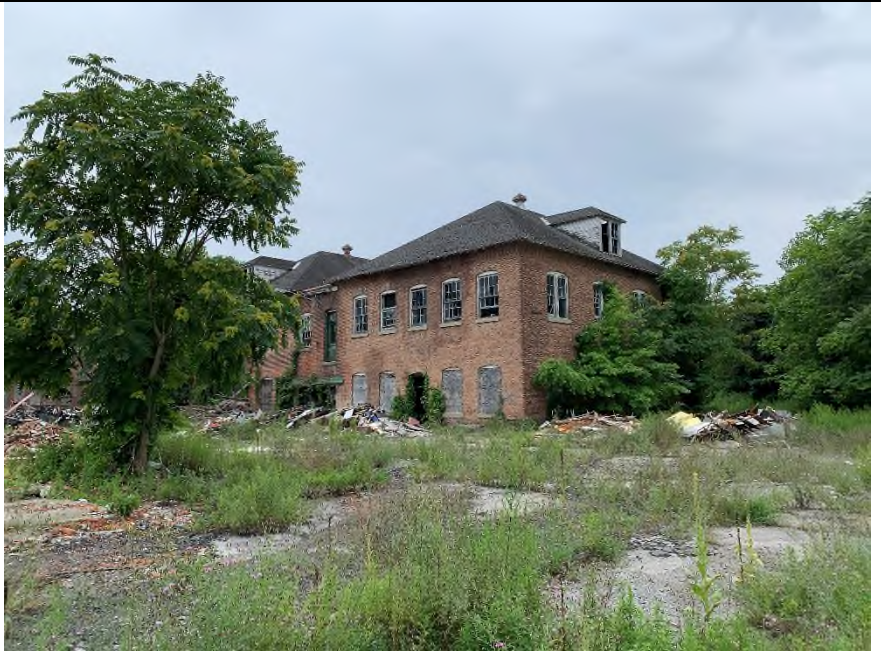
Photo 8 –

Maintenance Building with debris located east side of structure.

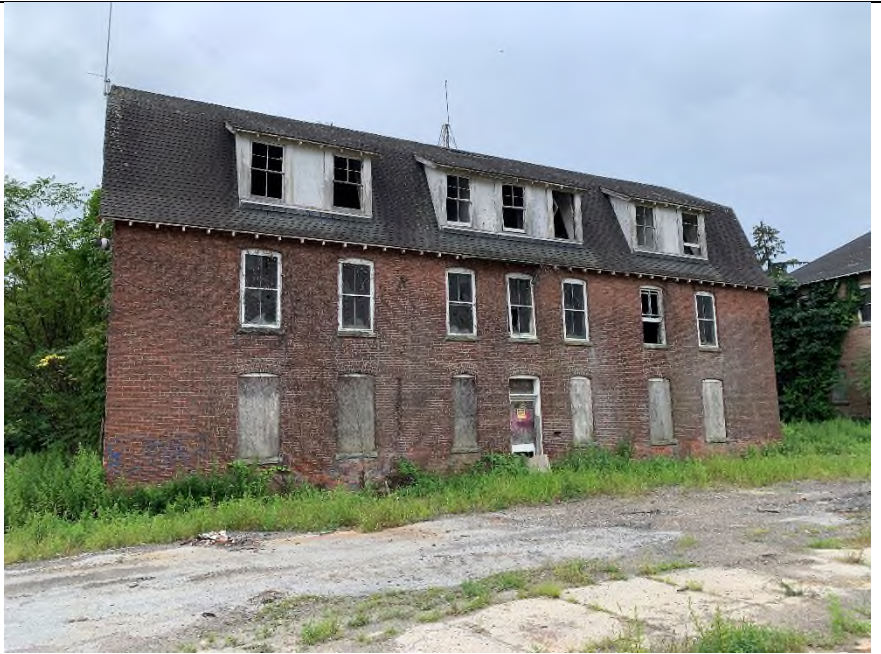
Photo 9 –

Fire House.

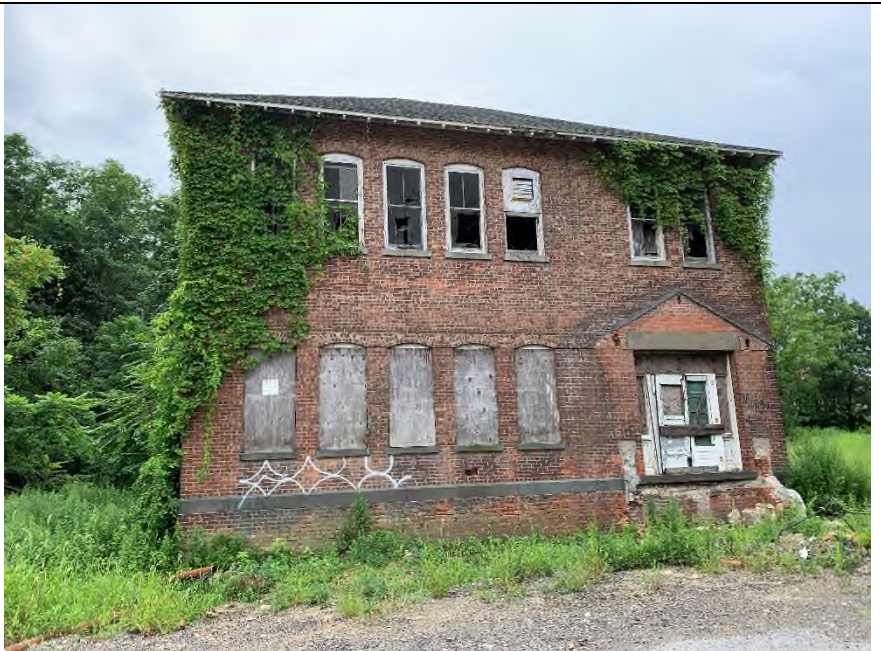
Photo 10 –

Mortuary Building.

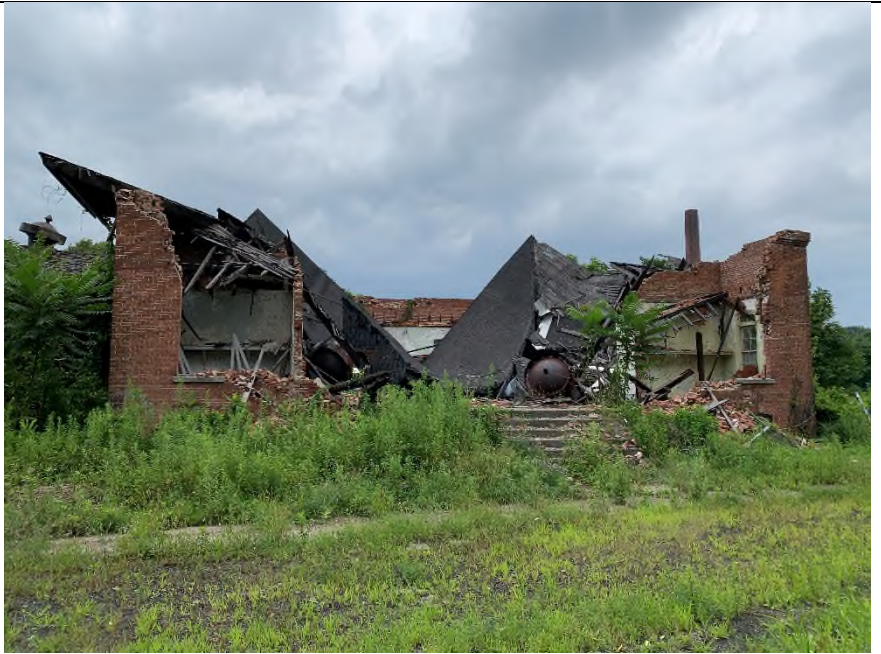
Photo 11 –

Structure west of the Mortuary Building, facing north (collapsed).

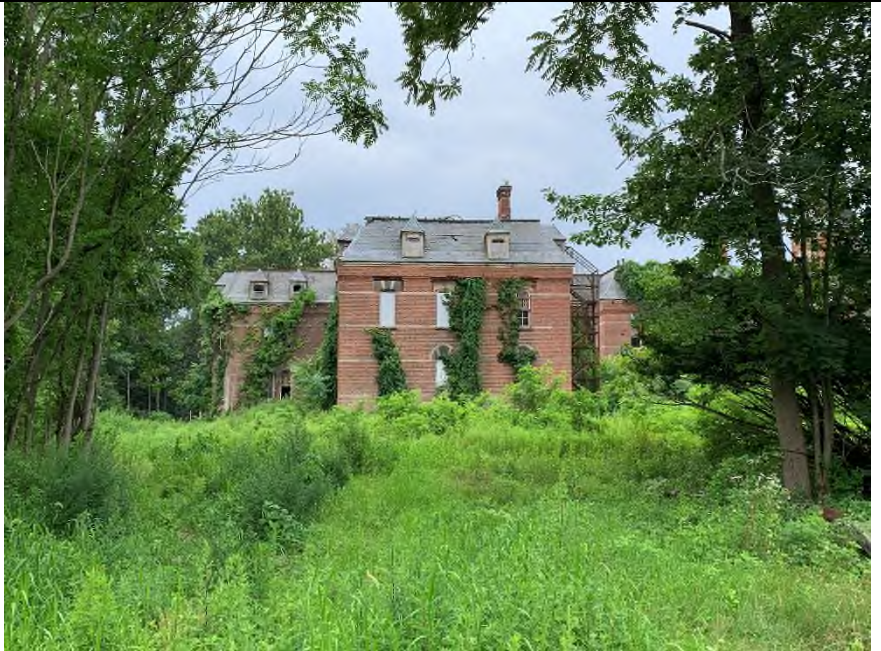
Photo 12 –

Structures in southwest corner of BCP boundary, facing south.

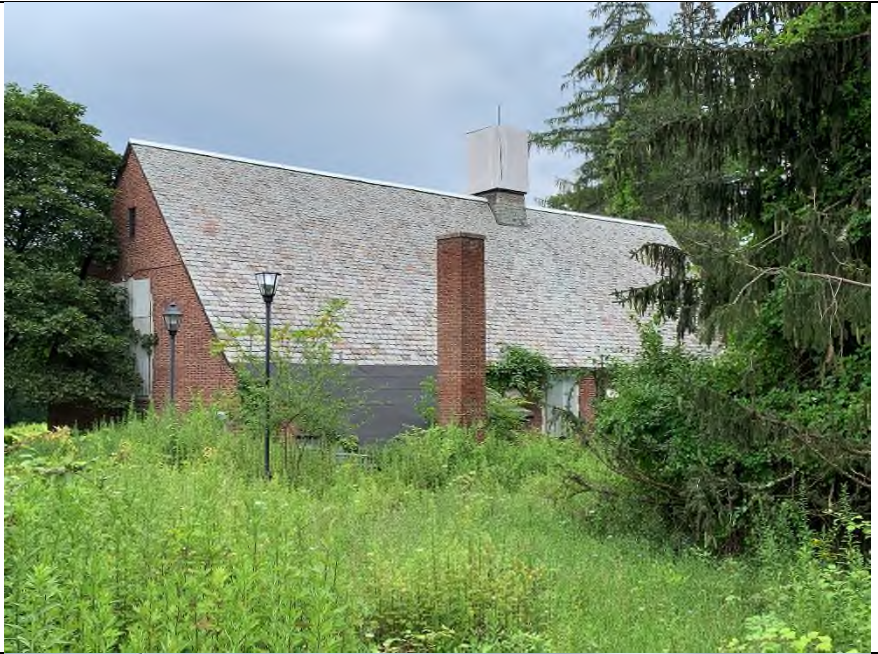
Photo 13 –

Rectory south of the Recreational Hall building.

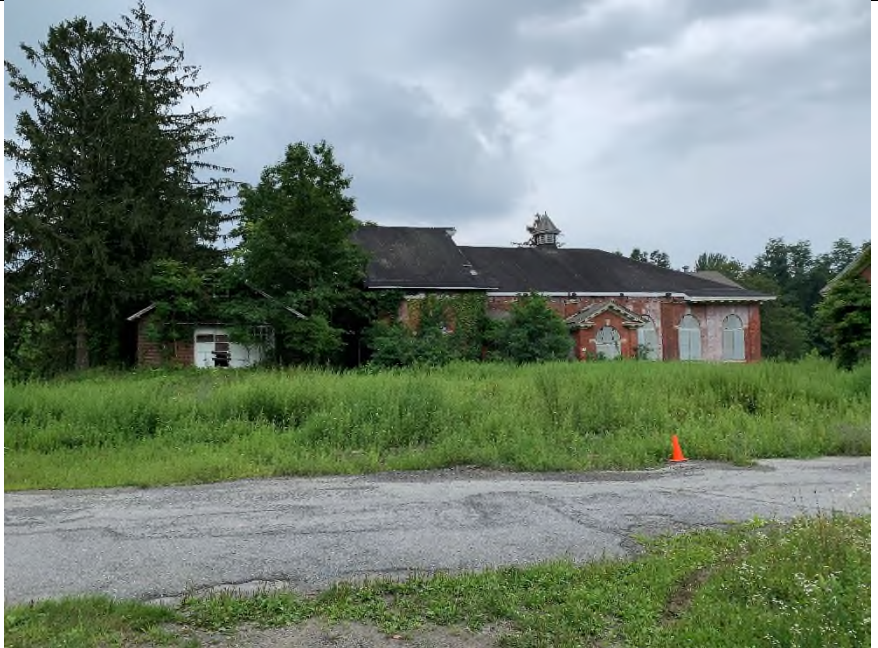
Photo 14 –

Recreational Hall. Backfilled trench observed north of Recreational Hall extending east to west.

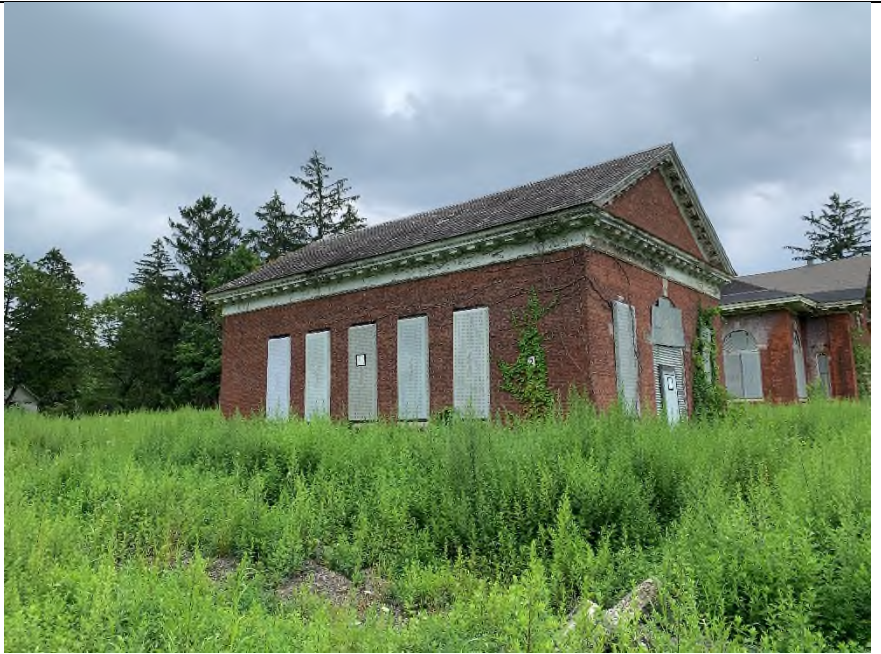
Photo 15 –

Library. Backfilled trench
observed north of Library,
extending east to west.

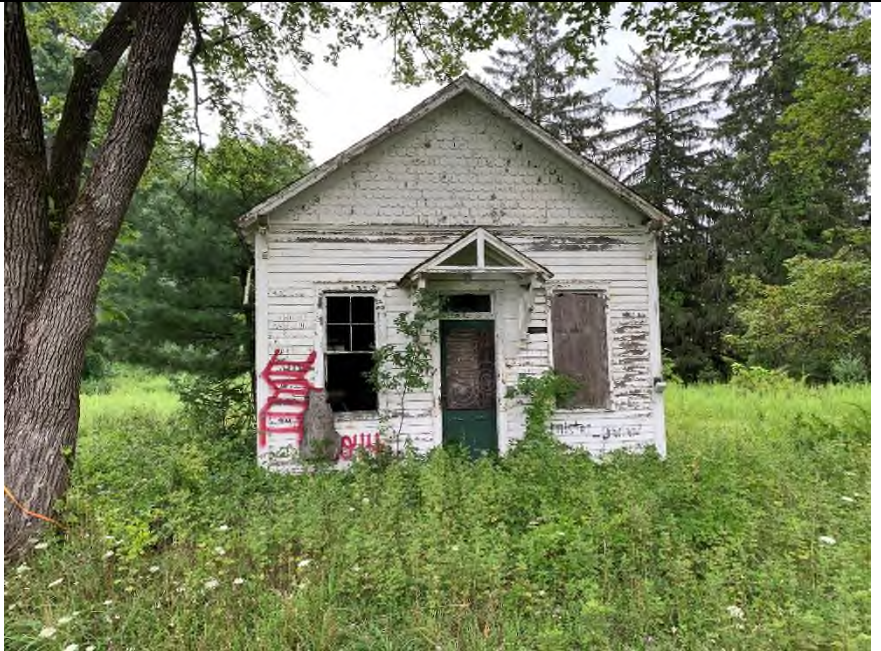
Photo 16 –

Small structure east of the Library.

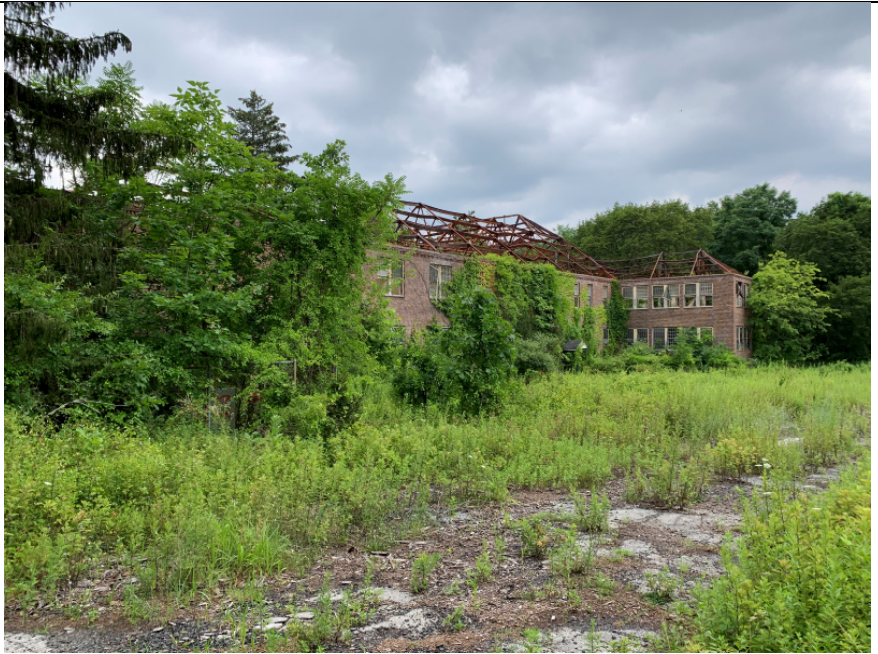
Photo 17 –

Brookside structure, severe deterioration of roof.

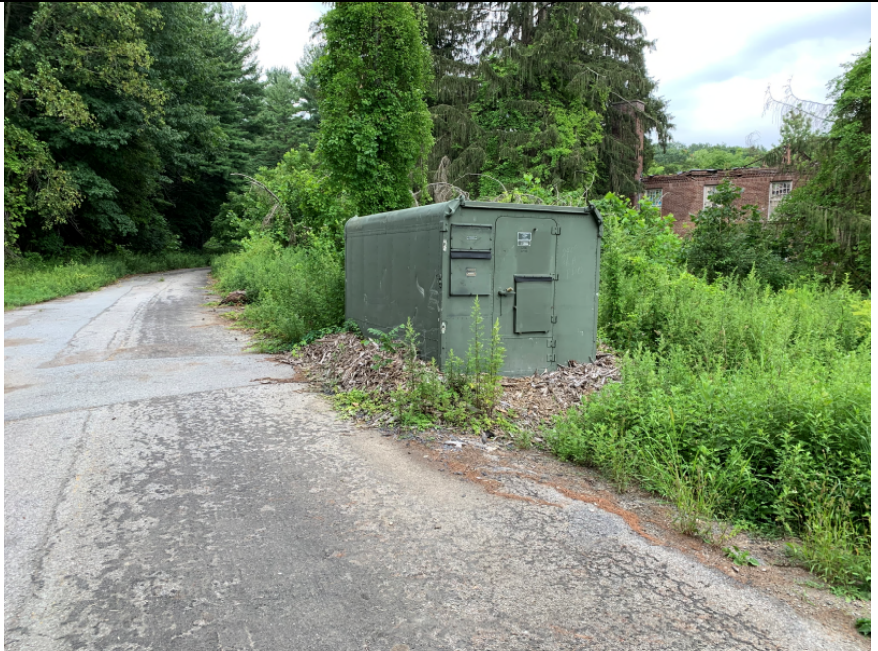
Photo 18 –

Metal container placed over fire hydrant. Base of container is bordered with wood chips.

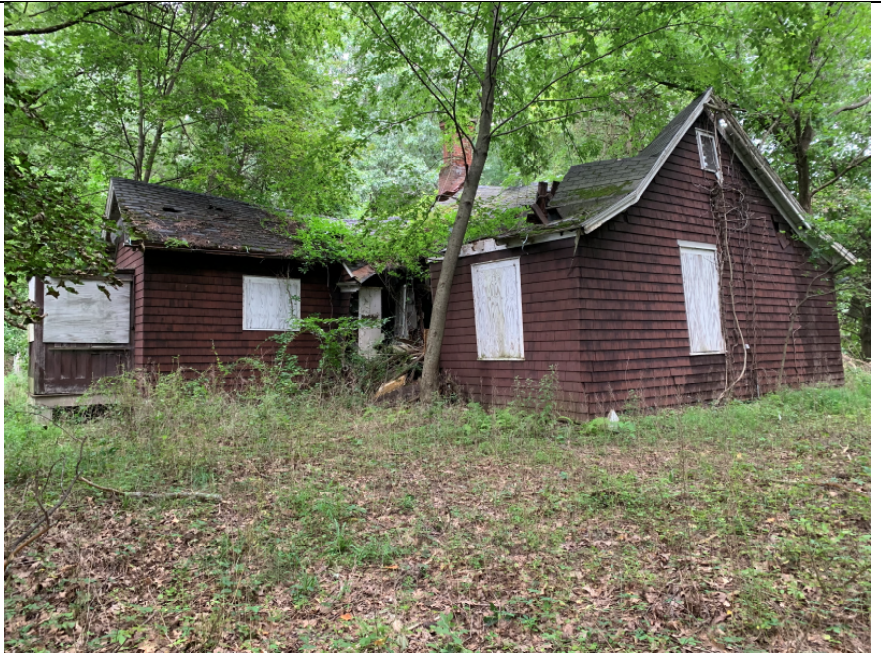
Photo 19 –

Staff House, severe deterioration of roof and interior floor.

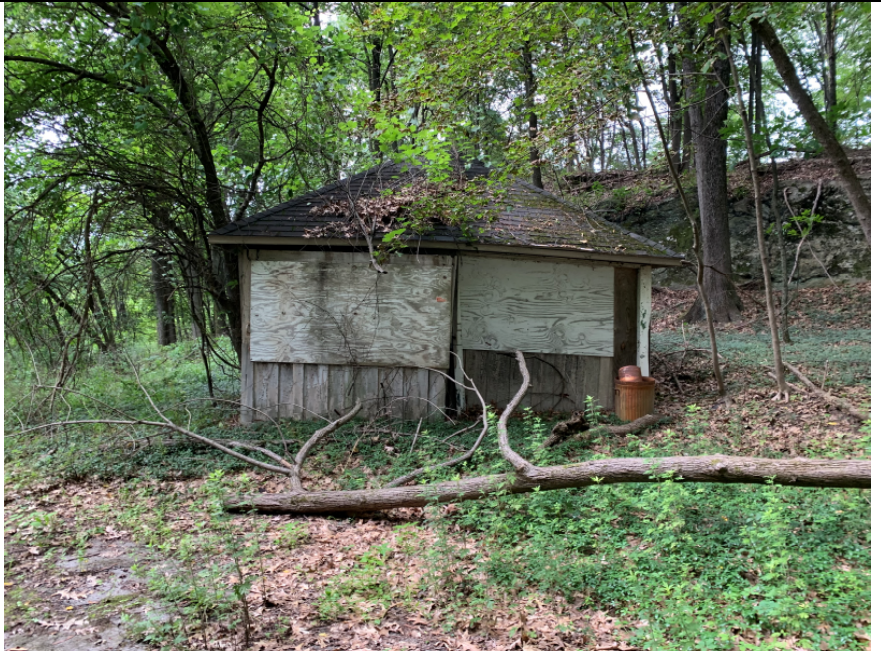
Photo 20 –

Small structure east of the Staff House.
