**PRE-DEMOLITION SURVEY REPORT
FOR
ASBESTOS-CONTAINING MATERIALS (ACM)**

**164 Garden Street
Poughkeepsie, NY 12601**

QuES&T Project #Q20-3106

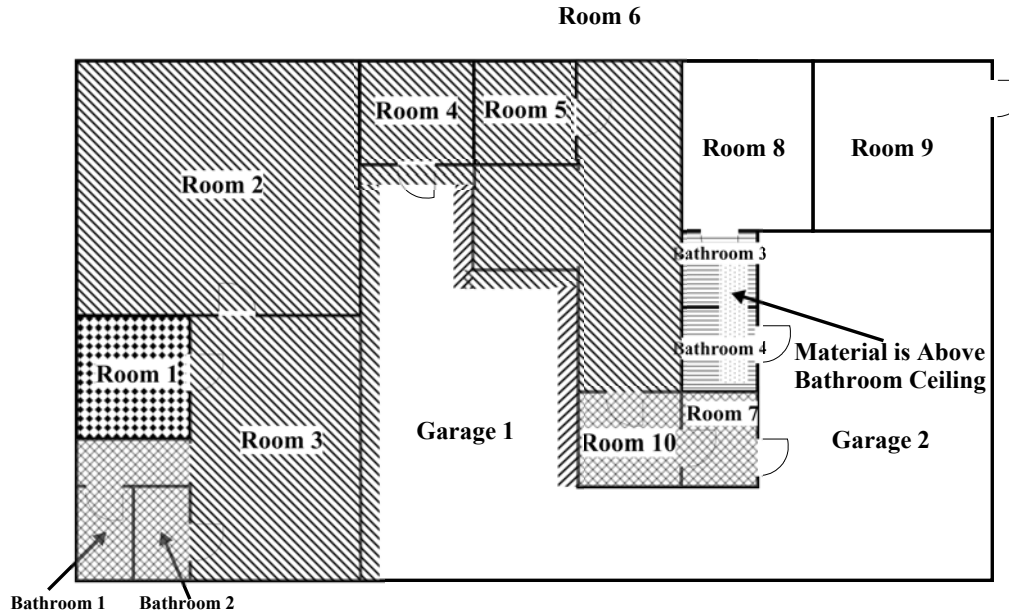
ASB-01

ACM LEGEND: (see report for details)	
	ACM Ceramic Tile Adhesive on Non-ACM CMU Walls & ACM Joint Compound on Non-ACM Sheetrock Ceiling
	ACM Cement Board on Walls and Ceiling
	ACM Fiber Panel Below Air Handler Units
	ACM Joint Compound on Non-ACM Sheetrock Walls
	ACM Joint Compound on Non-ACM Sheetrock Walls & Ceilings

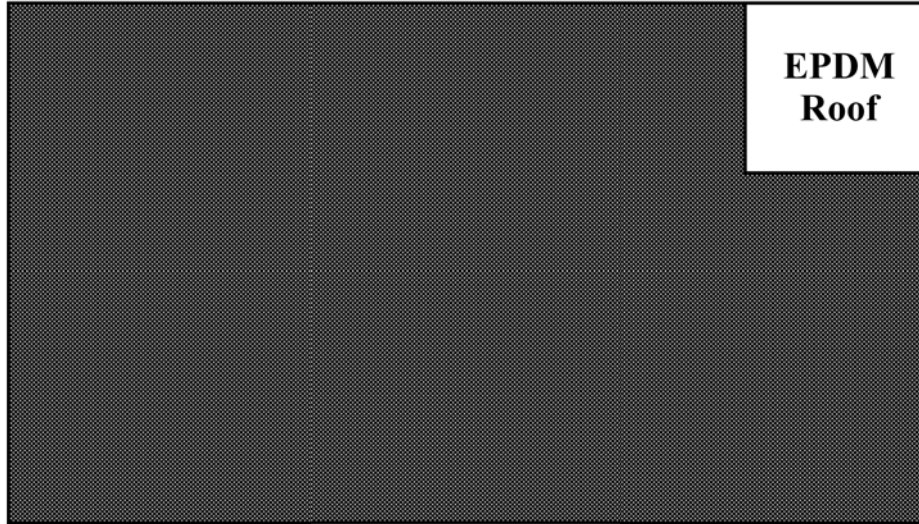
ASB-02

ACM LEGEND: (see report for details)	
	ACM Roofing Throughout; Second Layer Built-up Roofing on Field, Second Layer Tar on Perimeter Flashing, Flashing Tar on Metal Vents/ Dunnage, Pitch Pocket Tar.

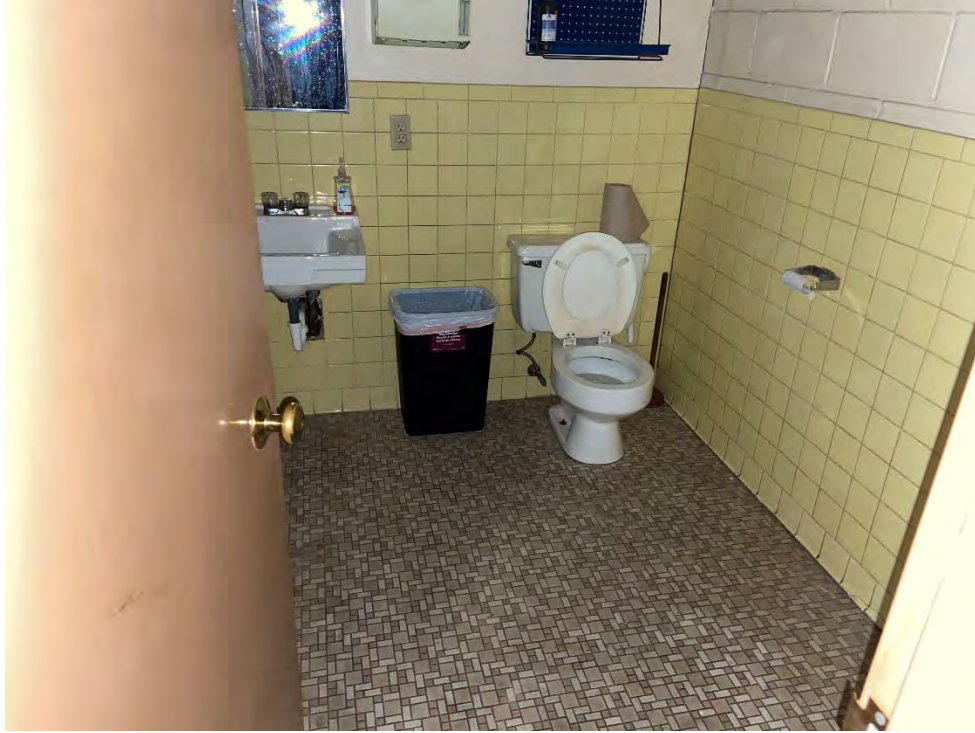
(ACM Ceramic Tile Adhesive Behind Ceramic Tiles in Bathroom 4)

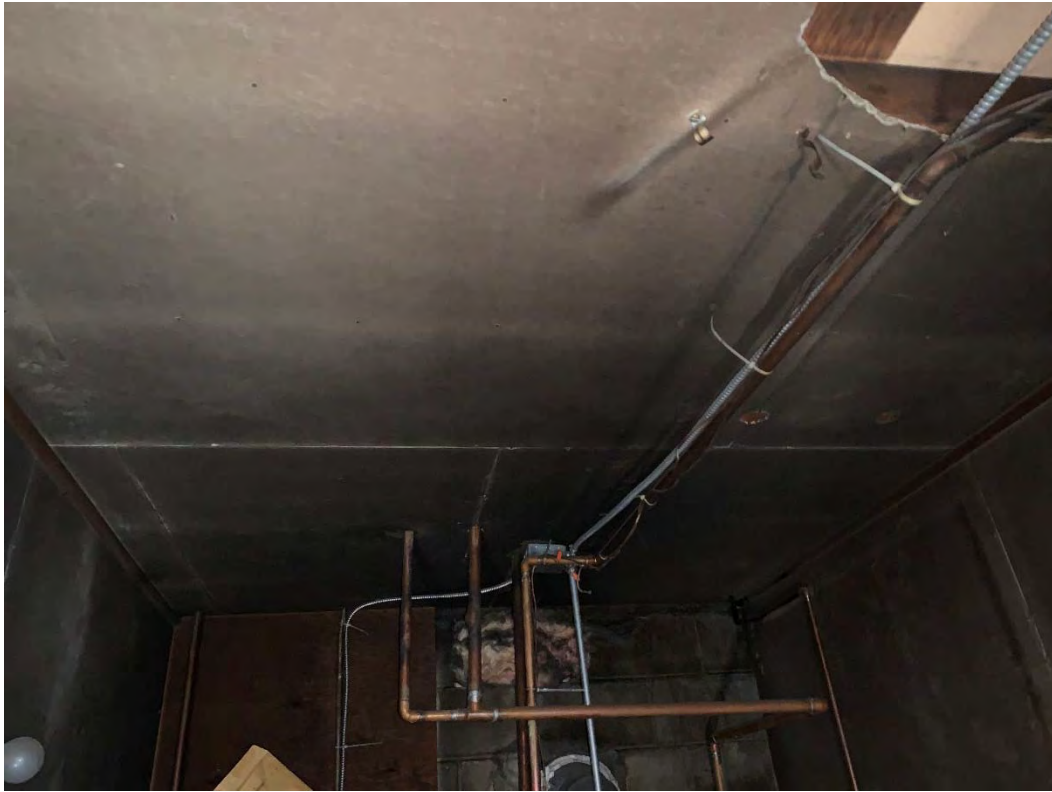
(ACM Cement Panels on Walls & Ceiling in Room 1)

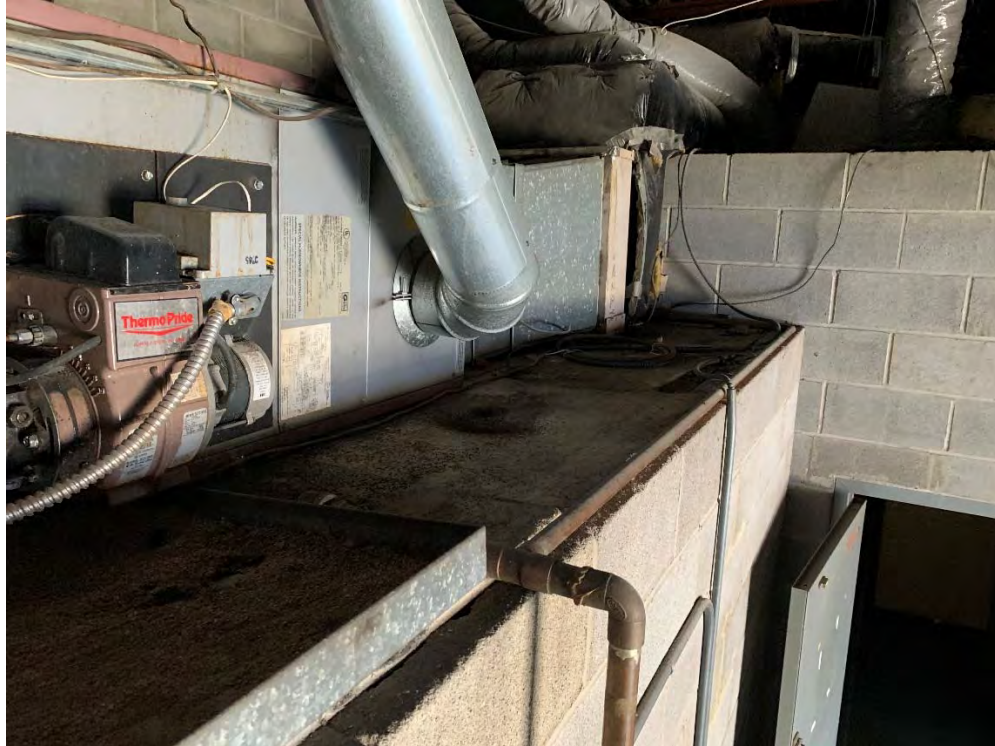
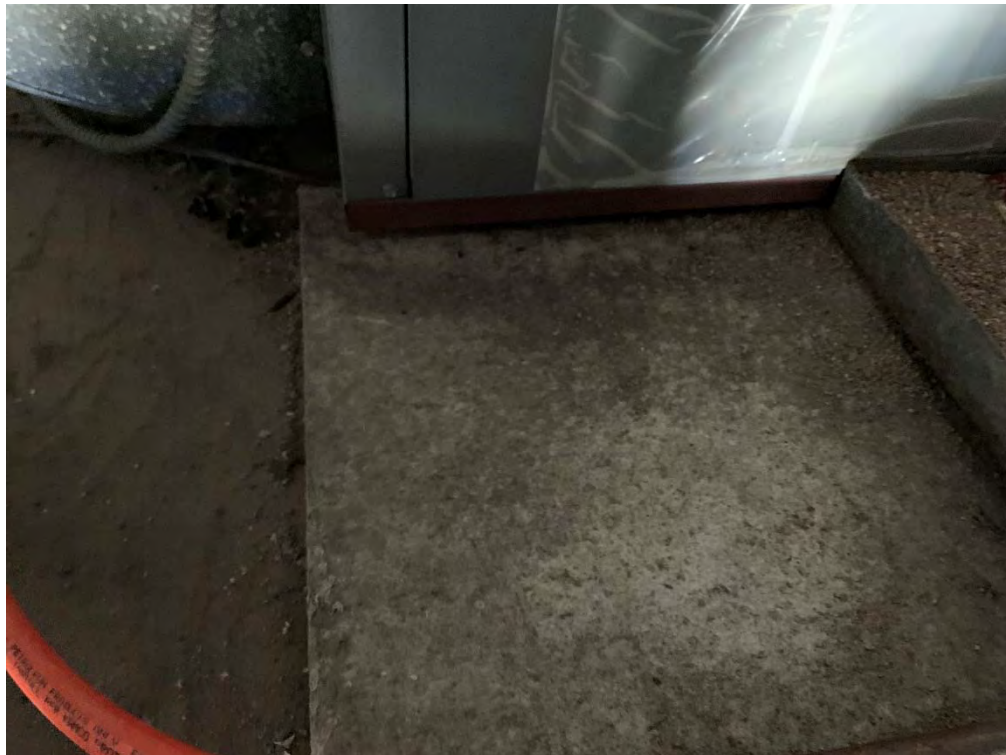
(ACM Fiber Panel Under HVAC Equipment in Garage 2)

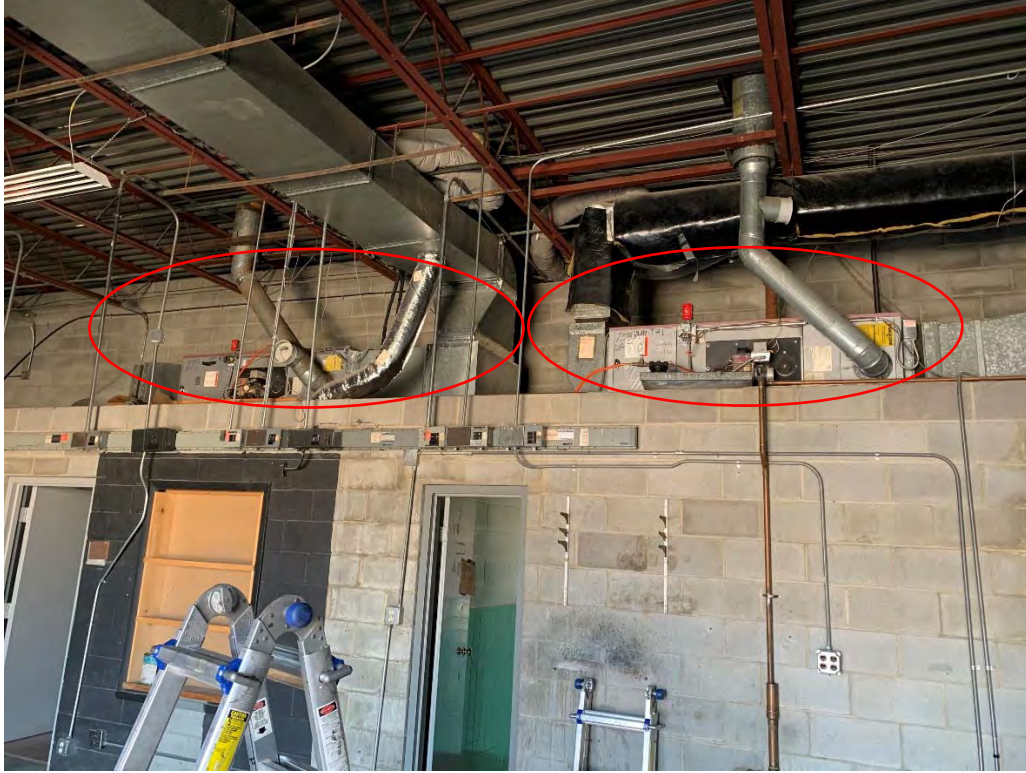
(Circled in Red: Location of Fiber Panel under HVAC Equipment in Garage 2)

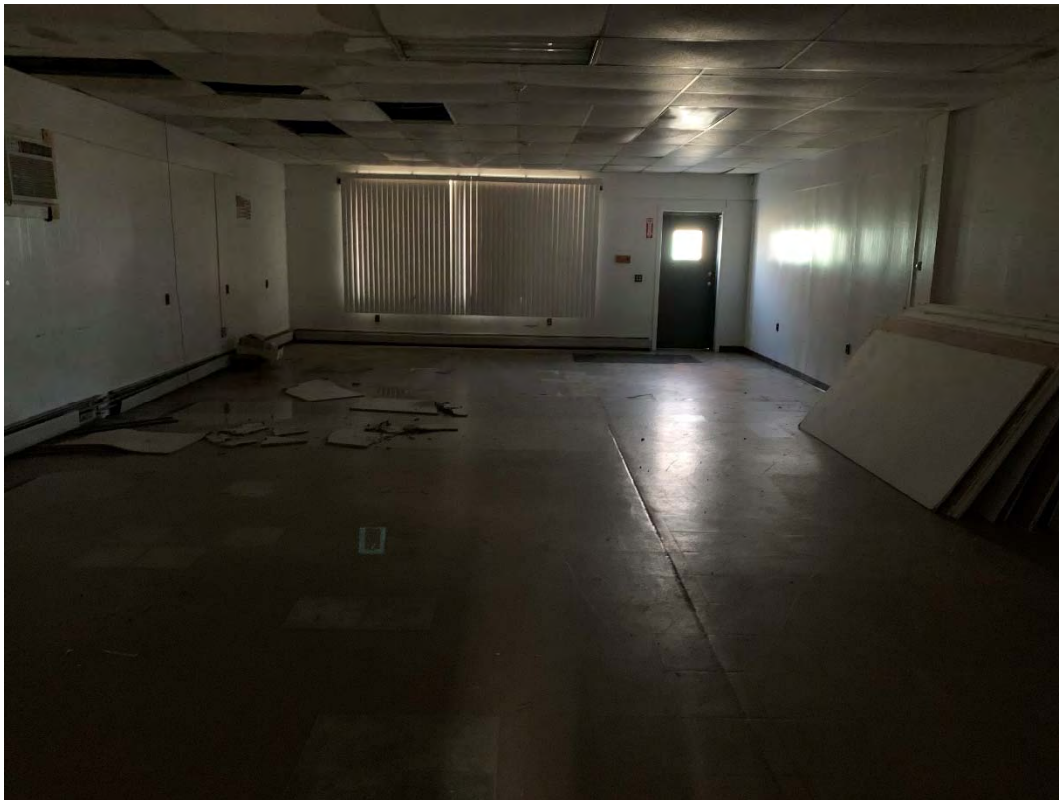
(ACM Joint Compound on Non-ACM Sheetrock Walls in Room 2)

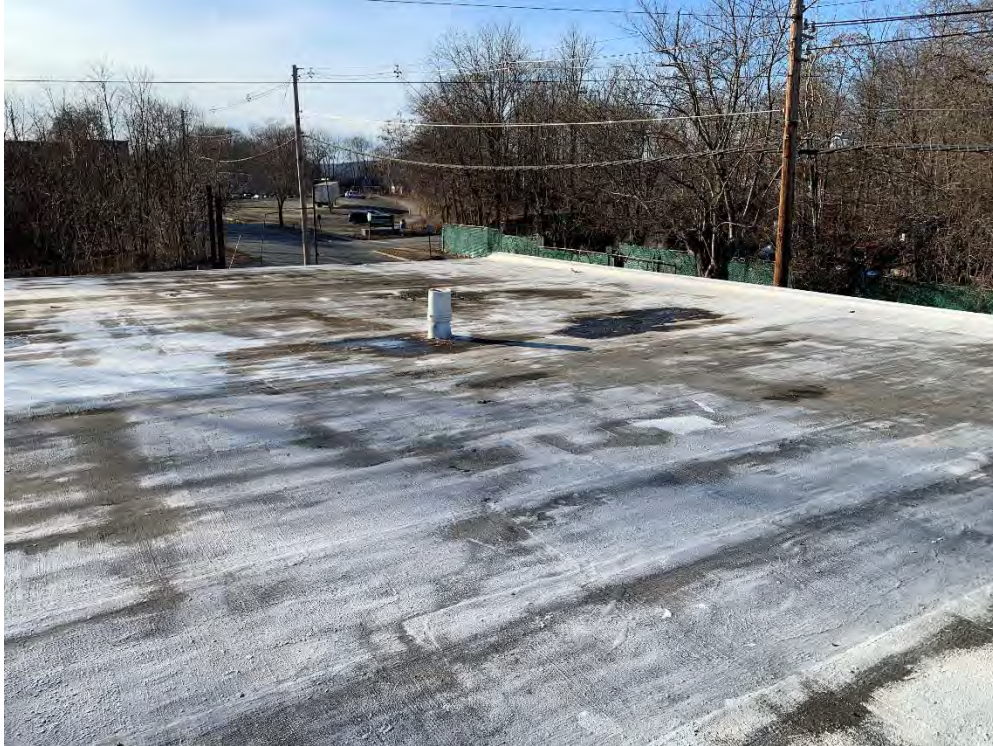
(Roof with Second Layer ACM Built-up Roofing and Second Layer ACM Perimeter Flashing Tar)

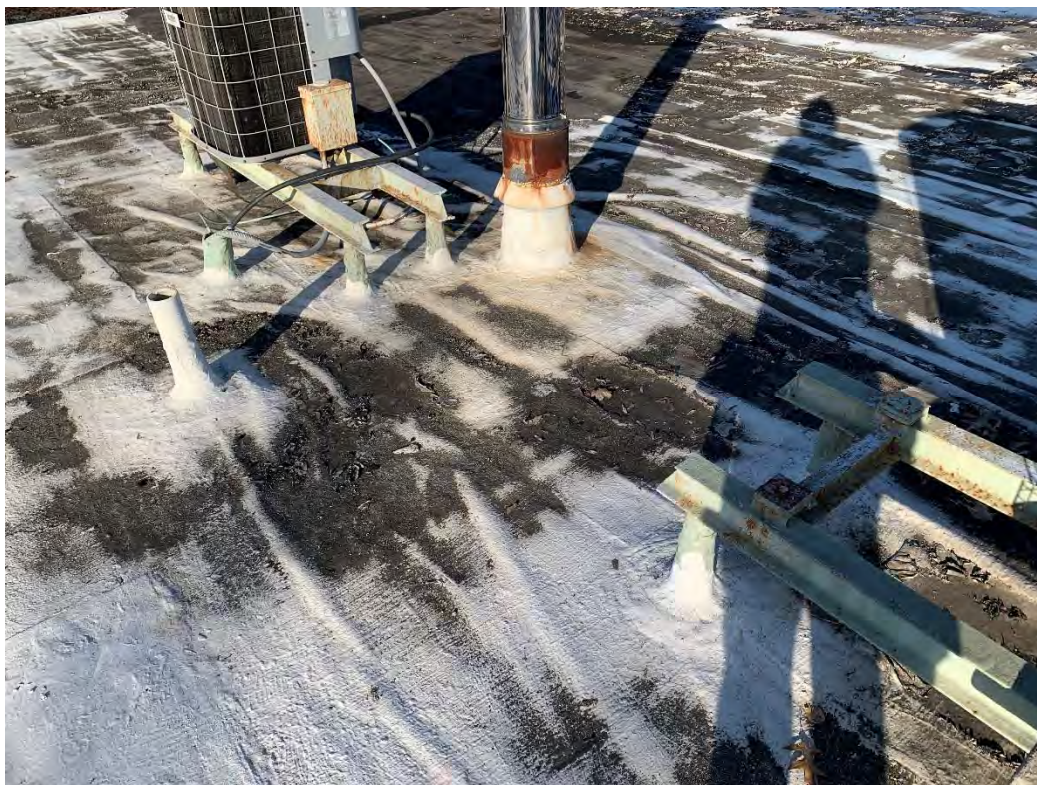
(ACM Flashing Tar and ACM Pitch Pocket Tar on Roof)
