Daily Activity Report			
	Former United Hospital Port Chester, NY BCP No. C360202			
	General Site Information			
Date:	Thursday, April 13, 2023			
Weather:	Sunny, ~85°F			
Wind Direction/Speed:	Wind from the northwest @ ~7mph			
AKRF Personnel on Site:	Steve Schmid			
AKRF Equipment on Site:	Handheld PID and Dustrak			
Visitors:	None			
Contractor Information				
Contracting Company	Key Personnel		Equipment	
Capital Industries Corp.	Joe Cianciulli		Boom Lift, Excavator, and Hand Tools	
Description and Location of Work Activities Performed				
NOVA prepped the work area around the former power plant building and mobilized equipment and supplies.				
NOVA began abatement of asbestos- and PCB-containing caulking at the former power plant building.				
Site Soil Disposal Tracking Information				
Destination Facility	Daily Trucks	Daily Approx. Cubic Yds.	Total Site Loads	Total Approximate Cubic Yards
Not Applicable (N/A)	N/A	N/A	N/A	N/A

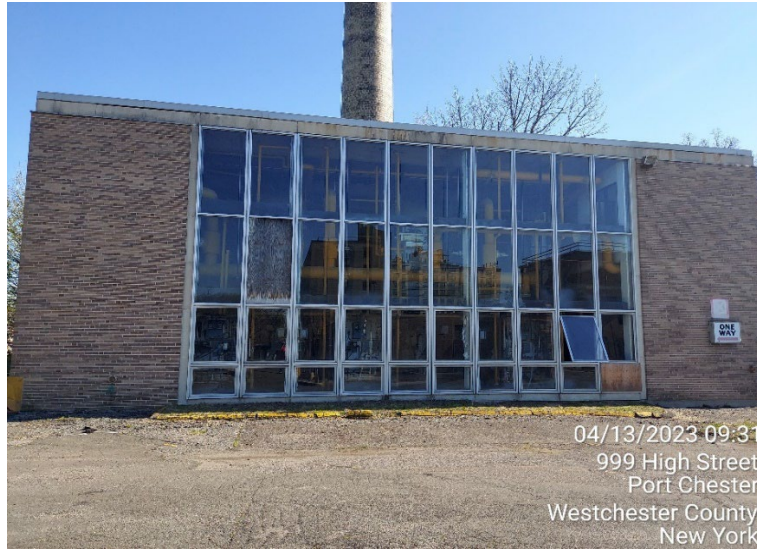
Photograph 1 - A
view of the work area
prior to mobilization,
view facing north.

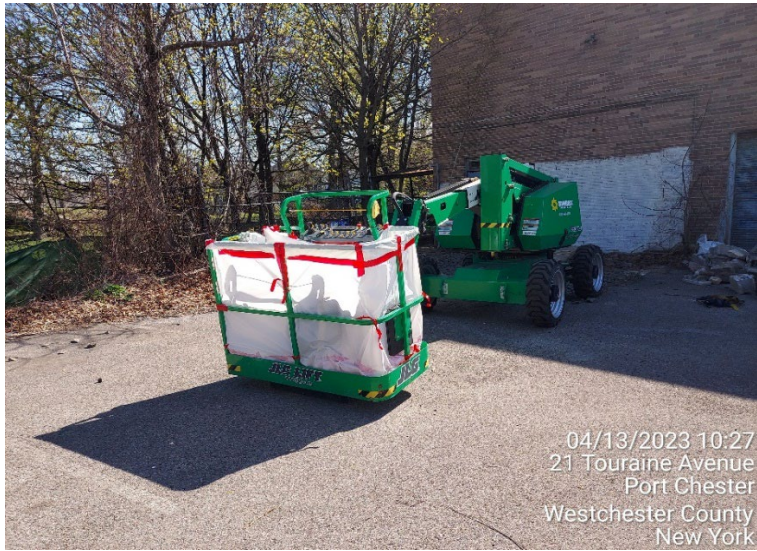
Photograph 2 -
Preparation of the
work area and boom
lift with poly, view
facing northeast.

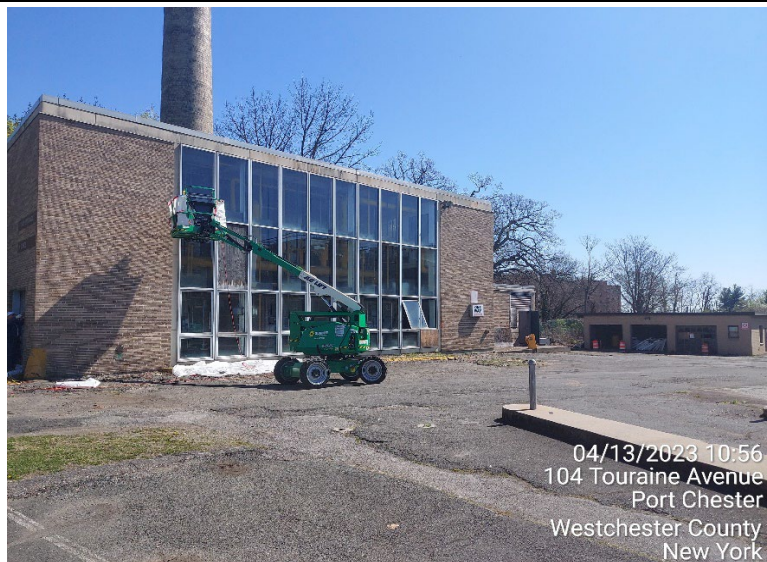
Photograph 3 -
Abatement of
asbestos- and PCB-
containing caulking
at the former power
plant using hand
tools, view facing
east.
