Daily Activity Report			
	Former United Hospital			
	Port Chester, NY BCP No. C360202			
General Site Information				
Date:	Friday, April 14, 2023			
Weather:	Sunny, ~85°F			
Wind Direction/Speed:	Wind from the south @ ~3mph			
AKRF Personnel on Site:	Steve Schmid			
AKRF Equipment on Site:	Handheld PID and Dustrak			
Visitors:	None			
Contractor Information				
Contracting Company	Key Personnel		Equipment	
Capital Industries Corp.	Joe Cianciulli		Boom Lift, Excavator, and Hand Tools	
Description and Location of Work Activities Performed				
NOVA completed abatement of asbestos- and PCB-containing caulking at the former power plant building.				
NOVA began to demob from the work area at the former power plant.				
Site Soil Disposal Tracking Information				
Destination Facility	Daily Trucks	Daily Approx. Cubic Yds.	Total Site Loads	Total Approximate Cubic Yards
Not Applicable (N/A)	N/A	N/A	N/A	N/A
	Daily Import (CY)	0	Total Import (CY)	0

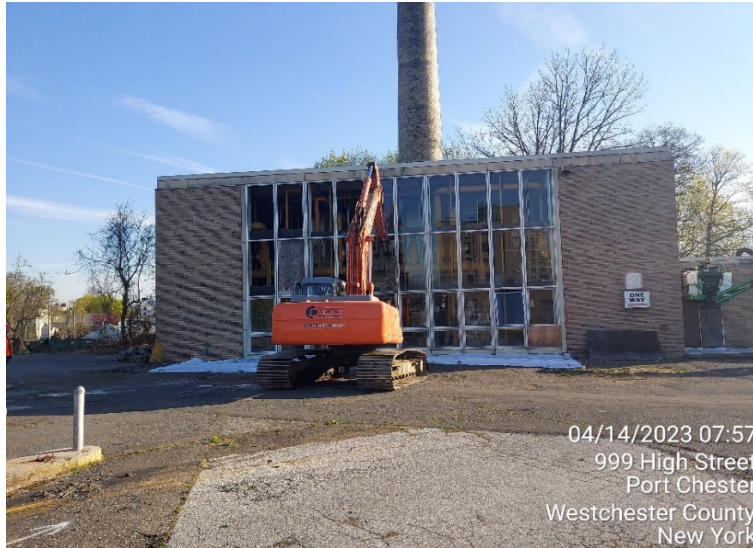
Photograph 1 -
Breaking windows on
the former power
plant building to
facilitate the
abatement of asbestos
and PCB-containing
caulking, view facing
north.

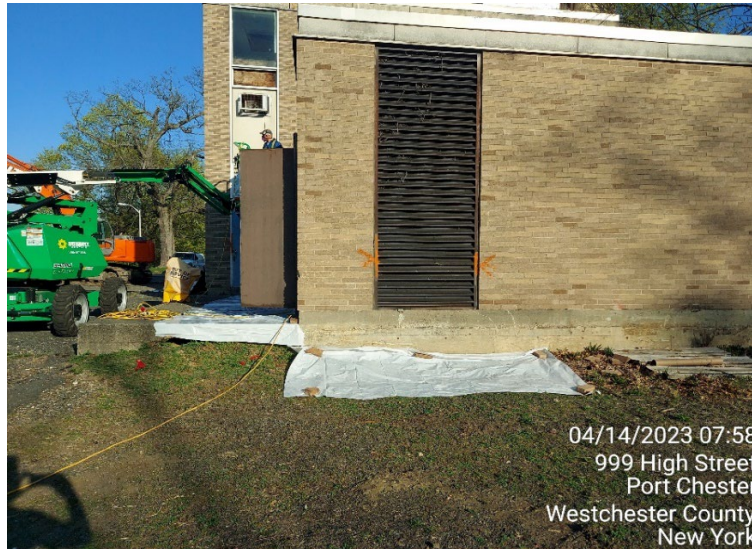
Photograph 2 -
Abatement of
asbestos- and PCB-
containing caulking
at the former power
plant using hand
tools, view facing
west.

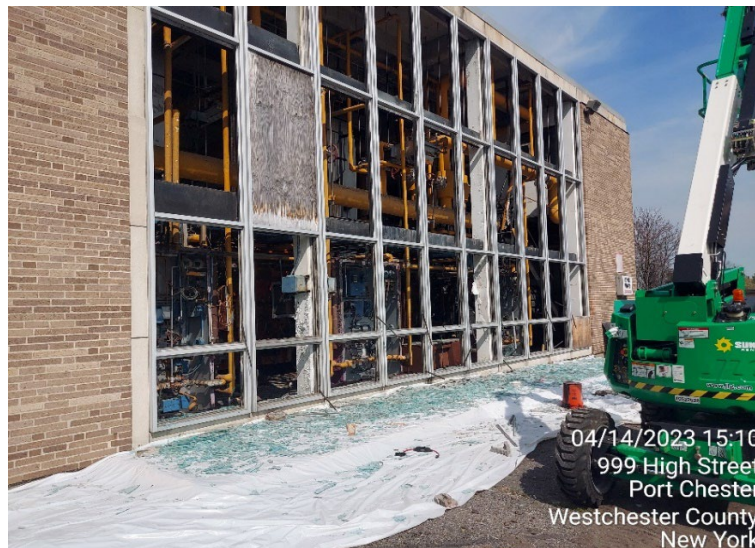
Photograph 3 -
Abatement of
asbestos- and PCB-
containing caulking
at the former power
plant using hand
tools, view facing
northeast.
