**PHASE II ENVIRONMENTAL
ASSESSMENT
GATEWAY OFFICE COMPLEX
WHITE PLAINS, NEW YORK**

**Prepared for:
CB Richard Ellis Investors L.L.C.,
a Delaware Limited Liability
Company**

December 28, 1999
D&M No. 40863-022-027

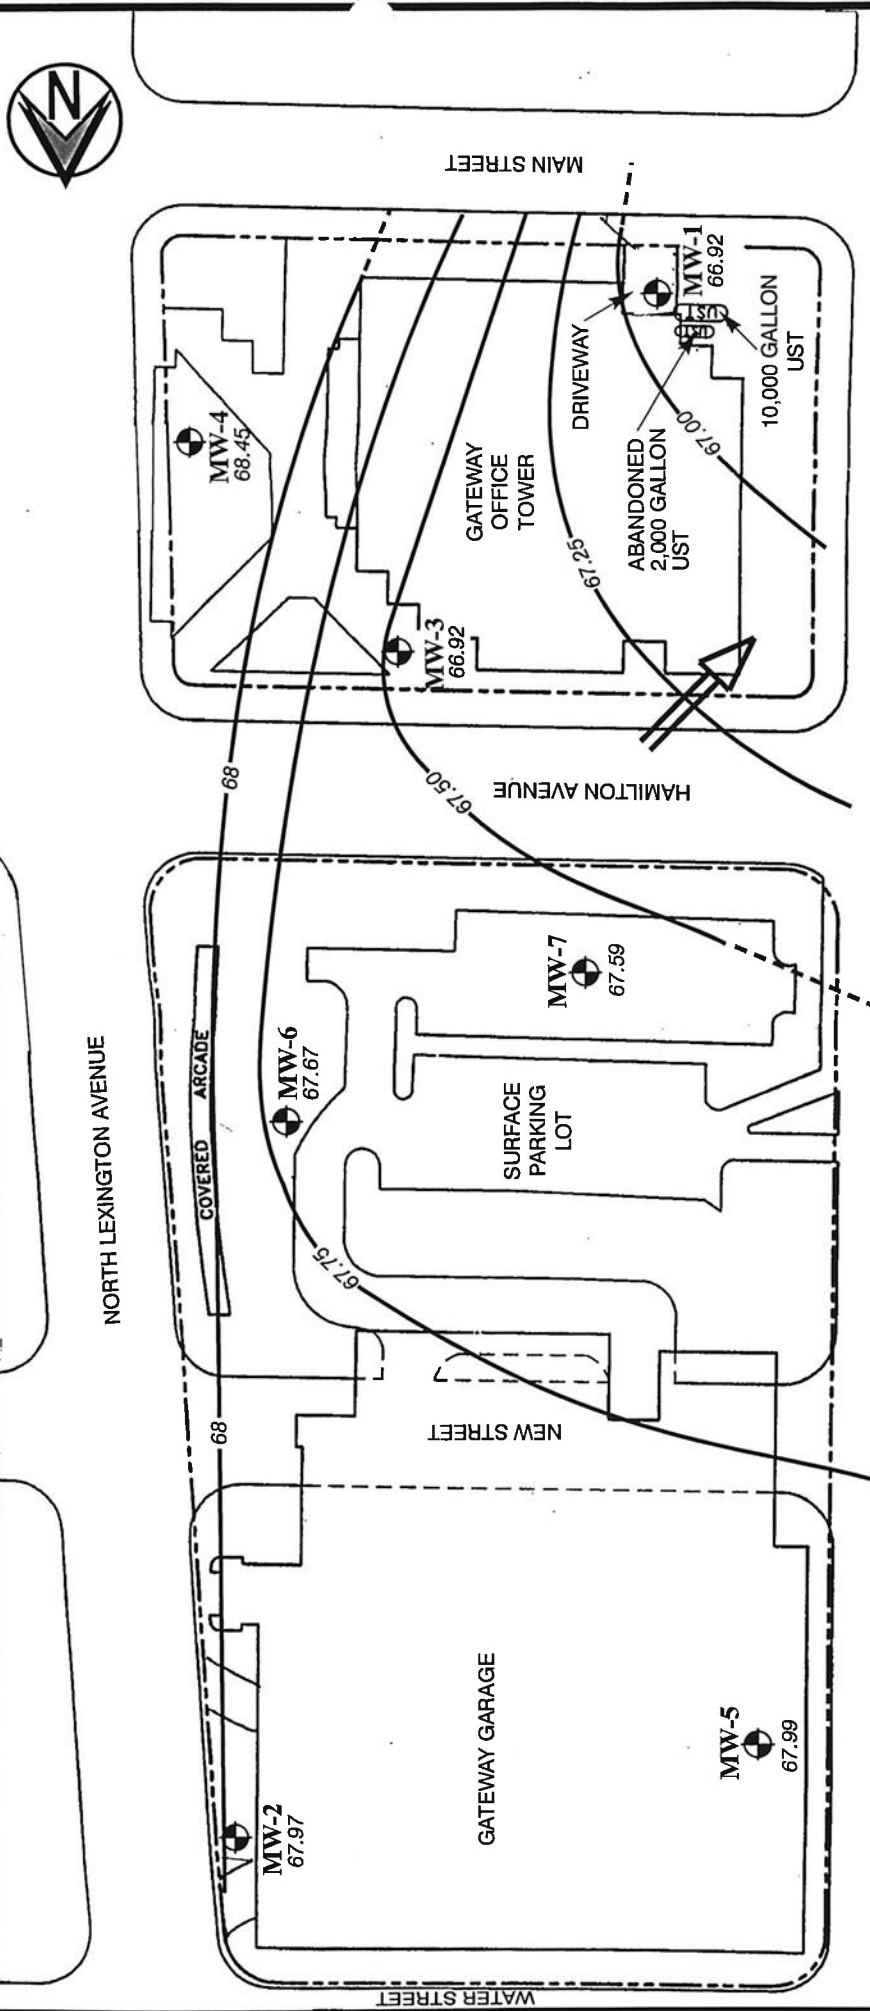
FIGURE 3
GROUNDWATER CONTOUR MAP
GATEWAY OFFICE COMPLEX
WHITE PLAINS, NEW YORK

On Friday, December 10th, Dames & Moore met with a representative of Gabriel E. Senor, P.C., a licensed Professional Surveying firm in the State of New York. The purpose of surveying the wells was to obtain precise elevations and distances between the wells for determining groundwater gradient and flow directions. Based upon this surveying, groundwater flows in a southwest direction towards the Bronx River. At the office tower parcel, the groundwater gradient is approximately ± 0.0025 feet/feet towards the southwest. Figure 3 presents the groundwater contour map.
