# C.T. MALE ASSOCIATES

January 8, 2014

RE: *Supplemental Site Investigation  
Old Champlain Mill BCP Site  
Village of Whitehall, Washington County, NY  
BCP Site No. C558036  
CTMA Project No. 06.6448*

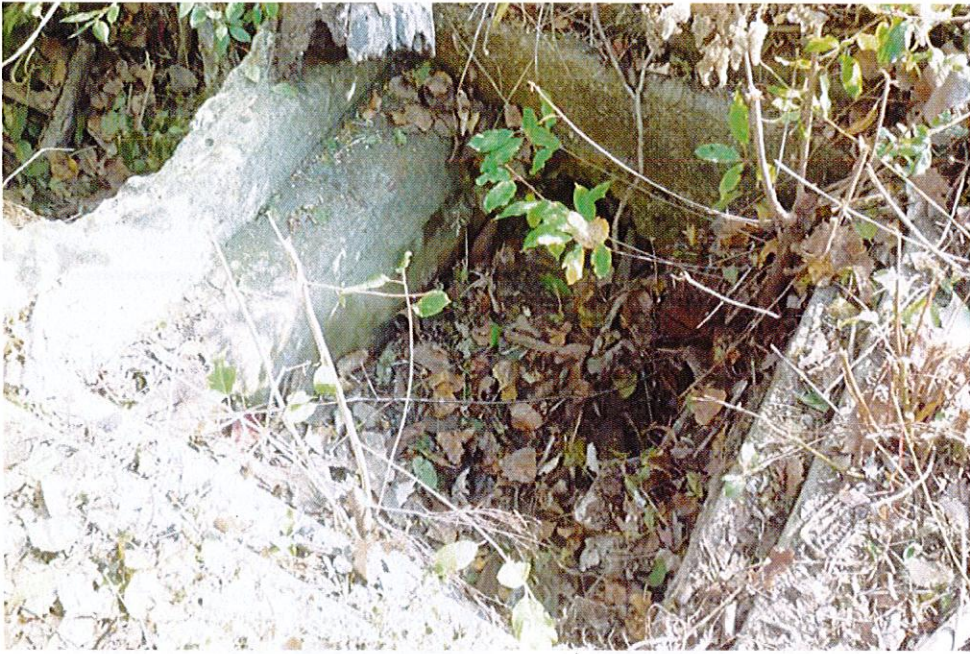
01 Interior of catch basin.jpg

**Catch Basin Investigation:** The catch basin is located in the central portion of the study area. The catch basin was observed to be partially full of debris including dimensional lumber (possibly a former cover for the catch basin), tree trunks & limbs, brick, concrete

and leaves. The debris was removed from the catch basin in order to access and sample the sediment.

The sediment was comprised of organic dark brown loose sand containing brick, concrete and wood fragments. The sediment thickness was approximately 8 to 12 inches and present directly above the concrete bottom within the basin.

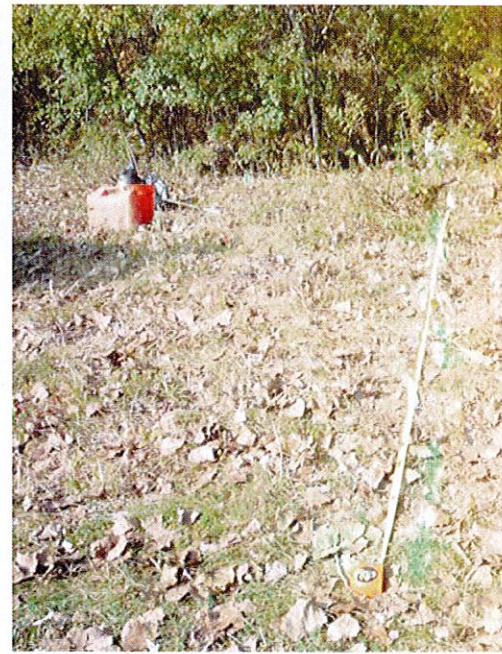
02 Anomaly 1 from CB

**Anomaly 1:** Anomaly 1 was traced from an inlet pipe entering the southern side of the catch basin southwest of monitoring well MW-19A to the south for a distance of approximately 16 feet, toward the building foundation. The pipe at the inlet was comprised of concrete with an approximate diameter of 1.1 feet. NYLD reported that the pipe was either blocked or collapsed at 16 feet, and more likely to have collapsed as the GPR did not detect the pipe beyond this point. It should be noted that there is no information available regarding where the subject pipe originated within the mill and as such could have been connected to roof drains or possibly a floor drain.

northern portion of the site and the inlet and outlet pipes connected to that basin. The geophysical survey was able to identify that an inlet pipe to the catch basin originates south of the basin in the direction of the former mill, and the outlet pipe is directed to the west toward the Champlain Canal. Due to poor signal recovery, the actual discharge location of the storm water basin discharge pipe was not identified, but appears to be into the Champlain Canal. Similarly, the lack or loss of signal approximately 16 feet south of the storm water basin suggests a portion of the inlet pipe is broken or has collapsed.

Given that we do not know when the inlet pipe to the catch basin collapsed, if in fact it did, there is a potential that the liquids from the mill may have historically discharged from the pipe into the surrounding soils for some period of time. Due to the suspected collapse of the inlet pipe leading from the former mill to the catch basin, further targeted exploration of the soils beneath and adjacent to the (suspected) collapsed portion of the pipe is warranted to determine if a hot spot of soil contamination by chlorinated solvents is or is not present.

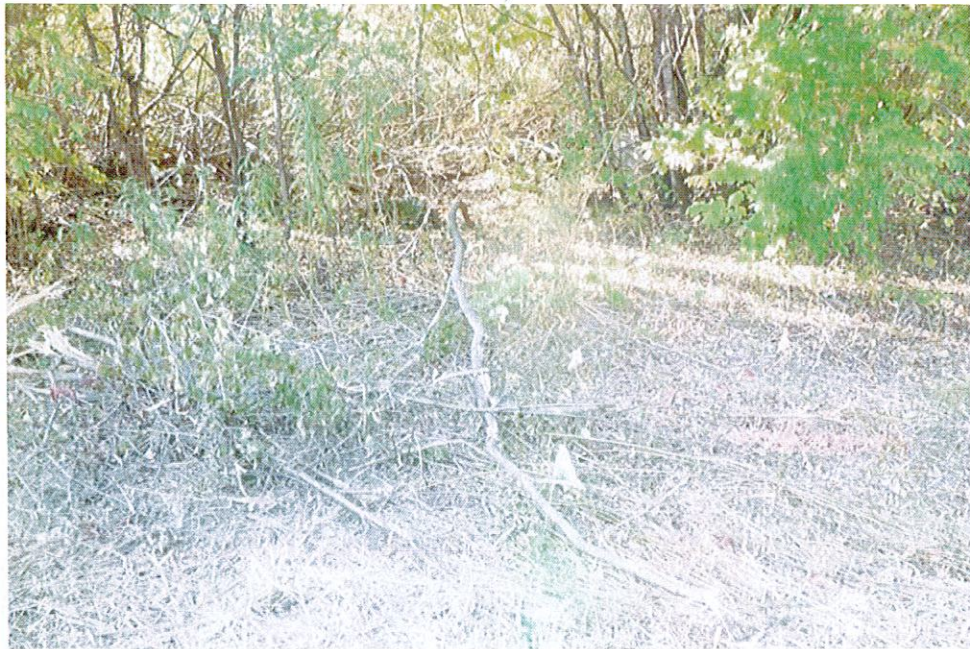
03 Anomaly 2 at woods.jpg

**Anomaly 2:** Anomaly 2 was traced from an inlet entering the west side of the catch basin to the west toward the canal for a distance of approximately 130 feet, to the edge of a wooded area. The anomaly was not present in the wooded area or to the west of the wooded area toward the canal.

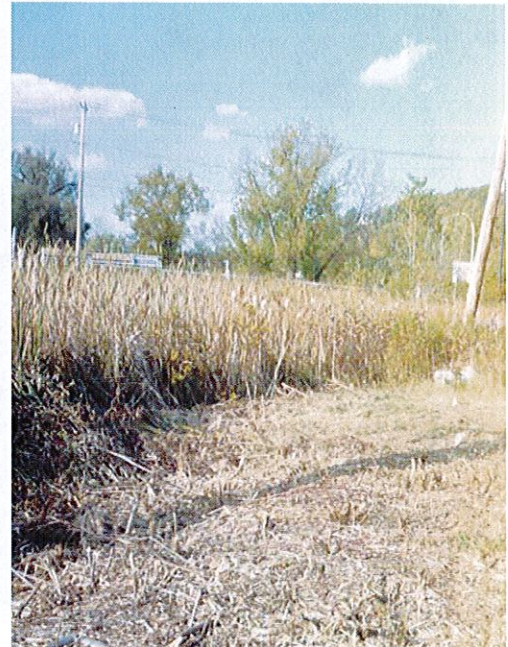
06 Anomaly 3 e

**Anomaly 3:** Anomaly 3 was noted in the northeastern portion of the study area running in an approximate north/south direction. NYLD indicated that the anomaly was consistent with a cable as opposed to a larger diameter structure. The anomaly terminated just south of a utility pole suggesting that the anomaly was related to an electrical conduit.

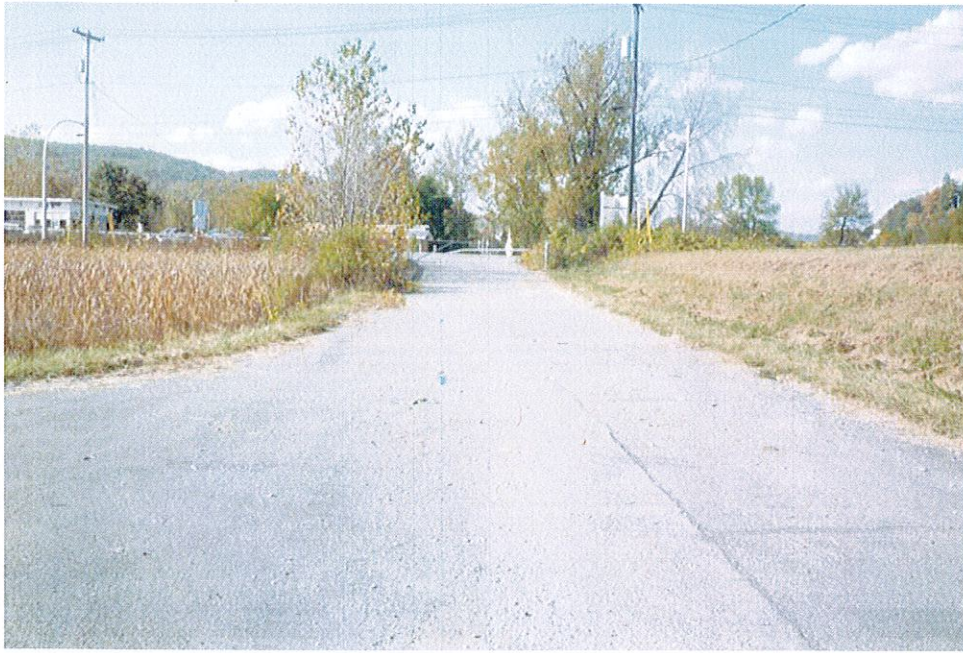
13 Anomaly 5 looking north.jpg

**Anomaly 5:** Anomaly 5 was noted in the northeastern portion of the study area. The anomaly extended outside of the study area to the north, within the site's driveway. NYLD indicated the anomaly was associated with the municipal water line as it connected to a hydrant located within the northeastern portion of the site.

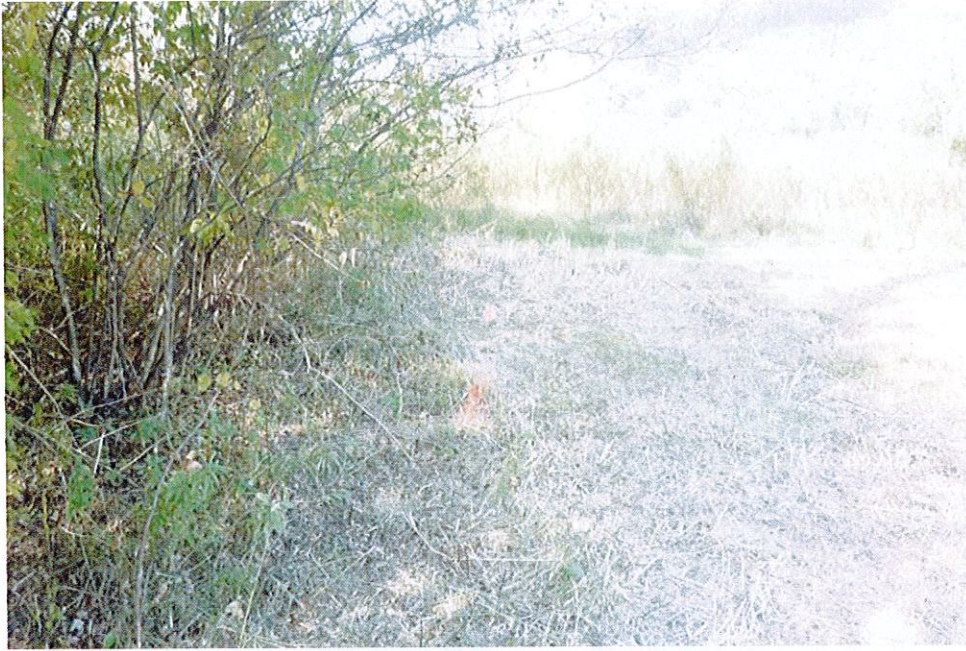
09 Anomaly 4 communication cable looking north.jpg

**Anomaly 4:** Anomaly 4 was noted in the northwestern portion of the study area running in an approximate north/south direction. NYLD indicated that the anomaly was associated with a communication cable which originated off-site to the north at a utility pole located along Route 4.
