Periodic Review Report

110 Luther Avenue BCP Site(BCP Site #C734118)March 17, 2019 to March 17, 2020Reporting Period

Syracuse Label Company Inc.

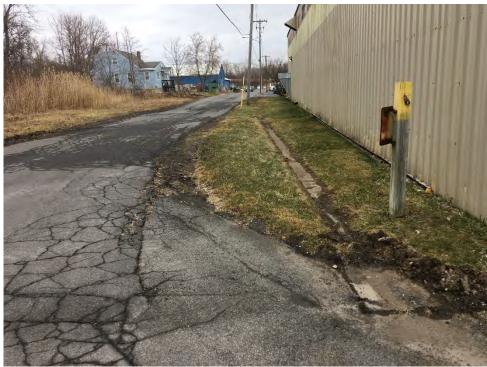
During the Site visit on March 17, 2020, those areas that could be observed (accessible portions of building slab, asphalt pavement, and landscaped areas) appeared to be functioning as intended. However, isolated portions of the landscaped areas adjacent to Albion Avenue asphalt pavement, which is outside the BCP Site boundary, had some rutting apparently due to snow removal activities. These areas were reportedly regraded by Box Capital personnel on March 20, 2020, outside of this PRR's certification period.

Photo 1 - View of minor soil cover system damage near southwestern corner of building. Reportedly repaired by Box Capital by regrading on March 20, 2020.

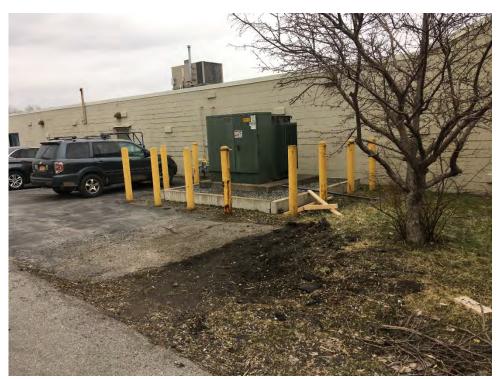
Photo 2 - View of minor soil cover system damage near northwestern portion of Site. Reportedly repaired by Box Capital by regrading on March 20, 2020

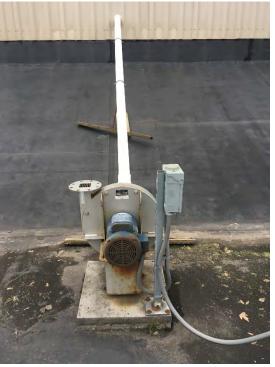
Photo 7 - View of Fan 1 pipe supports that need to be repaired. Temporary repairs were made by Box Capital on March 20, 2020 (outside of this PRR's certification period) until parts for permanent repair are available.

The necessary repairs to SSDS suction riser S-14 and the permanent repairs to the supports for the PVC pipe leading to Fan 1 should be arranged and completed.

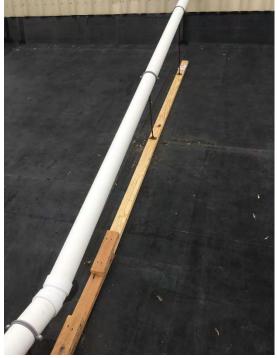
Photo 8

View of Fan 1 pipe supports temporary repairs made by Box Capital on March 20, 2020 (outside of this PRR's certification period).

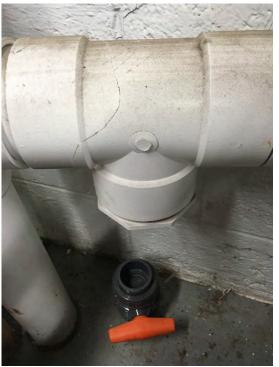
Photo 9 - View of broken "T" fitting and dislodged ball valve on SSDS suction riser S-14 leading to Fan 2. Repairs will be arranged outside of this PRR's certification period.

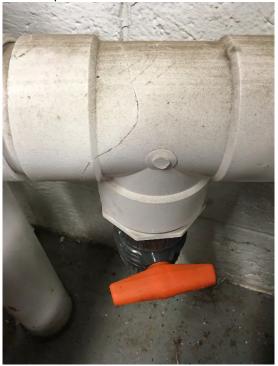
Photo 10 - The dislodged ball valve was able to be temporarily re-inserted until repairs can be arranged outside of this PRR's certification period.

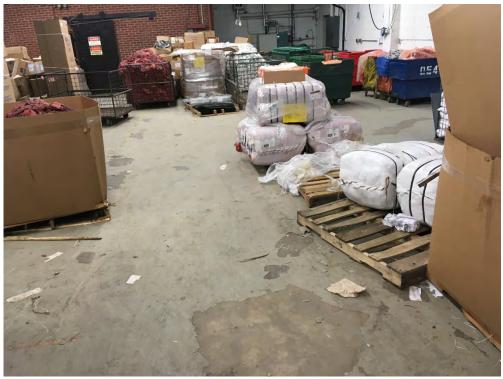
Photo 11 - View of use of room and condition of concrete floor slab engineering control in vicinity of damaged SSDS suction riser S-14.

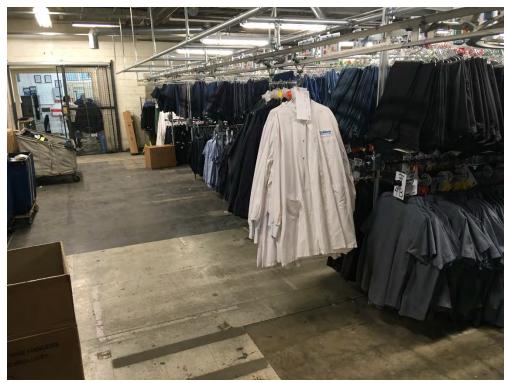
Photo 12 - View of use of room and condition on concrete floor slab engineering control in vicinity of former MW-13 and former MW-16.

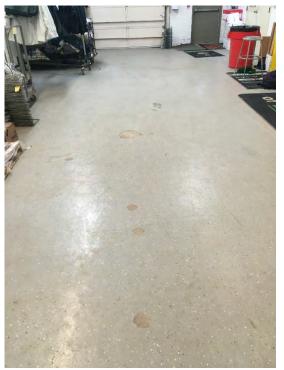
Photo 15 - View of interior concrete floor slab engineering control in vicinity of former MW-11.

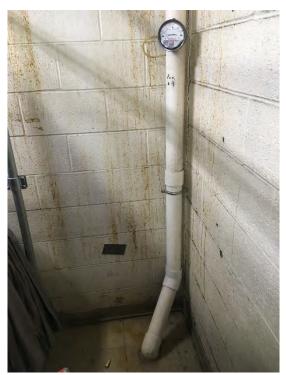
Photo 16 - View of typical SSDS suction point riser and magnehelic gauge.
