Periodic Review Report

NYSDEC Site #C828115

Rochester Drug Cooperative Building
320 North Goodman Street
Rochester, New York

LaBella Project No. 211352

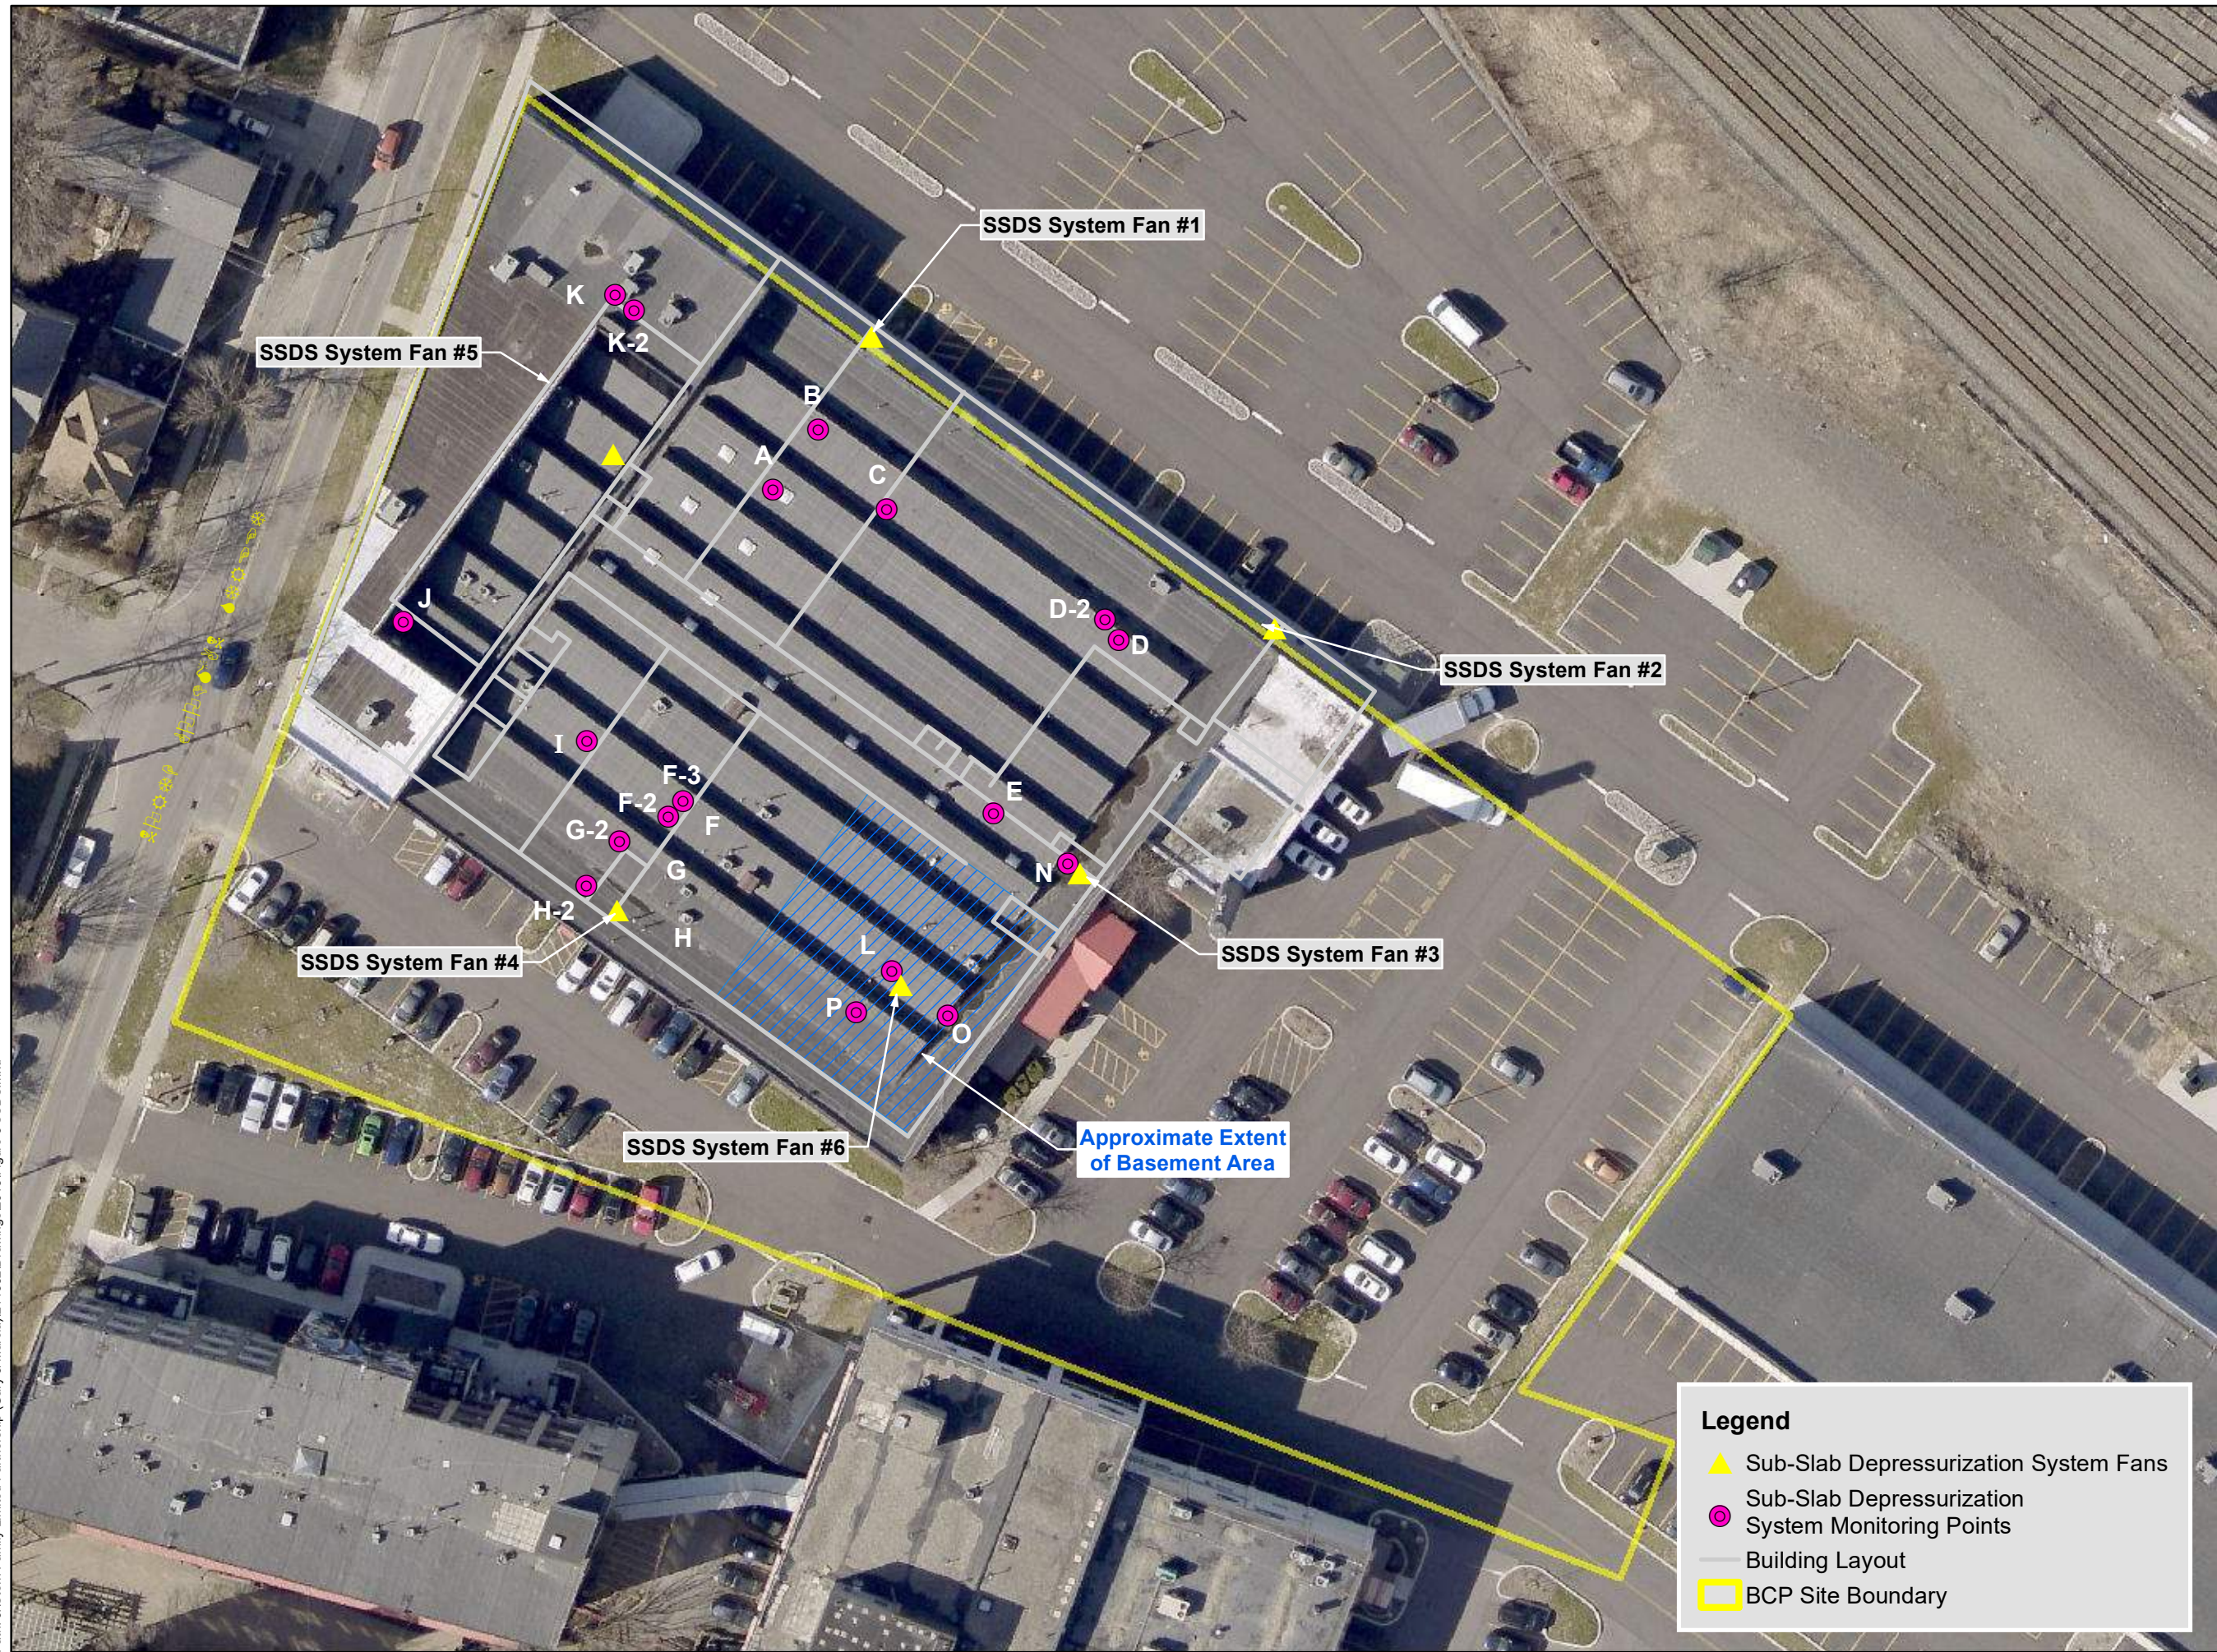
[211352]
[FIGURE 3]

An active Sub-Slab Depressurization System (SSDS) was installed beneath the concrete slab of the on-site building in November 2006. The SSDS was designed to depressurize the subsurface immediately below the concrete floor slab, thus restricting soil vapor intrusion into the on-site building from beneath the floor slab. Additional sub-slab depressurization fans were installed in the on-site building in 2009. Subsequent testing of these monitoring points (i.e. radius of influence testing) indicated negative pressures beneath the floor slab throughout the on-site building. The location of the SSDS components are depicted on Figure 3.

Based on the inspection, the SSDS appeared to be in good working order (e.g. each manometer indicated the SSDS was working, the fan was observed to be working, and the piping appeared in good condition). Copies of the inspection forms and photographs of pertinent portions of the system are included in Appendix A.

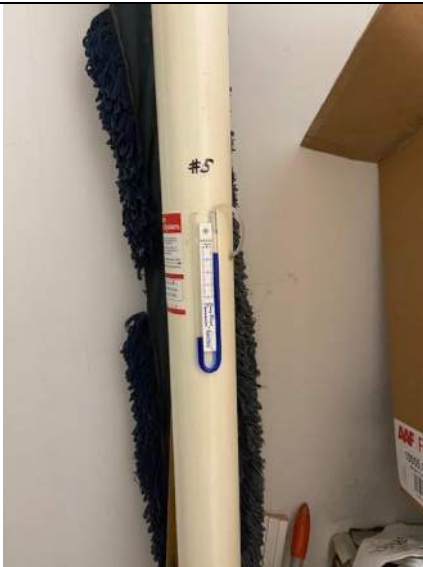
SSDS #5 pump the water from the pad into drums. A LaBella
