**PRE-DEMOLITION  
ASBESTOS SURVEY**

**5392 STATE ROUTE 19  
AMITY, NEW YORK**

**AUGUST 2011**

**Reference: Pre-Demolition Asbestos Survey  
5392 State Route 19  
Town of Amity, New York 14813**

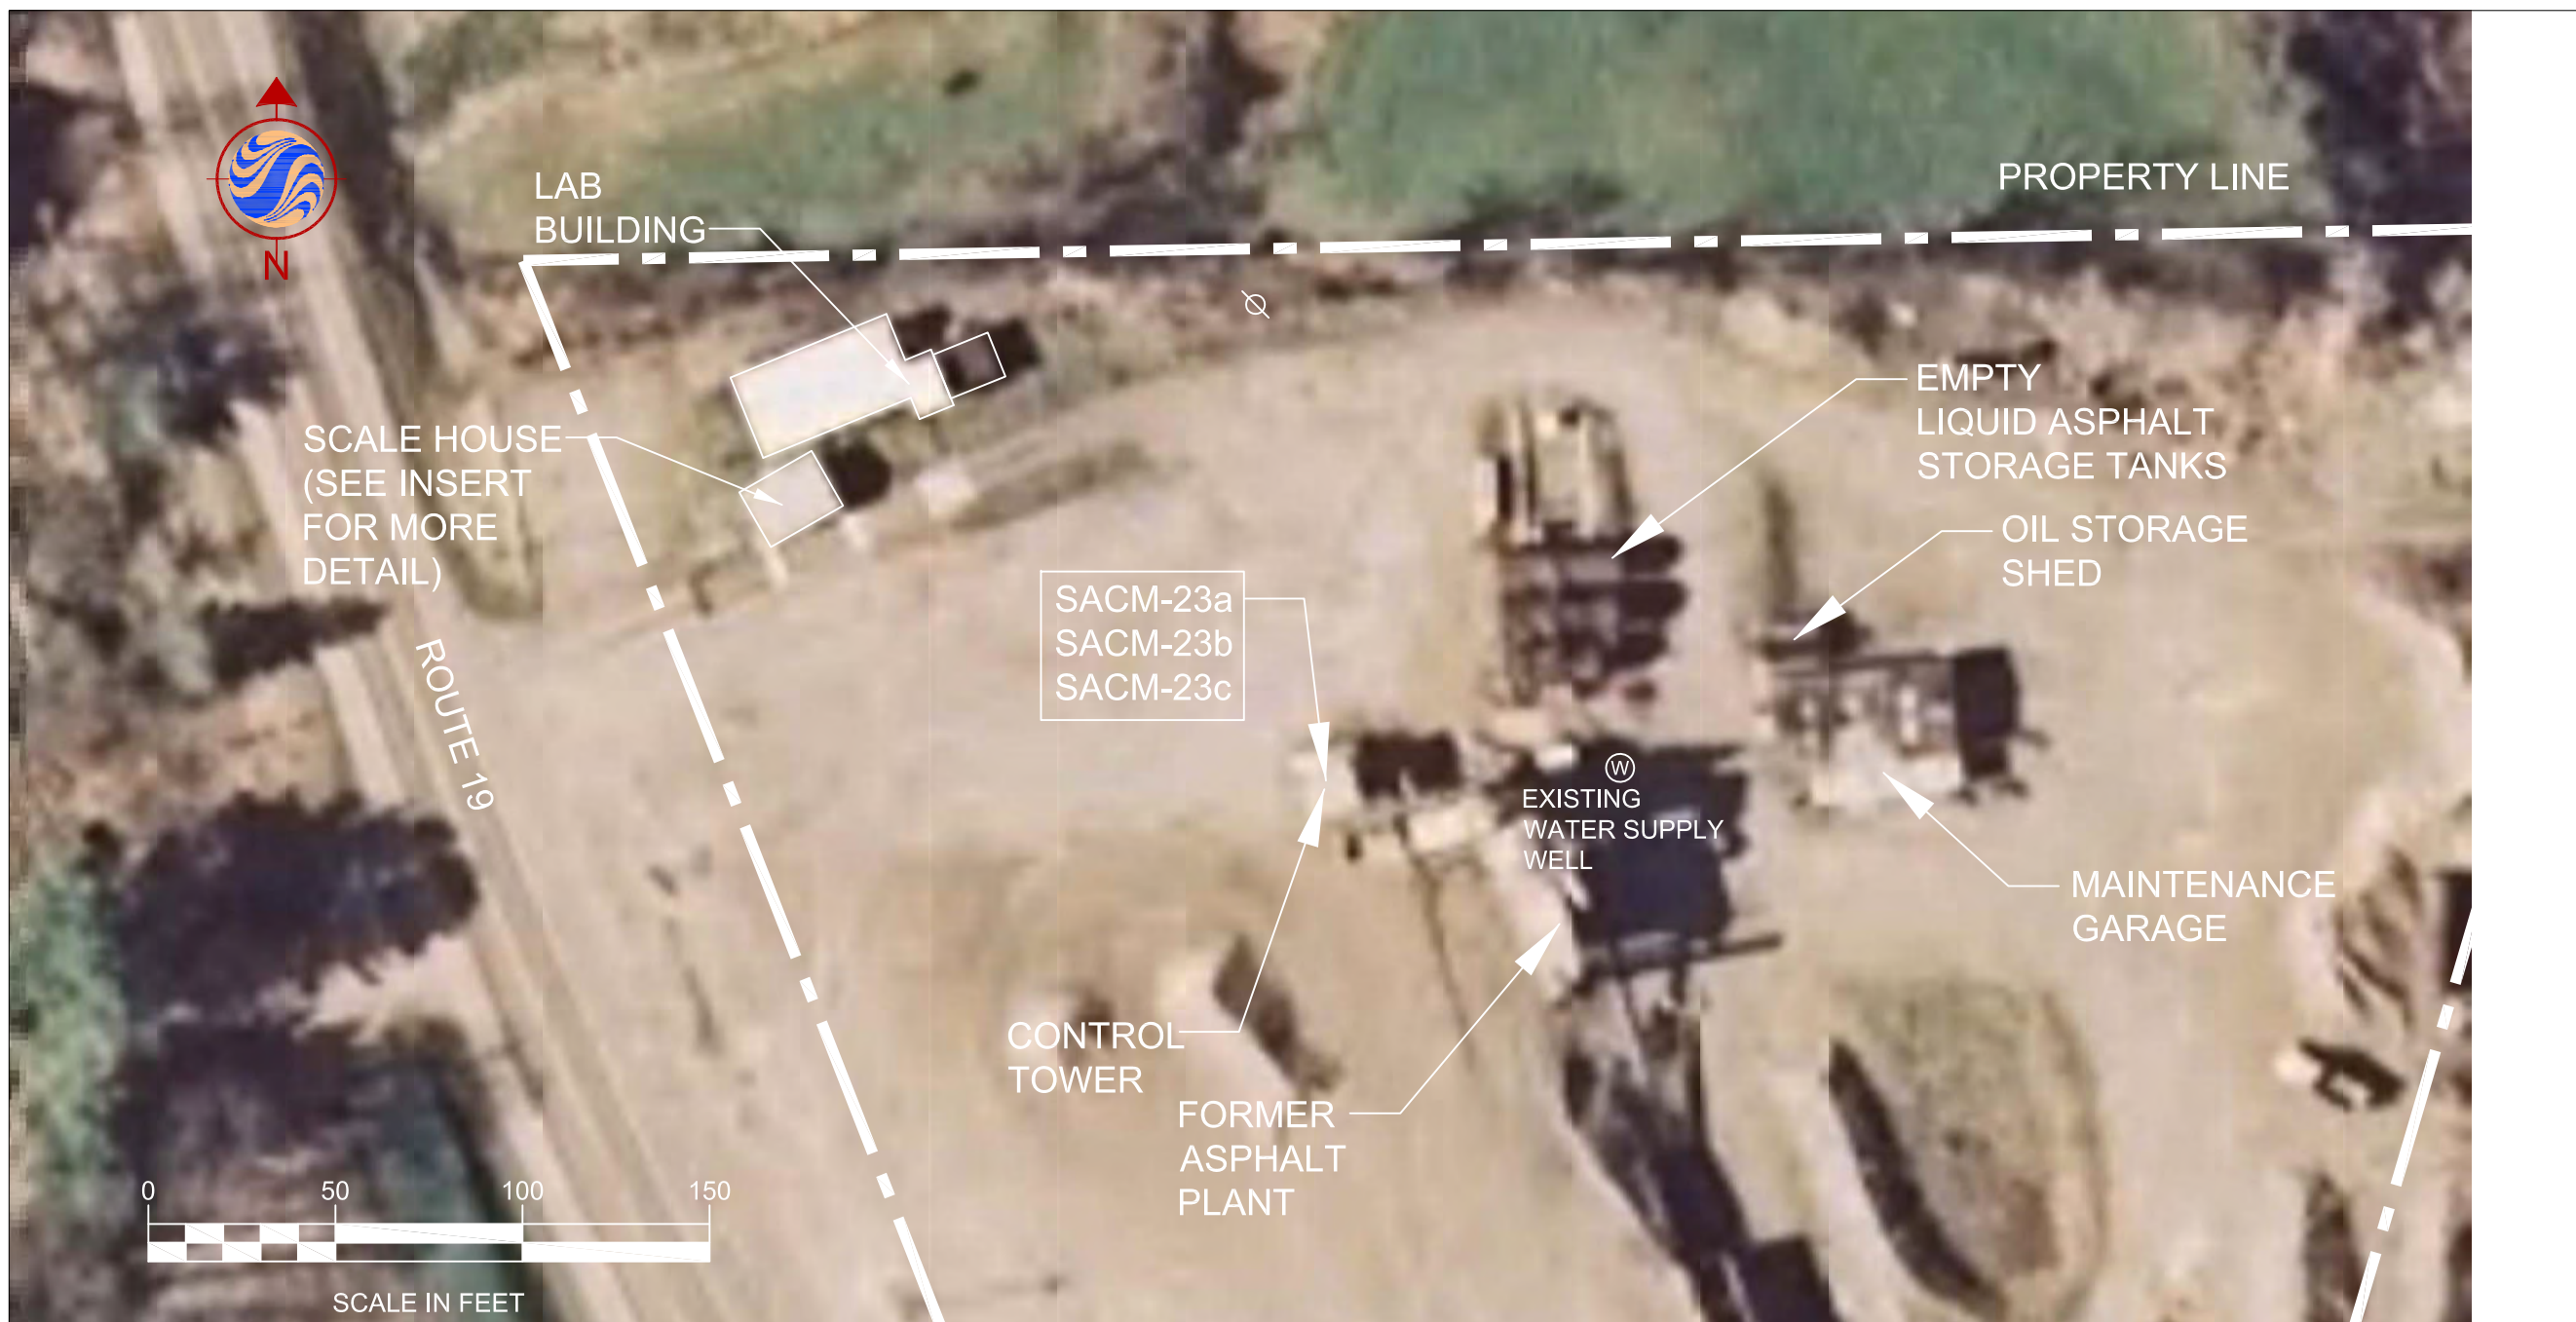
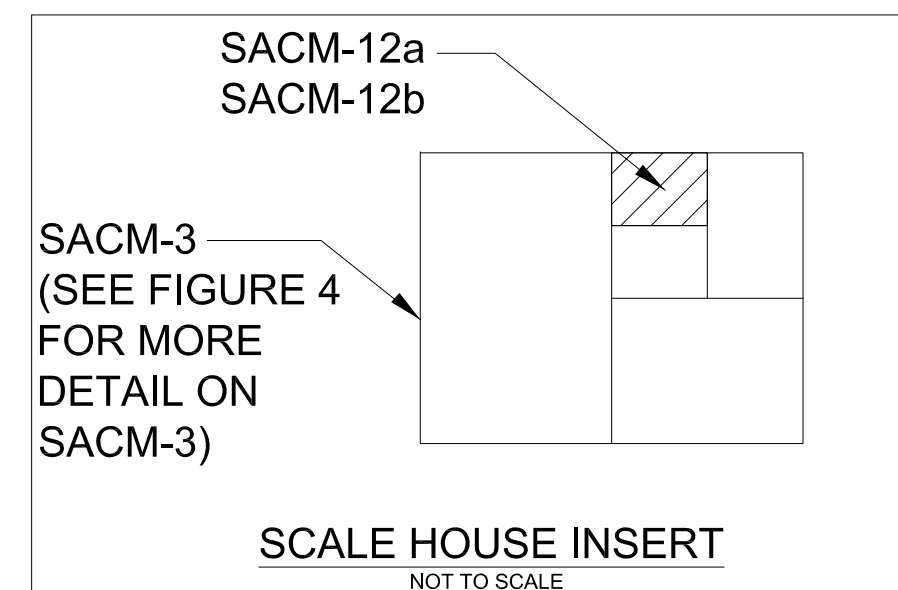
SITE LAYOUT AND ASBESTOS CONTAINING MATERIALS SAMPLE LOCATIONS

The estimated quantities of the above noted ACM are presented in Table 2. Photographs of the above noted ACM are presented in Appendix D. The locations of suspect ACM that tested positive for asbestos are identified on Figure 2. Figure 4 presents the presumed homogeneous locations for sample SACM-3.

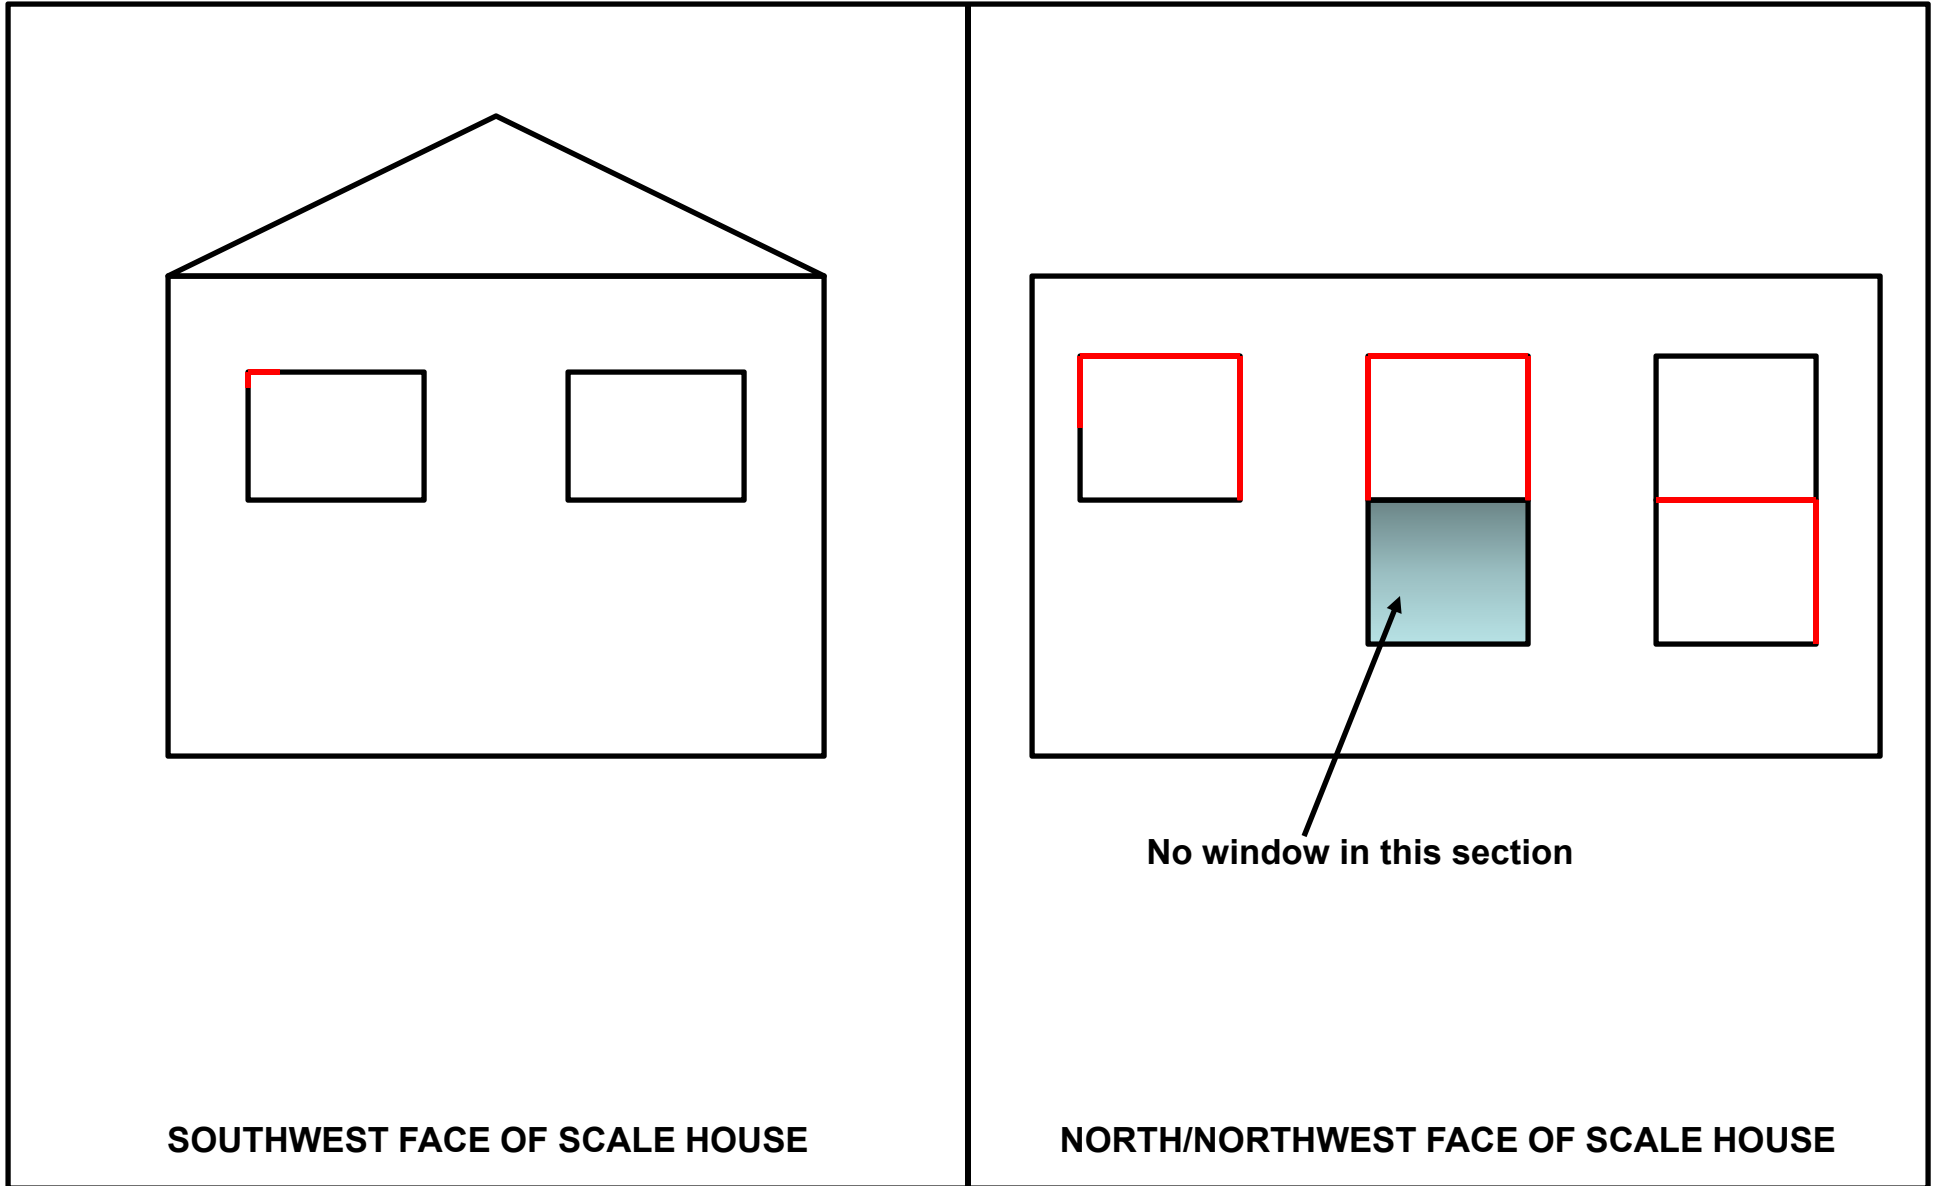
**FIGURE 4  
PRESUMED HOMOGENEOUS LOCATIONS OF SACM-3  
5392 STATE ROUTE 19  
TOWN OF AMITY, ALLEGANY COUNTY, NEW YORK**

**SOUTHWEST FACE OF SCALE HOUSE**

**NORTH/NORTHWEST FACE OF SCALE HOUSE**

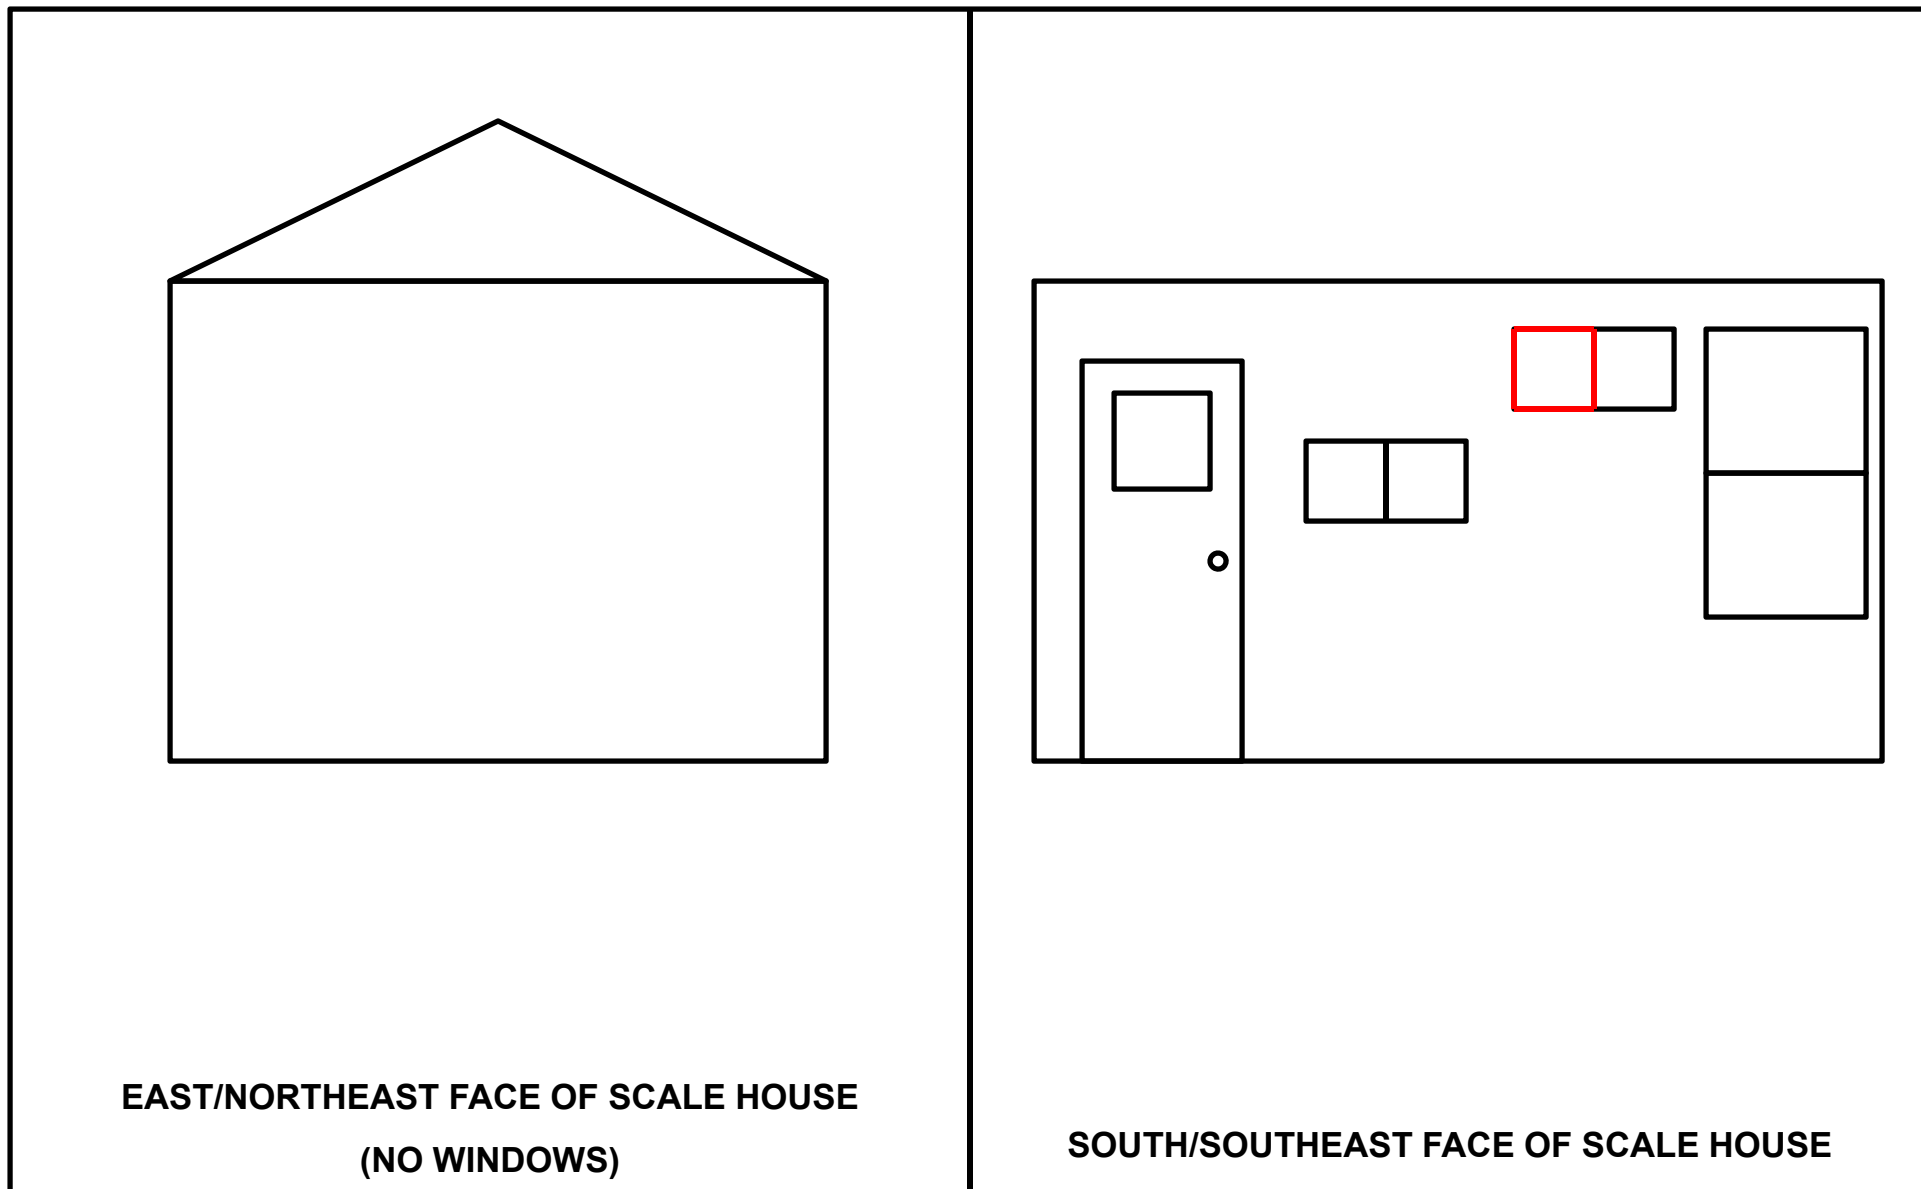
**FIGURE 4  
PRESUMED HOMOGENEOUS LOCATIONS OF SACM-3  
5392 STATE ROUTE 19  
TOWN OF AMITY, ALLEGANY COUNTY, NEW YORK**

**EAST/NORTHEAST FACE OF SCALE HOUSE  
(NO WINDOWS)**

**SOUTH/SOUTHEAST FACE OF SCALE HOUSE**

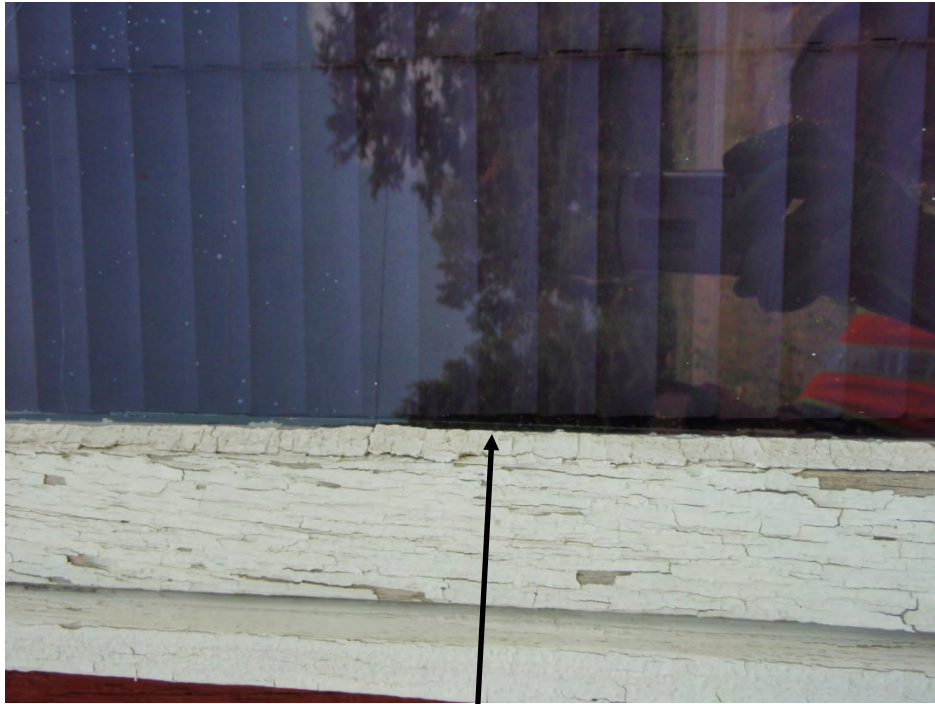
**SACM-3**

- Caulk, found on some of the exterior window of the scale house (SACM-3);
- Floor tiles and associated mastic, found on the furnace room floor in the scale house (SACM-12a and SACM-12b); and
- Shingles on control tower roof (SACM-23a, SACM-23b, and SACM-23c).

**Photo 1:  
Confirmed asbestos containing building material –  
window caulk.**

Given the pending demolition of the subject structures, it is required as per Code Rule 56 that the confirmed ACM be properly abated by a licensed asbestos contractor in accordance with local, state, and federal regulations prior to the commencement of any demolition work (see Appendix A). Therefore, reporting to regulatory agencies should be completed a minimum of ten (10) days prior to asbestos abatement and subsequent building demolition. Please note that, although it is acceptable for the building owner's agent to do so, it is ultimately the building owner's responsibility to provide a copy of this Asbestos Pre-Demolition Survey to the appropriate New York State Department of Labor (Asbestos Control Bureau) office.

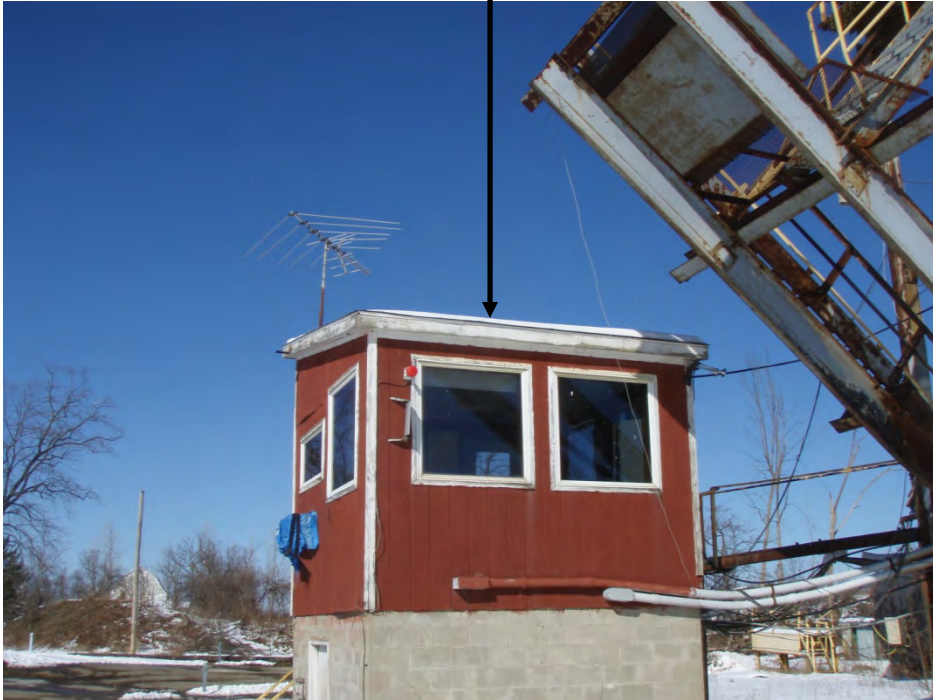
SACM-23a, SACM-23b, and SACM-23c

**Photo 3:**  
Confirmed asbestos containing building material – shingles.

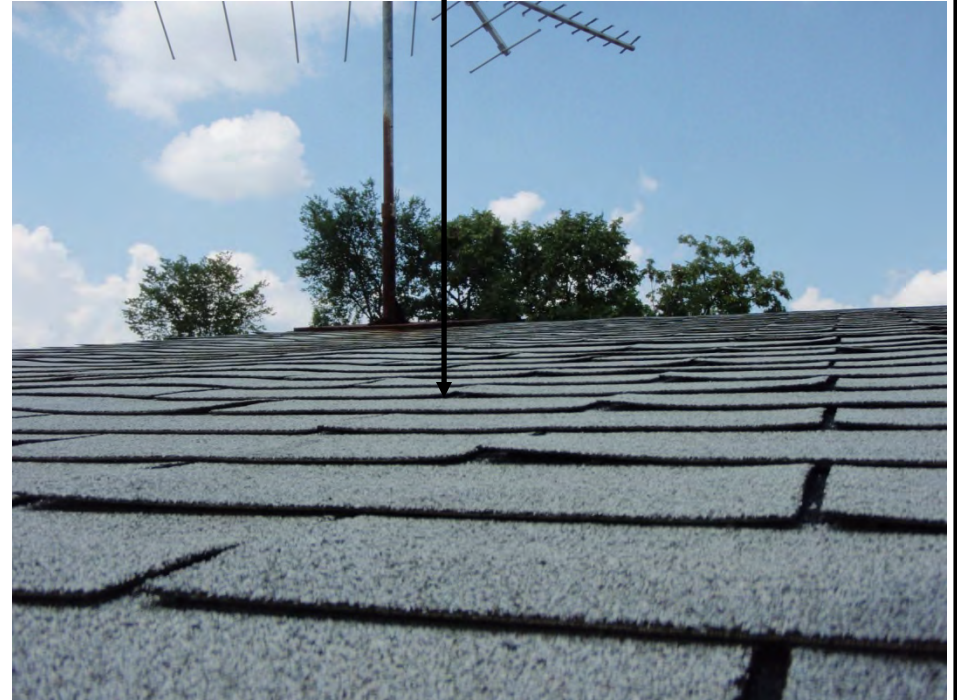
SACM-23a, SACM-23b, and SACM-23c

**Photo 4:**  
Confirmed asbestos containing building material – shingles.
