Re: Sub-Slab Depressurization System Installation Report
Southside Plaza
704-744 Foote Avenue
Jamestown, New York 14701

Apex Companies, LLC (Apex) is pleased to provide Southside Station Inc. with this report documenting the installation of the sub-slab depressurization system (SSDS) at Southside Plaza, 704-744 Foote Avenue, Jamestown, New York (Site).

**Sub-Slab Depressurization System
Construction Completion Report**

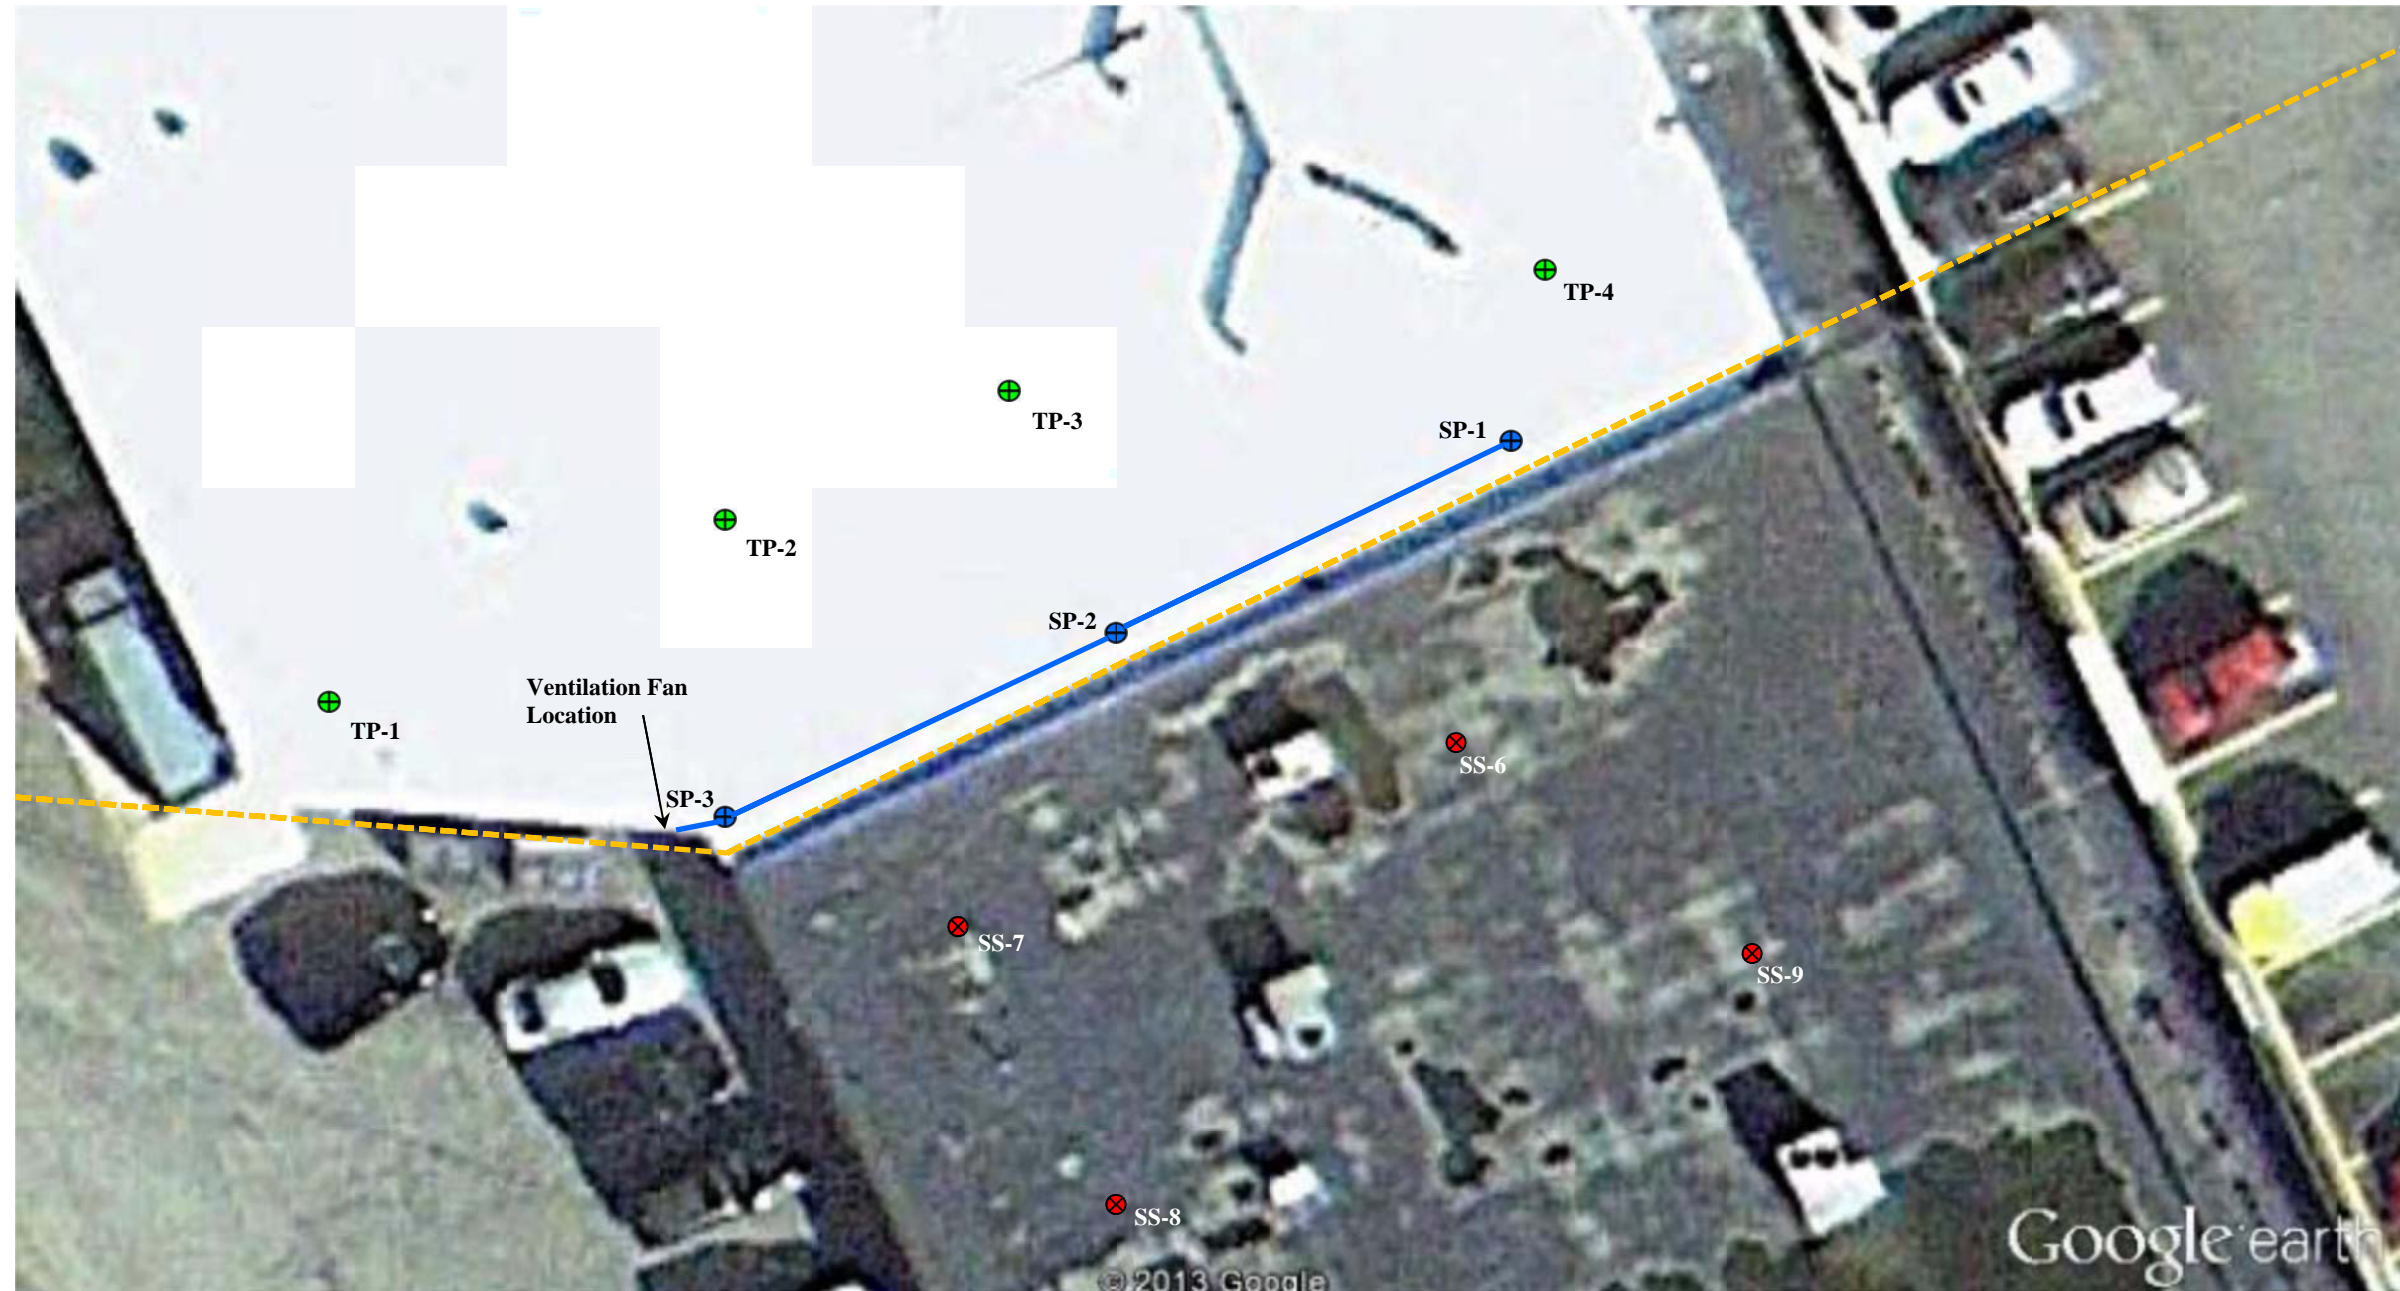
Figure 1:
Sub-Slab Depressurization System Map

On February 26 and 27, 2013, an Apex associate was onsite to oversee the installation of a SSDS at the Site. The system was installed along the southern boundary of the property within the existing Tops Markets tenant space. All installation activities were performed in conformance with the New York State Department of Health (NYSDOH) document, "Guidance for Evaluating Soil Vapor Intrusion in the State of New York, October 2006". The SSDS Construction Completion Report (CCR) submitted by Apex's SSDS contractor, Mitigation Tech, documenting the installation of the system, is provided in Attachment A. Photographic documentation of the installed SSDS system is provided in Attachment B.

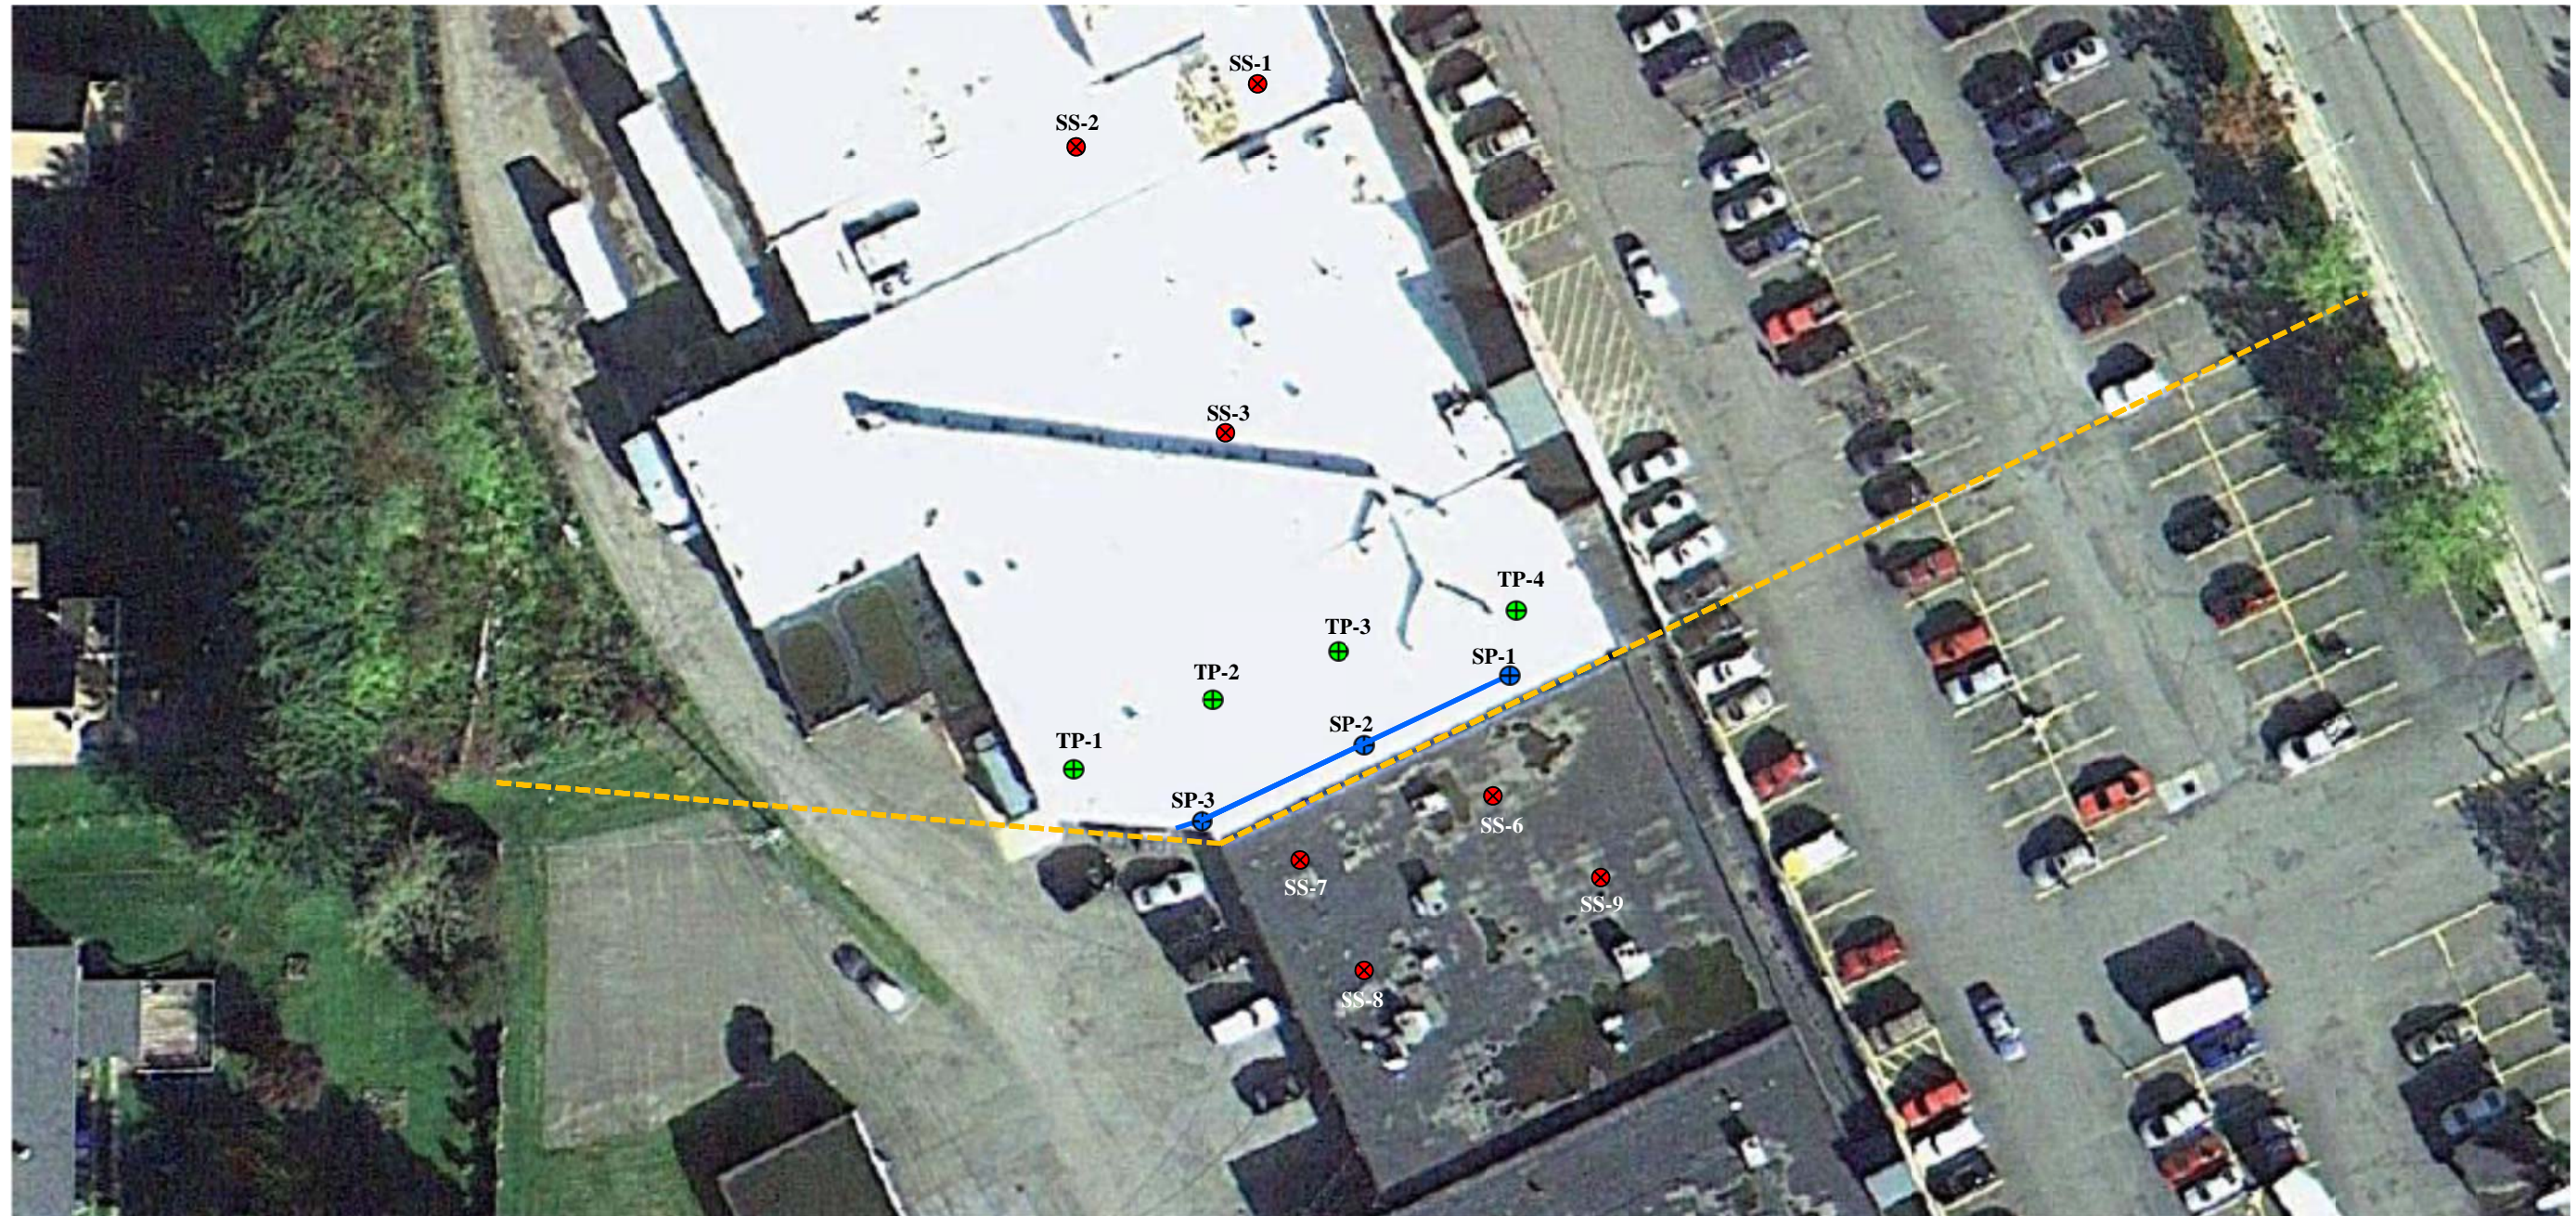
Figure 2:
 SSDS Test Point Location Map

Environmental Conservation (NYSDEC). Test points for the additional performance testing included the four post-installation test point locations, TP-1 through TP-4, as well as previously installed sub-slab vapor points, SS-1 through SS-3 and SS-6 through SS-9. Test point locations are shown on the SSDS Test Point Location Map provided as Figure 2.

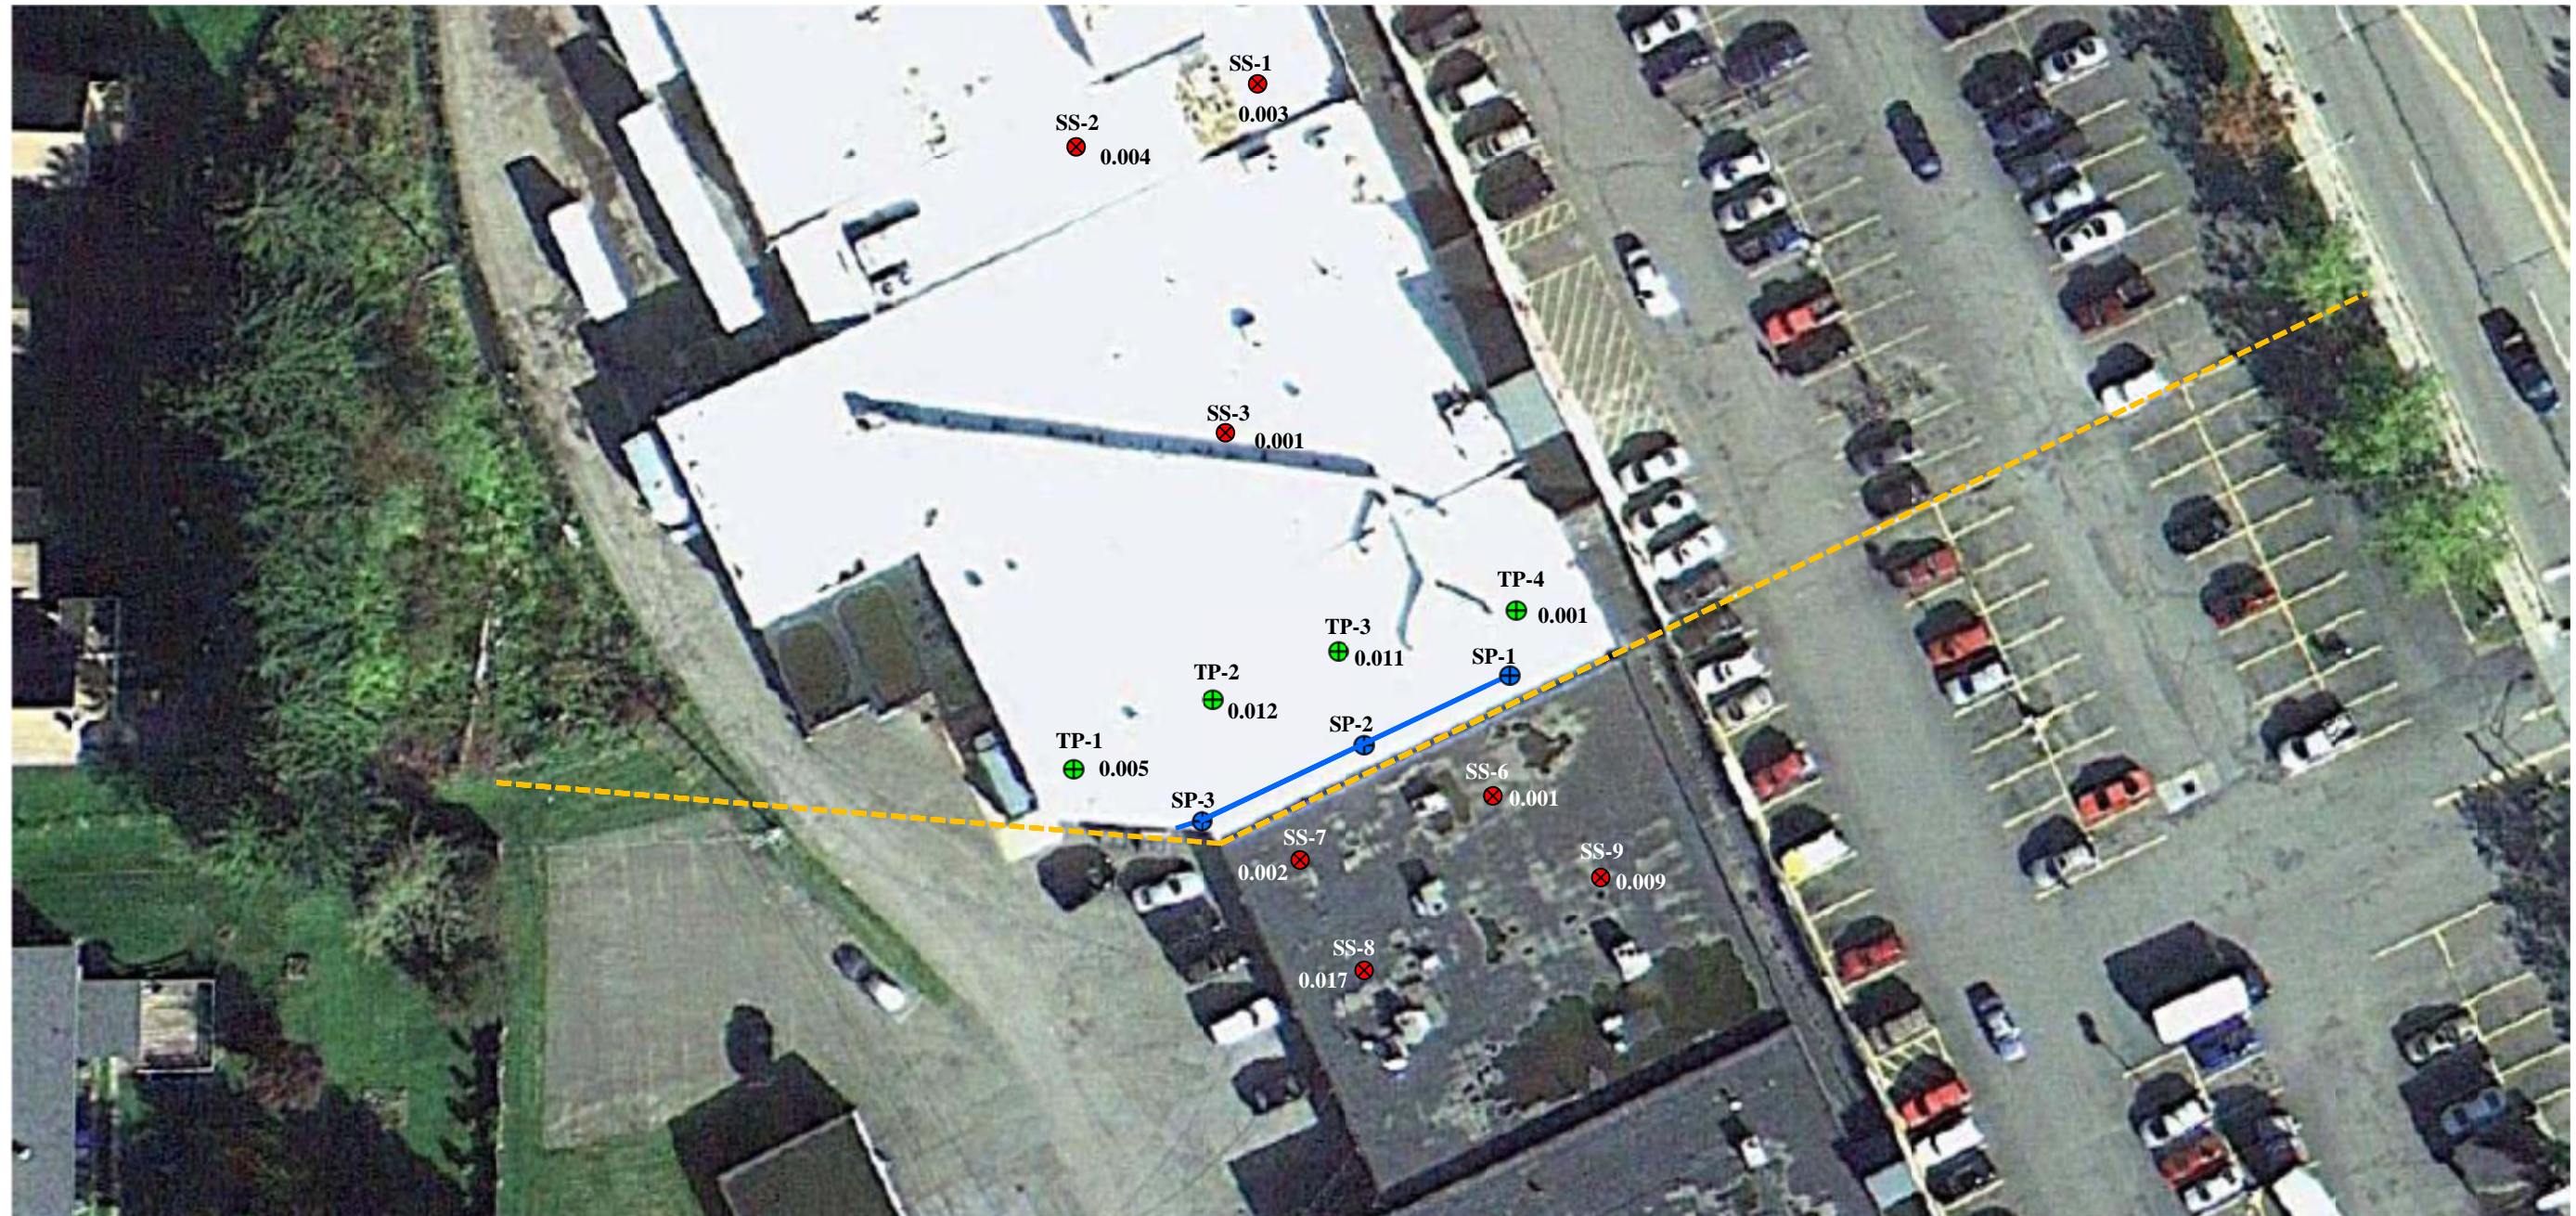
Figure 3
 SSDS Radius of Influence Map

The vacuum influence from the SSDS system was tested beneath the concrete slab at each of these test point and sub-slab vapor point locations. A digital manometer was used to measure the vacuum at each test point and sub-slab vapor point to determine the radius of influence of the SSDS. Vacuum testing results from the test points are provided in Table 1 and are shown on the SSDS Radius of Influence Map provided as Figure 3. Test results ranged from 0.001 to 0.017 wci with an average of 0.006 wci of vacuum across the radius of influence of the SSDS. Therefore, it is Apex's opinion that the SSDS is providing a sufficient vacuum to mitigate the potential vapor intrusion of dry cleaning solvent vapors at the Site and on the adjoining SFAP property.

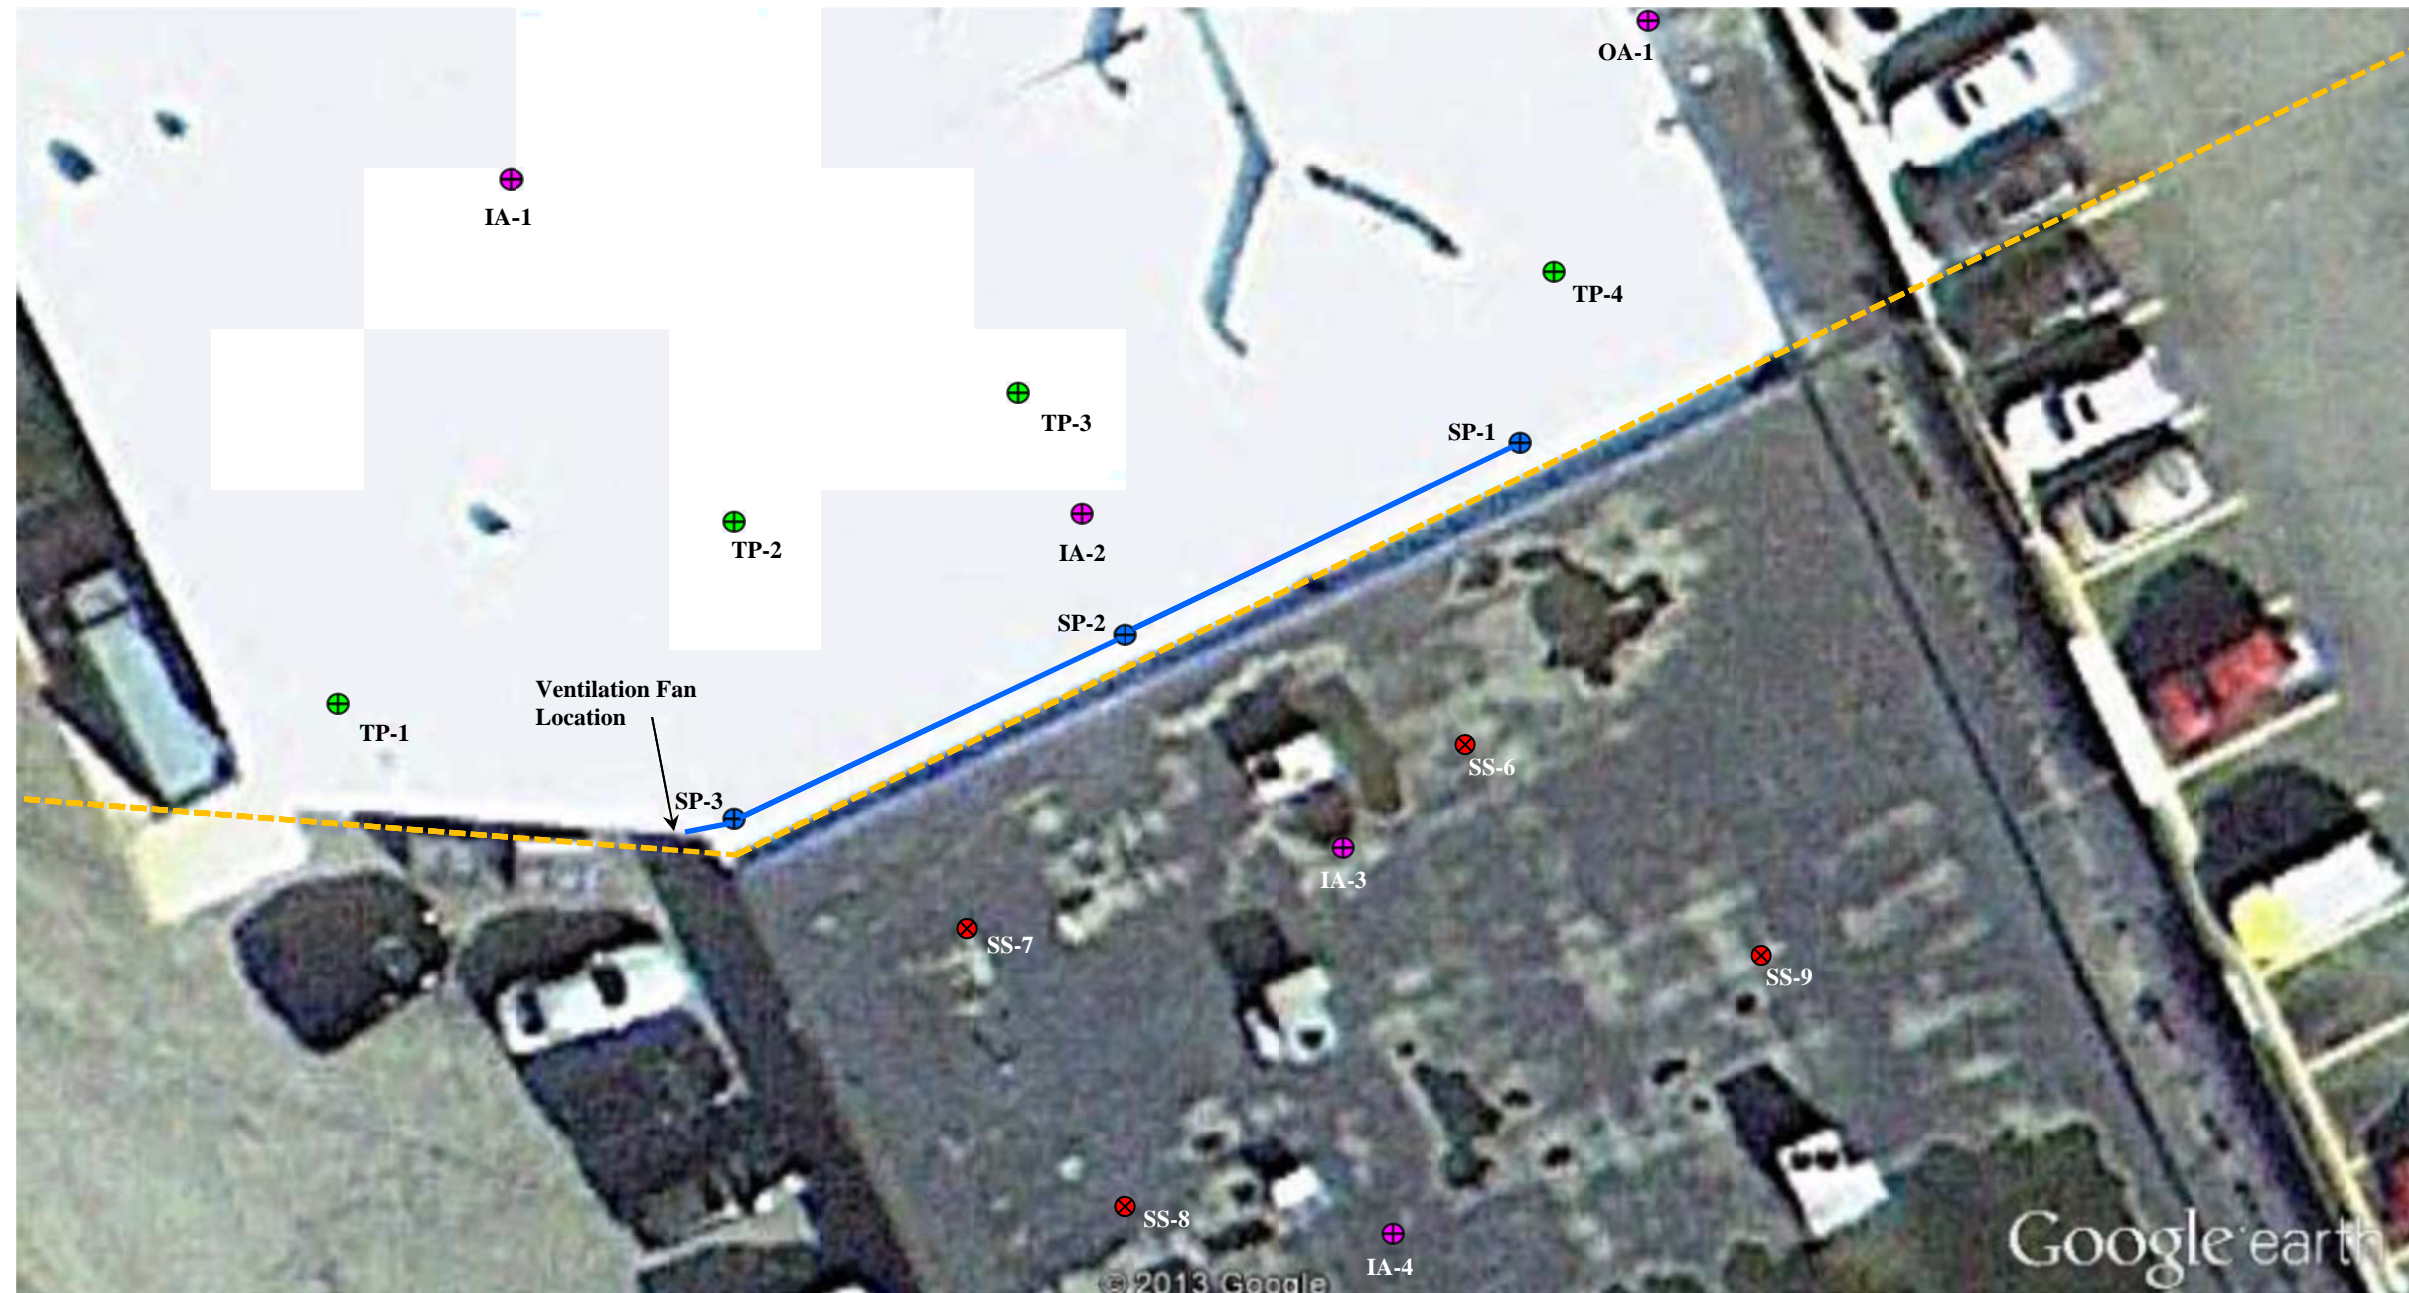
Figure 4:
Indoor and Outdoor Sample Location Map

Apex returned to the site on April 2, 2013 to collect indoor air and outdoor air samples at the Tops Market and inside two tenant spaces on the adjoining SFAP property. The indoor air and outdoor air sampling locations are shown on the Indoor and Outdoor Air Sample Location Map provided as Figure 4. Indoor and Outdoor Air samples were collected over an eight (8) hour period using batch-certified clean Summa[®] canisters equipped with appropriate flow controllers. Samples were considered representative when pressure within the Summa[®] canister dropped from an initial reading of approximately 30 inches Hg to less than 10 inches Hg. The Summa[®] canisters were shipped to Columbia Analytical Services, part of ALS Group, in Rochester, NY for analysis of volatile organic compounds (VOCs) using USEPA Method TO-15. The laboratory analytical report and chain-of-custody documentation is provided in Attachment D. Analytical results are presented in Table 2.

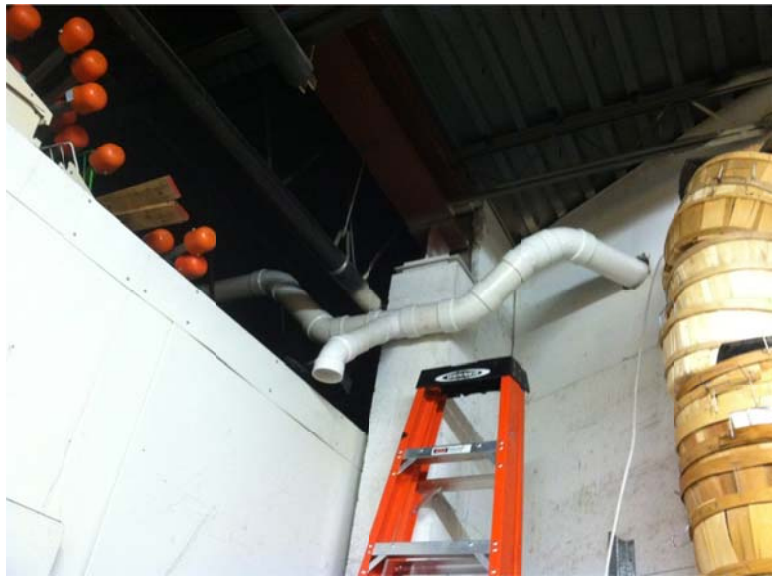
Photograph 1

View of 4" PVC manifold line extending from overtop of the produce cooler (left) to a tee for the 3" riser for suction point #3 and the 4" vent line through the southwest exterior wall to the fan. Note this was the first piping installed so that the crew could make sure to properly align the vent pipe through the exterior wall for installation of the fan.

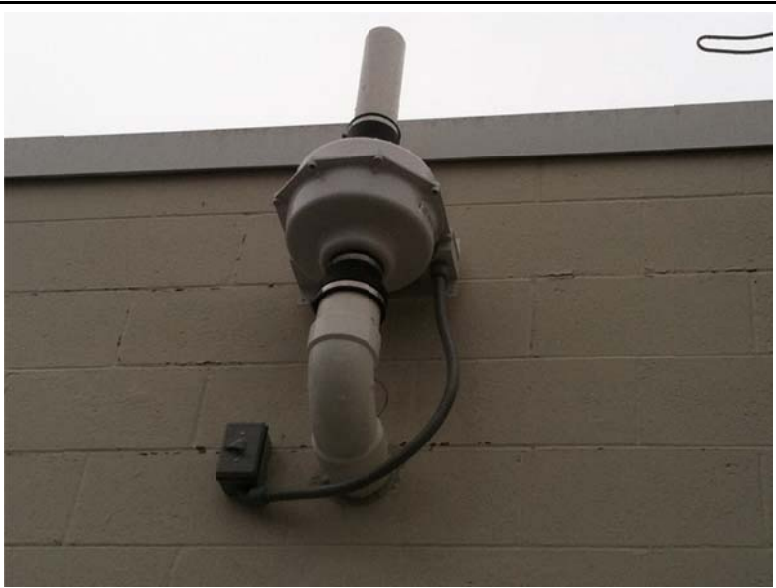
Photograph 2

View of the vent pipe exterior to the southwest wall with the installed fan and switch.

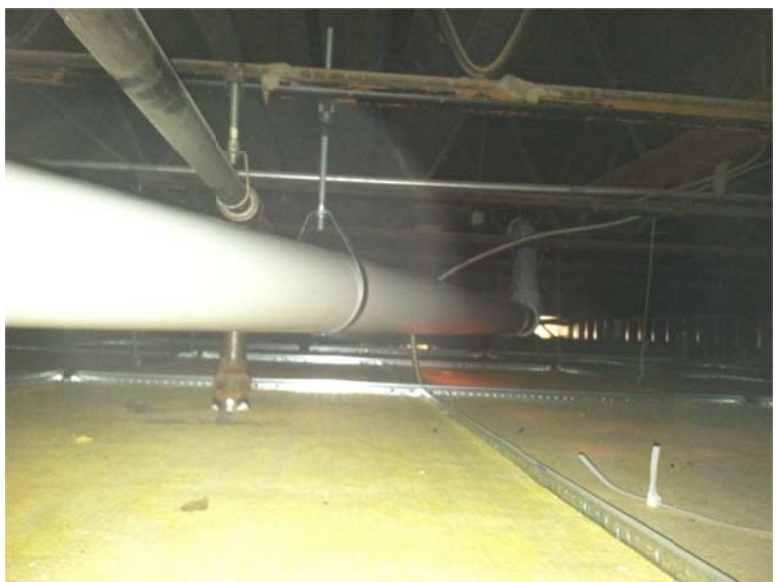
Photograph 3

View of the 4" manifold piping running above the suspended ceiling tile above the produce and floral prep room.

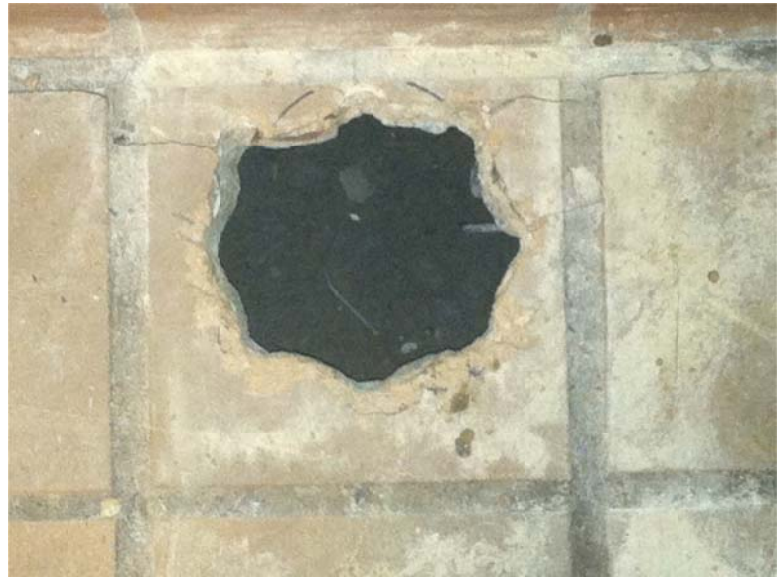
Photograph 4

View looking into the suction point #2 hole in the produce and floral prep room.

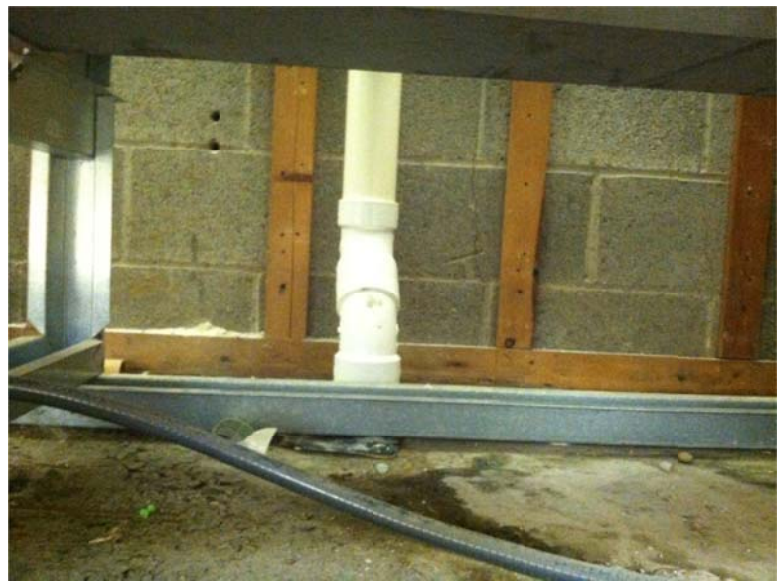
Photograph 5

View of the bottom portion of the 3" riser at suction point #1 behind the produce cooler along the south wall. View is looking underneath the cooler where the contractor had temporarily removed the front panel.

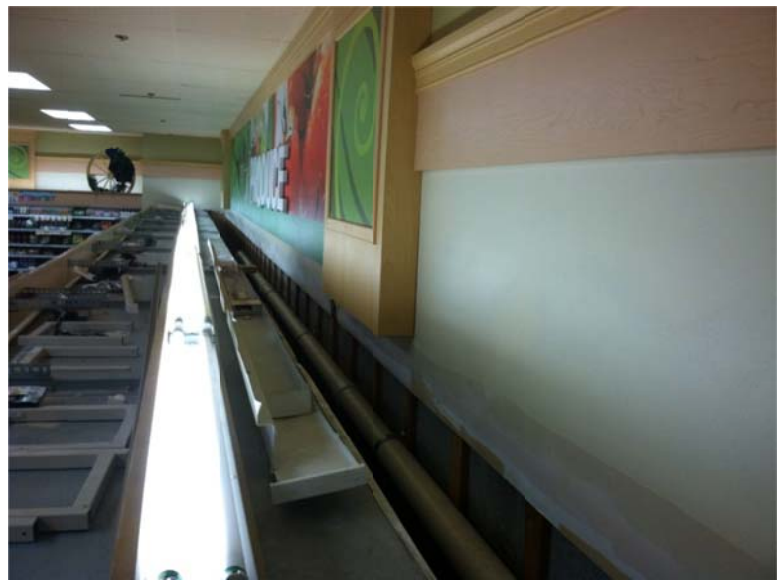
Photograph 6

View of piping running along the south wall from suction point #1 behind the produce cooler.

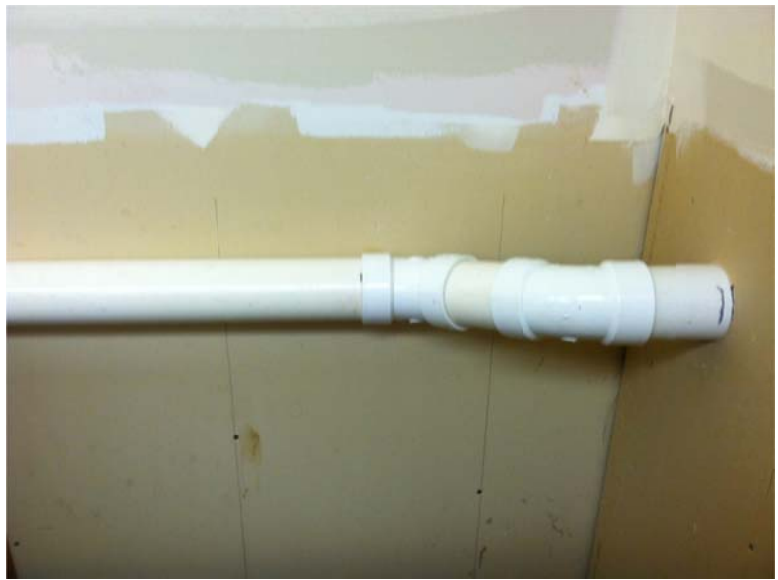
Photograph 7

View of the same piping shown in Photograph 6 where it enters the southeast wall of the produce and floral prep room.

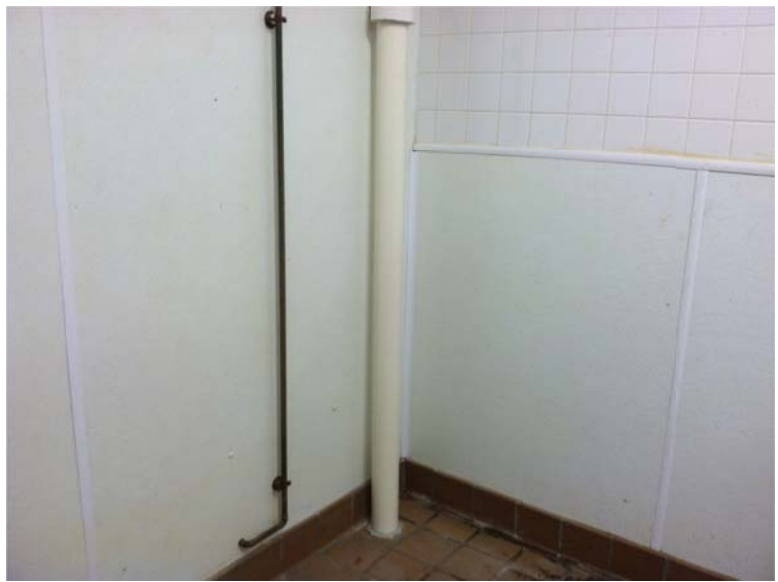
Photograph 8

View of the 3" riser at suction point #2 in the southeast corner of the produce and floral prep room up to the tee that extends through the wall for the piping to suction point #1 behind the produce cooler.

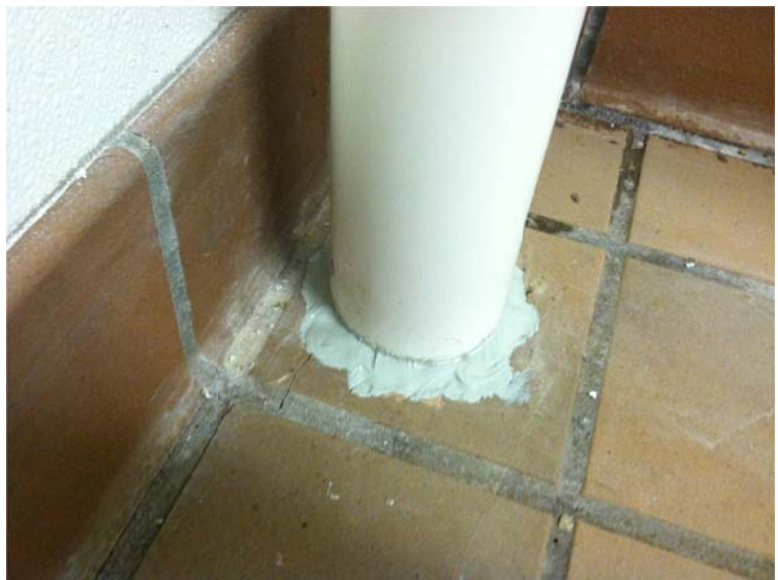
Photograph 9

View of the floor penetration at suction point #2 in the produce and floral prep room after the sealant was applied.

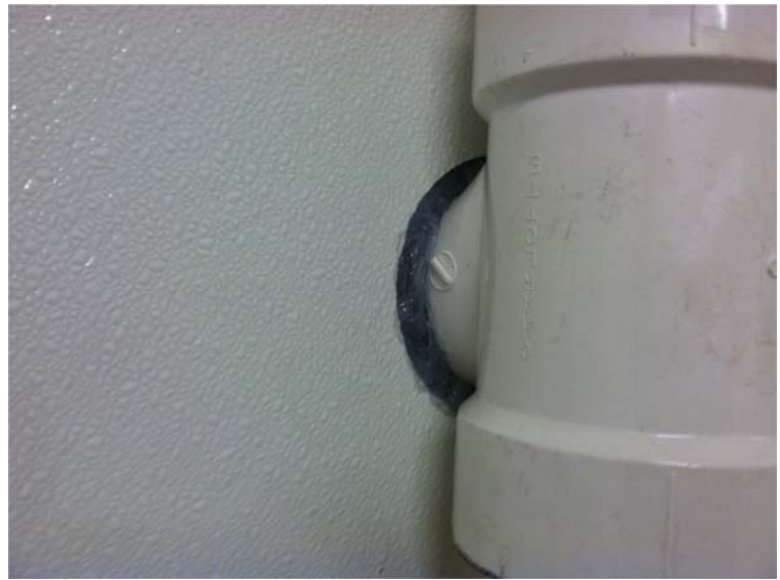
Photograph 10

View of the wall penetration at suction point #2 in the produce and floral prep room after the sealant was applied.

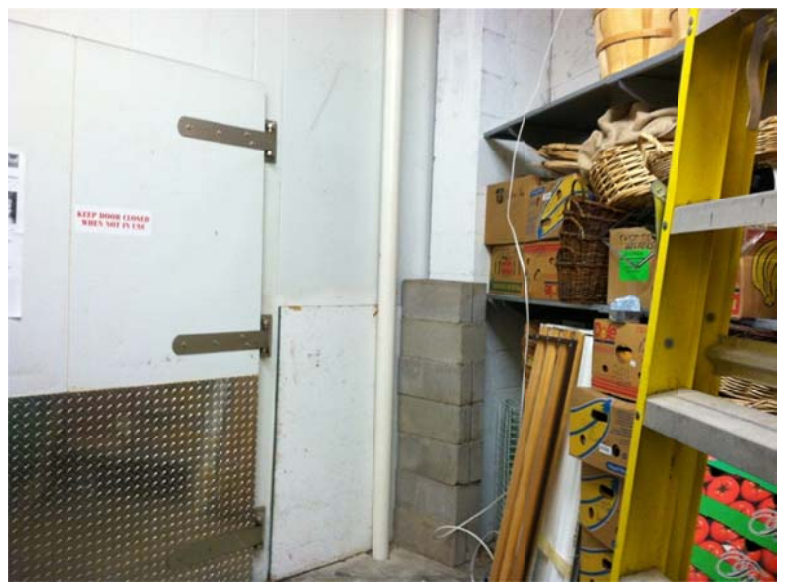
Photograph 15

View of the riser at suction point #3 located immediately west of the produce cooler.

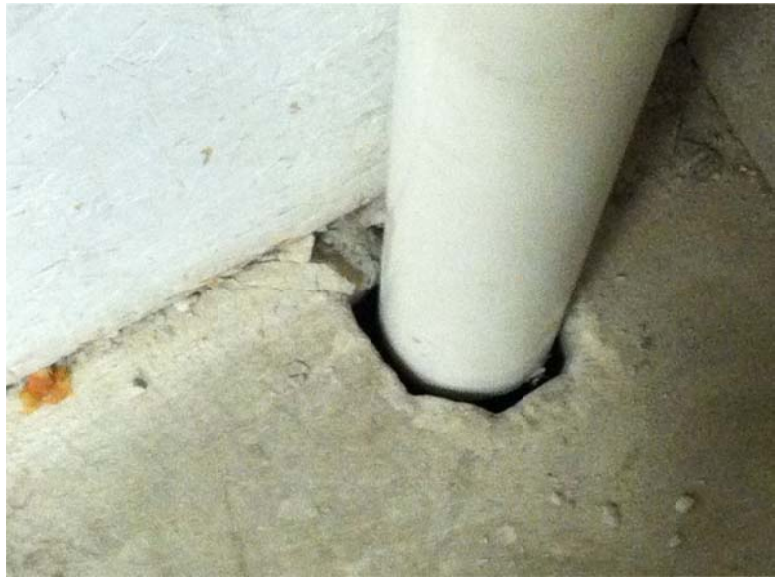
Photograph 16

View of the riser at suction point #3 entering the floor penetration prior to the sealant application.

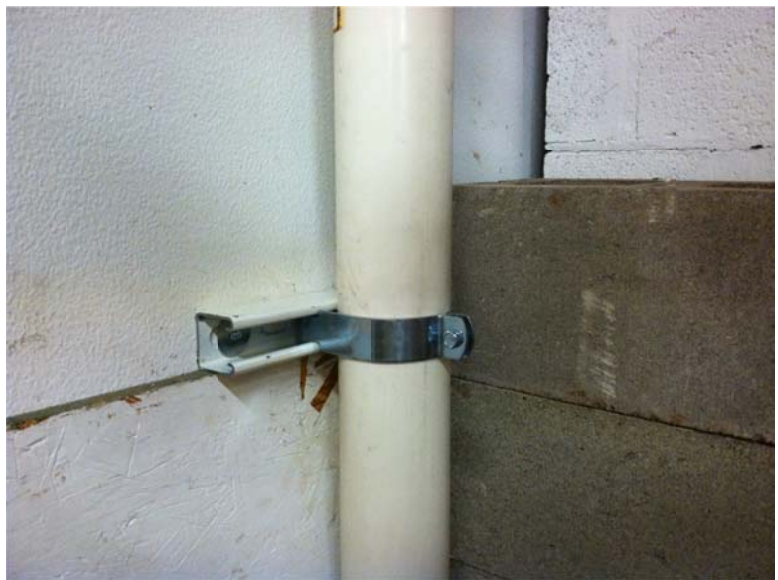
Photograph 17

View of the pipe support used to secure the riser for suction point #3.

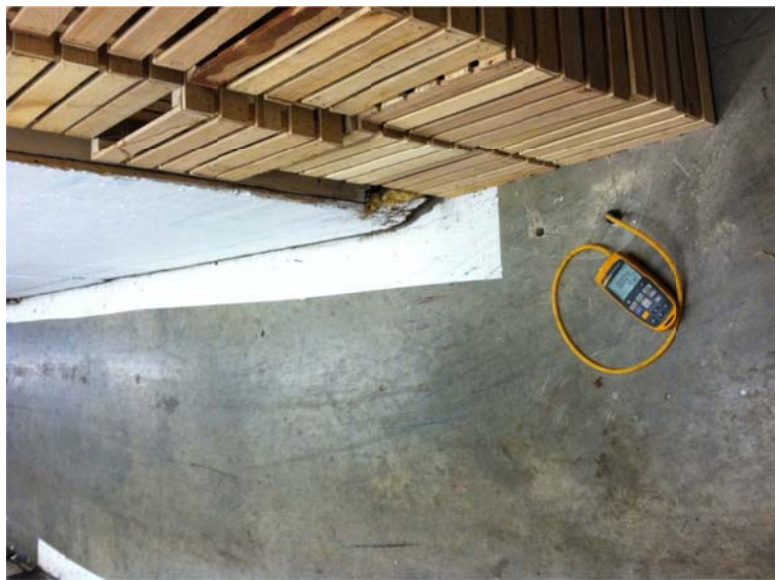
Photograph 18

View of the test point #1 located at the inside corner of the back hallway approximately 10 feet inside the southwest exit door. This location is approximately 34 feet west-northwest of suction point #3.

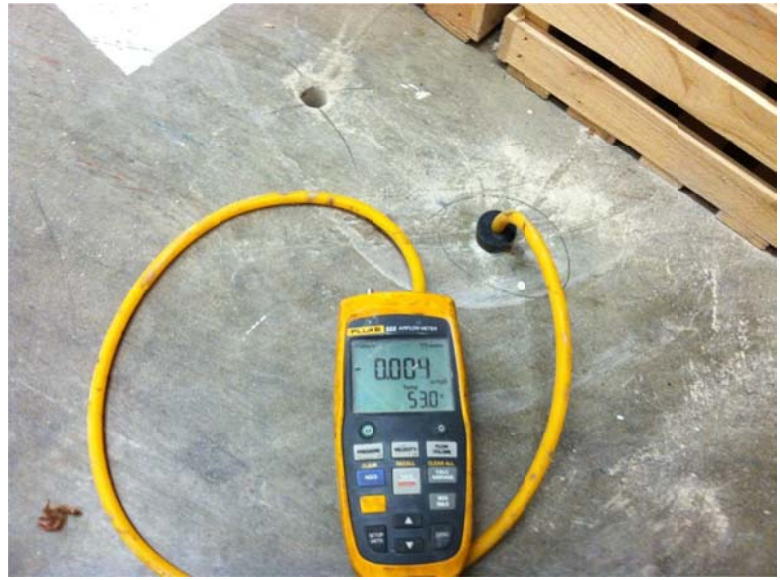
Photograph 19

View of the airflow reading at test point #1 during the initial test run on the system.

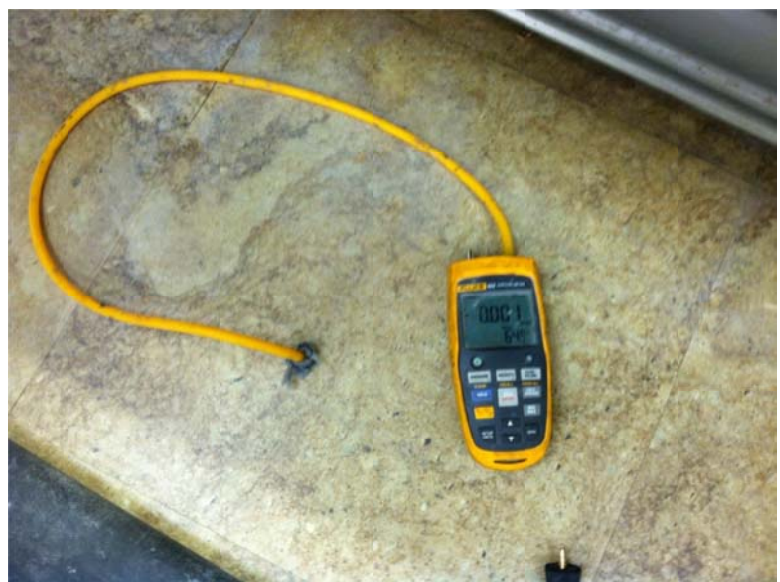
Photograph 23

View of the airflow reading at test point #4 during the initial test run on the system.

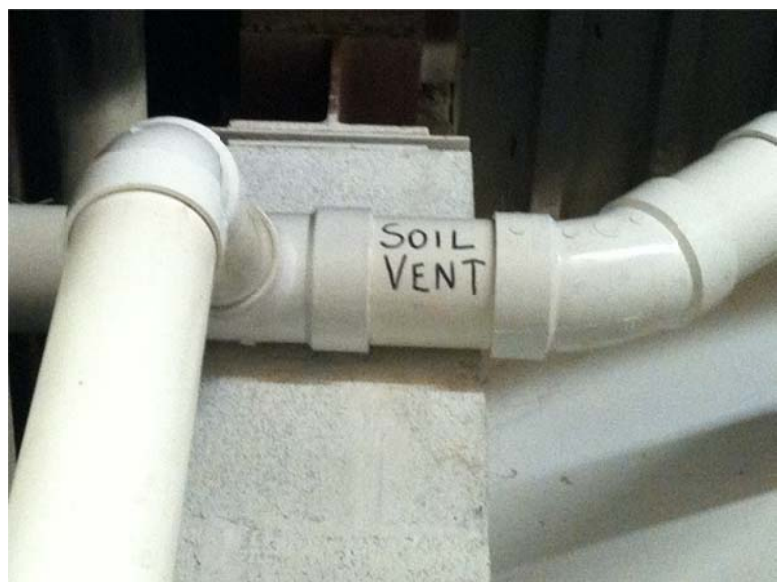
Photograph 24

View of the “soil vent” labeling above suction point #3 on the exhaust/vent line.

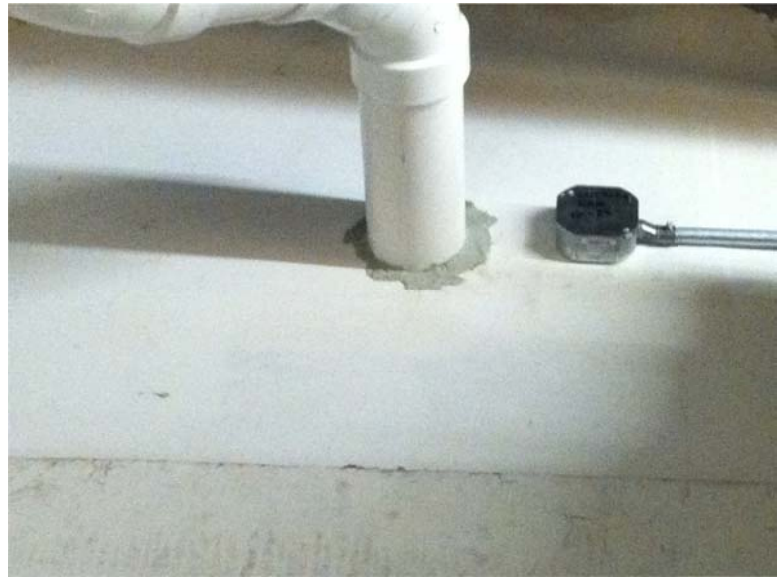
Photograph 25

View of the exhaust/vent line going through the exterior southwest wall after the sealant was applied. The electrical box to the right is for the system's exhaust fan.

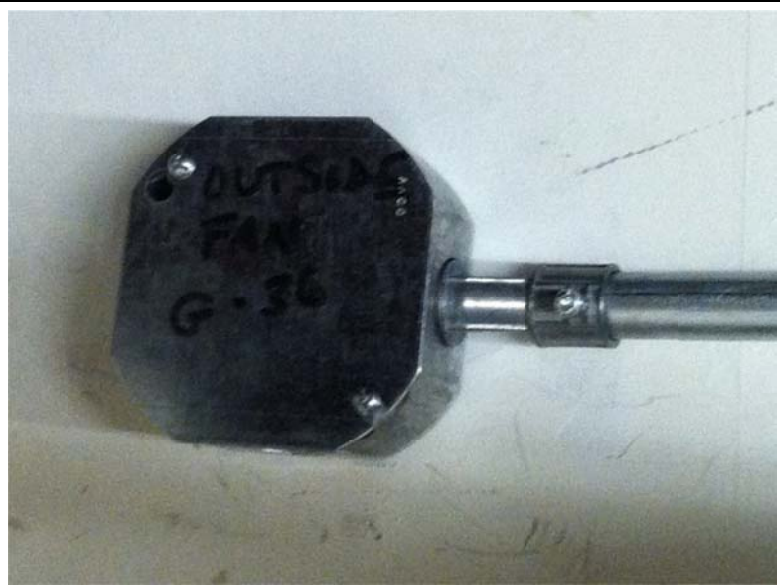
Photograph 26

Close up view of the front of the box cover shown in Photograph 25 which has been labeled "outside fan G-36", which indicates the electrical panel and circuit number.

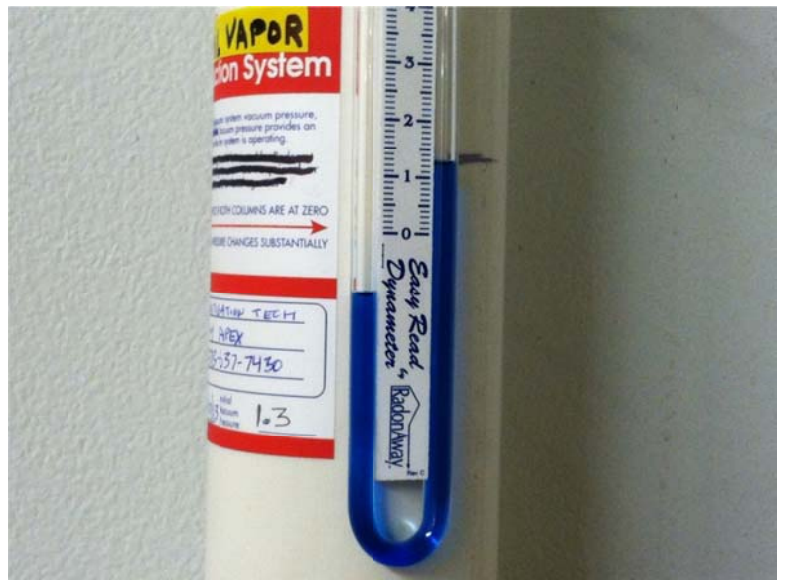
Photograph 29

View of the system gauge on the riser at suction point #3. Note the label is only temporary and will be replaced.
