Re: Sub-Slab Depressurization System Installation Report
Southside Plaza
704-744 Foote Avenue
Jamestown, New York 14701

Apex Companies, LLC (Apex) is pleased to provide Southside Station Inc. with this report documenting the installation of the sub-slab depressurization system (SSDS) at Southside Plaza, 704-744 Foote Avenue, Jamestown, New York (Site).

**Sub-Slab Depressurization System
Construction Completion Report**

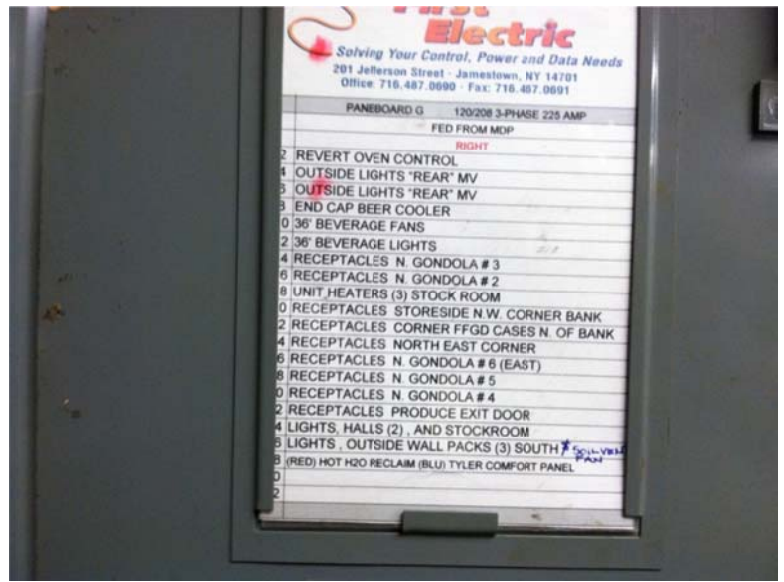
Photograph 31

View of the circuit label inside panel “G” showing that “soil vent fan” was added for circuit #36.

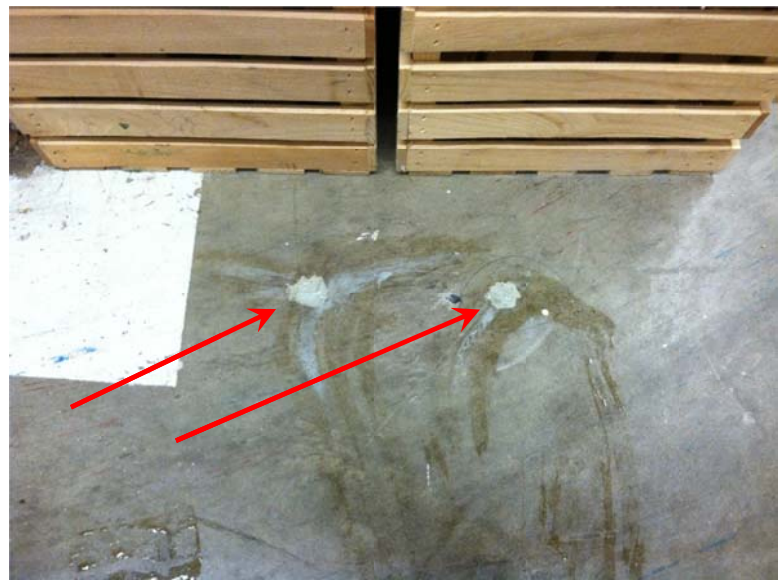
Photograph 32

View of the sealant applied the test hole #1 (including the initial hole that hit refusal).

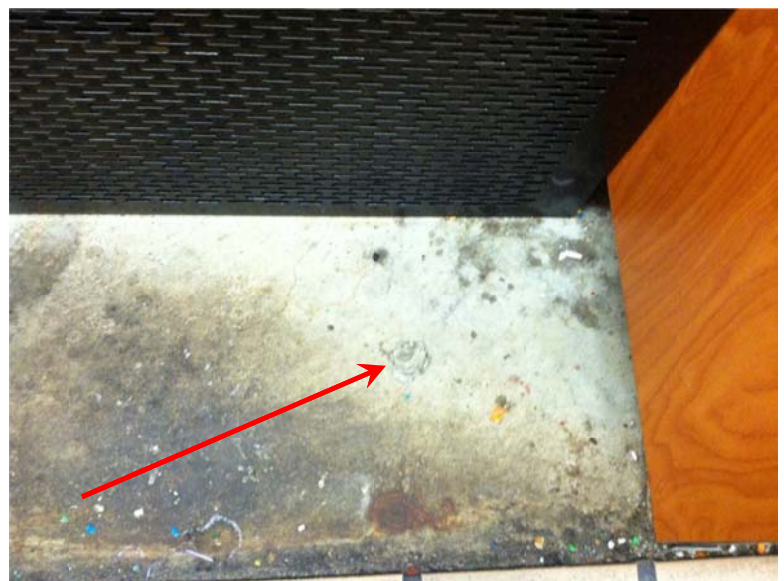
Photograph 33

View of the sealant applied to test hole #2.

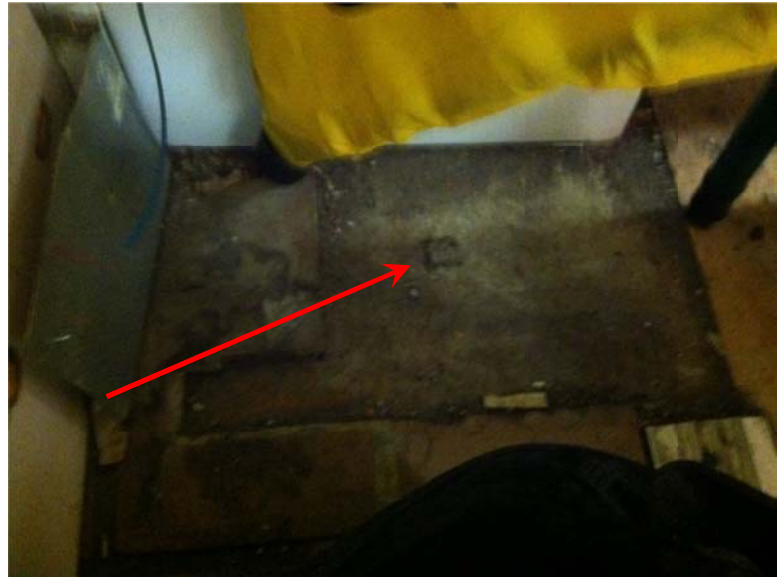
Photograph 34

View of the sealant applied to test hole #3.

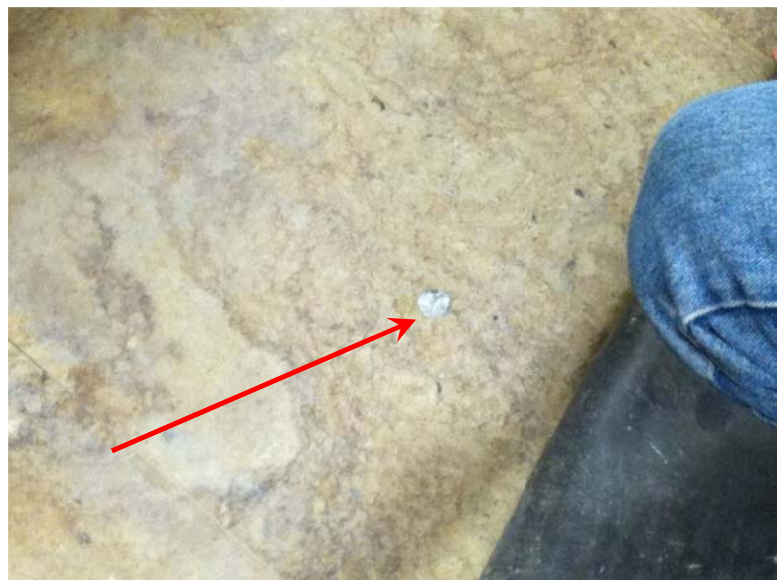
Photograph 35

View of the sealant applied to test hole #4.
