# **STORM-WATER COLLECTION SYSTEM INVESTIGATION REPORT**

**Buffalo Terminal  
Buffalo, New York**

**March 28, 2002**

**ROUX ASSOCIATES, INC.**  
1377 Motor Parkway  
Islandia, New York 11749

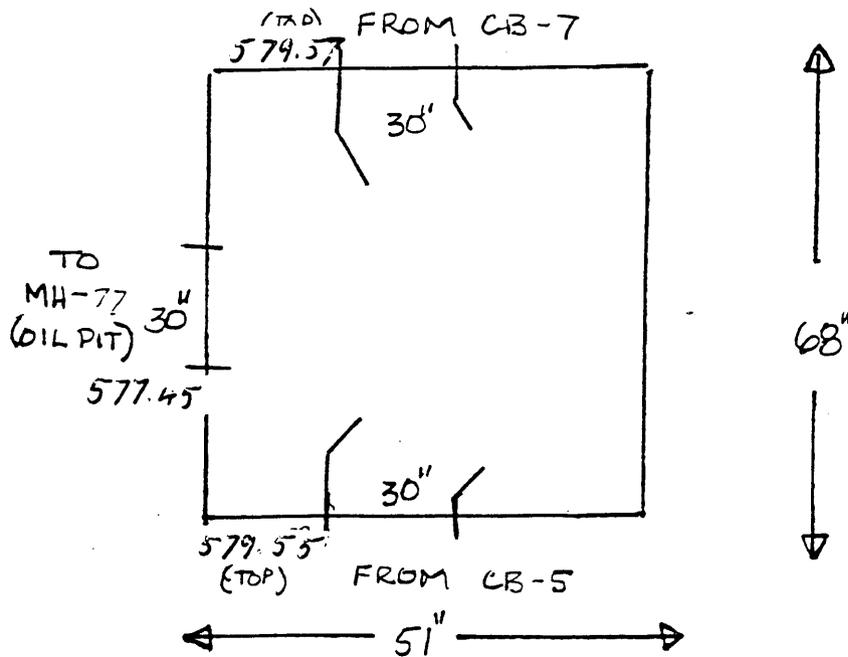
### Structure # CB-6

- NOTES: BC 9/29/00
- BRICK CONSTRUCTION
  - HEAVY OIL PRODUCT
  - W 30" TO MH-76
  - STEEL PLATE COVER
  - PRODUCT/WATER 1500 GALLS

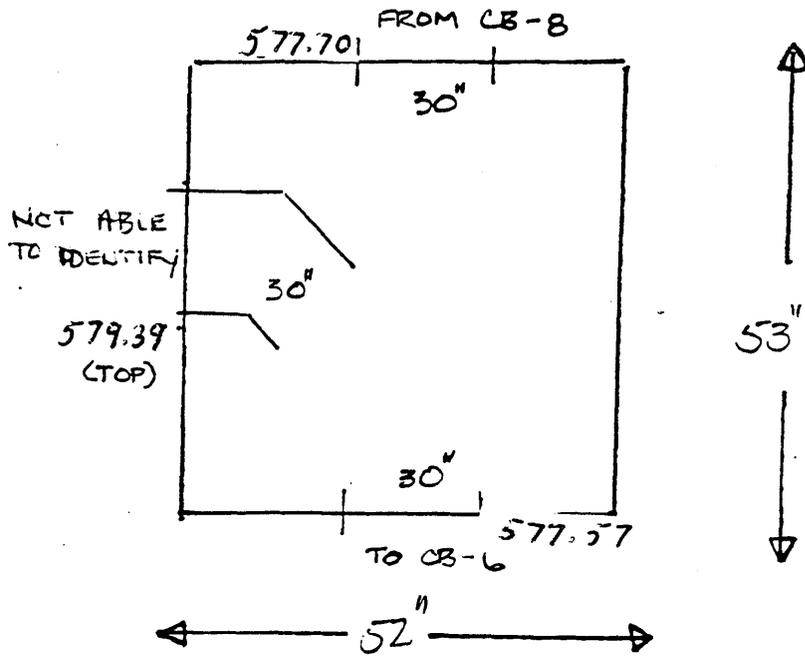
### Structure # CB-7

- NOTES: BC 9/29/00
- BRICK CONSTRUCTION
- HEAVY OIL PRODUCT
- STEEL PLATE COVER
- CLAY LINES
- 30" W LINE BEVELLED
- PRODUCT / WATER  
15 LOCATIONS

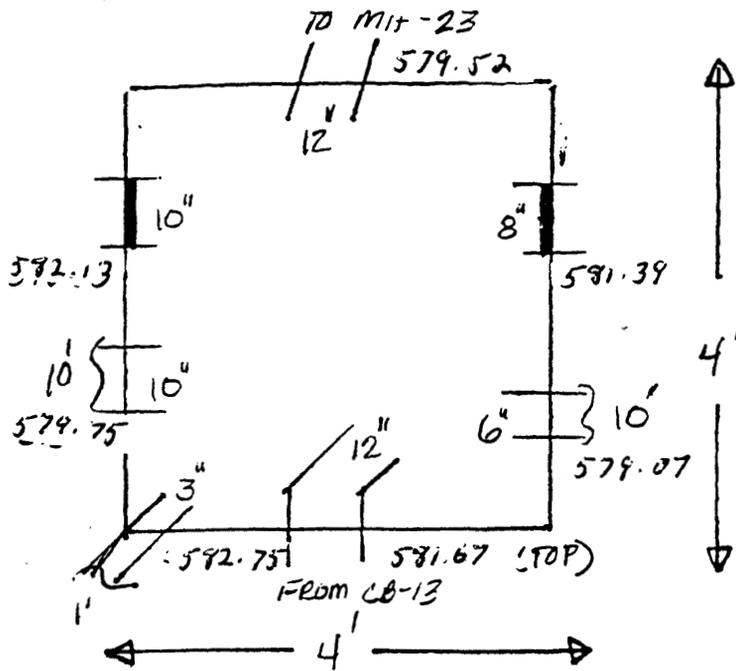
Structure # CB-14

- Notes: BC 9/25/00
- CONCRETE CONSTRUCTION
  - BOTTOM STRUCTURE CORRODED ON SIDES
  - FULL OF RAW WATER
  - STEEL COVER
  - 8" LINE STEEL
  - ALL OTHER LINES CLAY
  - 8" AND 10" CEMENTED
- Rim Elevation: 584.32

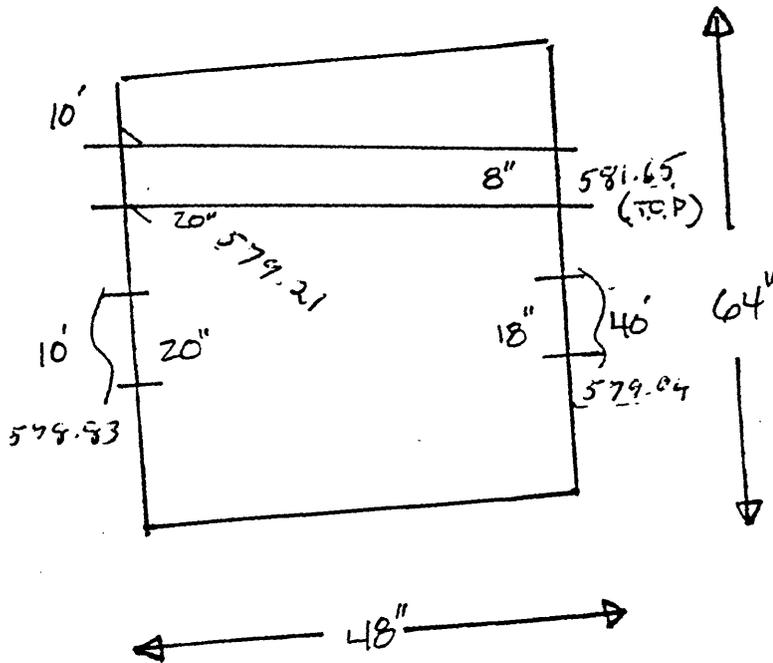
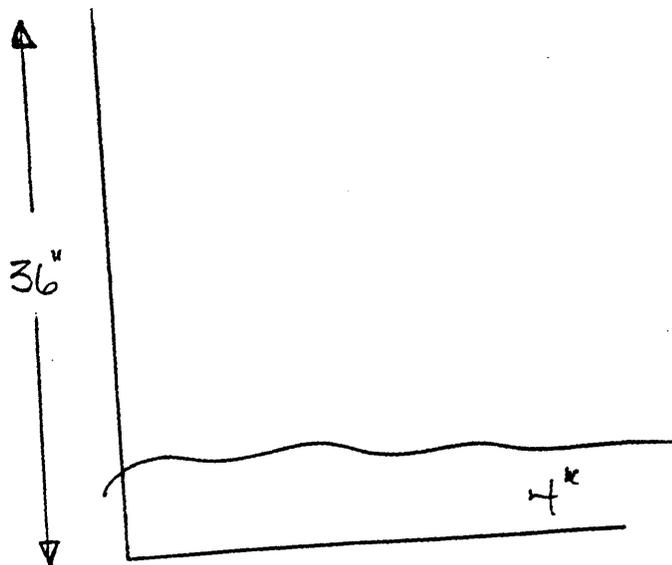
Structure # CB-15

Notes: BE 7/24/00  
Brick Construction  
Slow flow N/W  
very little product  
poor condition on top edges  
- Pipeline runs on top of CC

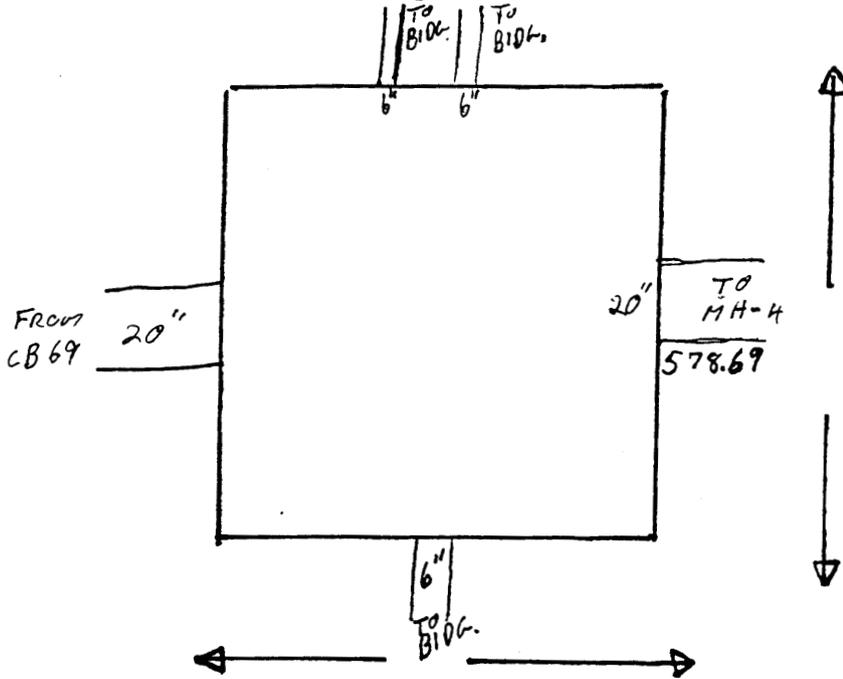
Structure # CB 70

CATCH BASIN  
 20" Line TO MH-4 HAS  
 3" VALVE CEMENTED IN  
 CENTER VALVE CLOSED.  
 VALVE REMOVED 9/30/00  
 ALLOWING FLOW TO MH-4

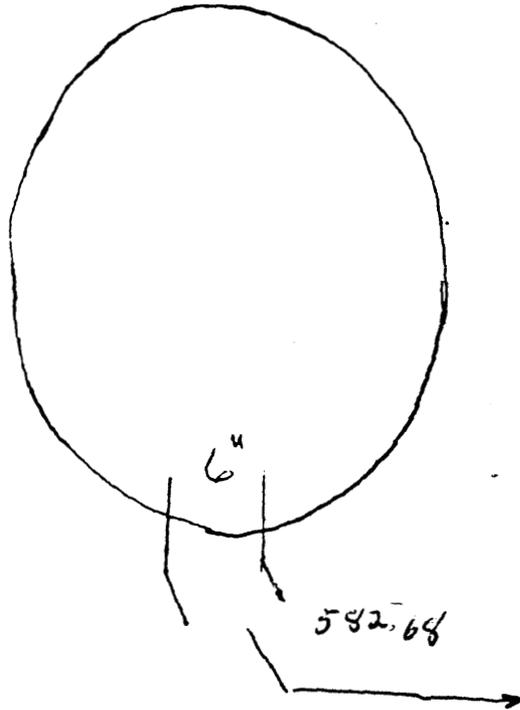
Structure # CB-77

- Notes: BC 9/29/01
- STEEL COVER
  - IN PARKING LOT
  - BRICK CONSTRUCTION
  - POOR SHAPE
  - WATER FLOW INCOMING FROM MISSING BRICKS
  - CLAY PIPE

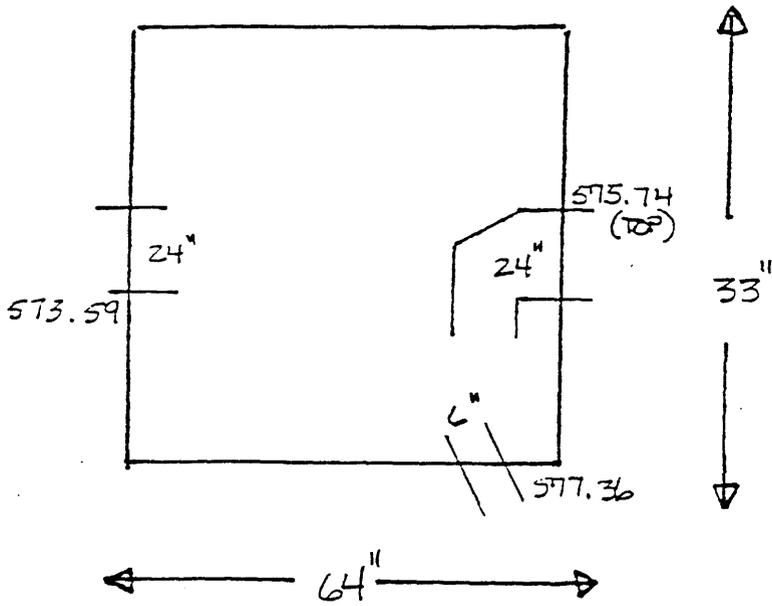
Structure # MH-22

- NOTES: BC 9/23/00
- CONCRETE / BRICK CONSTRUCT
  - FUEL OIL USABLE
  - SOME BRICKS MISSING IN STRUCTURE
  - PRODUCT FLOW FROM EAST BY TANK 75
  - CLAY LINES
  - STEEL PLATE COVER
- Rim Elevation: 585.44

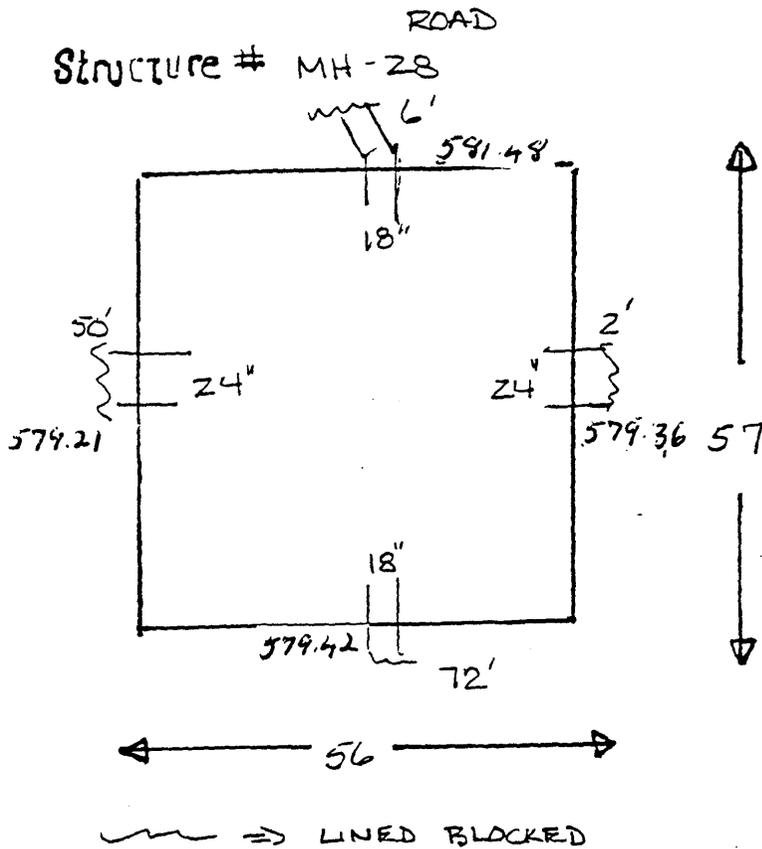
- NOTES: BE 9/13/00
- POOR CONDITION
  - BRICK CONSTRUCTION
  - SOUTH WALL COLLAPSING
  - N/W WALL COLLAPSING
  - 18" W / LINE 6' BLOCKED
  - 18" E / LINE 72' BLOCKED
  - 24" N / LINE 2' BLOCKED
  - 24" S / LINE 50' BLOCKED
- Rim Elevation. 595.92

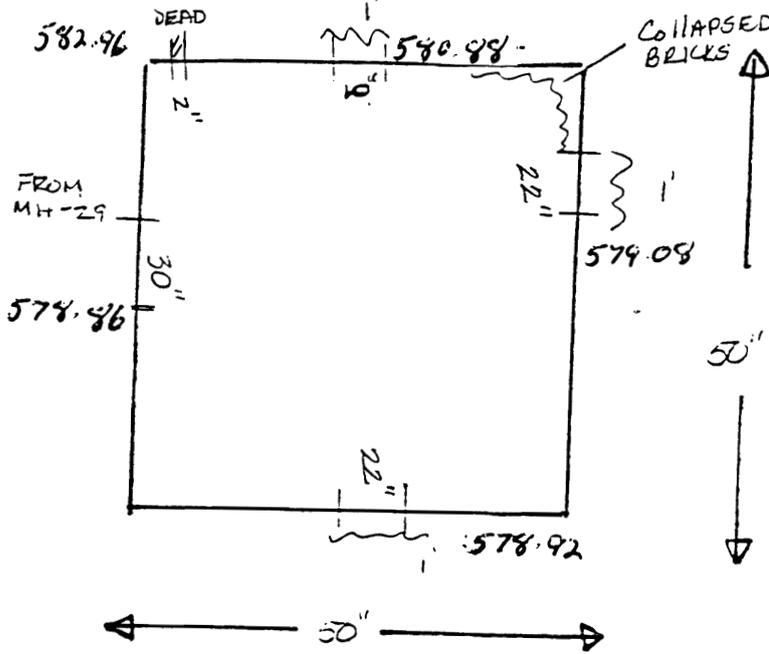
Structure # MH-30

- NOTES: BC 9/12/00
- BRICK CONSTRUCTION
  - 12" SLUDGE
  - L<sup>U</sup> REMAINING
  - N/E WALLS, BRICKS MISSING
  - 2" LINE DEAD AT WALL
  - 10" LINE BLOCKED 1' OUT
  - 22" LINES BLOCKED 1' OUT
- Rim Elevation: 575.91

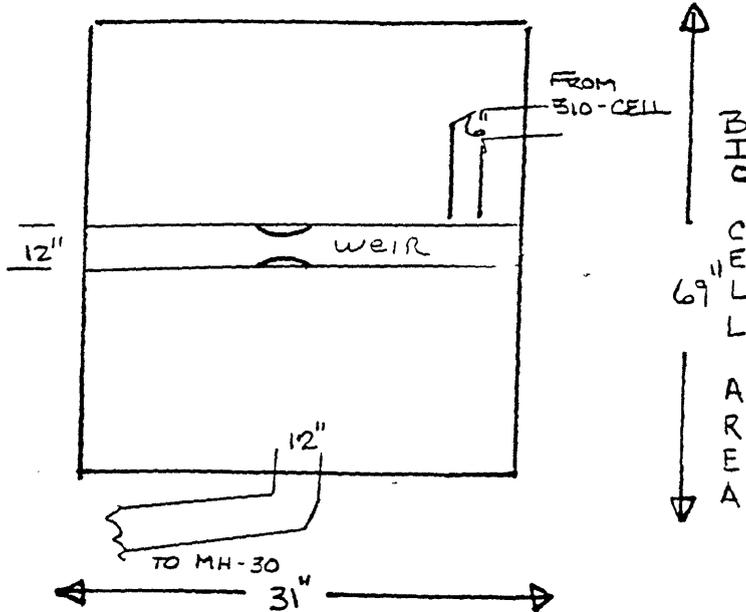
Structure # MH-31

- Notes: BC 1/1/00
- FORMED CONCRETE CONSTRUCT
  - 12" THICK WEIR IN MIDDLE OF MH W/ 12" PIPE.
  - SEVERAL CRACKS W/ W. FLOWING IN.
  - 6" STEEL PIPE
  - 12" CLAY PIPE
  - ABUTS BIO-CELL
- Rim Elevation. 580.32

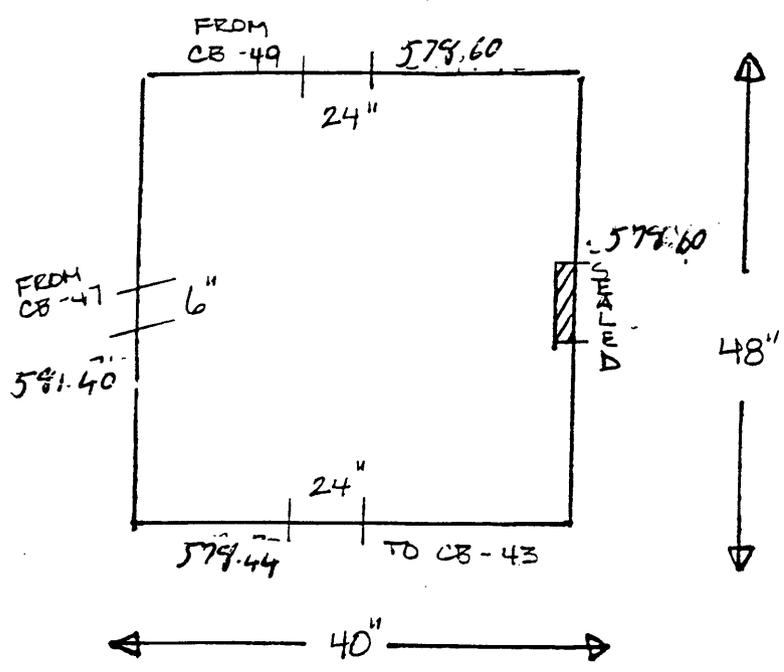
Structure # MH-34

- BRICK CONSTRUCTION
- WATER ENTERING FROM OUTSIDE OF EFFLUENT PIPE
- 12" DEBRIS REMOVED
- CLAY LINES

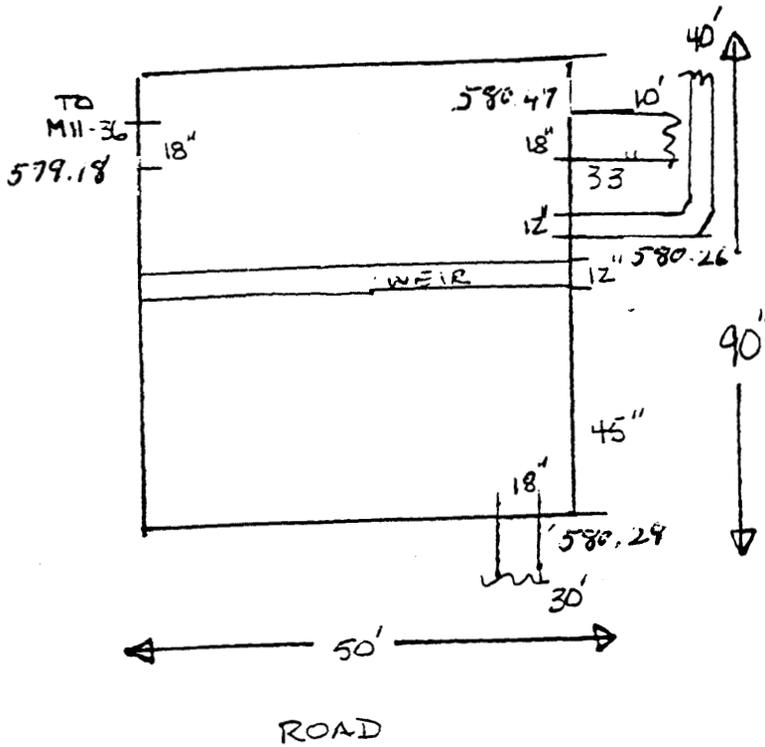
Structure # MH-35

- Notes: BC 9/14/00
- BRICK CONSTRUCTION W/ 15" CONCRETE RISER.
  - STEEL PLATE COVER
  - HEAVY PRODUCT STAINING
  - CLAY PIPES

Product: HEAVY PRODUCT  
STAINING. 2" PRODUCT  
REMOVED

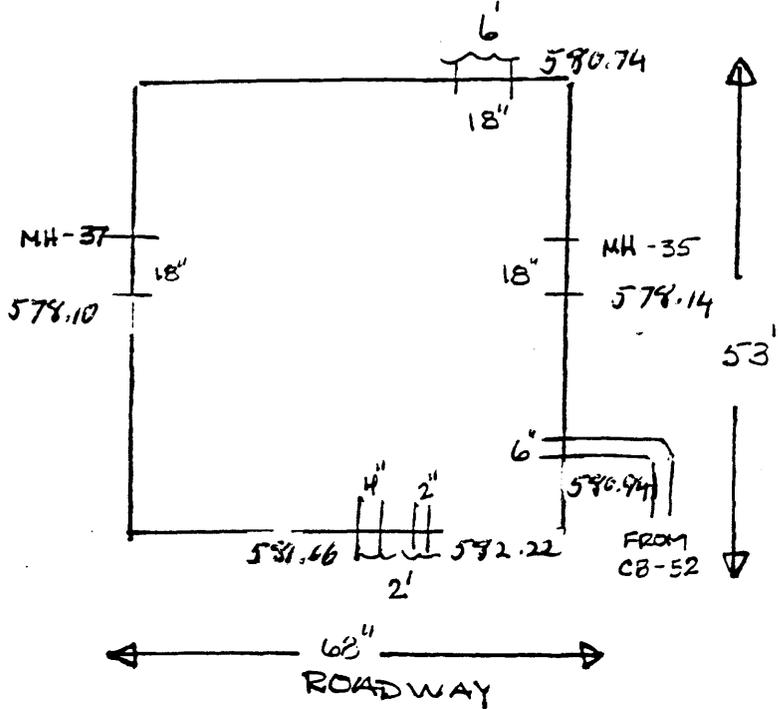
Structure # MH-36

- Notes: BC 9/18/00
- BRICK CONSTRUCTION W/ 20' CONCRETE RISER.
  - HEAVY OILY SLUDGE.
  - STEEL PLATE COVER
  - ASPHALT ROADWAY

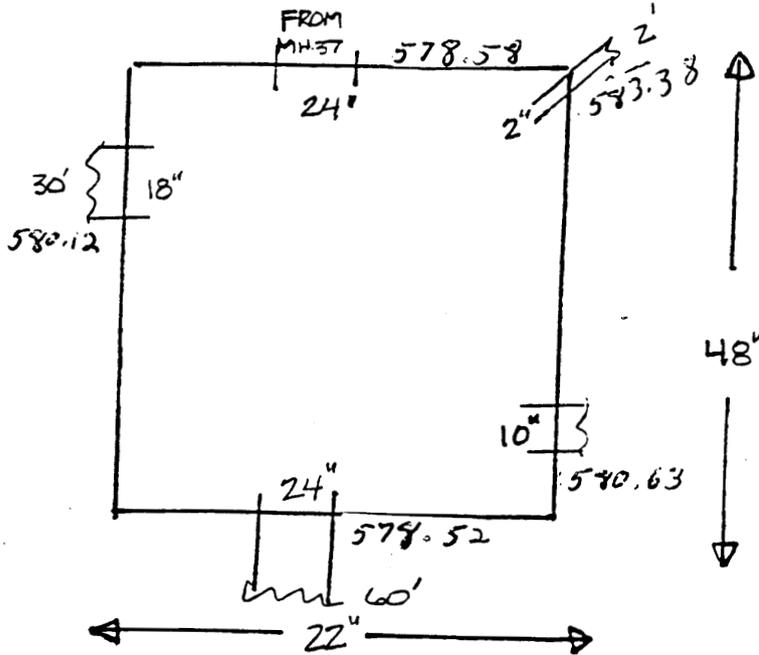
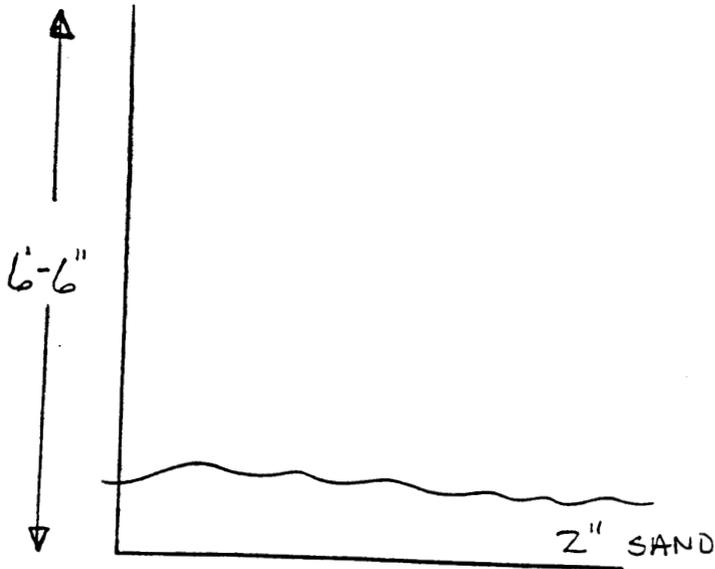
Structure # MH-39

- NOTES: BC 9/19/20
- FORMED CONCRETE
  - HEAVY OIL STAIN
  - 10" LINE HAS 2" LINE SEALED INSIDE.
  - 2" LINE STOPPED 1' OUT
  - 18" WEST LINE OUT 30' TO POSSIBLE BURIED TANK
  - CLAY LINES STRUCTURE
  - RISE Elevation: 585.02

Product: HEAVY PRODUCT STAINING 3" LAYER REMOVED

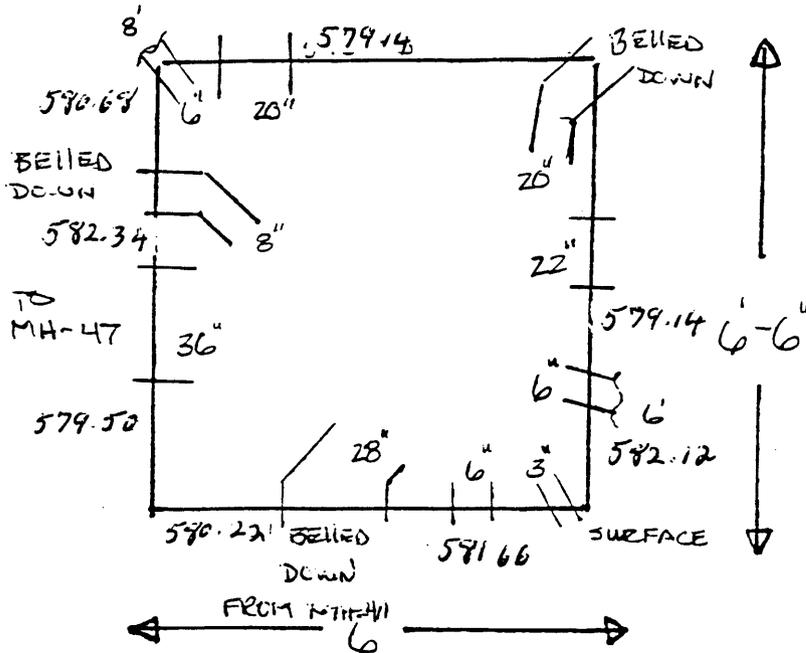
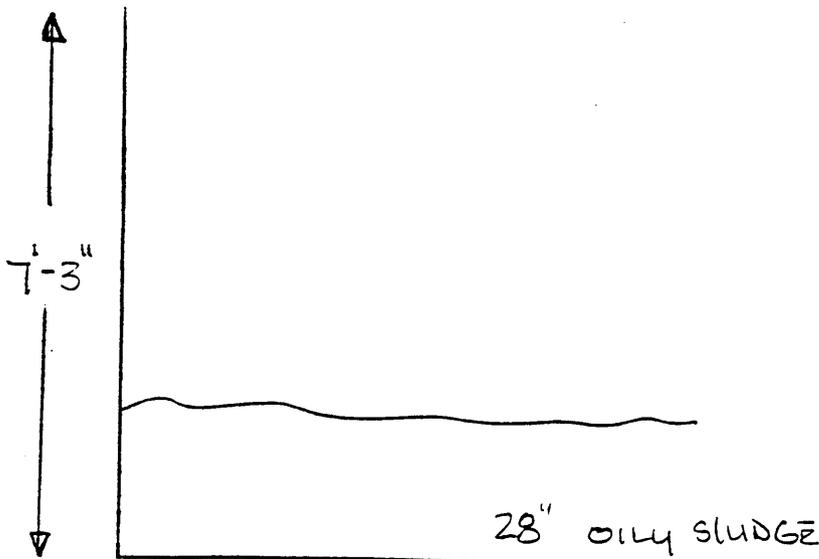
Structure # MH-40

- NOTES: 08/21/05
- CONCRETE RISER
  - BRICK CONSTRUCTION IN POOR SHAPE
  - VISIBLE FLOW w/ff
  - ALL PIPE 1/2 FULL
  - CURBING BROKEN
  - N/W LINE STEEL
  - CLAY LINES
- Rim Elevation: 584.98

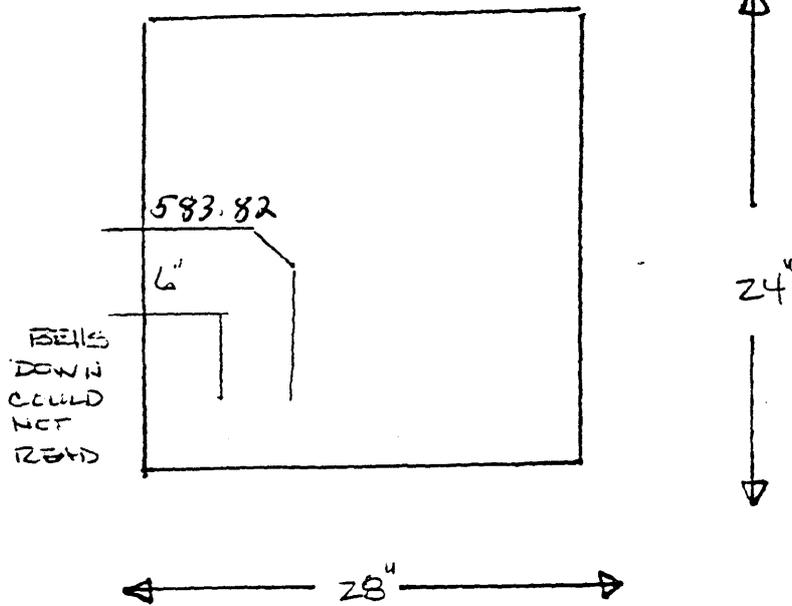
Structure # MH-43

- Notes: BC 7/21/00
- CONCRETE CONSTRUCTION
  - POOR CONDITION
  - WEED COVERED
  - STEEL PLATE COVER

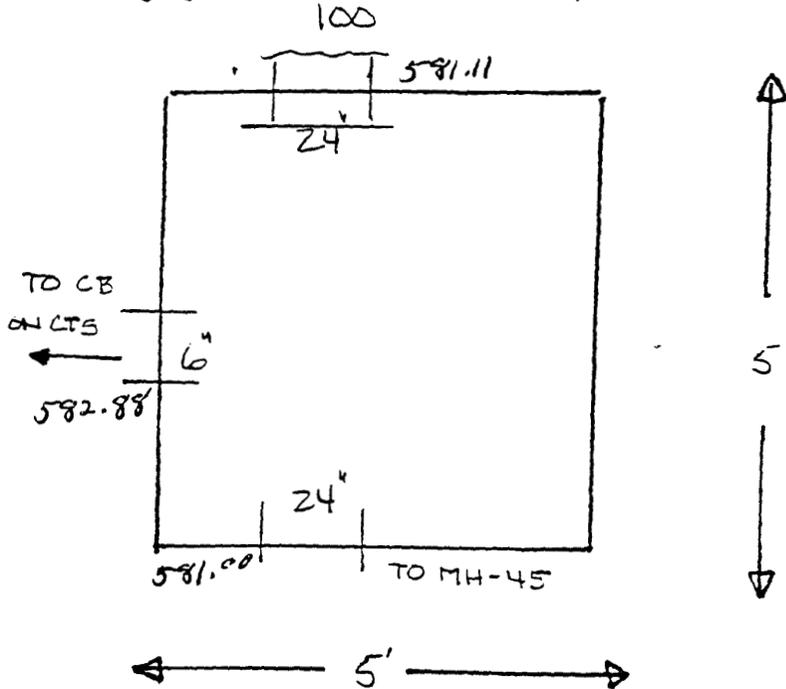
Structure # 100, MH-46

- Notes: BC 9/12/02
- CONCRETE / BRICK CONSTRUCTION
  - 2/3 FULL SILT / SAND
  - FENCE ON WEST SIDE
  - NORTH LINE 100' I OUT STOPPED
  - STEEL PLATE COVER
  - 3' WEST 6" LINE TO CB
- Rim Elevation: 586.60

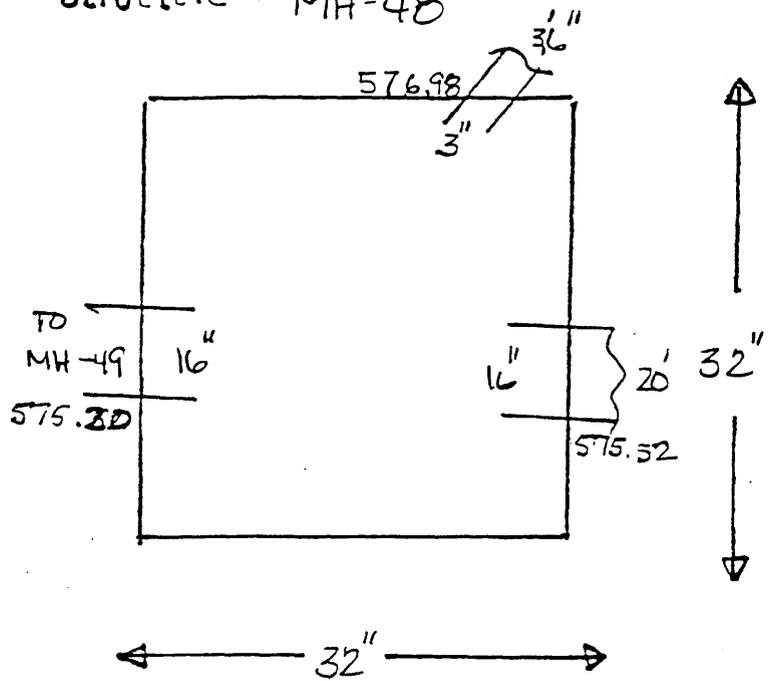
Structure # MH-48

- NOTES: BC 9/26/00
- BRICK CONSTRUCTION
  - CONCRETE RISER
  - 3" LINE STEEL, PLUGGED
  - STEEL PLATE COVER
  - POOR SHAPE
  - JOINTS SEPERATED
  - GROUNDWATER INFILTRATED
  - CONCRETE DEBRIS
  - CLAY LINES
- Rim Elevation: 585.44

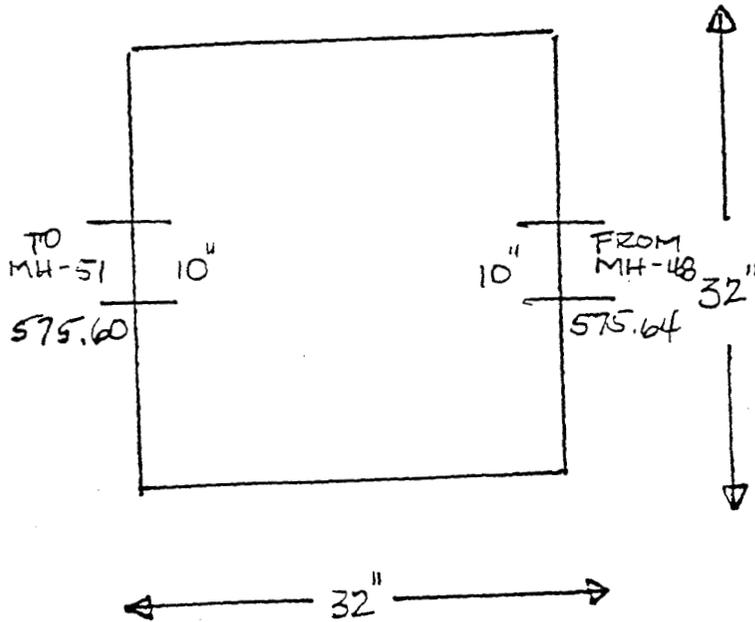
Structure # MH-49

- NOTES: BC 9/26/00
- BRICK CONSTRUCTION
  - CONCRETE RISER
  - STEEL PLATE COVER
  - CONCRETE DEBRIS
  - GROUNDWATER INFILTRATED
  - CLAY LINES

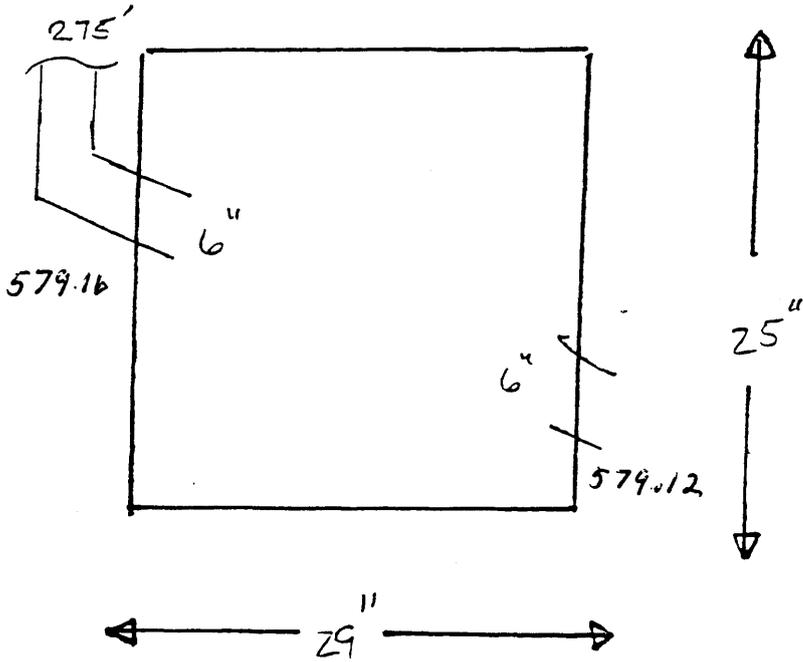
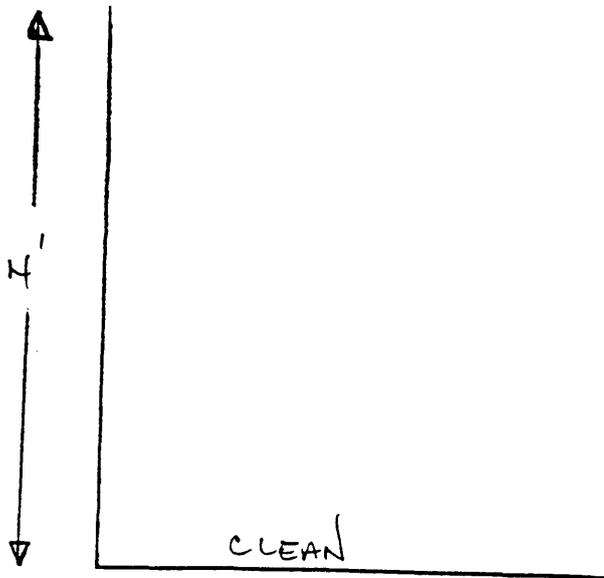
Structure # M475

Notes: BE 10/1/00  
formed concrete conc  
poor condition  
stone/dirt cover  
clean no debris  
liquid only

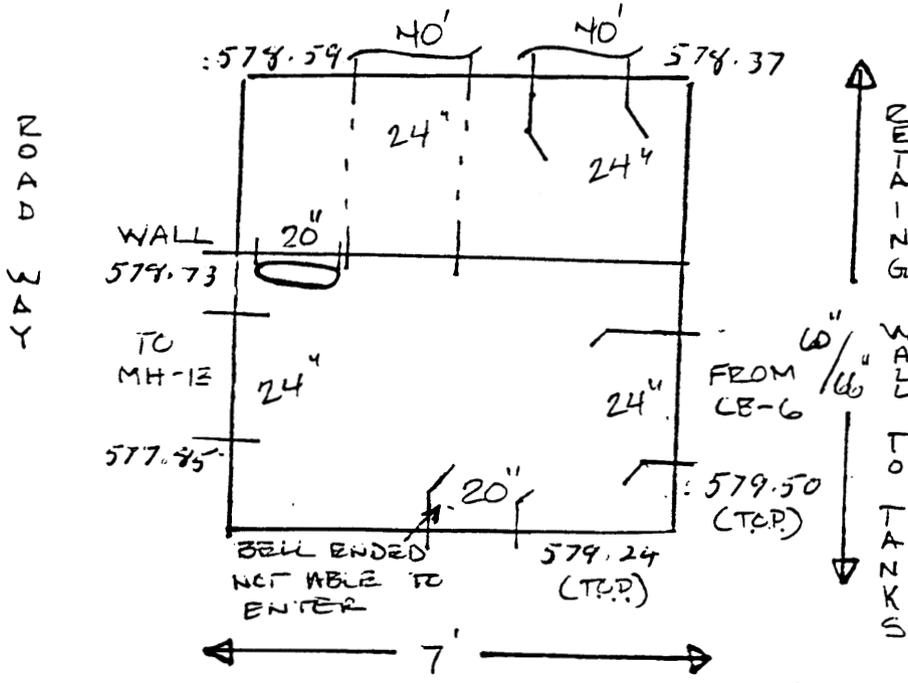
### Structure # Oil pit (MH-77)

Notes: BR 10/1/01  
Brick construction  
Heavy product stain

- POSSIBLE TRANSITE PIPING.
  - CAST PIPES
  - PRODUCT RECOVERED W/ WATER 1500 gallons
- Rim Elevation: 582.75  
Depth to Bottom: 84"
