**PHASE I
ENVIRONMENTAL SITE ASSESSMENT**

**Buffalo General Hospital
100 High Street
Buffalo, NY 14203**

**United States Department of Housing and Urban Development
26 Federal Plaza, Room 3200
New York, NY 10278-0068**

January 30, 2006

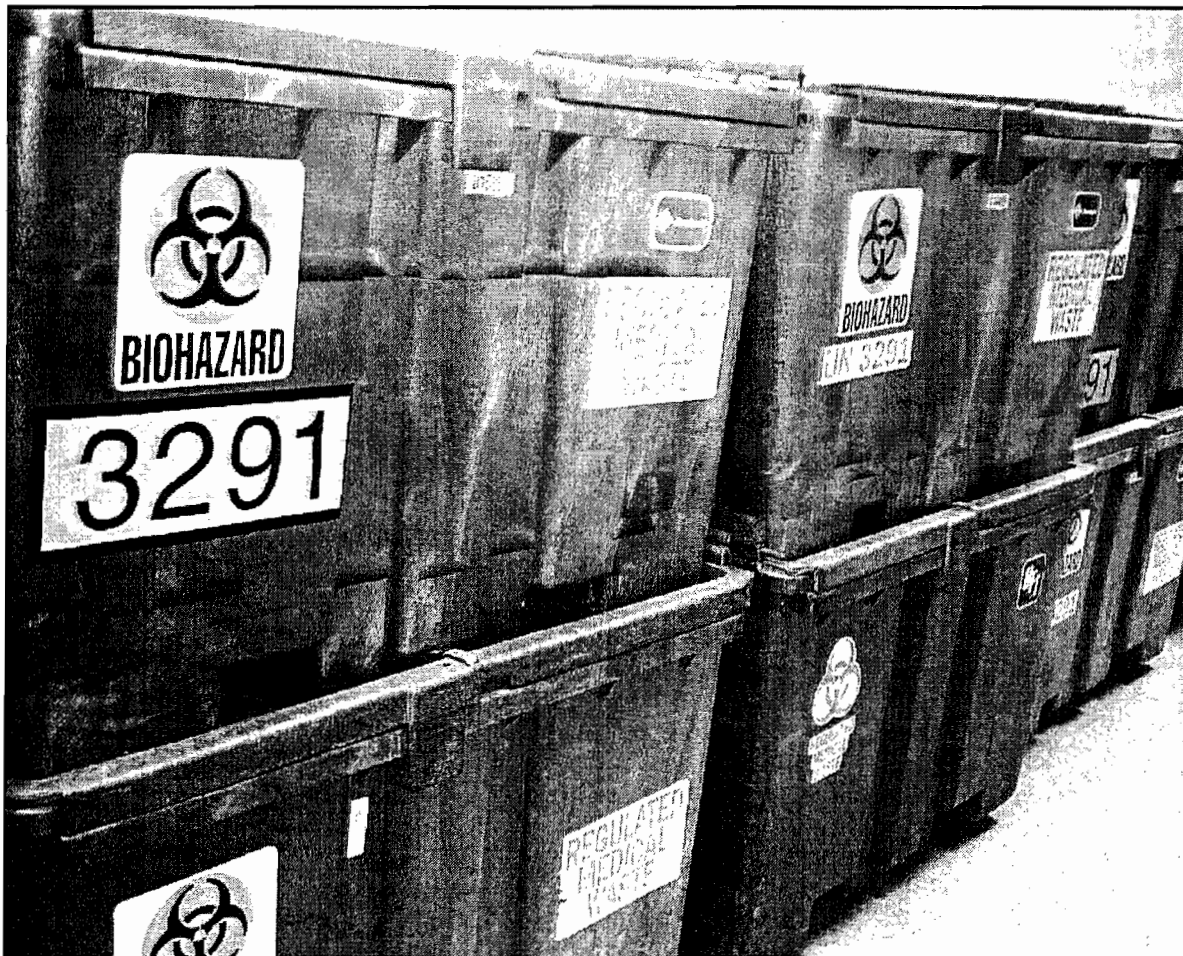
The clinical laboratories store and use various hazardous substances in scientific testing procedures. Since no evidence of leaks or spills was observed from the hazardous substance containers on the site and because the site is connected to the municipal sewer system, it is unlikely that these would pose an environmental concern.

16. Hazardous waste containers

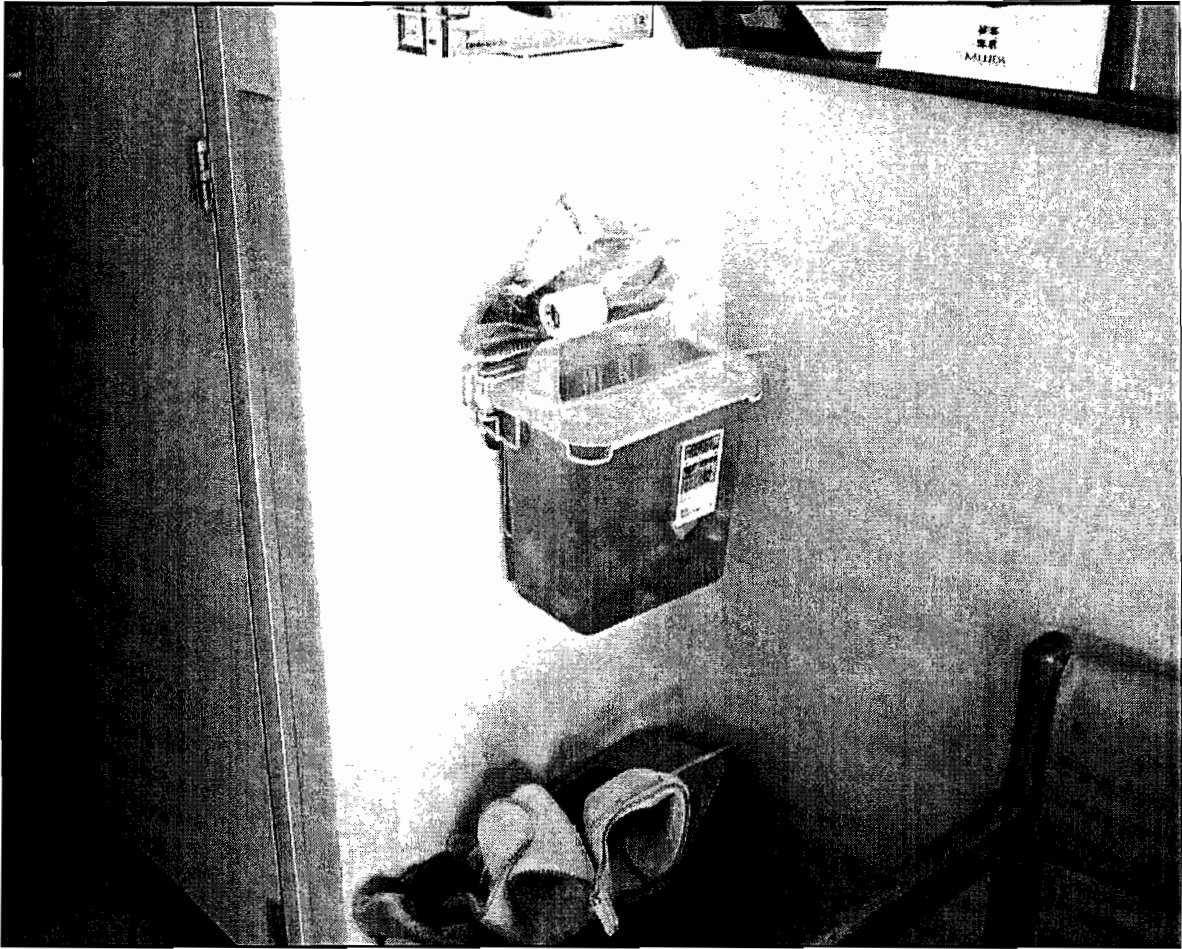
17. Medical and regular waste containers in a patient room

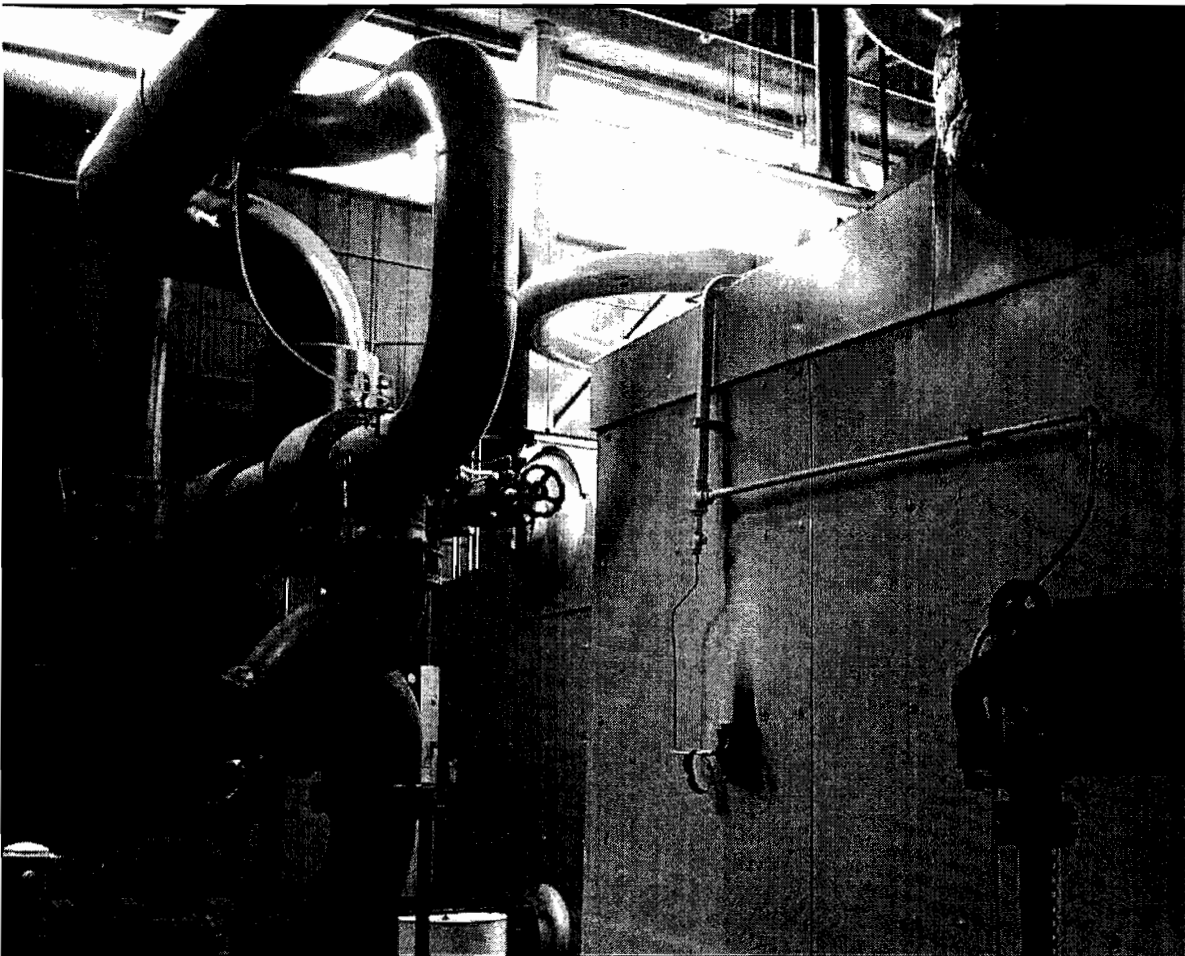
18. Boiler

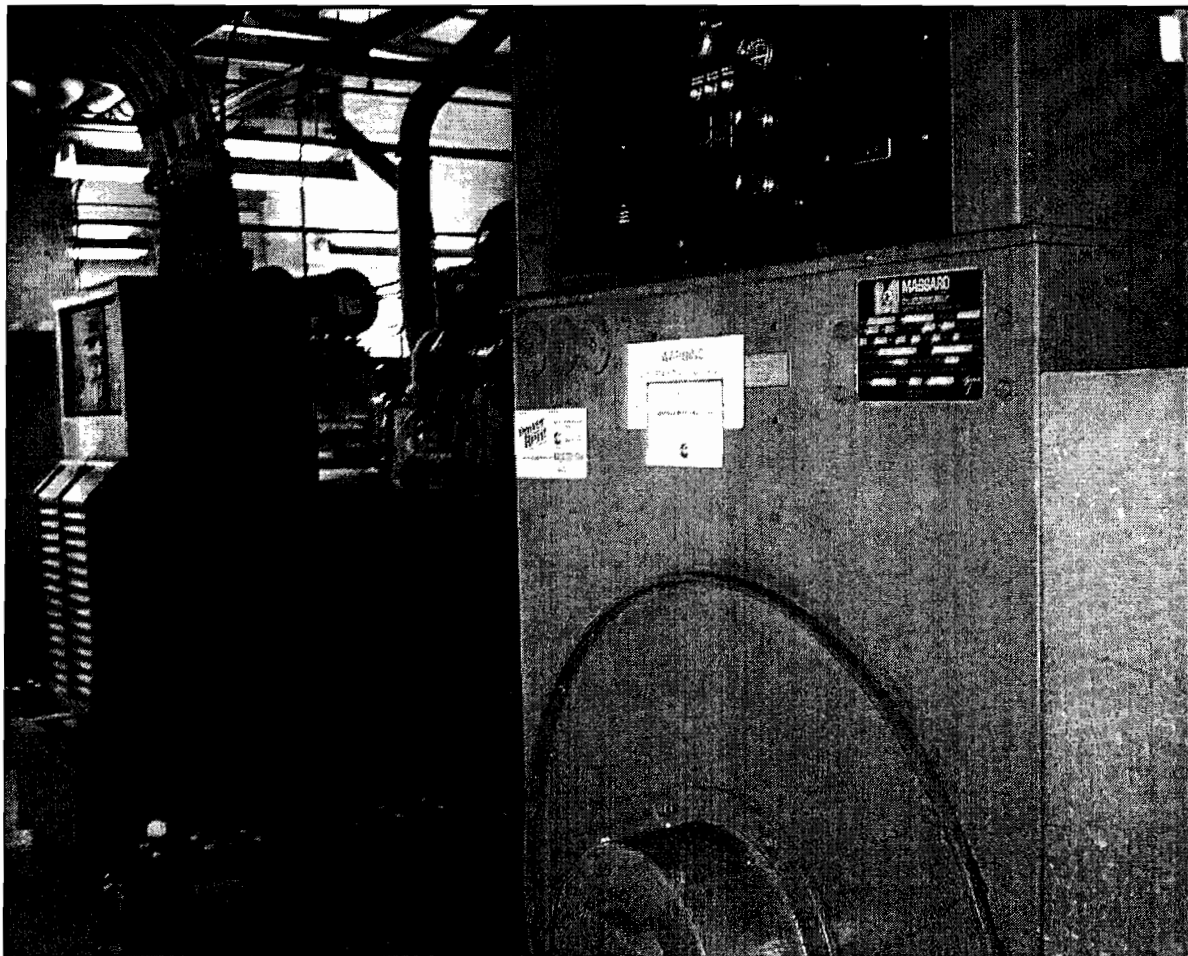
20. Generators

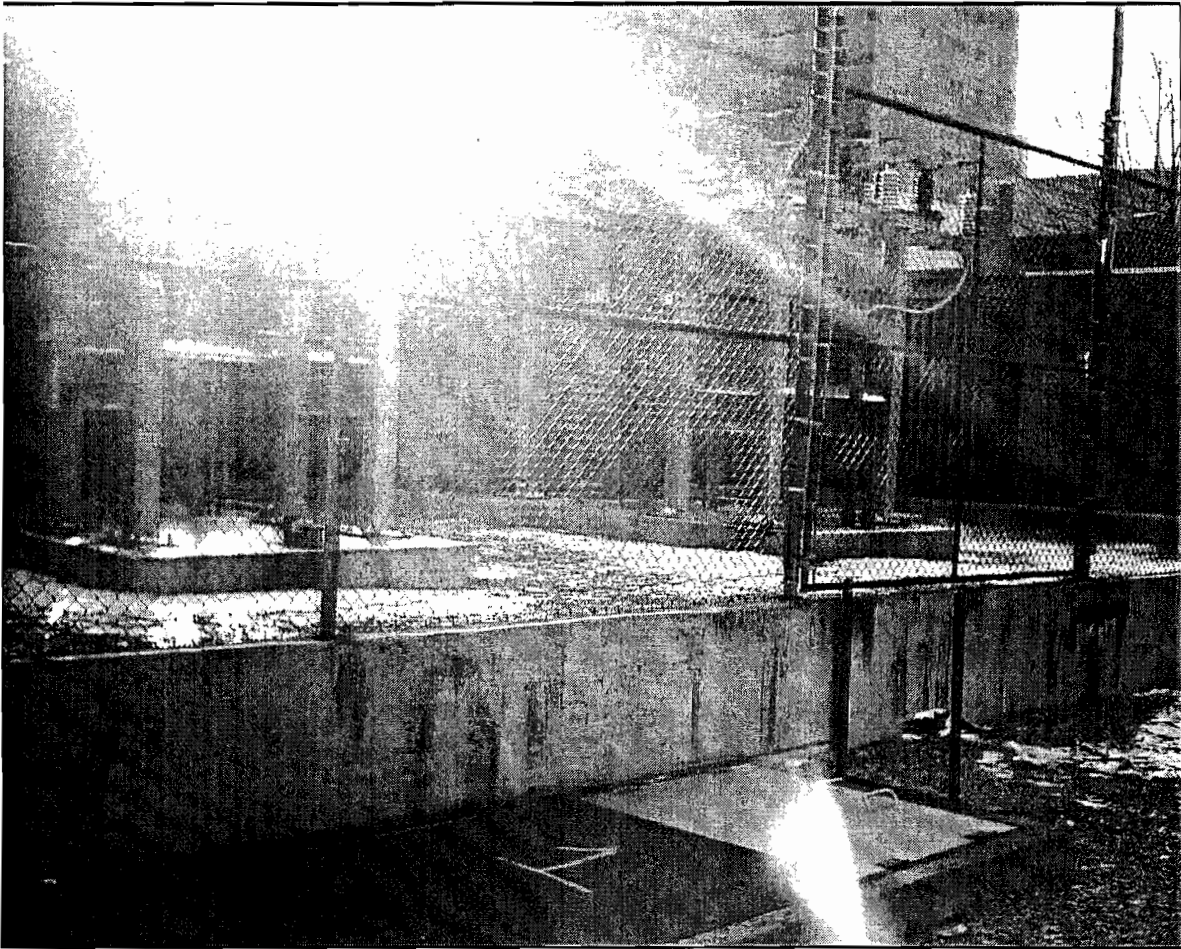
Suspect PCB-containing equipment, transformers which are located at north side of Goodrich Street was observed at the site. No leaking or spills from the transformers was observed during the site visit. The transformers are maintained by Buffalo General Hospital. Since the suspect PCB-containing equipment, transformer is properly maintained it would not pose an environmental concern.

21. Transformers and UST location
