PUMP TEST REPORT

FORMER MOBIL SERVICE STATION 99-MST - 979 MAIN STREET (1001 MAIN STREET) BROWNFIELD CLEANUP PROGRAM SITE NO. C9915260

CITY OF BUFFALO, ERIE COUNTY, NEW YORK

September 2016

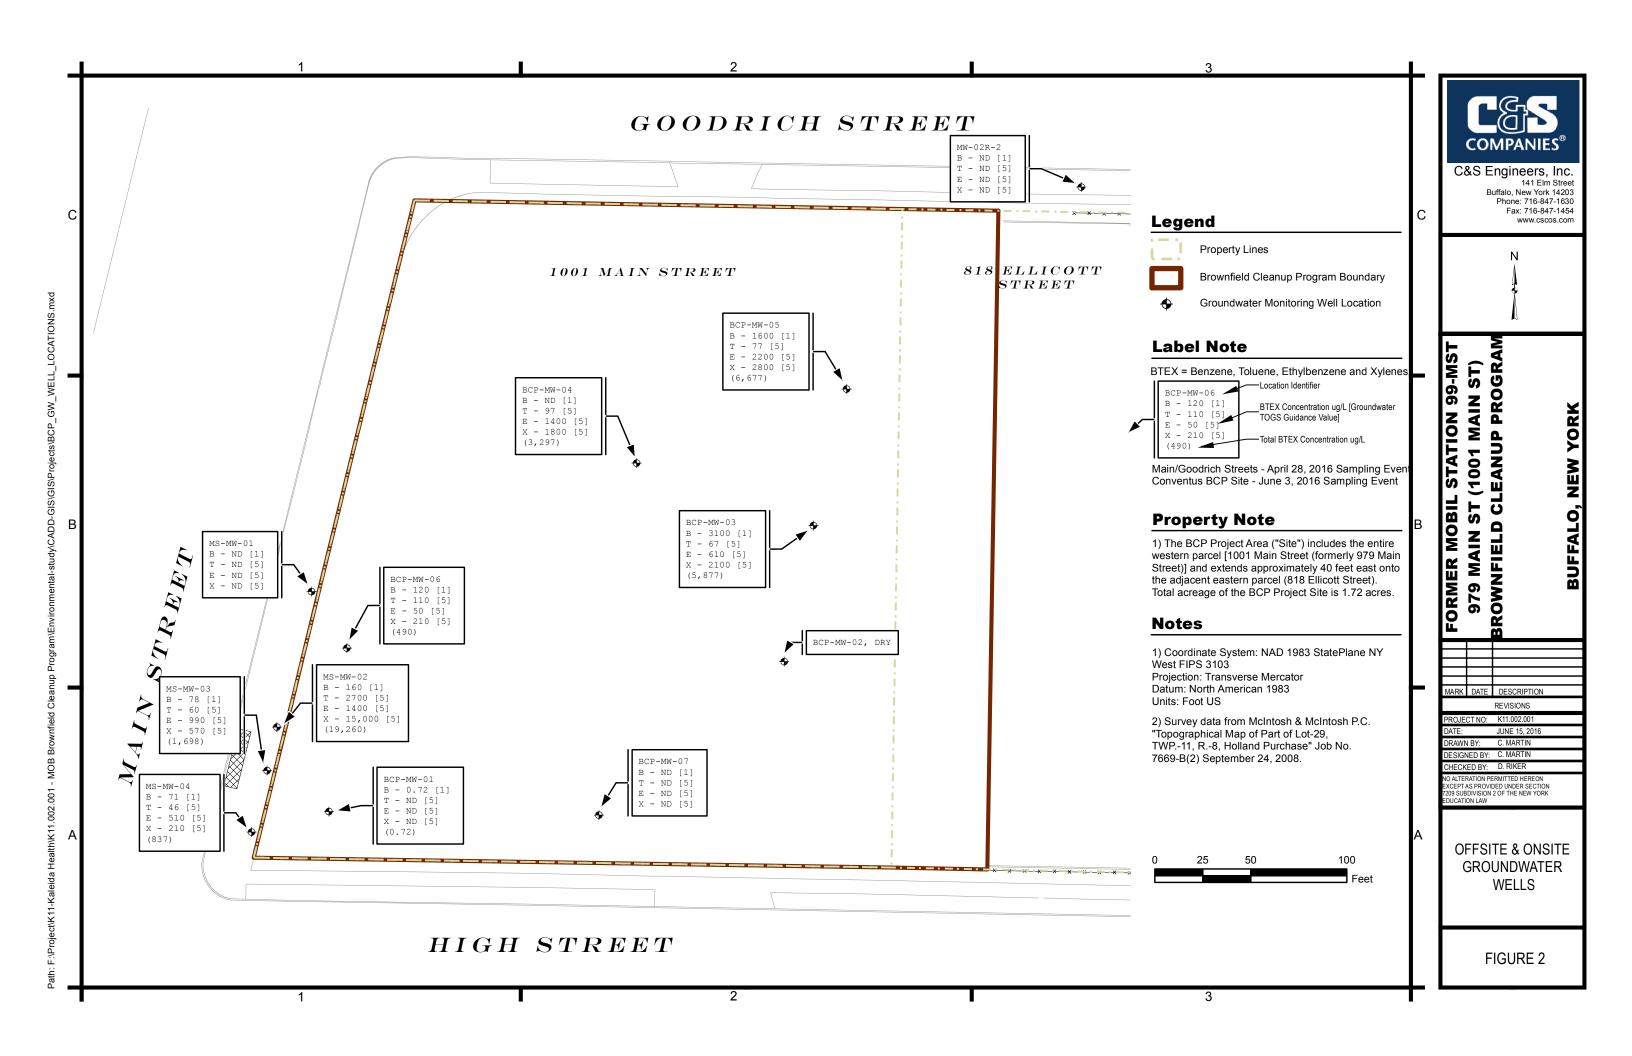
FIGURE 2 – GROUNDWATER WELL LOCATIONS

Figure 2 shows the well locations and Table 1 summarizes the analytical results generated for these wells since 2013. Graphs 2 and 3 also present the summarized results while Graphs 4 through 9 show the results for the individual wells. These results show that the contaminant concentrations have decreased in most wells to asymptotic levels (BCP-MW-3, BCP-MW5, BCP-MW6 and BCP-MW7) following removal of the source soils, generally remained the same in others (BCP-MW2 and increased in BCP-MW1 and BCP-MW4. These observations are discussed in greater detail at the end of this section.

These wells are also shown on Figure 2. C&S has been conducting periodic groundwater sampling events on these wells under the New York State Spills program for Kaleida Health. Attachment A provides a summary of remedial activities and groundwater monitoring for these offsite wells. Recent sampling has demonstrated that petroleum

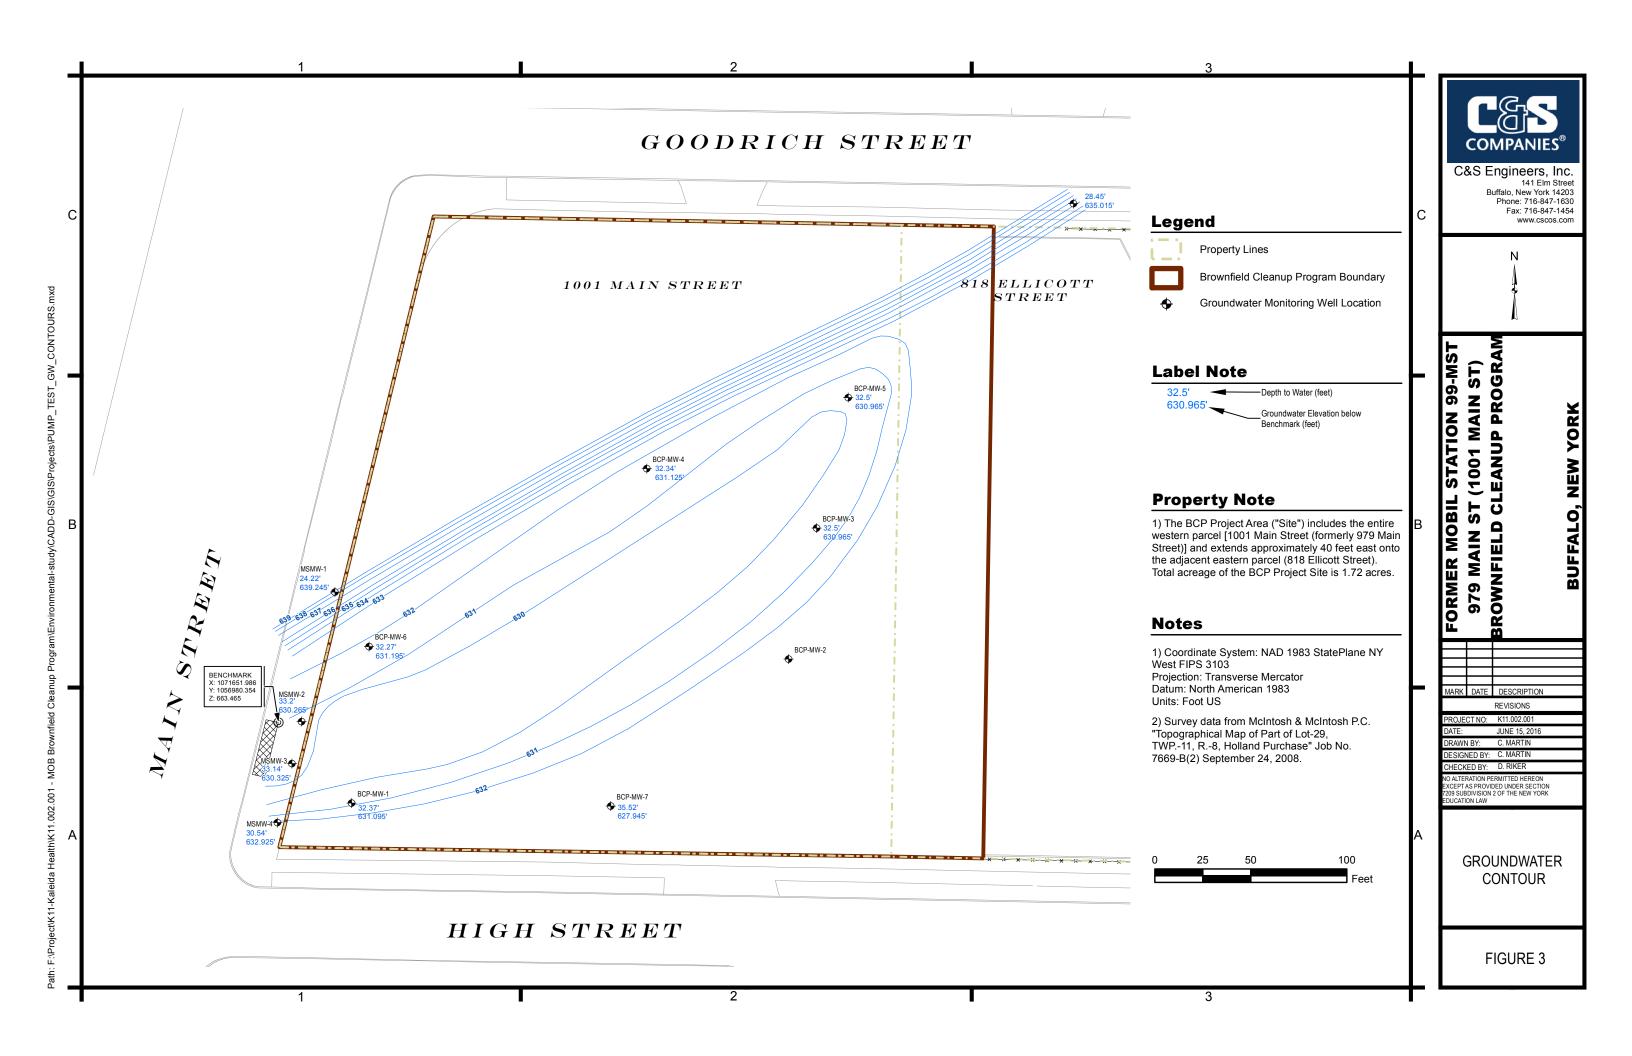
FIGURE 3 – GROUNDWATER CONTOURS

The June 18, 2016 water levels and inferred groundwater contours are shown on Figure 3. The groundwater contours suggest the following:

- Groundwater flow is generally limited to a slight gradient from the corner of Main and High Streets toward the Site, through the gap in the sheet piling discussed above. The elevations of MSMW-4 and BCP-MW1 demonstrate this gradient, as the elevation in MSMW-4 is almost two feet higher than the elevation in the BCP-MW1, which is approximately 40 feet away.

- The groundwater contours in the remainder of the Site suggest a general lack of flow, as gradients are generally towards the center of the Site. This result suggests that the sheet piling has been effective in eliminating hydraulic connection to areas outside the Site, with the exception of the southwestern corner, as discussed above.

- The sheet piling effectively eliminates hydraulic connection between MSMW-1 and the Site, as the contours appear be anomalous in this portion of Figure 3. Additionally, the significant gradient between MSMW-1 and BCP-MW6 (more than eight feet) adds further support to the lack of a hydraulic connection between MSMW-1 and the Site.

- Similarly, the sheet piling effectively eliminates hydraulic connection between MW-02R-2 and the Site, as the contours appear be anomalous in this portion of the Site. Additionally, the current gradient between MW-02R-2 and BCP-MW5 is actually to the southwest (towards the Site) rather than the northeast direction of groundwater flow prior to the installation of the sheet piling. The lack of detectable concentrations of contaminants in MW-02R-2 during recent sampling events, following remediation, also demonstrates the efficacy of the remedial efforts in this portion of the Site.

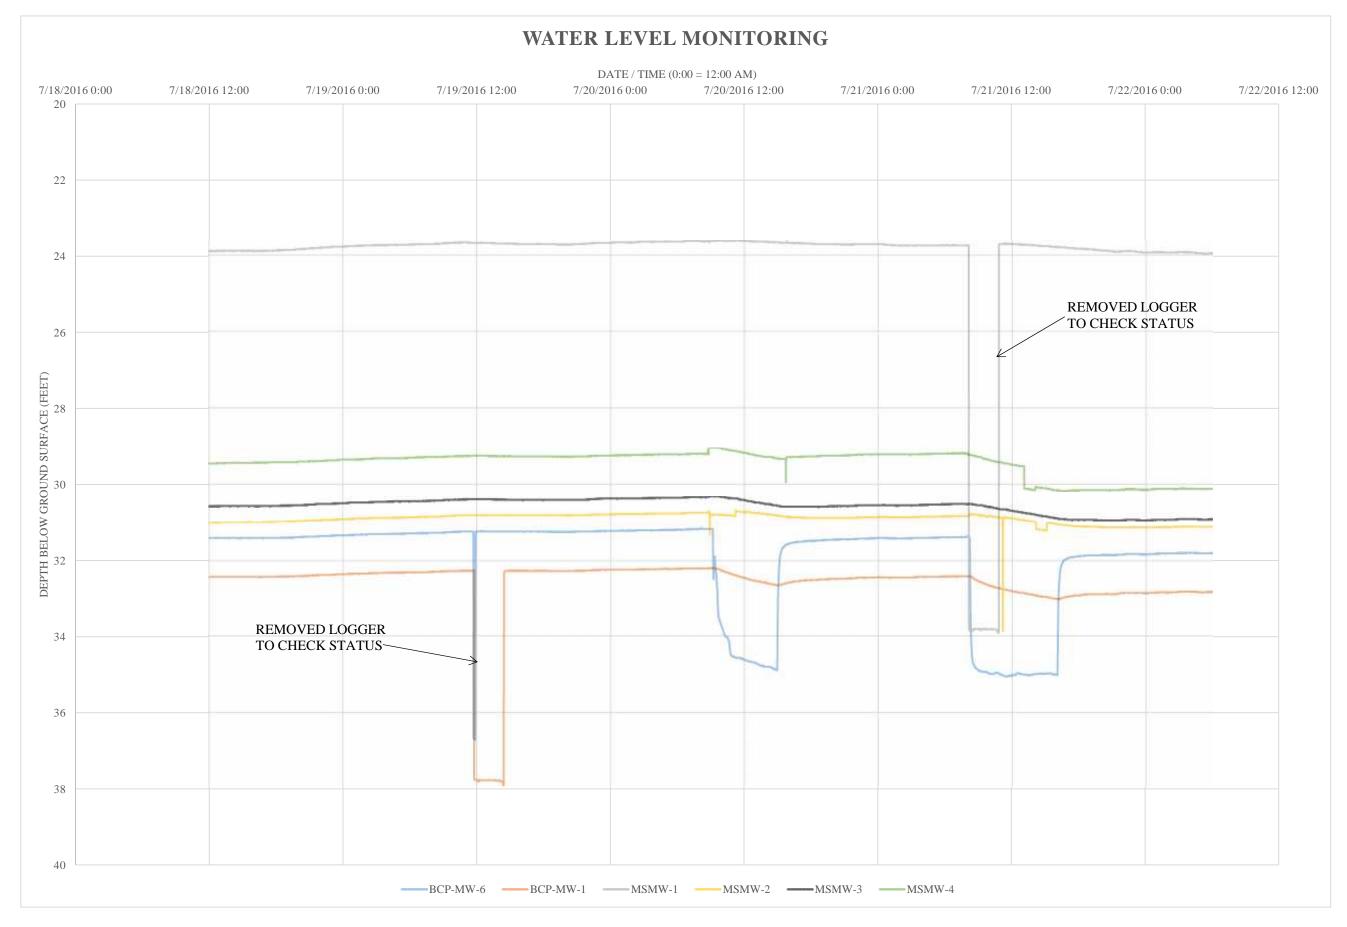
GRAPH 1 – WATER LEVEL MONITORING

The water level measurements in the wells with pressure transducers are shown in Figure 3. These measurements indicate the following.

- Static conditions are present throughout the wells prior to pumping on July 20, 2016. This indicates that any responses during days on which pumping occurs would be reflective of changes due to the pumping test rather than from outside influences. The cause of the dramatic changes in two transducers on July 19, 2016 are from removing the transducers to check on their functionality, as noted on the figure.
- The water levels in the pumping well (BCP-MW6) decreased by almost four feet during pumping on both days.
- Water levels in all wells with transducers except MSMW-1 showed significant decreases in elevation during the two pumping episodes. The decreases coincide

with the duration of pumping and can therefore only be attributed to the pumping itself. These observations indicate:

- The immediate response of water levels in BCP-MW1 was expected due to its proximity and presence within the building footprint along with the pumping well;

- Three of the four off-site wells along Main Street showed a decrease in elevation – a number of interesting observations can be made about these results:

- The closest well to the pumping well, MSMW-1 did not show a response to pumping. This suggests that the sheet piling, which did extend to the planned depth of 50 feet in this area, effectively eliminated the communication between this well and the Site.

- MSMW-4 and MSMW-3, which are the two wells adjacent to the areas in which the sheet piling was not advanced to its full planned depth, responded quickly to the on-site pumping. This demonstrates a direct hydraulic connection from these off-site locations to the Site.

- MSMW-2, which is located adjacent to an area where sheet piling was advanced to its full planned depth, reacted to the pumping but the decrease in water levels was delayed when compared to wells MSMW-4 and MSMW-3. This suggests a hydraulic connection through the gap in the sheet piling, but the relative delay indicates that the pressure changes first needed to travel around the gap in the sheet piles.

- The wells that responded to pumping showed a recovery, although in each case the recovery was muted and none of the wells recovered to their original water levels within the monitoring period. This suggests a general lack of water within the limited water-bearing zone.

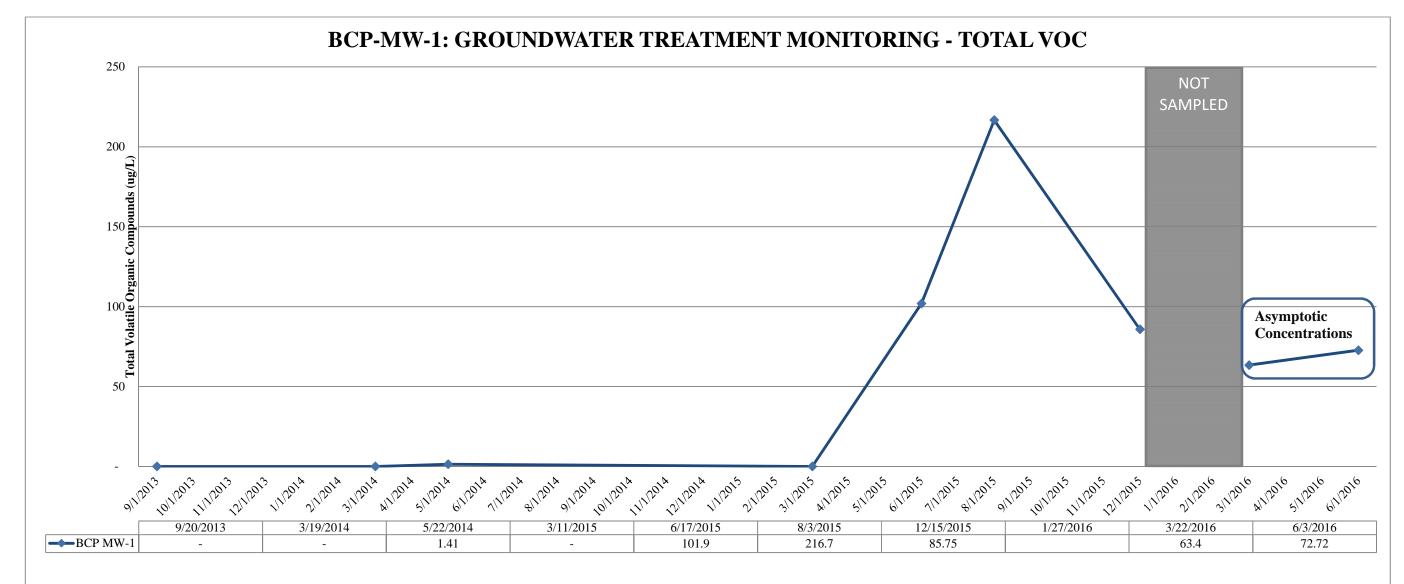
GRAPH 4 – BCP-MW1 – GROUNDWATER TREATMENT MONITORING – TOTAL VOC

- BCP-MW-1: Concentrations in this well were low until a significant spike occurred following period in which groundwater levels dropped anomalously due to pumping at the proximal construction site. Concentrations peaked immediately following the dry period and have decreased below NYSDEC guidance levels during the most recent sampling event.

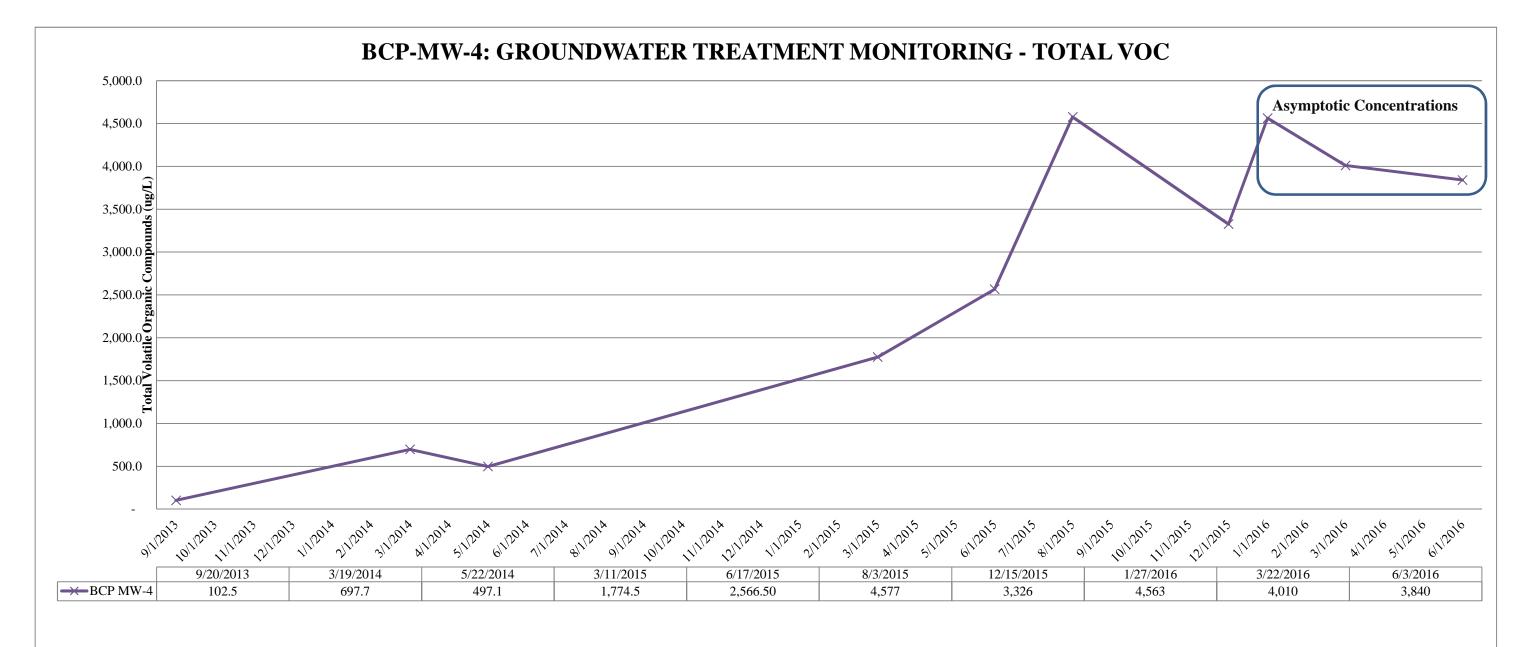
GRAPH 6 – BCP-MW4 – GROUNDWATER TREATMENT MONITORING – TOTAL VOC

- BCP-MW-4: Contaminant concentrations in this well were generally stable prior to the pumping activities at the nearby construction site. Following the cessation of pumping, contaminant concentrations increased significantly. Recent sampling has shown that the contaminant concentrations peaked in August 2015 and have since decreased.

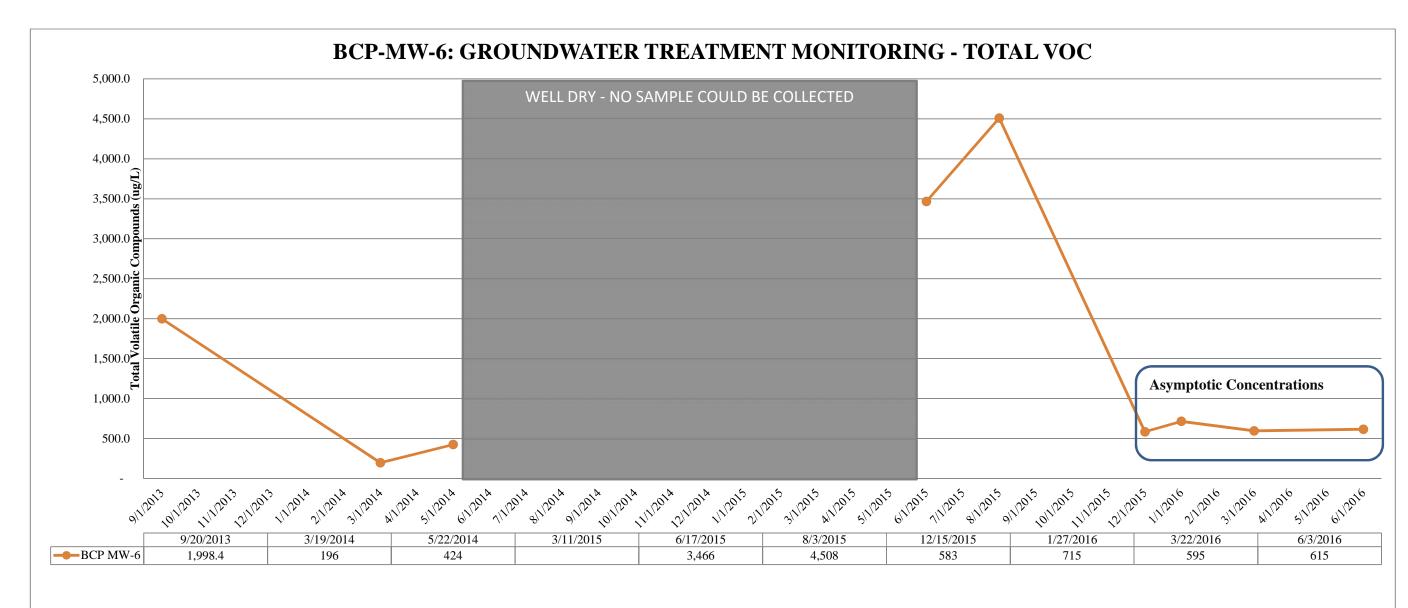
GRAPH 8 – BCP-MW6 – GROUNDWATER TREATMENT MONITORING – TOTAL VOC

No groundwater sample was collected from this well on January 27, 2016. During the winter of 2016, C&S conducted a limited pump and treat to evaluate groundwater conditions by pumping from BCP-MW-3, 4, 5 and 6. In January 2016, samples were collected from these four wells only.
