RE: 132 Dingens St. Site (Site #C915263)
Periodic Review Report and IC/ECC Certification Submittal (Revised)
Period December 20, 2016 through April 20, 2018

132 DINGENS ST. SITE
(Site No. C915263)
PERIODIC REVIEW REPORT (PRR)
Period from December 20, 2016 through April 20, 2018

**132 DINGENS ST. BCP SITE
SITE MANAGEMENT PLAN**

SMP INSPECTION

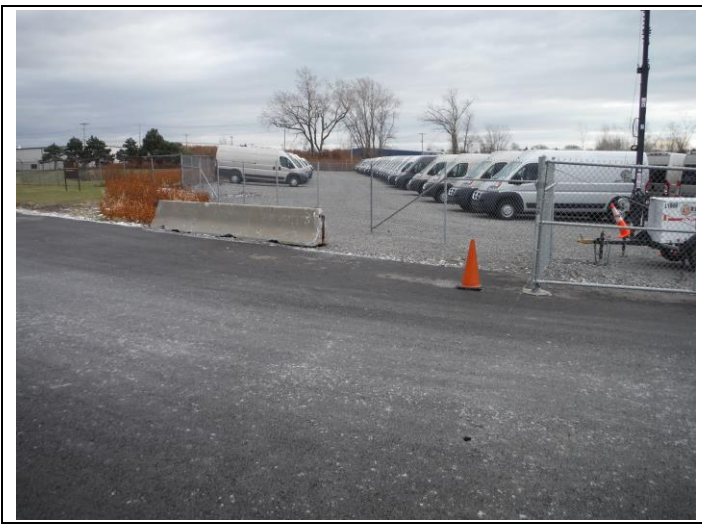
1. View along the northeast border of the site facing east

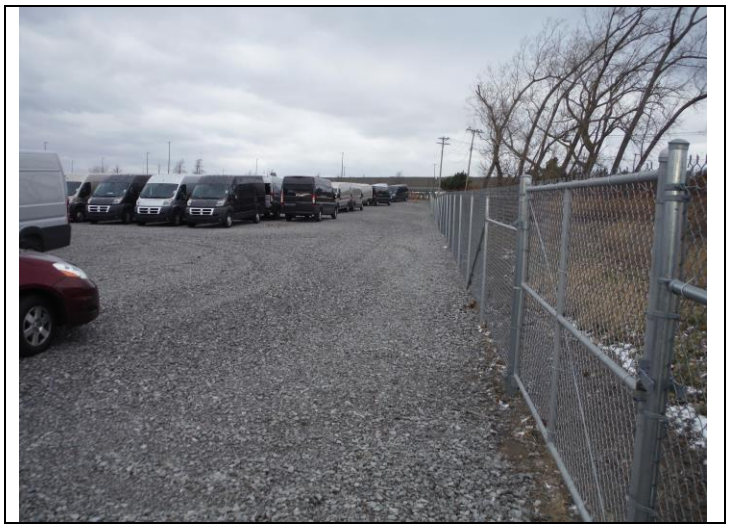
2. View along the eastern border of the property facing north

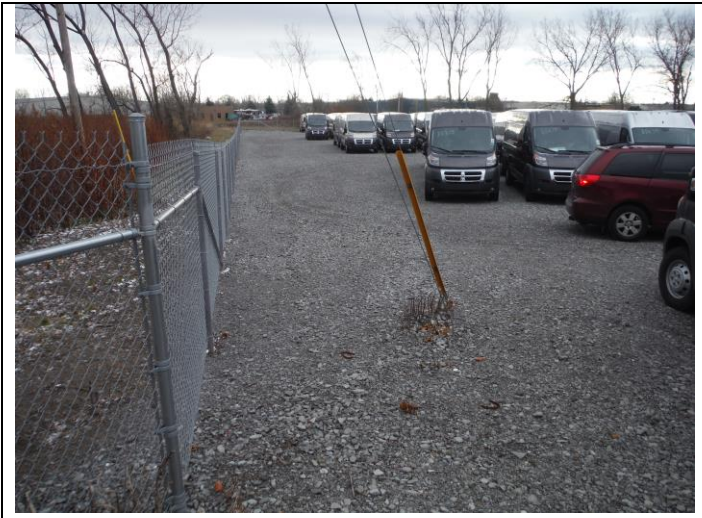
3. View along the eastern border of the property facing south

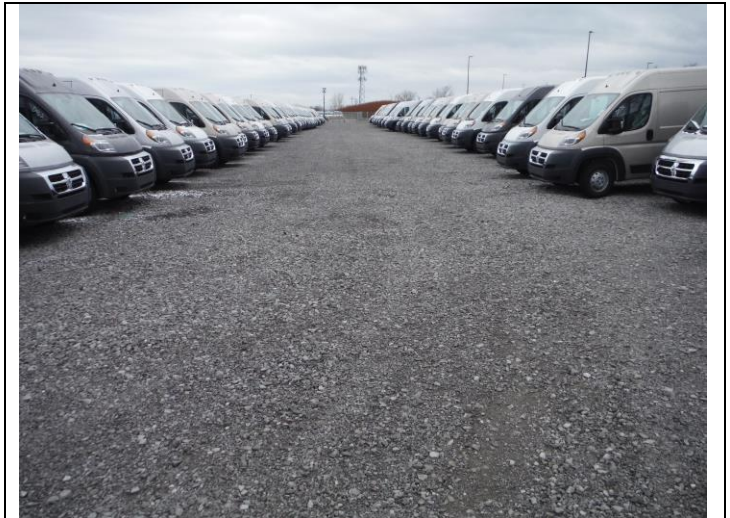
4. Looking across the middle of the east portion of the property

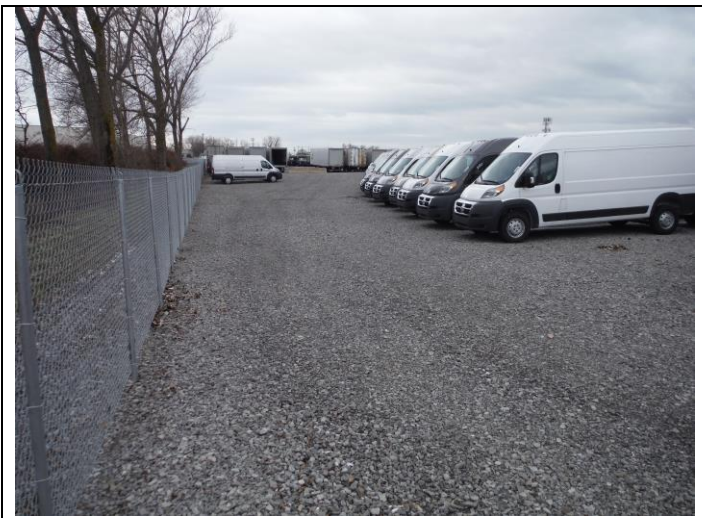
5. View along the southeast border of the site facing west

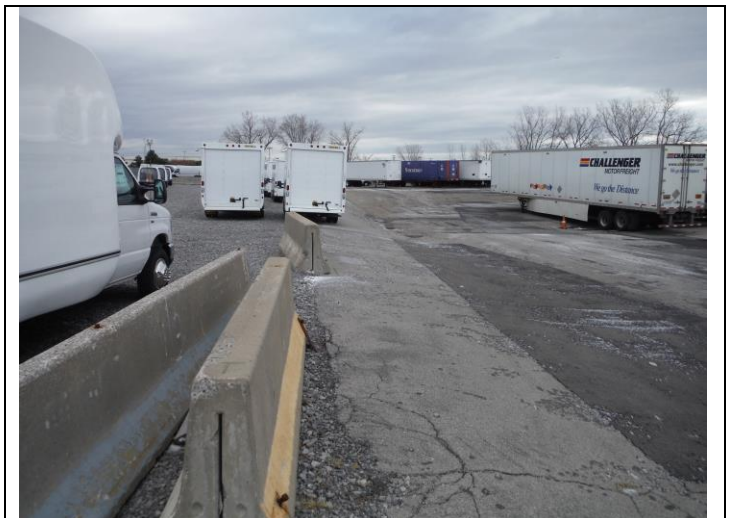
6. View along the east end of the paved area where the graveled east section of the property begins

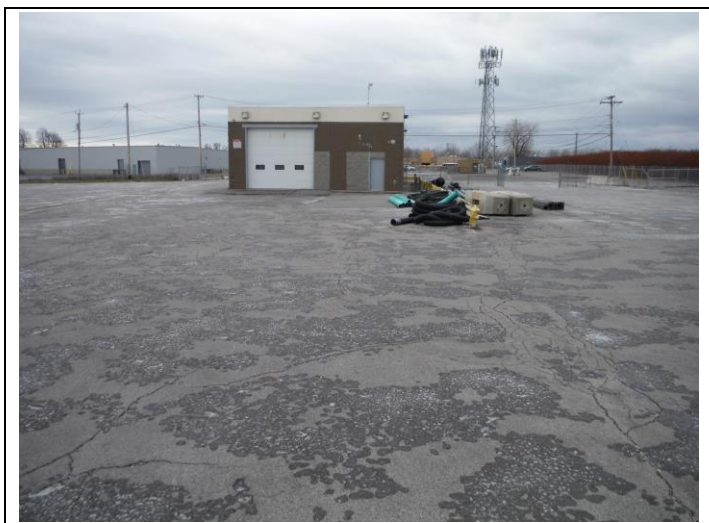
1. View of the north area of the central section of the site

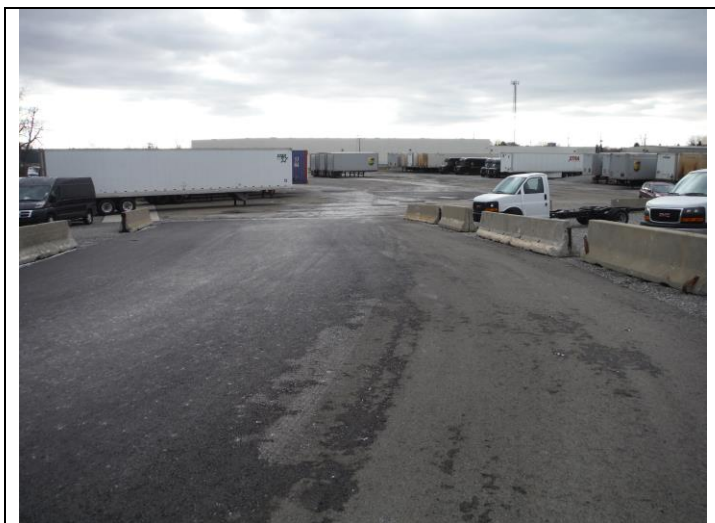
2. View from the UPS driveway on the north border of the site

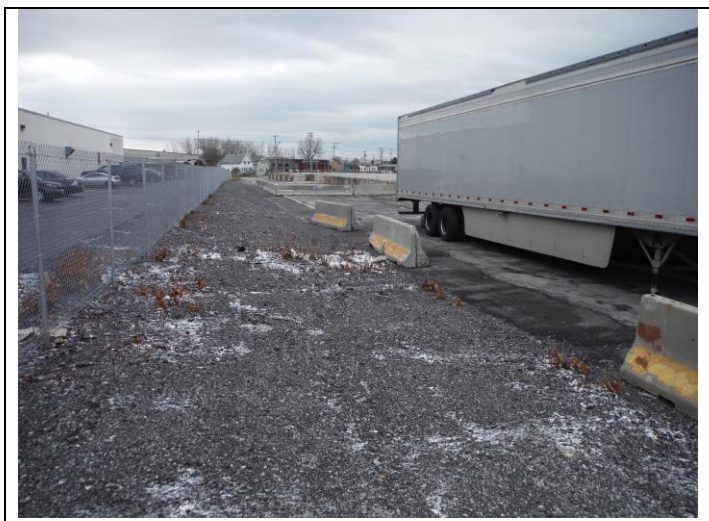
3. View along the south border of the property looking west

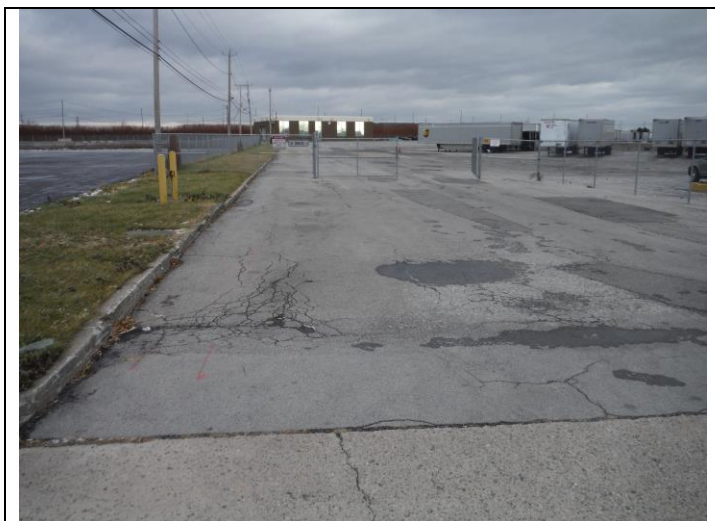
4. View of the main entrance along Dingens St

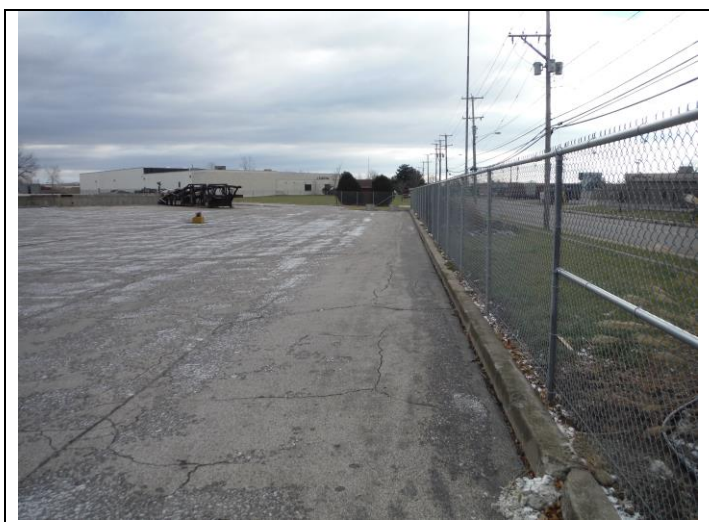
5. View along the south border of the property looking east

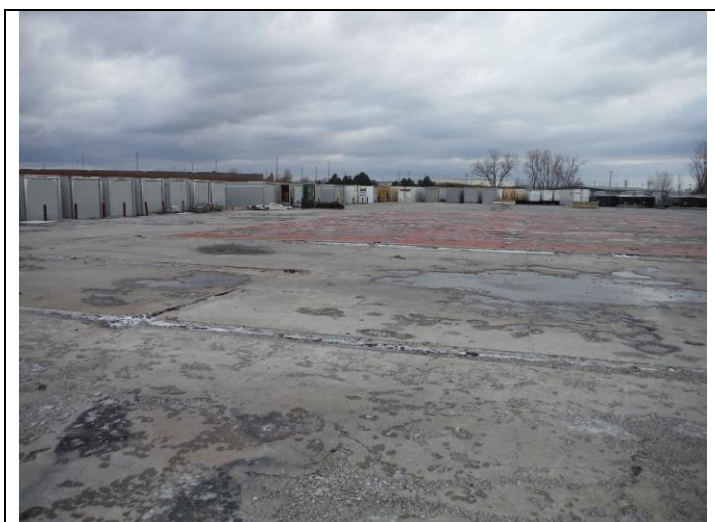
6. View across the center of the property from atop the Old Foundation

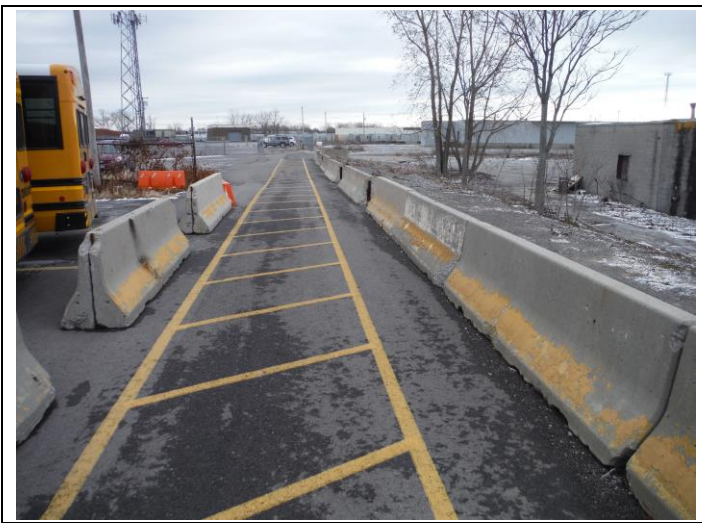
1. View from west end of the western leg of the site facing east

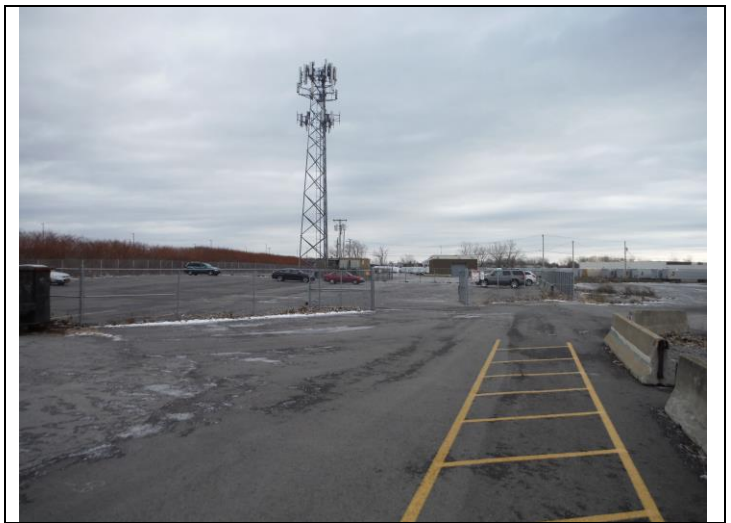
2. View from the middle of the west leg facing east

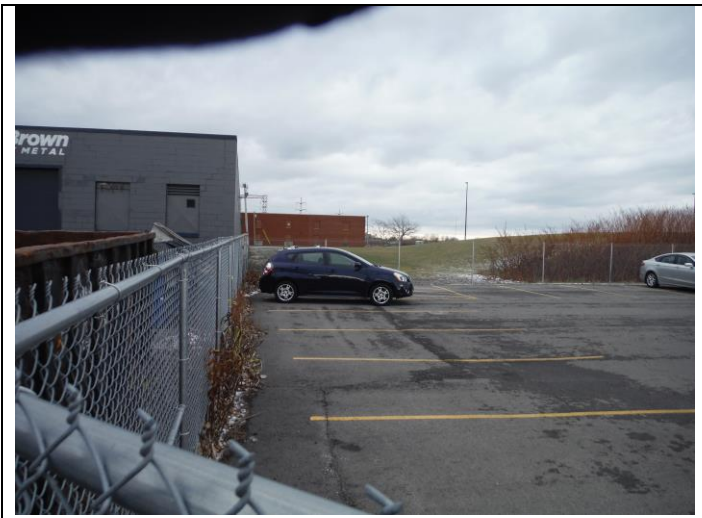
3. View of the northwest corner of the site

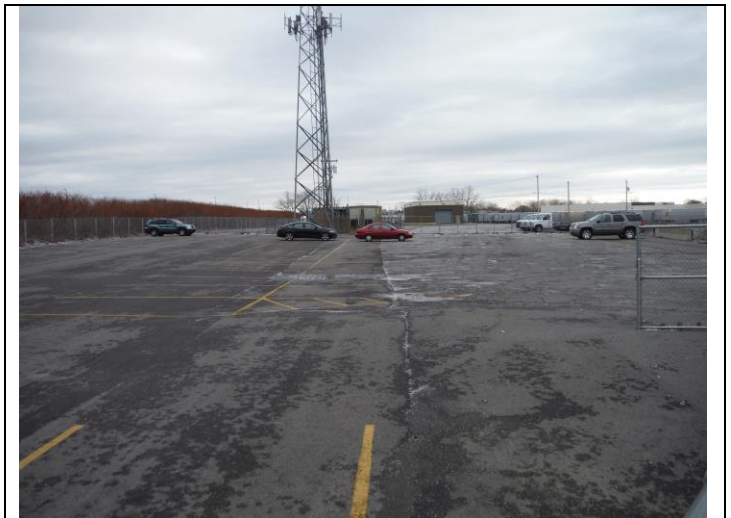
4. Looking across the western area of the site facing east

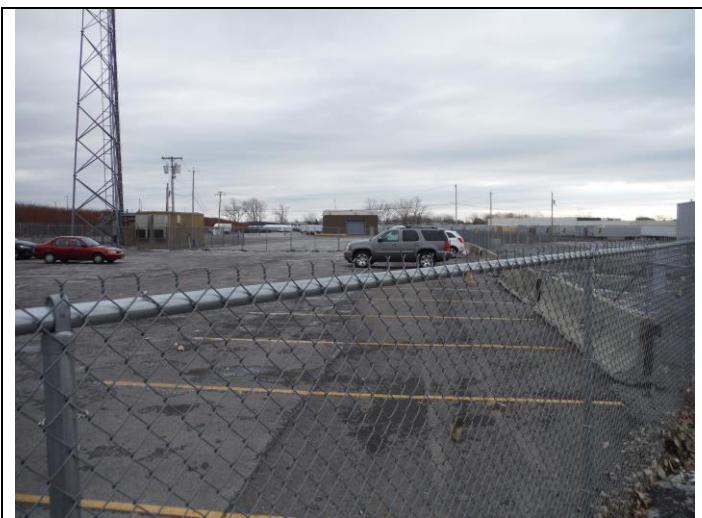
5. View along the south border of the west part of the property

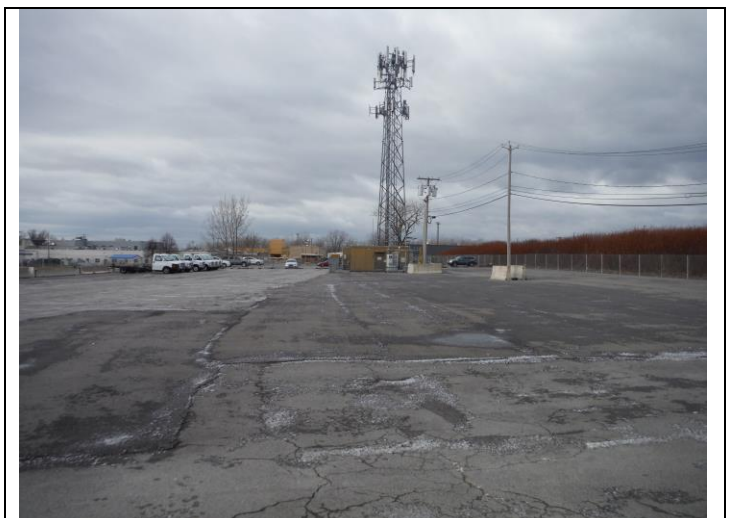
6. View across the west part of the site facing west

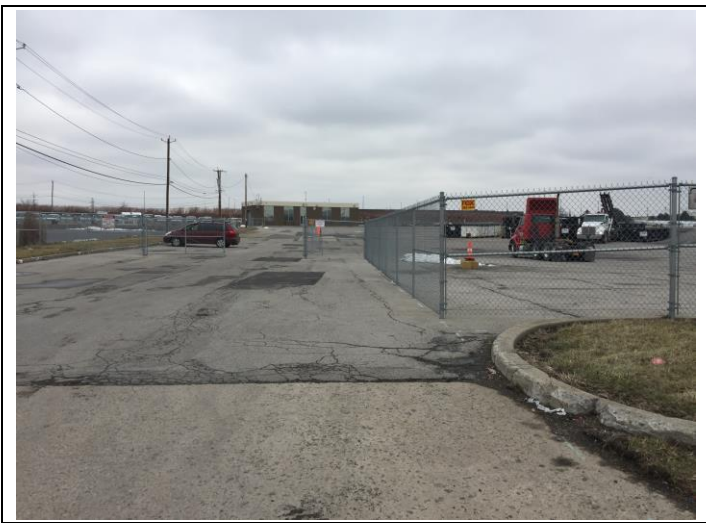
1. View facing north: Entrance to Site

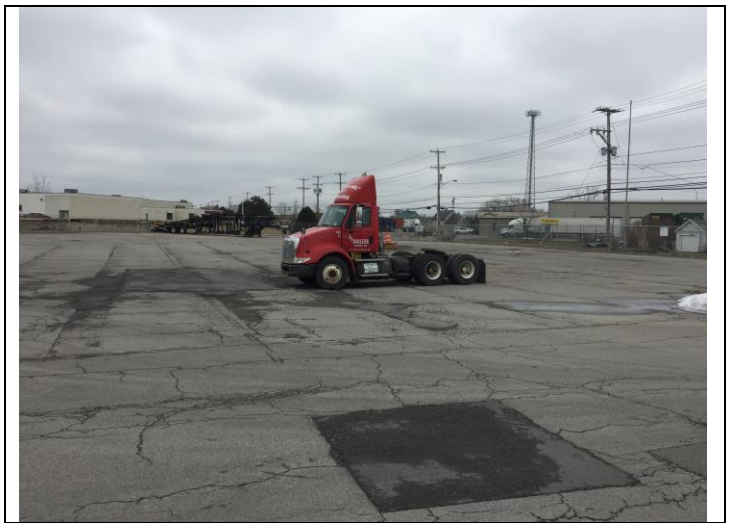
2. View facing east: Asphalt paved area front-middle section

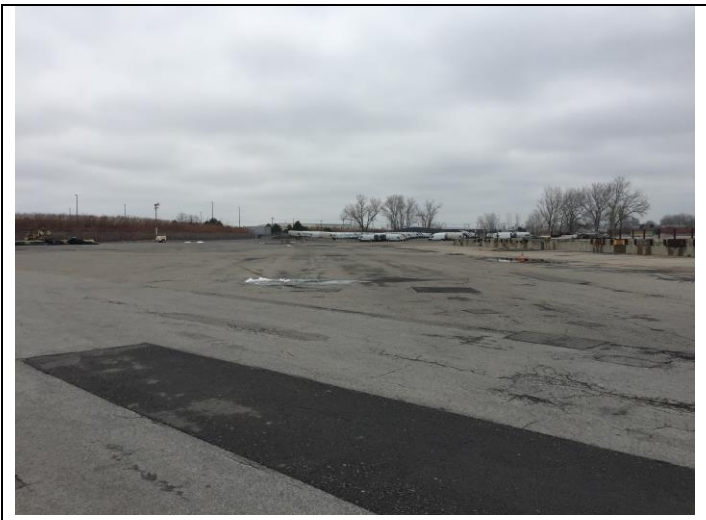
3. View facing southeast: south east section

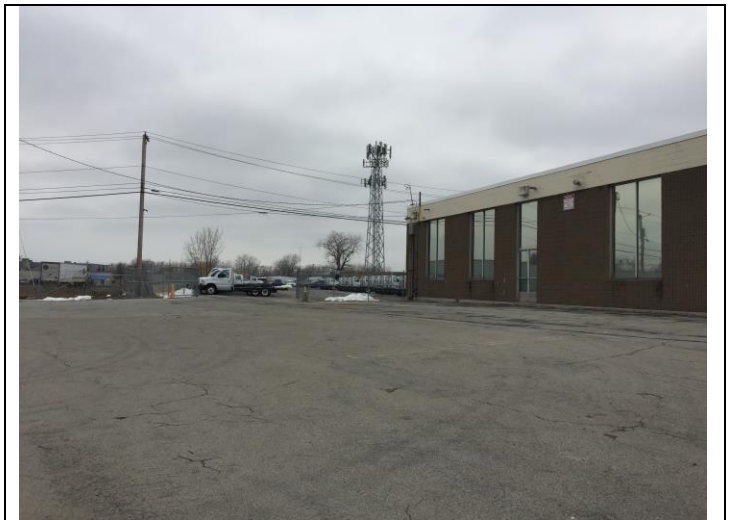
4. View facing west: Building, cell tower and western section

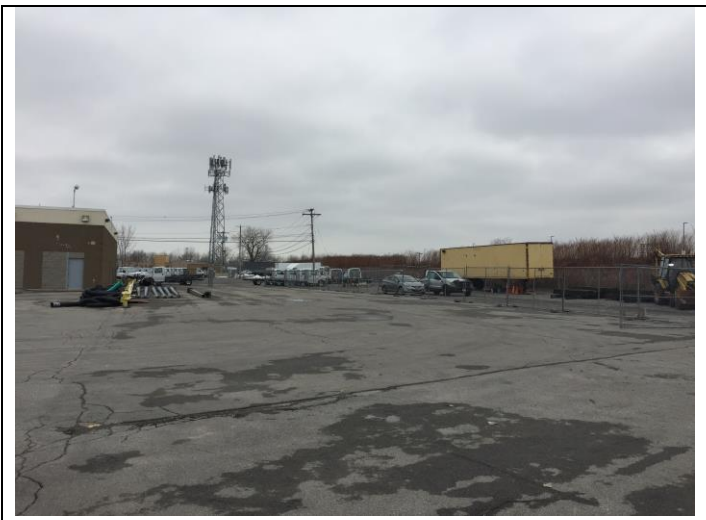
5. View facing west: Middle-north section

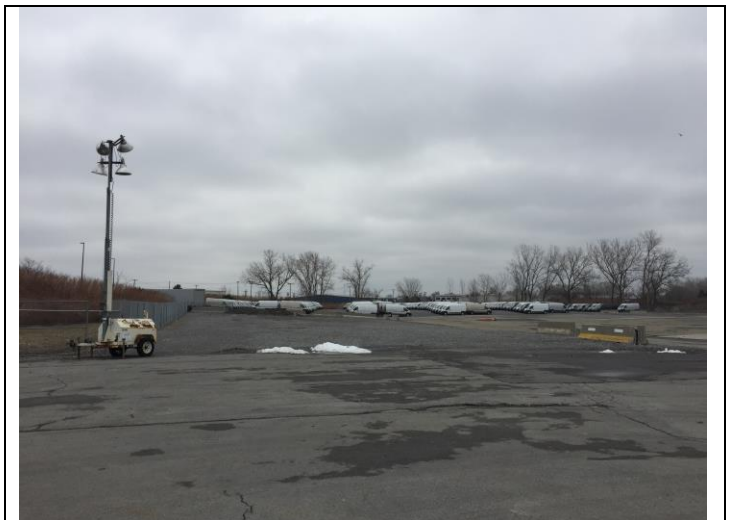
6. View facing east: Northeast section
