PERIODIC REVIEW REPORT

MARCH 11, 2018 TO MARCH 11, 2019 3 GATES CIRCLE SITE (BCP SITE No. C915272)

BUFFALO, NEW YORK

April 2019 0309-014-001

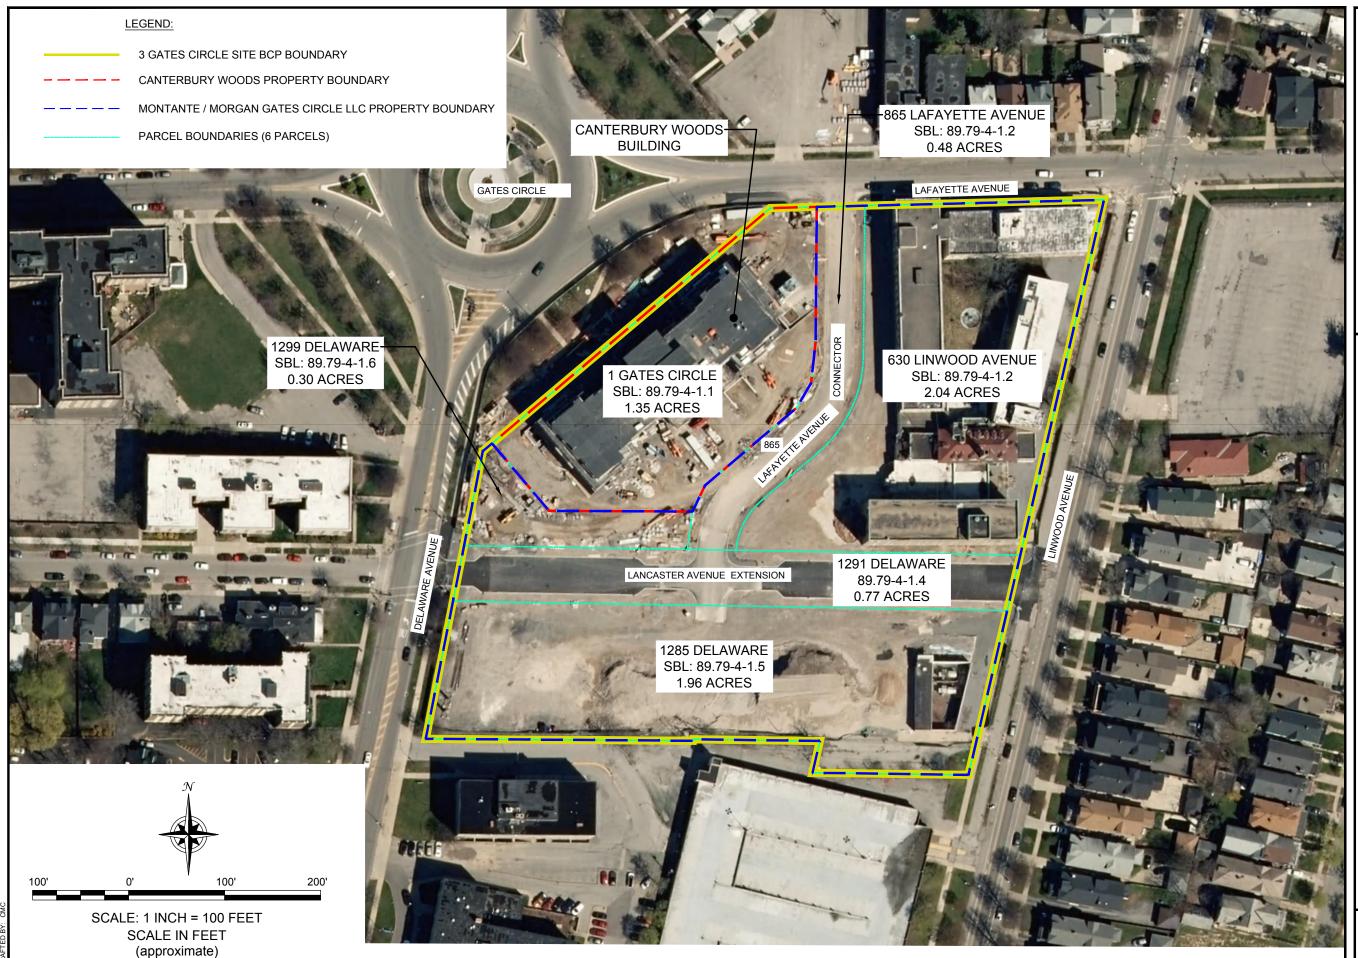
FIGURE 2

Prior to the start of redevelopment, five (5) buildings were demolished as well as portions of 3 other buildings. On May 10, 2016, 1.35 acres of the 6.9 acres Site was sold by GCH to Episcopal Church Home and Affiliates Life Care Community, Inc. d/b/a Canterbury Woods (Canterbury Woods, see Figure 2). The 1.35-acre area located in the northwestern portion of the Site was redeveloped as an assisted living facility. The southern and eastern portions of the Site are still awaiting redevelopment and five (5) former Millard Fillmore hospital buildings still remaining in the northeastern portion. Two (2) new roadways, the Lancaster Avenue Extension and Lafayette Connector were constructed and are substantially complete (see Figure 2).

In March 2017, the remaining 5.55-acre parcel owned by GCH was subdivided as follows (see Figure 2) and the ownership transferred to Montante/Morgan Gates Circle LLC (M/MGC). Notice of Transfer of Certificate of Completion was filed with the Erie County Clerk's Office on May 3, 2017.

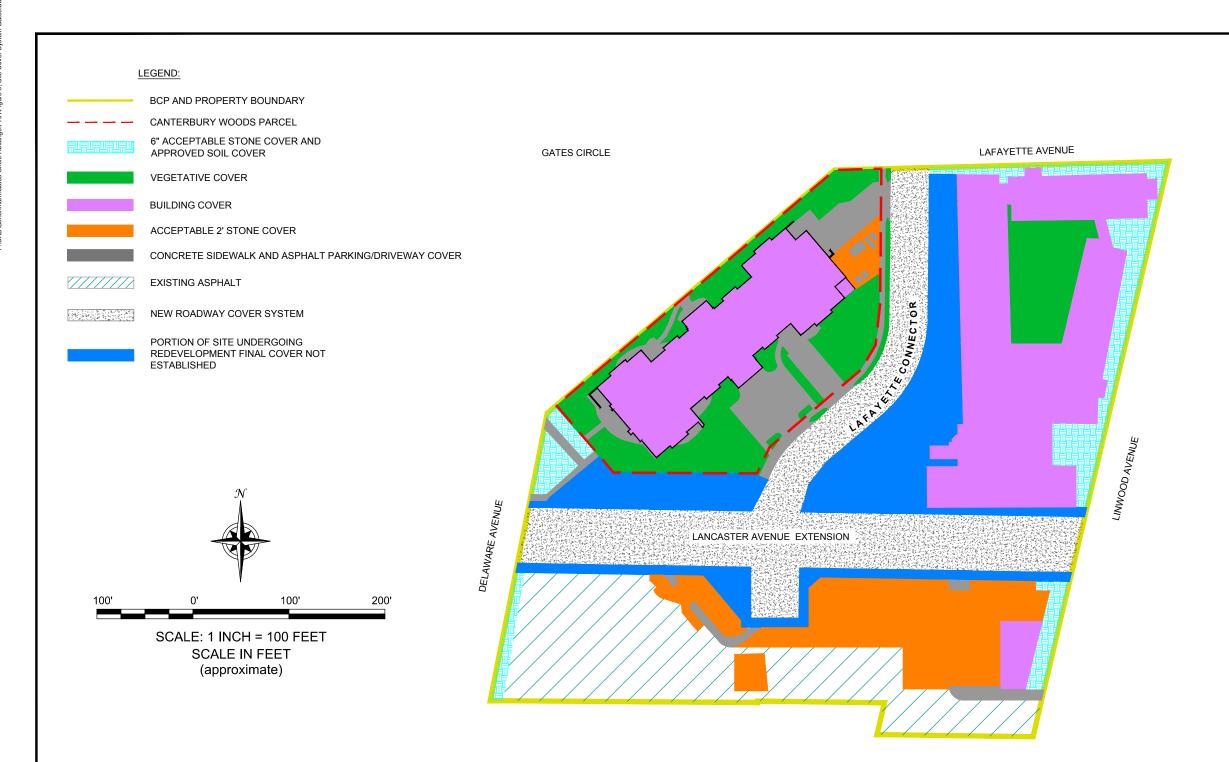
FIGURE 3

Figure 3 identities the updated cover system for the Site. SMP activities were observed by Benchmark and TurnKey personnel to verify conformance with the SMP.

The vacant portions of the Site and five (5) former Millard Fillmore hospital buildings still await redevelopment but remain in compliance with the SMP, as the cover system is in place (see Figure 3).
