January 3, 2014

LIMITED PHASE II SUBSURFACE INVESTIGATION

Rite Aid 350 Niagara Street Buffalo, NY 14202

AEI Project No. 326182

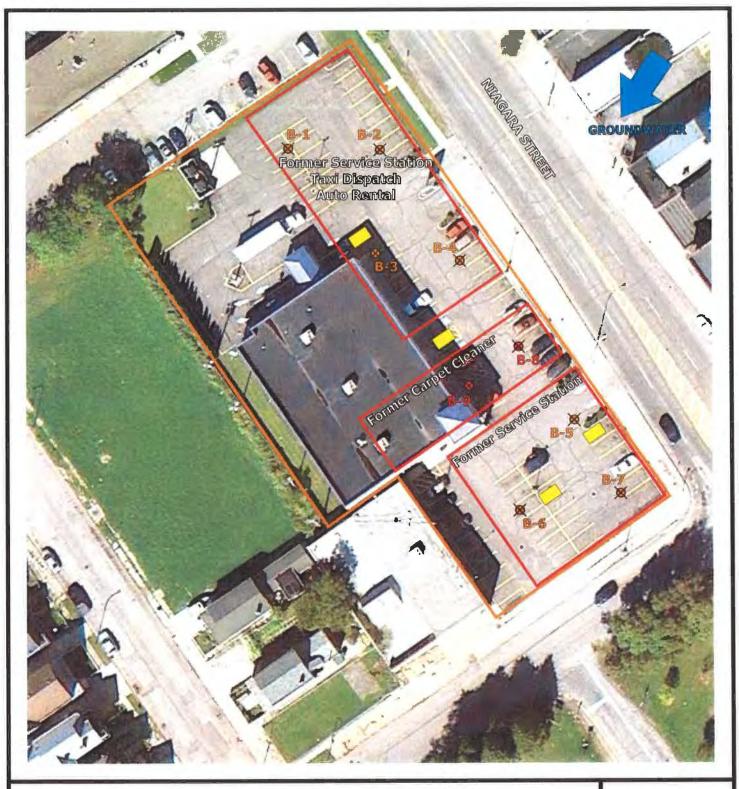
FIGURE 2 SITE MAP

On December 18, 2013, a geophysical survey was conducted by GPRS of New York. The purpose of the survey was to evaluate the potential presence of current or former USTs. The geophysical survey was conducted using ground penetrating radar (GPR). The geophysical survey results indicate four potential anomalies that may have a subsurface structure present such as an UST. The four potential subsurface anomalies locations are shown on Figure 2.

- Borings B-1 through B-4 were advanced in the former service station, taxi dispatch and auto rental area in the northern portion of the property. Boring B-3 is located south of the more northern subsurface potential anomaly identified by GPRS.
- Borings B-5 through B-7 were located in a second area at the south end of the property formerly occupied by a service station. Boring B-6 is located southwest of a potential subsurface anomaly. Boring B-6 is also located south of another potential subsurface anomaly and B-5 is to the north of the same anomaly.
- Borings B-8 and B-9 are located where the former carpet cleaner operated. Boring B-9 is located south of a potential subsurface anomaly.

- Chlorinated volatile organic compounds were detected in soil samples from borings B-2 and B-3. Soil sample B-3 sample from 10-12 feet bgs was found to have concentrations of 1,2-dichloroethane at 0.28 mg/kg, chlorobenzene at 2.3 mg/kg, cis 1,2 dichlorethene at 22 mg/kg, tetrachlorethene at 800 mg/kg, trichloroethene at 58 mg/kg and vinyl chloride at 3.3 mg/kg, however all were below the unrestricted use soil cleanup objectives (USCO). Soil sample B-2 from 8-11 feet bgs contained tetrachlorethene at 3.2 mg/kg and trichloroethene at 0.84 mg/kg at concentrations below the USCOs. Borings B-2 and B-3 are located in the northern part of the property where the former service station, taxi dispatch and auto rental business operated.

- Chlorinated organic compounds were detected in groundwater sampled from borings B-2 and B-3 exceeding NYSDEC groundwater standards. Groundwater sample B-3 contained the following compounds that exceeded the groundwater standards: 1,2-dichloroethane at 2.6 ug/l, chlorobenzene at 11 ug/l, cis 1,2 dichlorethene at 230 ug/l, tetrachlorethene at 3,600 ug/l, trans 1,2 dichloroethene at 16 ug/l, trichloroethene at 520 ug/l and vinyl chloride at 16 ug/l. Groundwater sample B-2 exceeded groundwater standards for acetone at 14 ug/l and tetrachloroethene at 7.4 ug/l. Borings B-2 and B-3 are located in the northern area of the site where a former service station, taxi dispatch and auto rental business operated.

- Generally, petroleum-related contamination was detected in groundwater samples B-5 and B-6 at concentrations greater than the NYSDEC groundwater standards. Groundwater sample B-5 exceeded for benzene at 7.3 ug/l, ethylbenzene at 170 ug/l, isopropylbenzene at 22 ug/l, and total xylenes at 130 ug/l. Groundwater sample B-6 exceeded for benzene at 420 ug/l, ethylbenzene at 280 ug/l, isopropylbenzene at 29 ug/l, toluene at 140 ug/l, and total xylenes at 410 ug/l. Borings B-5 and B-6 are located in the southern portion of the property where a service station historically operated.

Soil borings advanced in the area of the former service station located on the south end of the property was found to have petroleum-related soil and groundwater contamination in borings B-5 and B-6 with the highest concentrations reported in boring B-6. In addition to soil impact above the USCOs, a groundwater sample collected from this location exhibited concentrations of benzene at 420 ug/l, ethylbenzene at 280 ug/l, methylene chloride at 28 ug/l, toluene at 140 ug/l, xylenes at 410 ug/l, as well as other petroleum constituents to a lesser extent. Based on the estimated direction of groundwater flow there is a potential that the impacted groundwater is migrating off site.

In addition to the soil and groundwater results, four anomalies which may be underground storage tanks were identified at the property as a result of the GPR survey. These anomalies should be further evaluated and if underground tanks, they should be removed in accordance with local and state requirements.

AEI recommends that the impacts to the subsurface soil and groundwater be evaluated and reported to the NYSDEC and environmental council should be consulted. The impacted soil and groundwater will need to be delineated and the extent of the dissolved VOC contaminated groundwater plumes evaluated. In addition, the potential for impact to the downgradient residential development should be assessed. As part of the additional investigation the potential for vapor intrusion will need to be evaluated for the site and the adjoining structures.
