LIMITED ENVIRONMENTAL INVESTIGATION

1205 SOUTH PARK AVENUE
BUFFALO, NEW YORK

BUFFALO URBAN RENEWAL AGENCY
920 CITY HALL
BUFFALO, NEW YORK 14202-3376

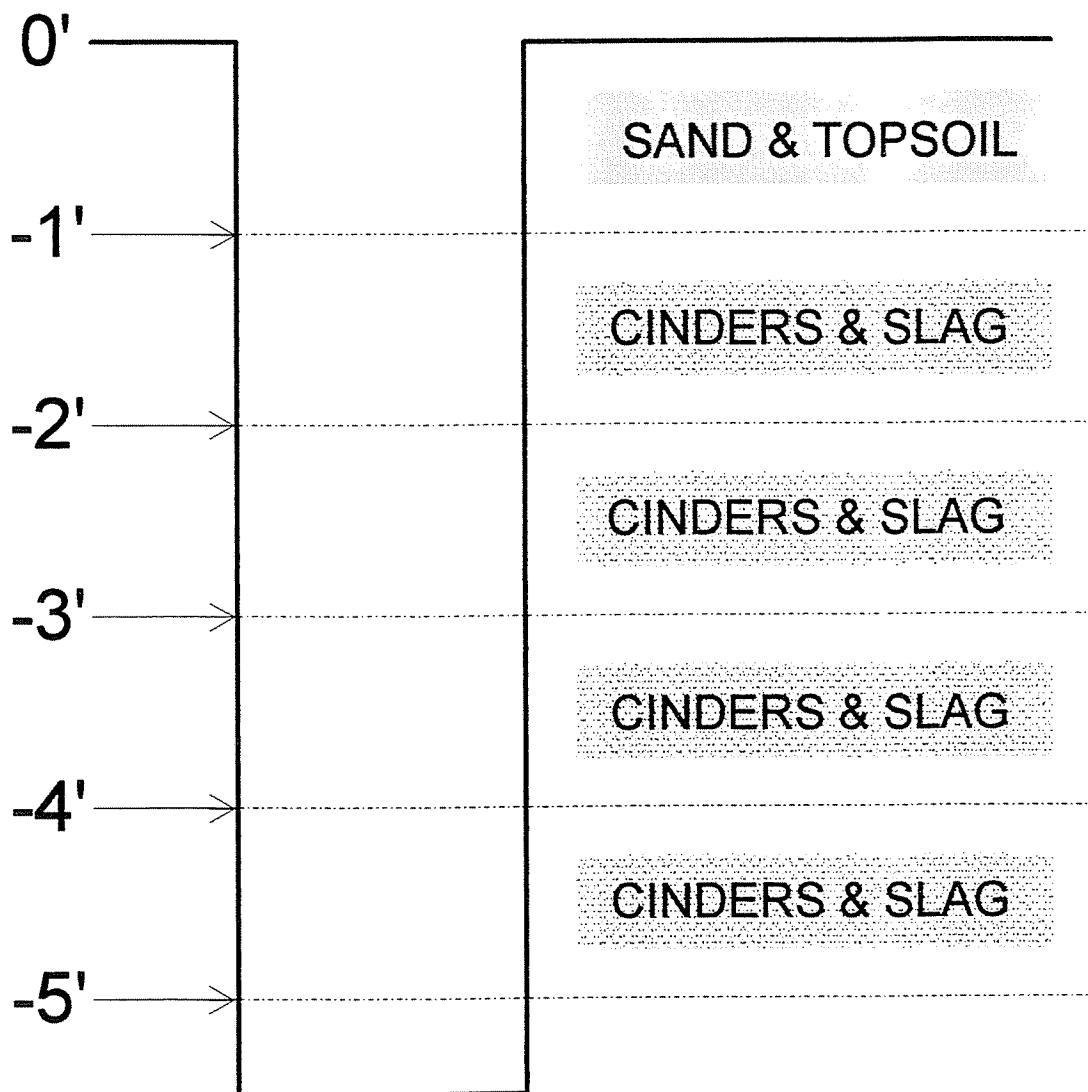
NOTES: 1.) PETROLEUM PRODUCT ENCOUNTERED AT -2'
2.) STRONG PETROLEUM ODOR ENCOUNTERED
3.) PERCHED WATER ENCOUNTERED -2.5'

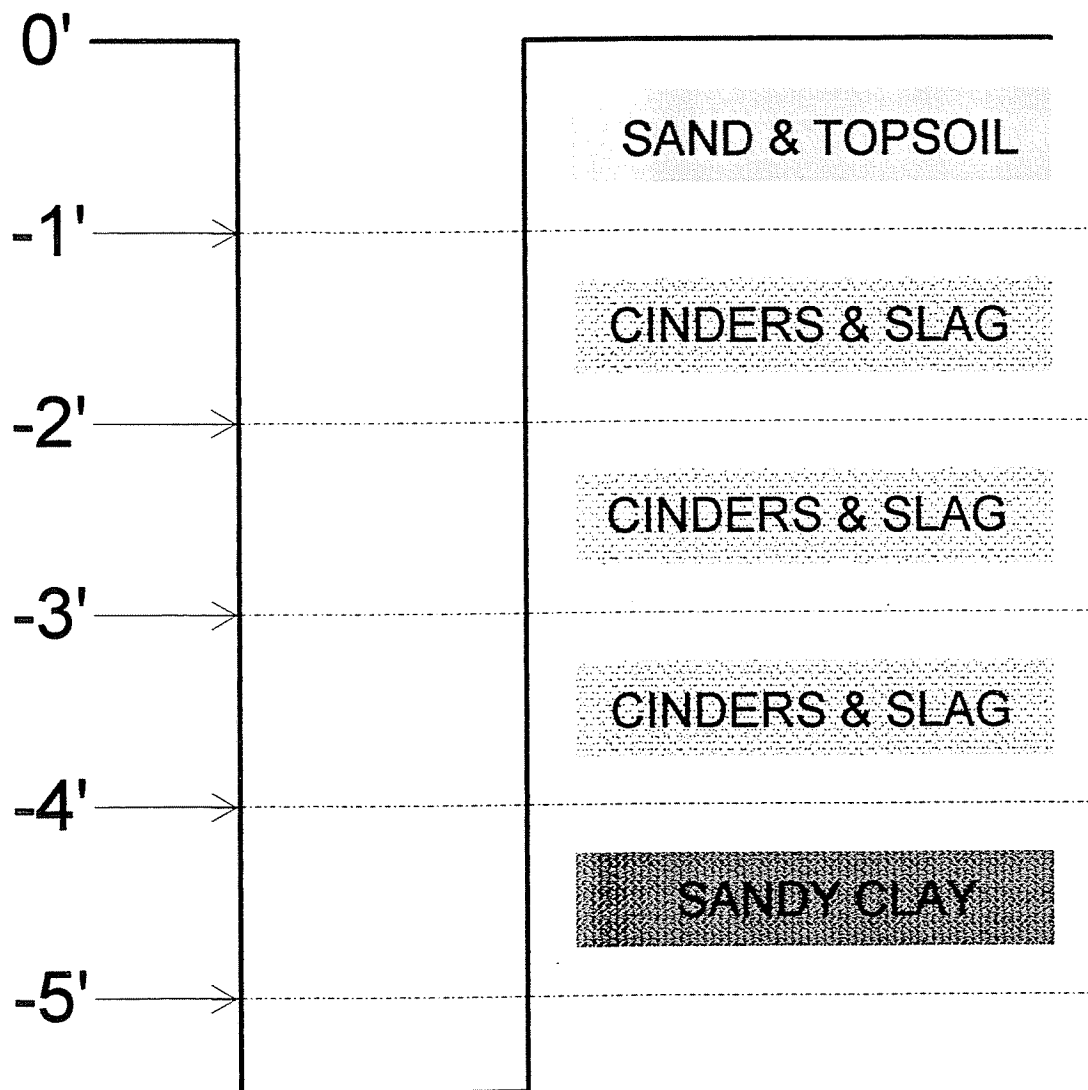
NOTES: 1.) PETROLEUM PRODUCT ENCOUNTERED AT -2'
2.) STRONG PETROLEUM ODOR ENCOUNTERED
3.) PERCHED WATER ENCOUNTERED -2.5'

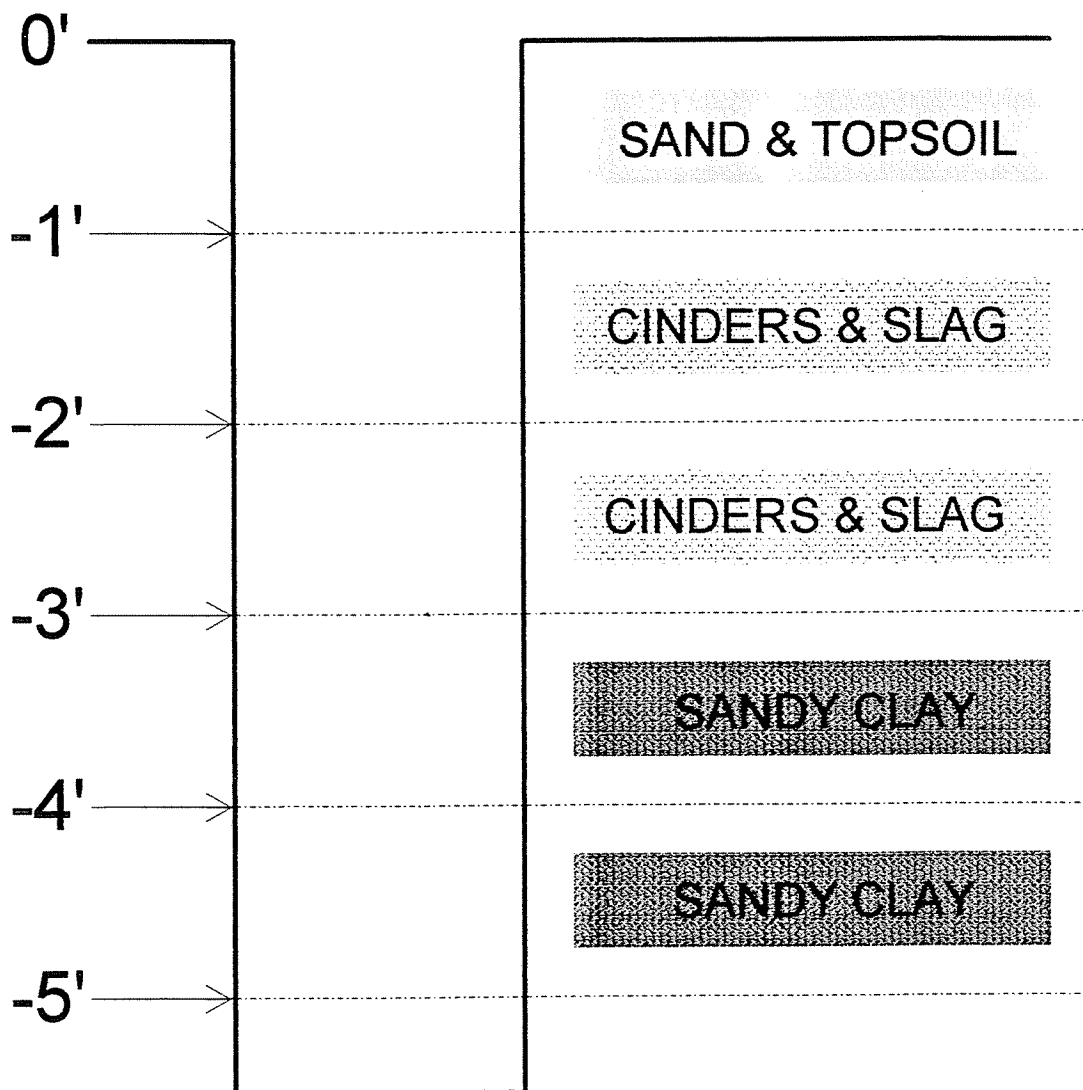
NOTES: 1.) PETROLEUM PRODUCT ENCOUNTERED AT -2'
2.) STRONG PETROLEUM ODOR ENCOUNTERED
3.) PERCHED WATER ENCOUNTERED -2.5'

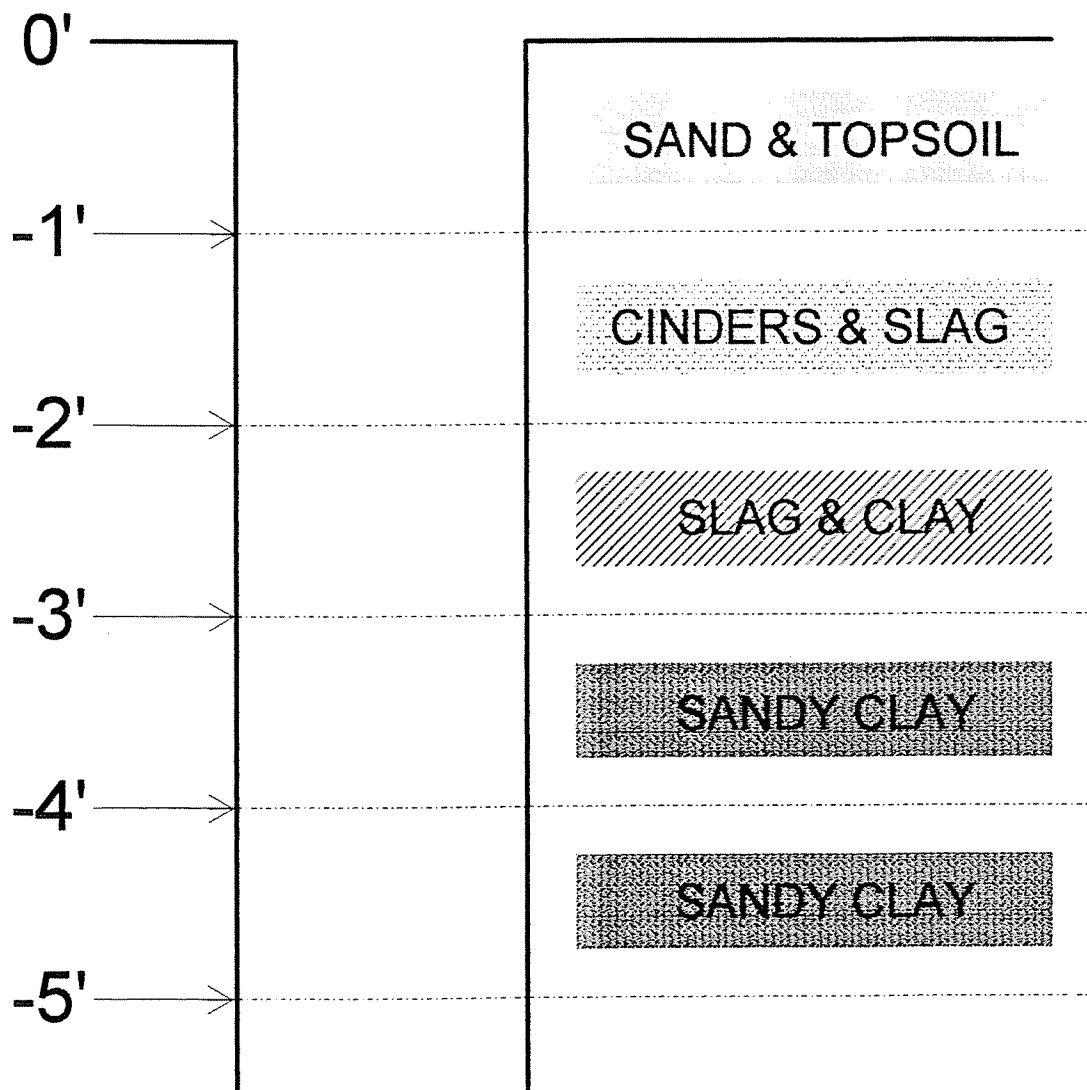
NOTES: 1.) PETROLEUM PRODUCT ENCOUNTERED AT -2'
2.) STRONG PETROLEUM ODOR ENCOUNTERED
3.) PERCHED WATER ENCOUNTERED -2.5'

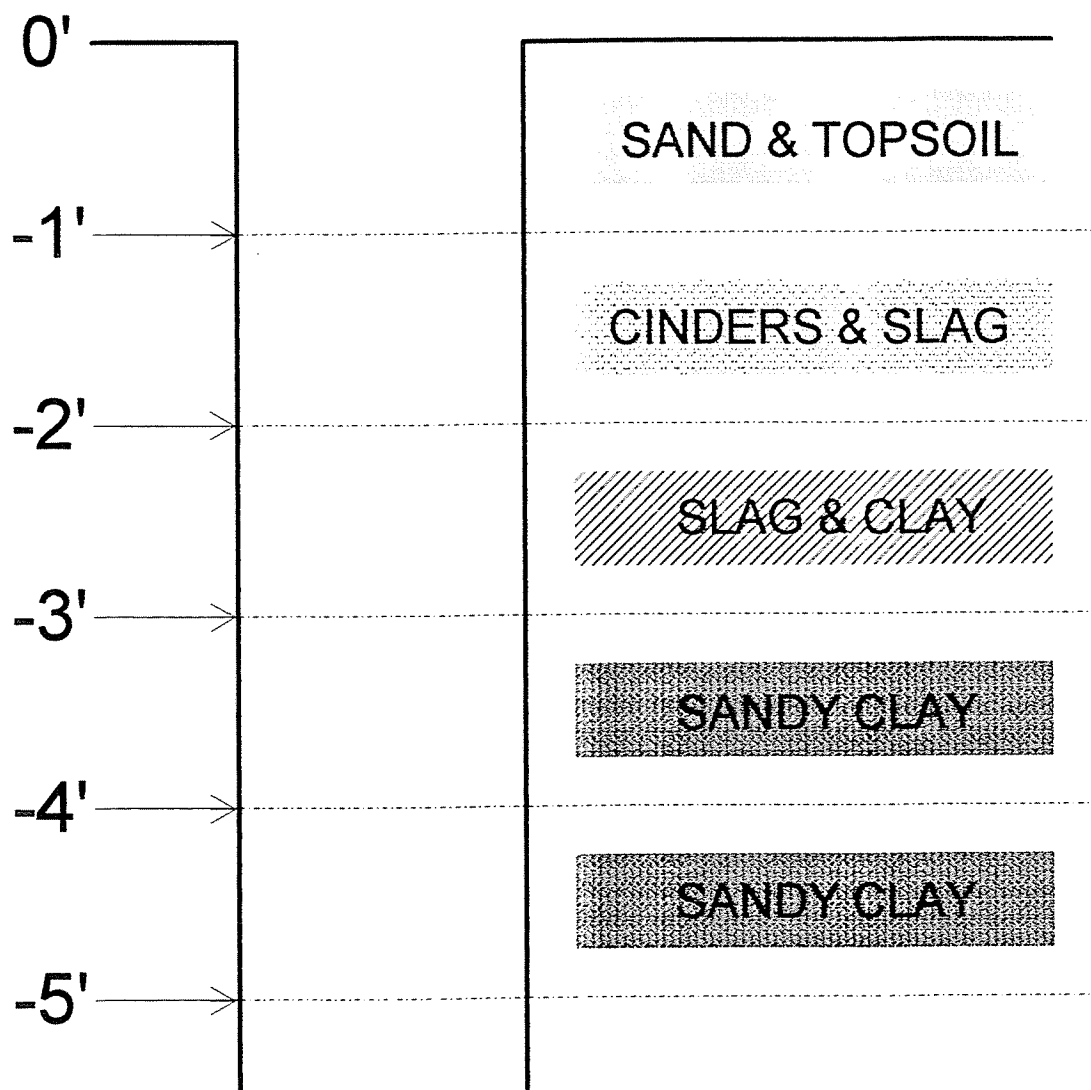
NOTES: 1.) PETROLEUM PRODUCT ENCOUNTERED AT -2'
2.) STRONG PETROLEUM ODOR ENCOUNTERED
3.) PERCHED WATER ENCOUNTERED -2.5'

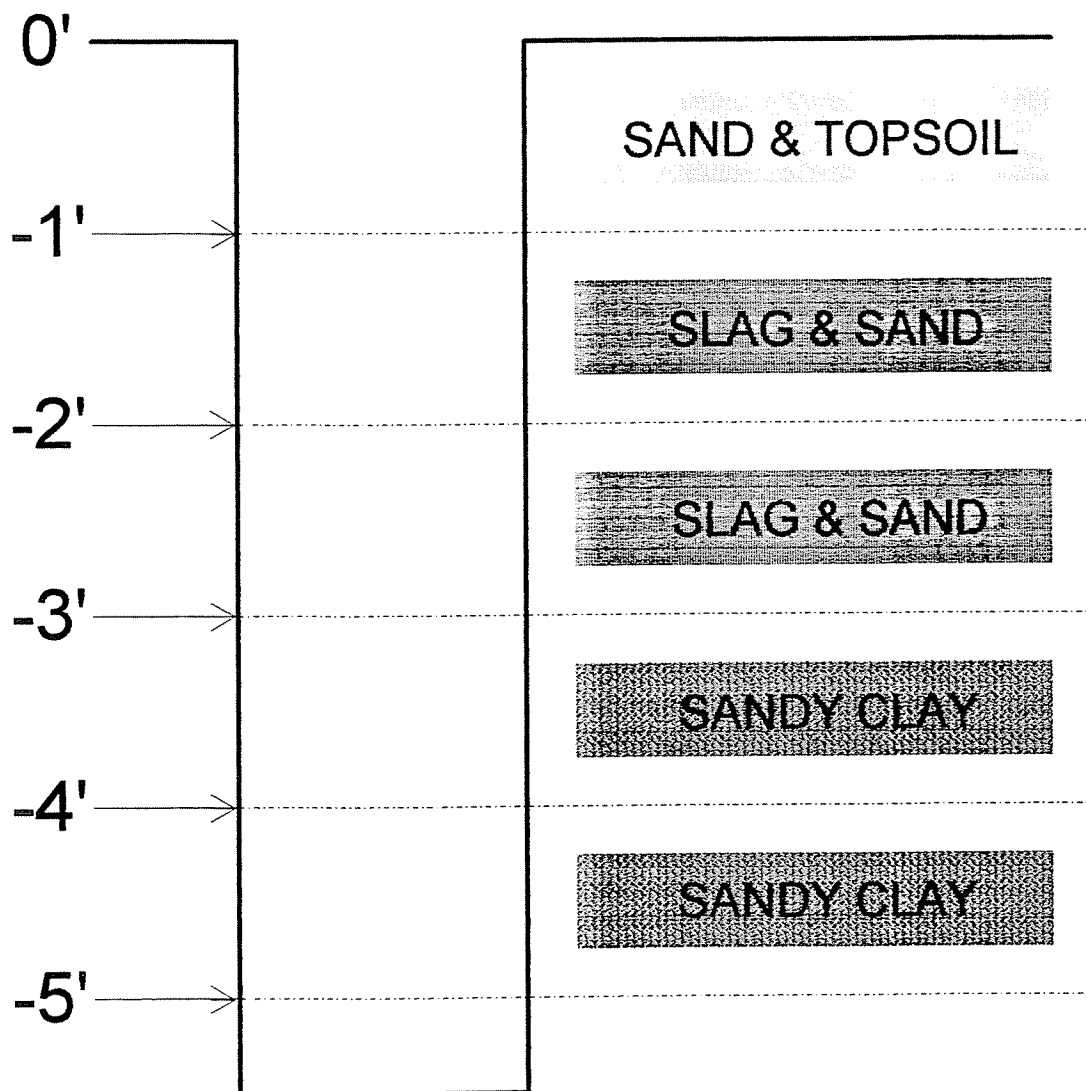
NOTES: 1.) PETROLEUM PRODUCT ENCOUNTERED AT -2'
2.) STRONG PETROLEUM ODOR ENCOUNTERED
3.) PERCHED WATER ENCOUNTERED -2.5'

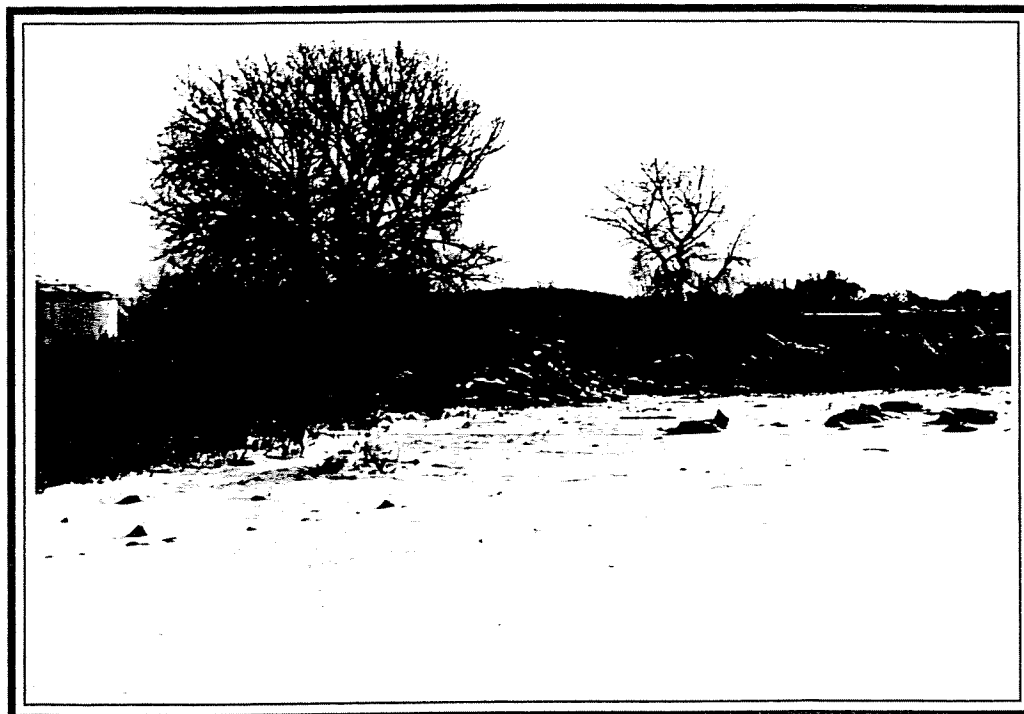
PHOTO 13 : Tires & Debris

A survey of the property also revealed other areas of concern. Of particular note are the housekeeping practices on the subject parcel that are cause for environmental concern. Of importance is the large amount of fill, rubble, tires and demolition debris observed present in various locations throughout the property. It should be noted that this site condition could constitute violations of 6NYCRR Part 360 regulations which control activities at Solid Waste Disposal Facilities.

- * The rubble, tires, construction debris and other materials that are abandoned be collected and disposed of in an environmentally sound manner.

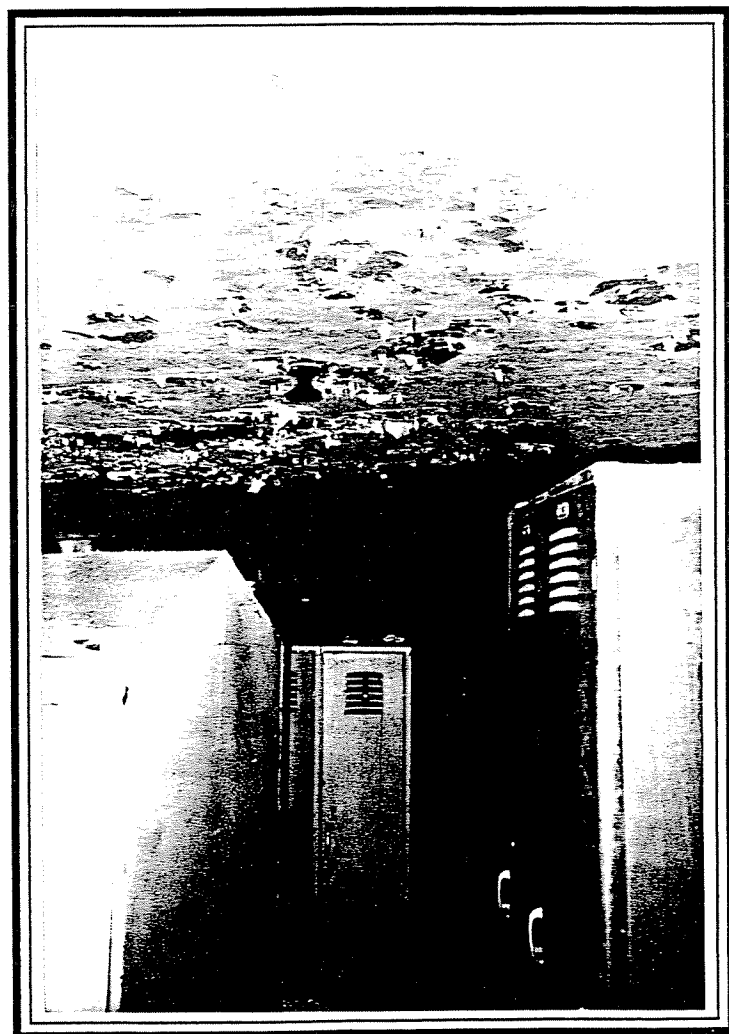
PHOTO 22 : Locker Room

Sample 2 was obtained from the ceiling plaster in the locker room of the warehouse. A photograph (Photo 22) of the sample matrix can be found in Appendix B.

Sample 7 was obtained from the ceiling plaster in the locker room of the warehouse. A photograph (Photo 22) of the sample matrix can be found in Appendix B.

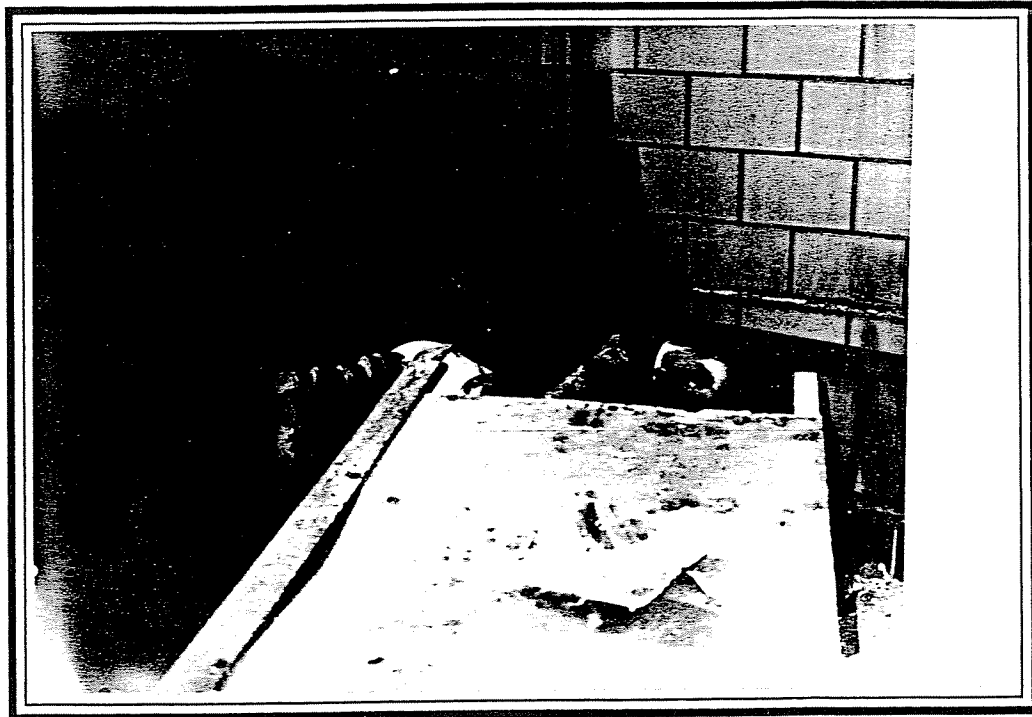
PHOTO 23 : Mechanical Room

Sample 1 was obtained from a pipe elbow in the mechanical room of the warehouse. A photograph (Photo 23) of the sample matrix can be found in Appendix B.

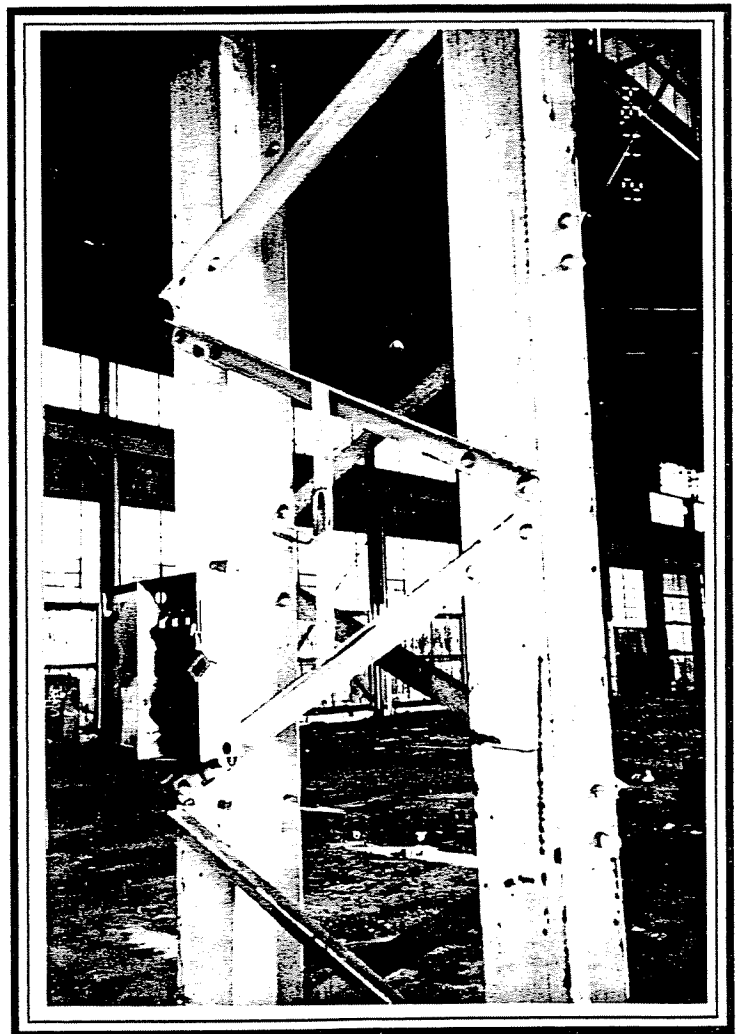
PHOTO 26 : Support W/ Lead Paint

Sample 8 was obtained from one of the structural supports in the warehouse structure. A photograph (Photo 26) of the sample matrix can be found in Appendix B.

3.) Lead was found in varying degrees in all the paint samples taken. The highest value was noted in the structural supports.

With respect to the levels of lead in the sampled paint materials found in the warehouse structure, it is recommended that if the structure is demolished, all the applicable safety and environmental regulations be followed.

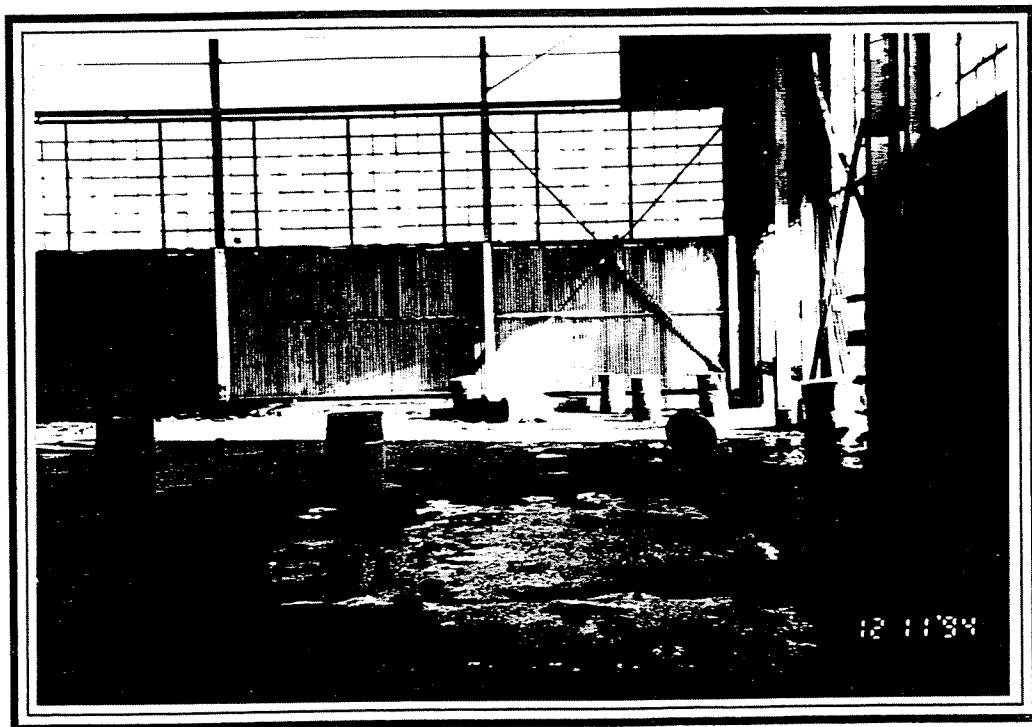
PHOTO 30 : Drums

In addition, it was observed that there were 14 empty drums within the warehouse structure. Most of these drums were observed to be RCRA empty, that is less than one inch of contents. However, some drums were observed to contain debris and other objects. Based upon the marking of these containers, it appears they originally contained lubricants and other common petroleum based fluids.

- * The empty drums that are found in the warehouse be collected and disposed of in an environmentally sound manner.
