January 18, 2023

Re: Revised Non-aqueous Phase Liquid Response
East End of Coal Yard Tunnel Conveyor Control and Junction Building
Riverview Innovation & Technology Campus, Inc.
Town of Tonawanda, New York

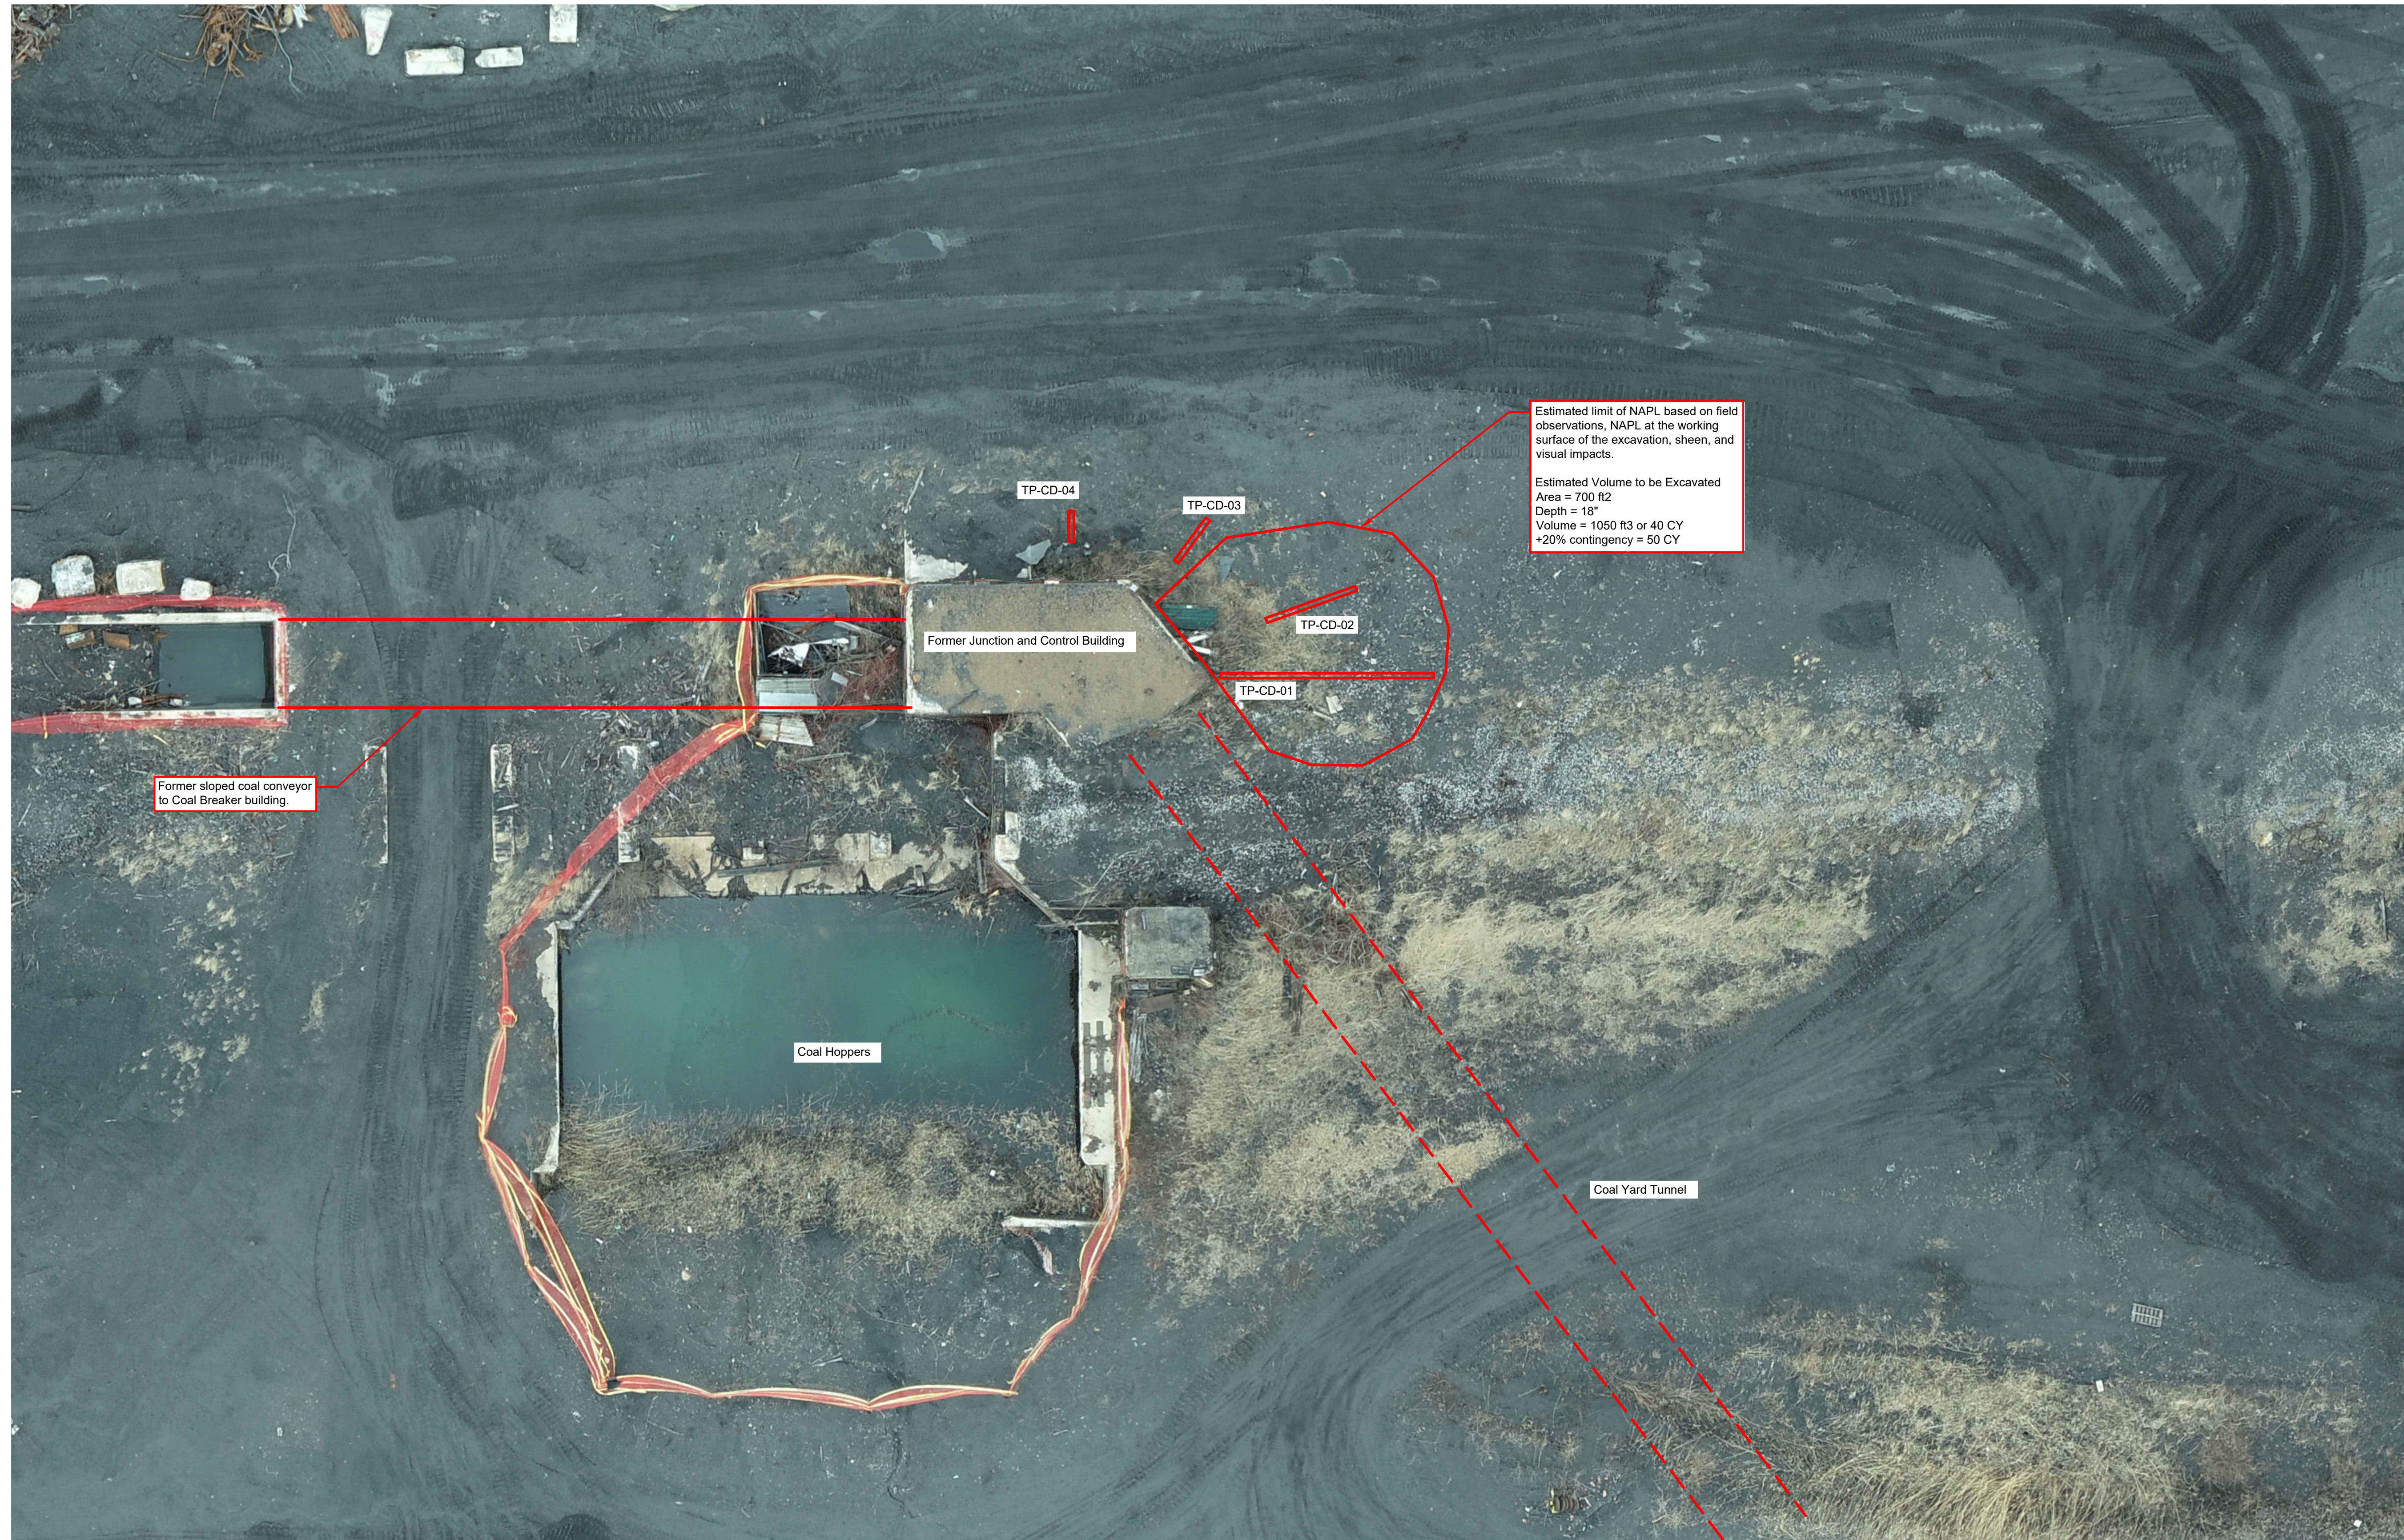
FIGURE 1

As shown on Figures 1 and 2 the NAPL is estimated to cover approximately 700 square feet, lies immediately on top of the silty clay that is typical of the BCP Site, and is contained in an estimated 50 cubic yards of the granular fill. The estimate is provided solely for planning the next phase of excavation.

The building foundation and associated debris are exposed and the foundation is dewatered. OSC would like to remove the debris and fill the foundation while it is exposed. As shown in Figure 1, the NAPL lies east of the foundation and Coal Yard Tunnel, so the following is proposed to manage the NAPL and Prevent the NAPL from flowing toward the closed structures:

- A temporary berm of silty clay from the benching excavation will be used to prevent migration from the benching excavation. No material is being imported from another part of the BCP Site;

- the layer of impacted material will be removed until no evidence of NAPL is observed, or the excavation is more than 50 feet from the foundation excavation. The impacted materials will be stockpiled on polyethylene sheeting in the grossly contaminated staging area in the Thaw Shed;

- the limits of the excavation will be backfilled with clay from the foundation excavation (No clay will be imported to the area) up to the elevation of the top of the granular fill (presumed rail bedding materials) around the perimeter of the eastern excavation. The clay was inspected, no signs of impact, and screened with a PiD, all readings were 0.; and

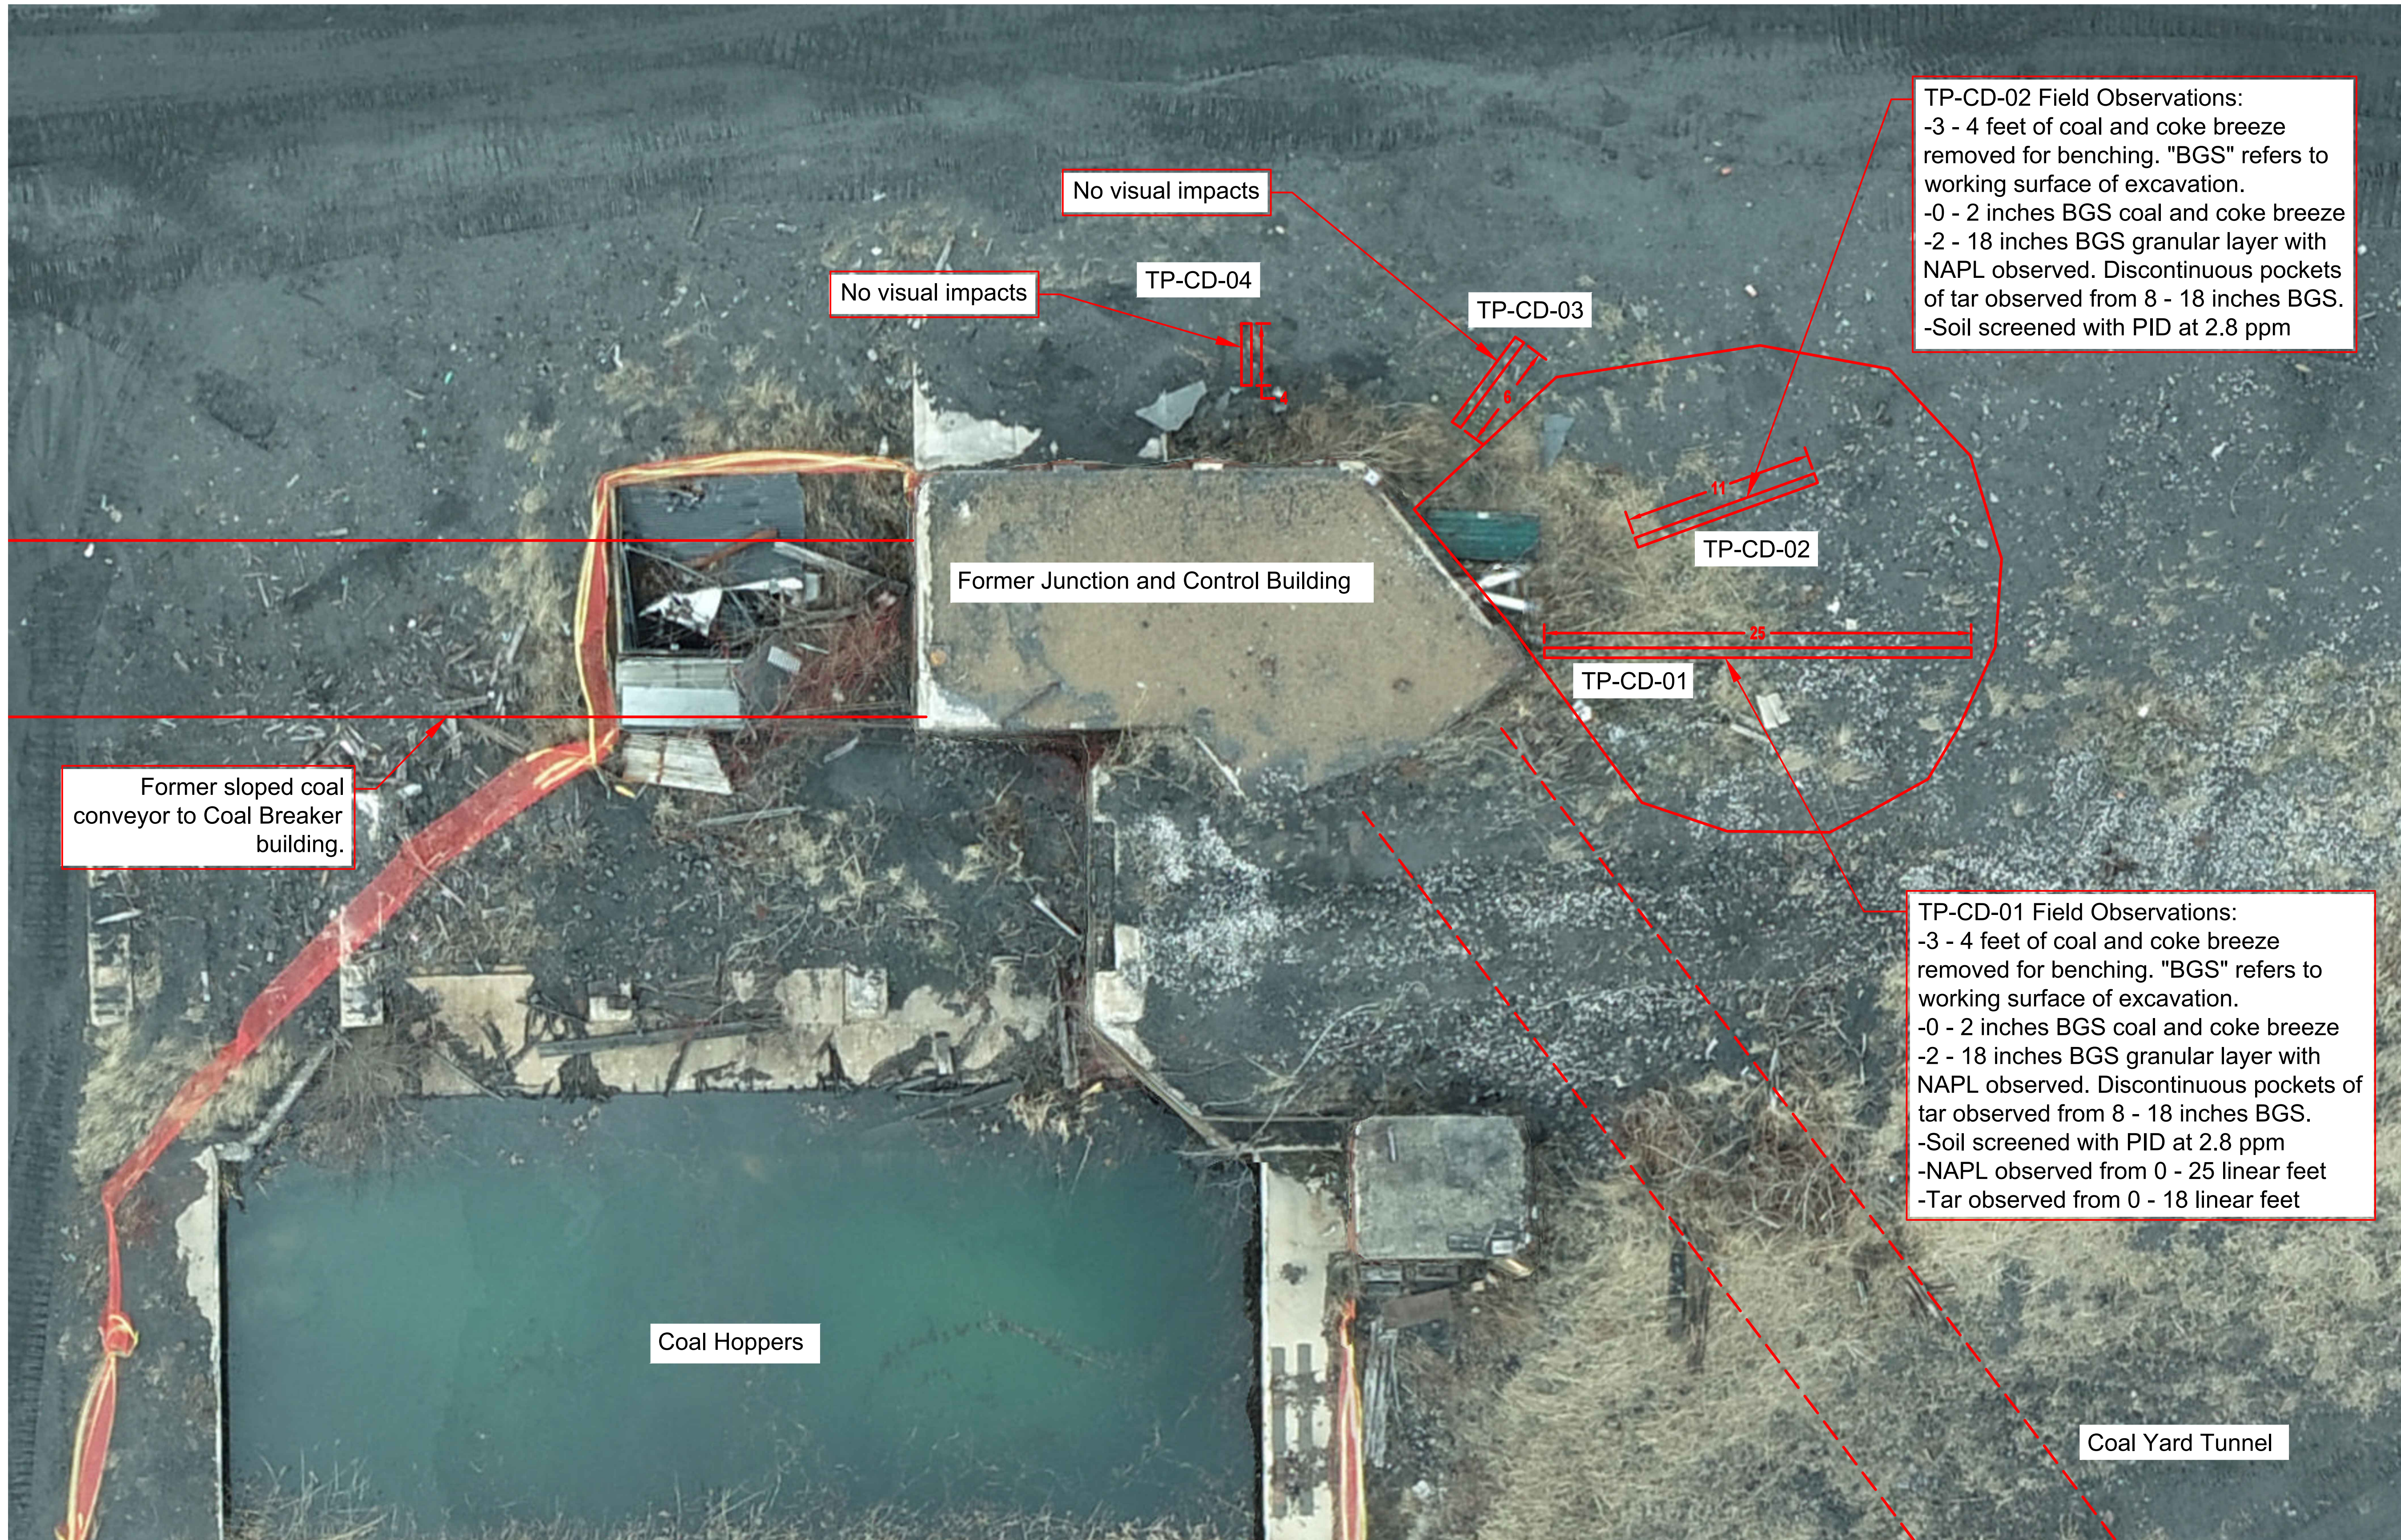
FIGURE 2

- No underground tank or pipes were encountered.
- The NAPL may be from multiple releases or of different ages as some was a green color and other orange.
- The NAPL flowed from a layer of granular material that was placed over the clay. The granular material observed distinct from the overlying coke and breeze fill and the underlying clay.
- In the exploratory trench TP-CD-01 and TP-CD-02, a small amount of viscous tar and several sections (approximately 12-inches long) of mixed tar and coke were identified along with the NAPL (Figure 2).
- No NAPL was identified in the two northern exploratory trenches.

TP-CD-02 Field Observations:
 -3 - 4 feet of coal and coke breeze removed for benching. "BGS" refers to working surface of excavation.
 -0 - 2 inches BGS coal and coke breeze
 -2 - 18 inches BGS granular layer with NAPL observed. Discontinuous pockets of tar observed from 8 - 18 inches BGS.
 -Soil screened with PID at 2.8 ppm

TP-CD-01 Field Observations:
 -3 - 4 feet of coal and coke breeze removed for benching. "BGS" refers to working surface of excavation.
 -0 - 2 inches BGS coal and coke breeze
 -2 - 18 inches BGS granular layer with NAPL observed. Discontinuous pockets of tar observed from 8 - 18 inches BGS.
 -Soil screened with PID at 2.8 ppm
 -NAPL observed from 0 - 25 linear feet
 -Tar observed from 0 - 18 linear feet

No visual impacts

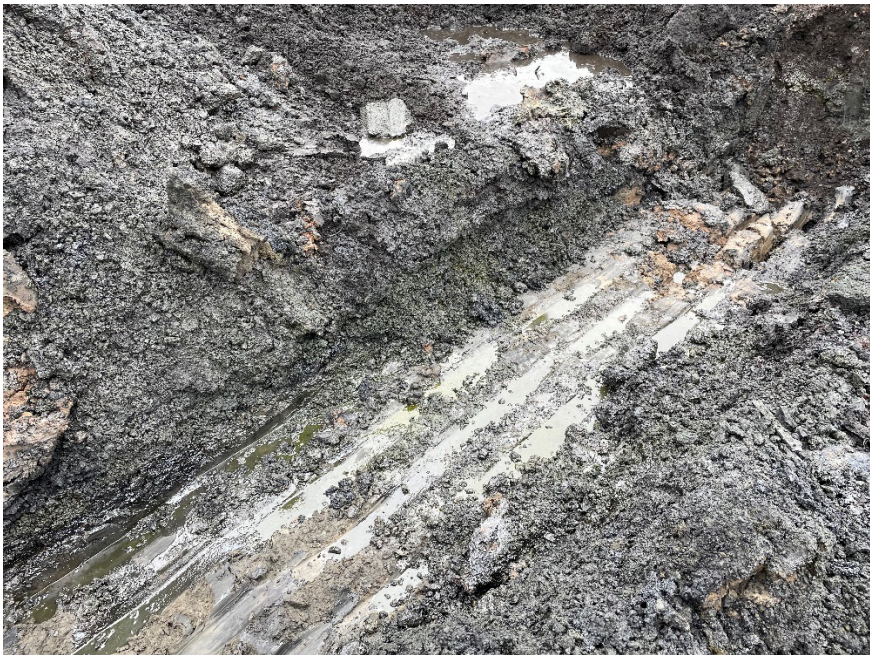
<p>Description: TP-CD-01</p>

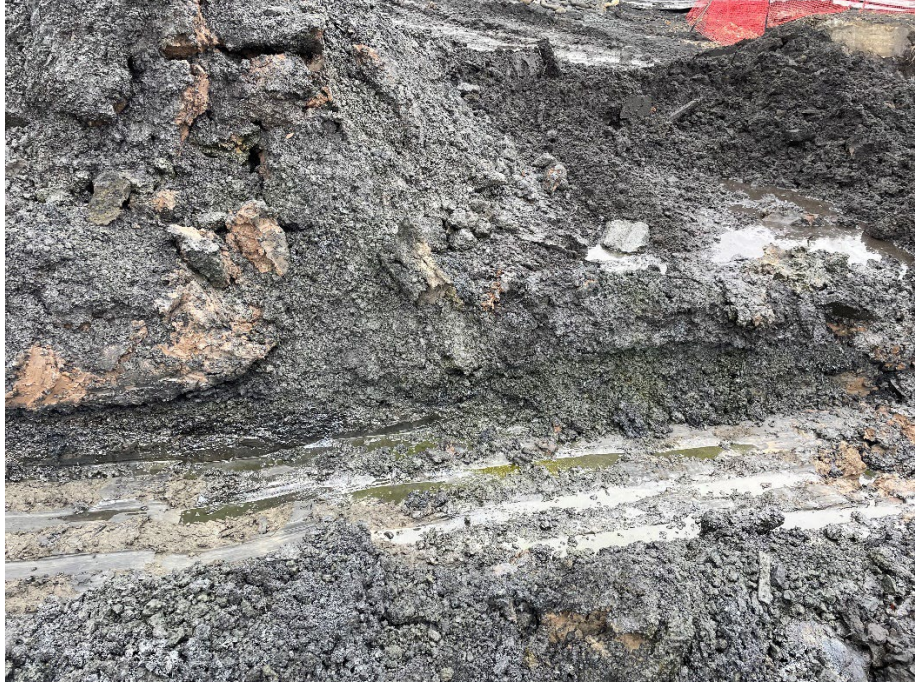
Client Name: Riverview	Date of Site Visit: January 10, 2023	Project: Riverview
Photo No. 3

Direction Photo Taken: Looking west		
Description: TP-CD-01		
Client Name: Riverview	Date of Site Visit: January 10, 2023	Project: Riverview
Photo No. 4

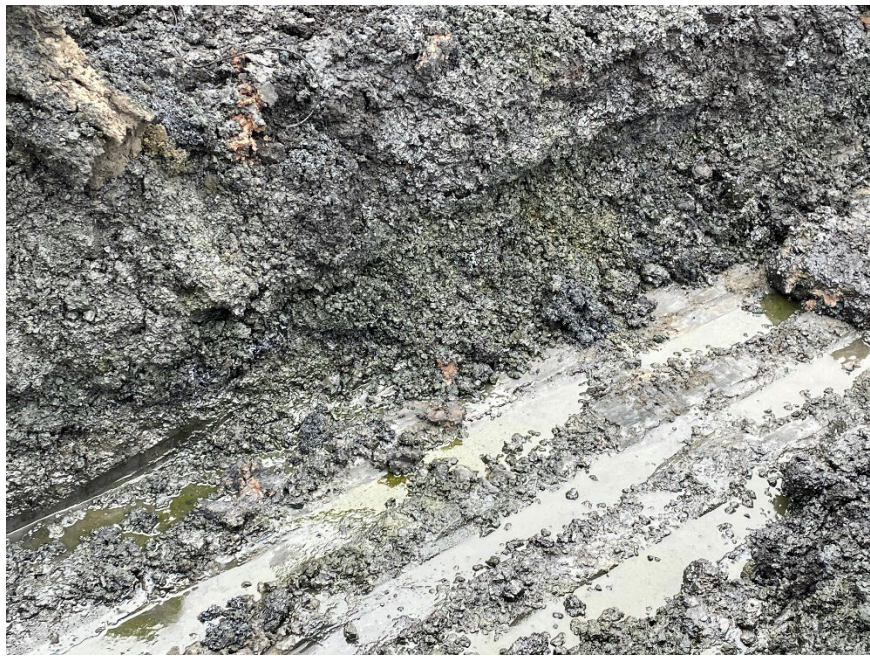
Direction Photo Taken: Looking southwest		
Description: TP-CD-01

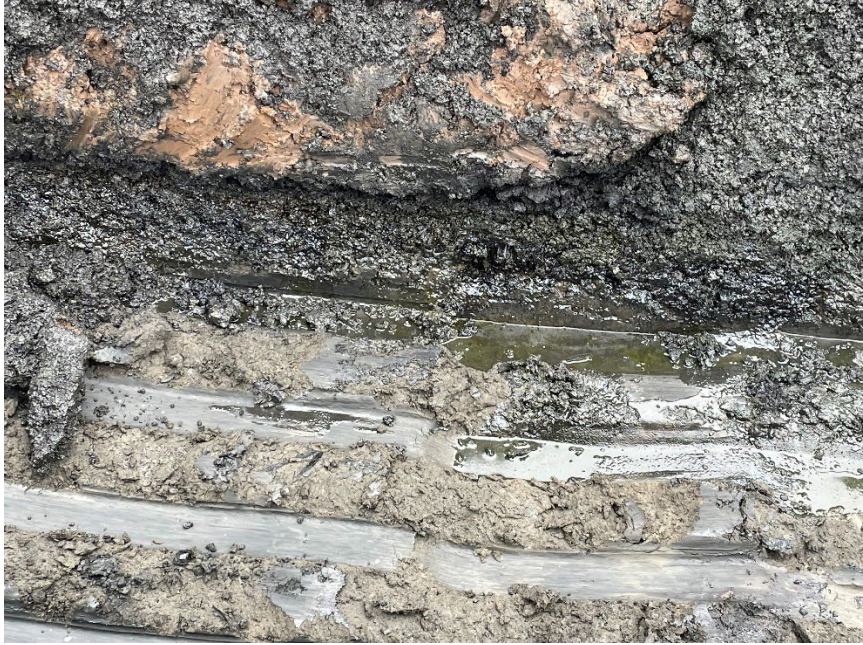
Client Name: Riverview	Date of Site Visit: January 10, 2023	Project: Riverview
Photo No. 5

Direction Photo Taken: Looking south		
Description: TP-CD-02		
Client Name: Riverview	Date of Site Visit: January 10, 2023	Project: Riverview
Photo No. 6

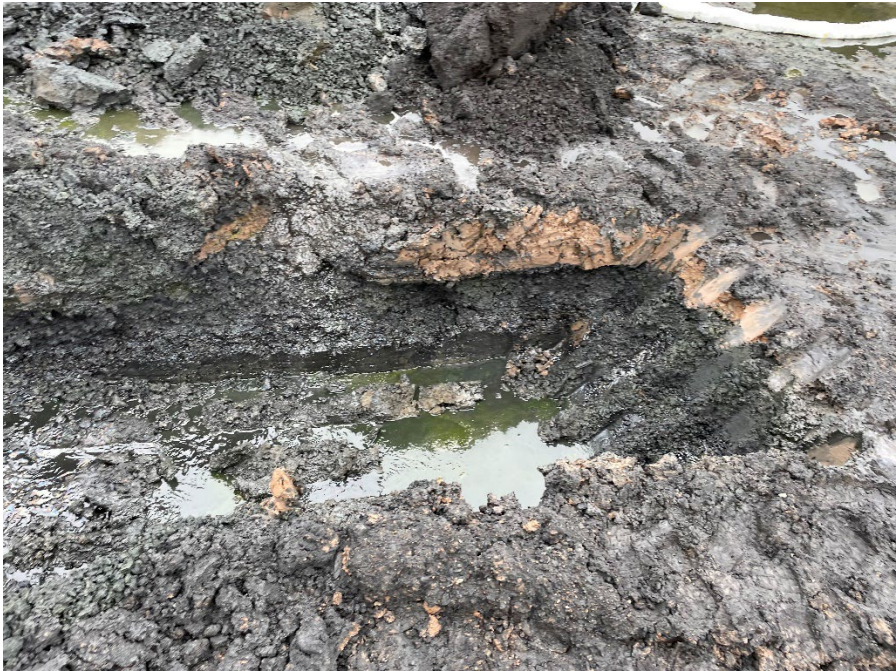
Direction Photo Taken: Looking south		
Description: TP-CD-02

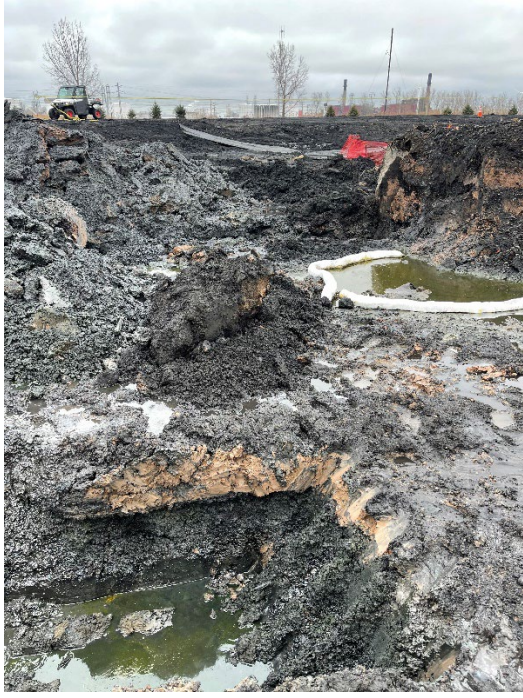
Direction Photo Taken: View looking south		
Description: TP-CD-02		
Client Name: Riverview	Date of Site Visit: January 10, 2023	Project: Riverview
Photo No.

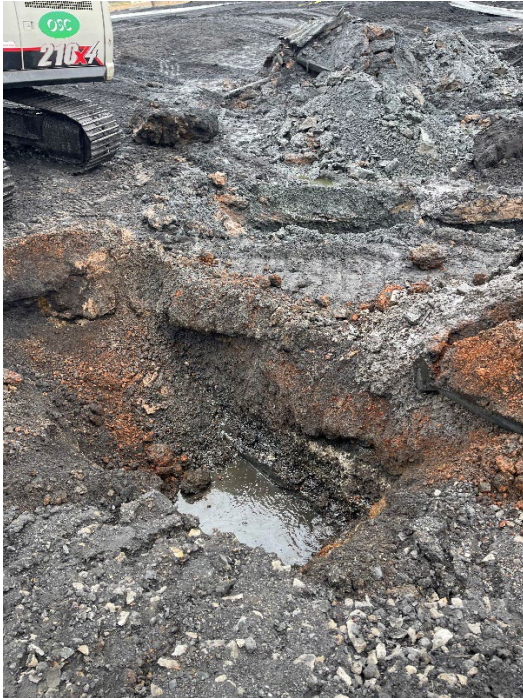
Direction Photo Taken: View looking southeast		
Description: TP-CD-03

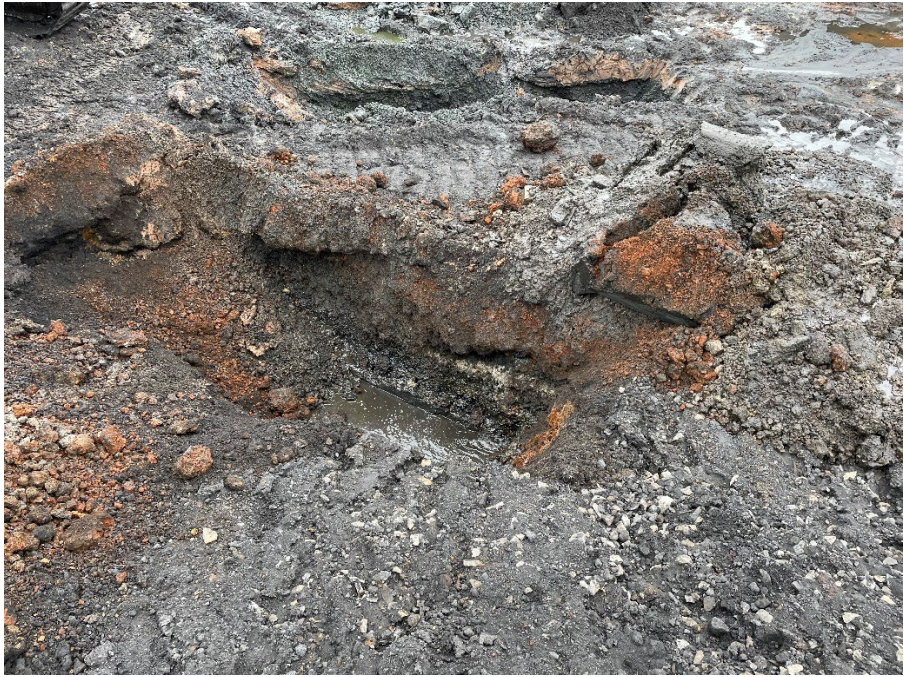
Client Name: Riverview	Date of Site Visit: January 10, 2023	Project: Riverview
Photo No. 15

Direction Photo Taken: View looking southeast		
Description: TP-CD-03		
Client Name: Riverview	Date of Site Visit: January 10, 2023	Project: Riverview
Photo No. 16

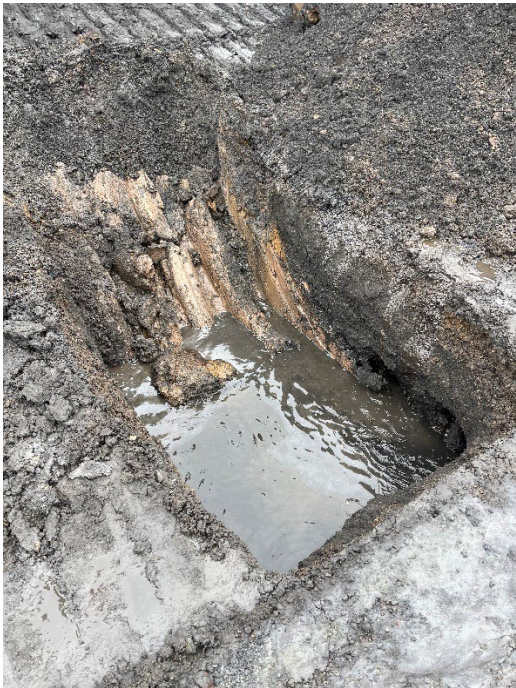
Direction Photo Taken: View looking northeast		
Description: TP-CD-04

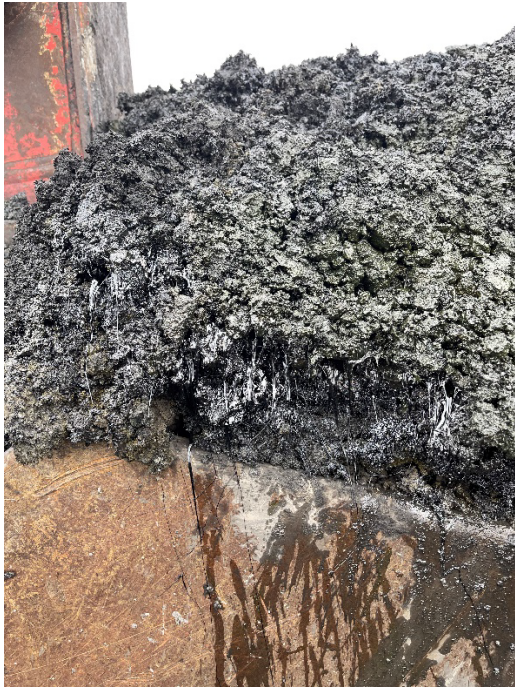
Client Name: Riverview	Date of Site Visit: January 10, 2023	Project: Riverview
Photo No. 15

Direction Photo Taken: View looking southeast		
Description: Tar impacted fill removed from TP-CD-01		
Client Name: Riverview	Date of Site Visit: January 10, 2023	Project: Riverview
Photo No. 16
