Phase I Environmental Site Assessment

750 East Ferry Street
Buffalo, New York

LaBella Project No. 2160590

March 16, 2016

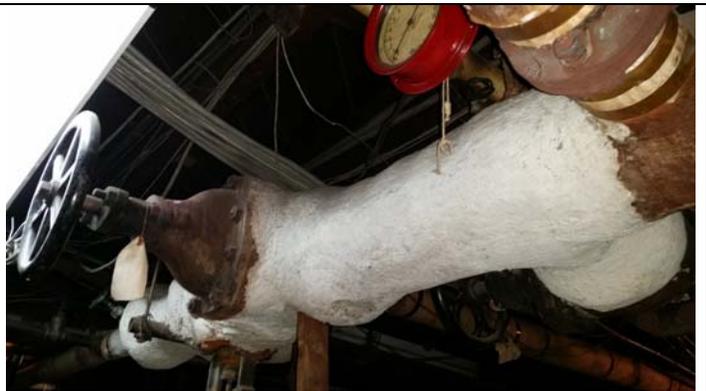
- Previous studies reported the presence of suspect asbestos containing materials (ACM) within several of the Site Building including materials such as pipe insulation, floor tile, tar and felt material, and transite. Astorino Branch Environmental, Inc. estimated a removal cost for the suspected ACM of approximately \$700,000 in 1993. LaBella observed suspect ACM at the time of the site visit consistent with that reported in the previous studies.
- Based on the age of the Site Buildings, there is the potential for lead based paint to be located on-site.

Suspected ACM in basement of Site Building 1

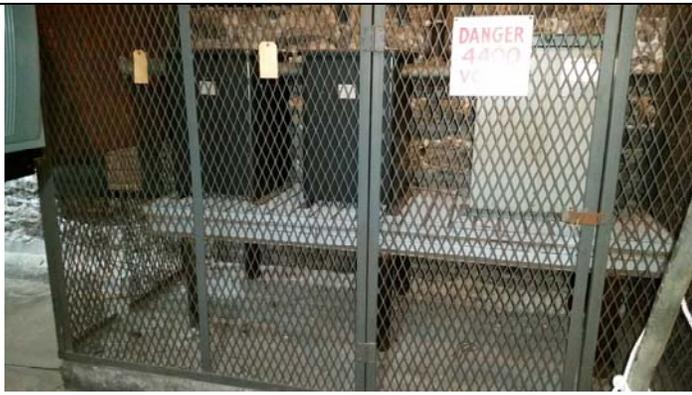
Transformers in basement of Site Building 1

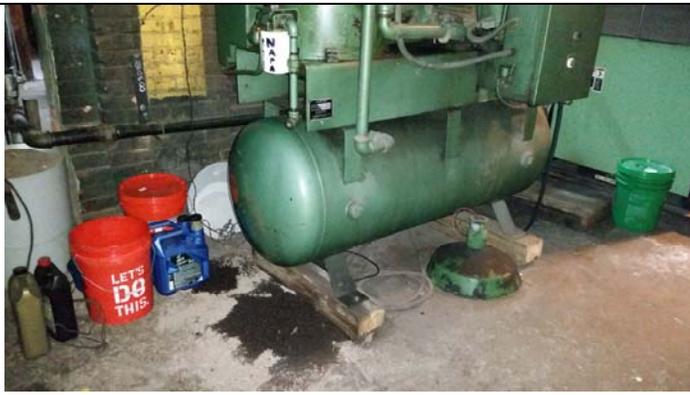
Leak near compressor in boiler room of Site Building 2

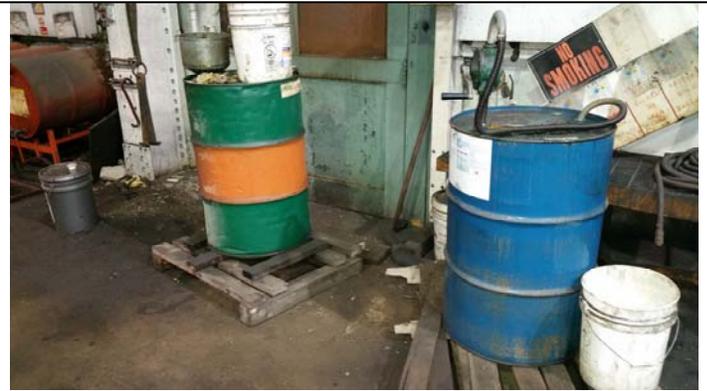
- The historical uses of the west adjacent properties as filling stations, automotive repair facilities, a machine shop, and an automotive junk yard.
- Staining observed at the time of the site visit proximate the 55-gallon drum storage/dispensing area in the Machine Shop portion of Site Buildings 2.

Drum storage/dispensing area in Machine Shop Main Floor portion of Site Building 2

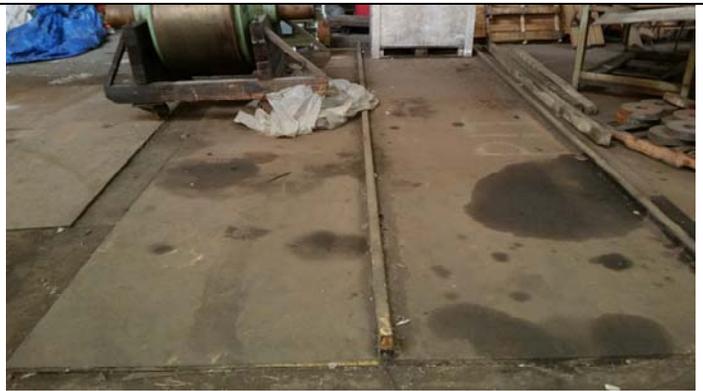
- The four reported pits located in the Fabricating Department portion of Site Building 2.
- The material observed at the bottom of the open pit in the Fabricating Department portion of Site Building 2 may contain hazardous material and petroleum products.

Covered pit in Fabricating Department portion of Site Building 2 used as storage

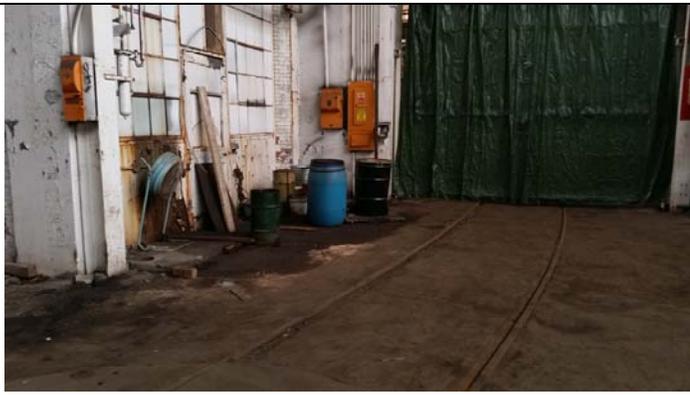
- Minor staining was observed proximate equipment in Site Building 2.
- Staining was observed in the boiler room and in the drum storage room.
- Various unused drums are located within the drum storage room and north of Site Building 3.

Drum area with staining at west end of Fabricating Department portion of Site Building 2

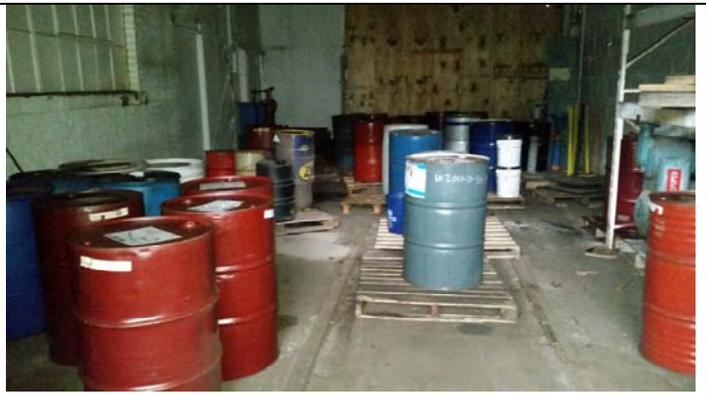
Drum storage room at west end of Fabricating Department portion of Site Building 2

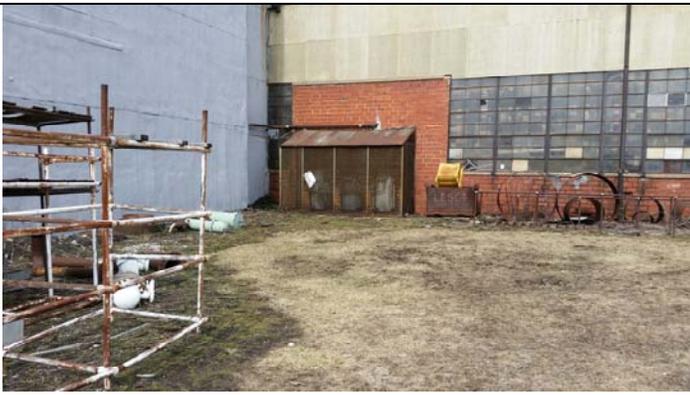
Transformers east of Storage Building & Receiving portion of Site Building 2

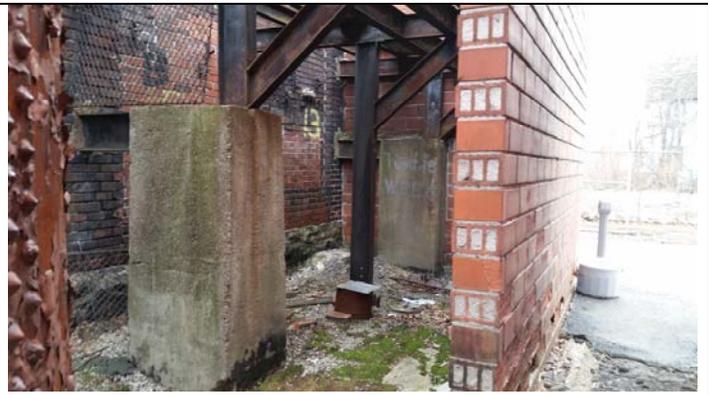
- Several transformers were historically present at the Site and were confirmed to contain polychlorinated biphenyl (PCB) oil. Stained soil consistent with the release of PCB oil was reported proximate the transformers. Soil samples collected for laboratory analysis in 1993 and 2001 from the Site identified PCBs at concentrations exceeding NYSDEC Part 375 Industrial Soil Cleanup Objectives in one soil sample collected. Although no other significant PCB concentrations were reported in the other soil samples collected for laboratory analysis, the laboratory analysis results cannot be relied upon as all laboratory results are not included within

Former transformer location west of Site Building 2

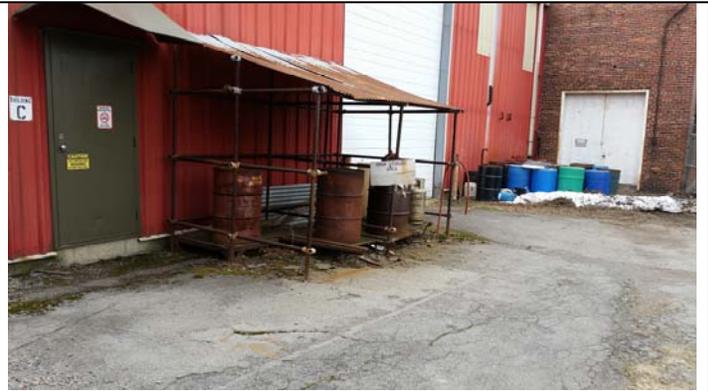
Drum storage north of Site Building 3

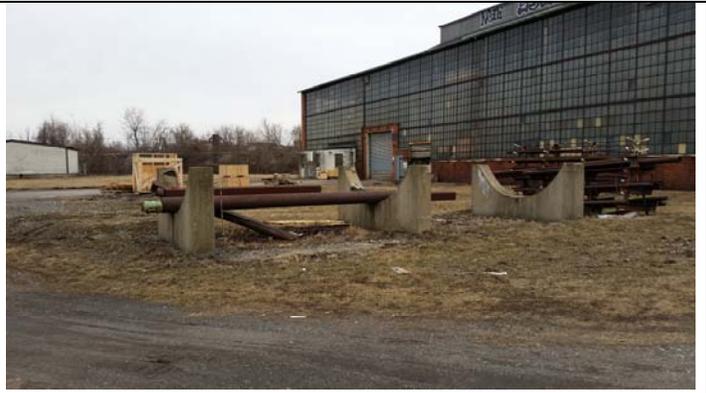
Concrete cradles and containment for removed 20,000-gallon AST west of Site Building 2
