March 8, 2013  
File No.: 21.0056546.00

Re: Storm Sewer Sampling Report  
BCP Sites # C932138, C932139, C932140  
GM Components Holdings  
200 Upper Mountain Road  
Lockport, NY 14094

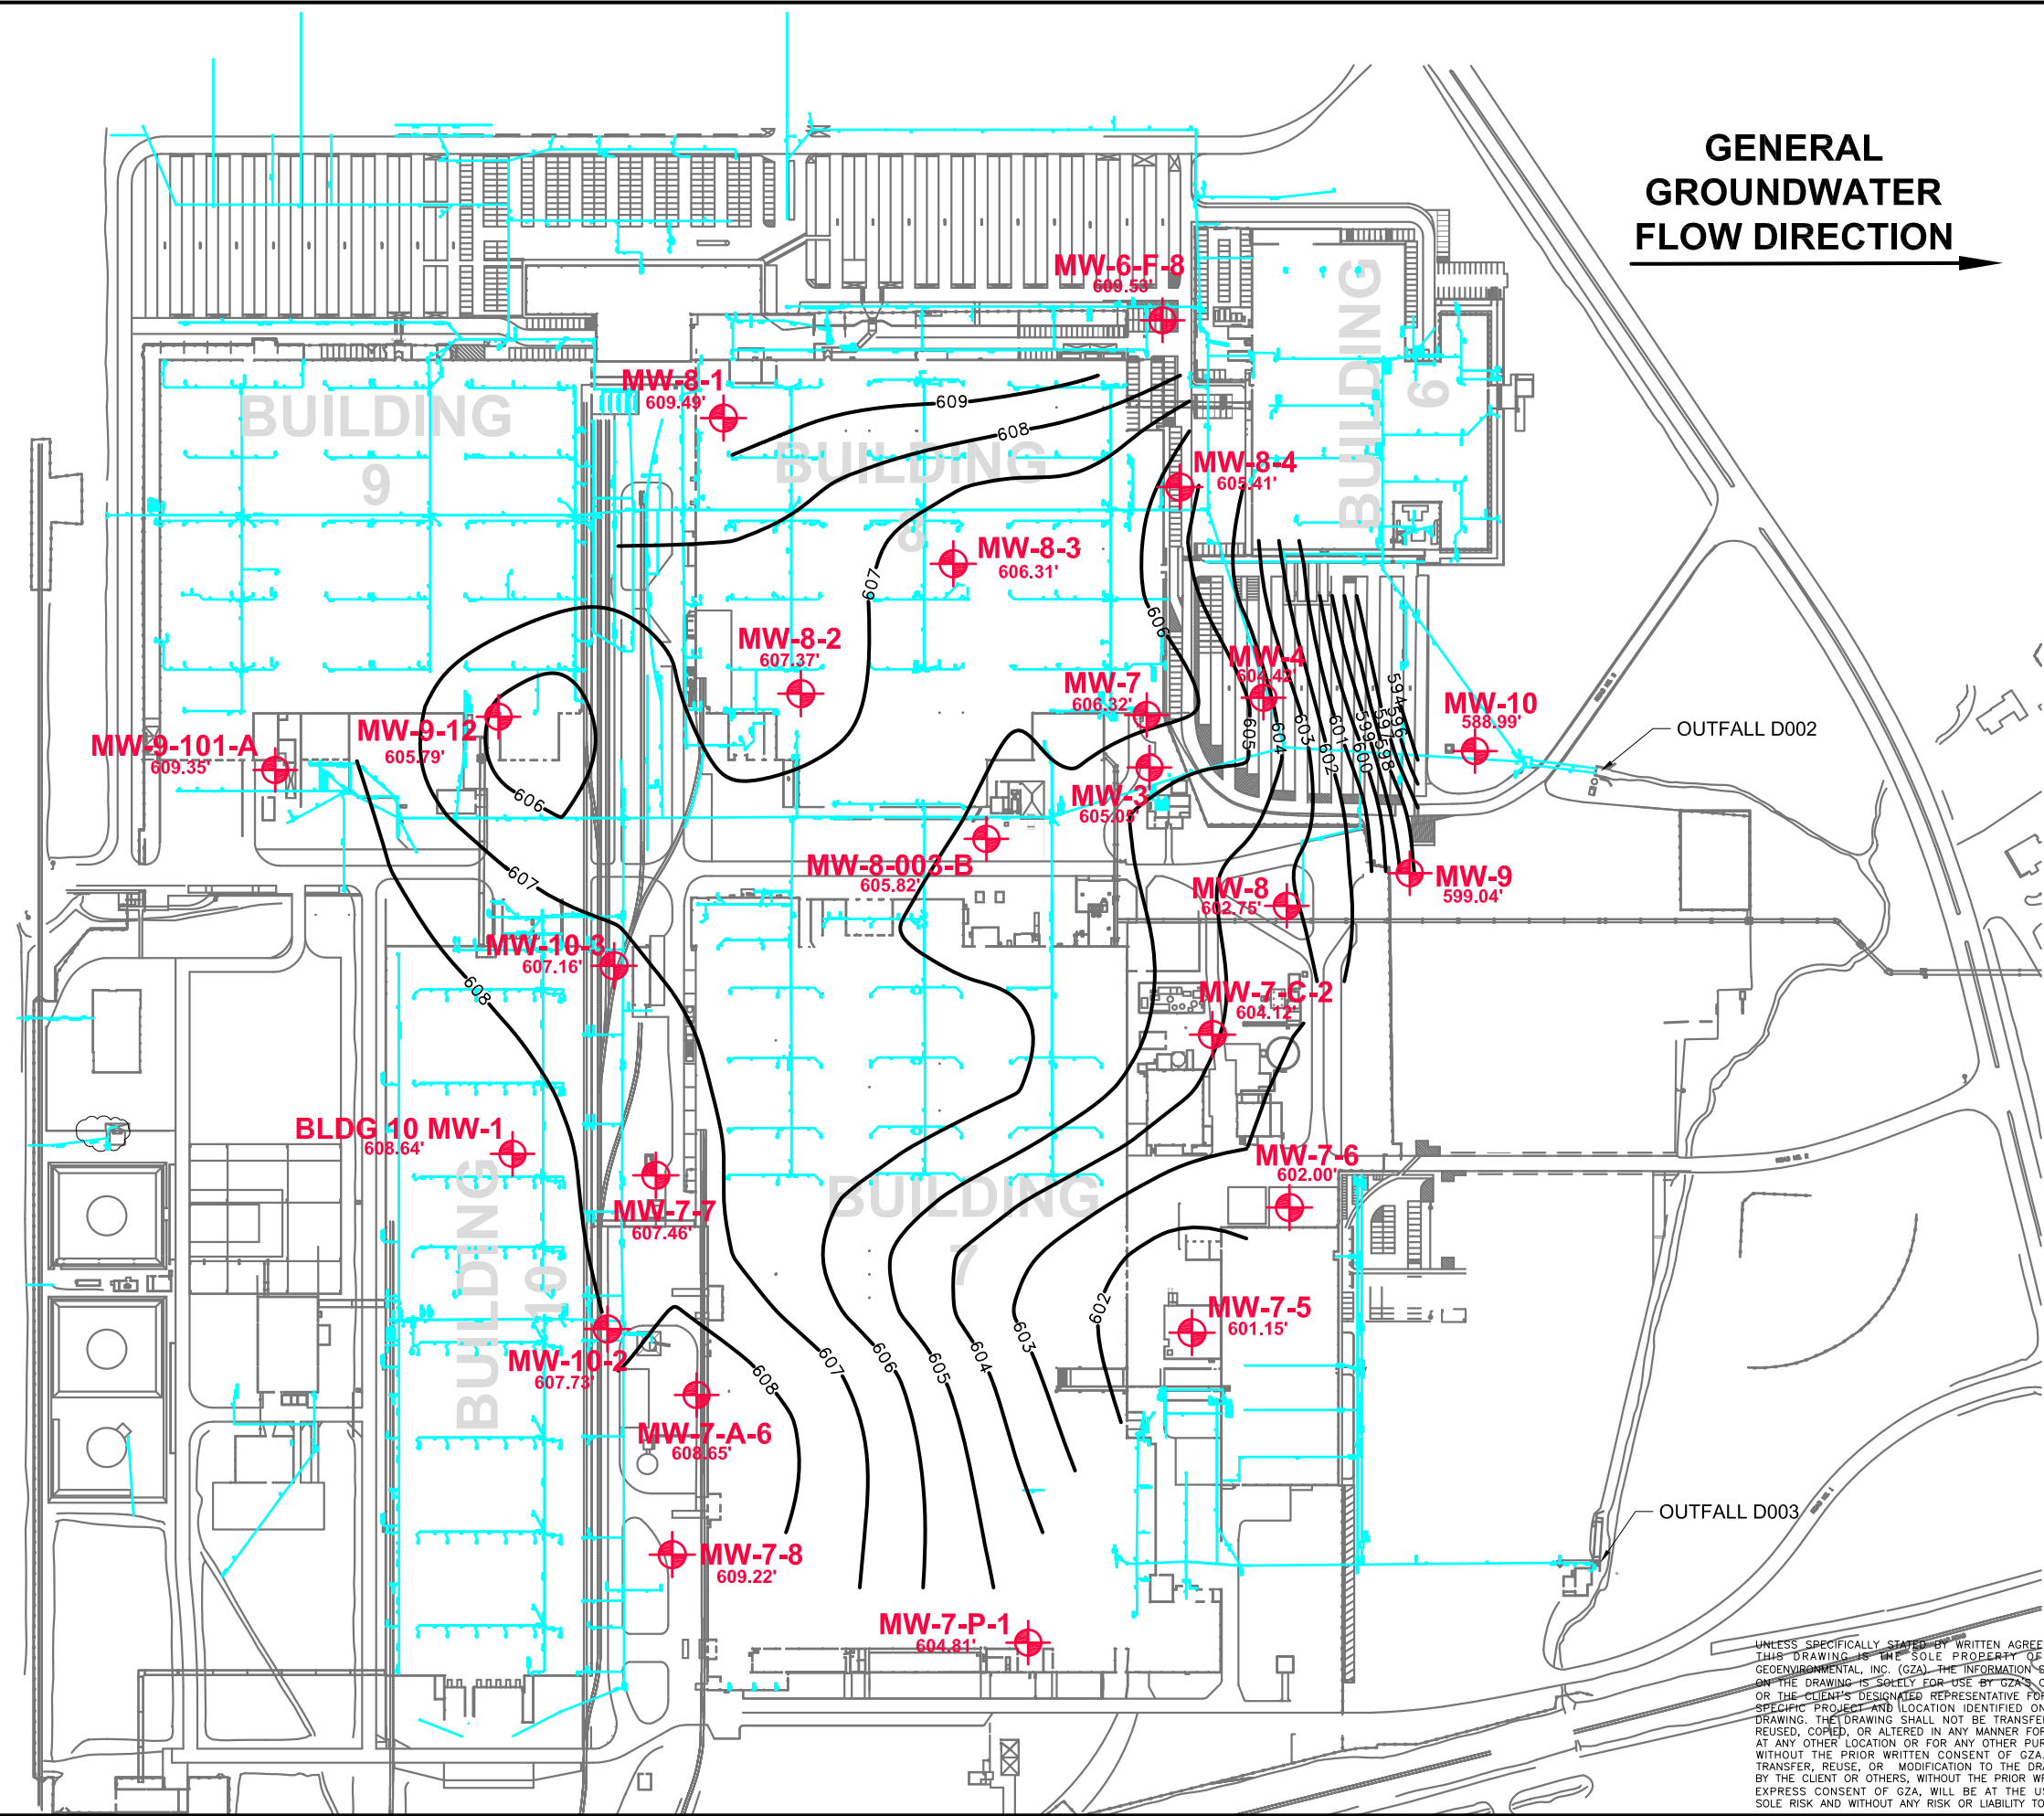
Groundwater elevations were measured at select monitoring wells within the storm sewer sampling area after the first sampling event. The groundwater measurements are depicted as groundwater contours shown on Figure 2. A comparison was done of the groundwater contours and the elevations of the various storm sewer components. The storm sewer component elevations were determined from a drawing provided by GMCH or from measurements collected from select components in the field. These elevations are provided on Table 1. The portions of the storm sewer system highlighted in orange on Figure 3 represent portions of the system that are located at or below the groundwater elevation based on the comparison completed.

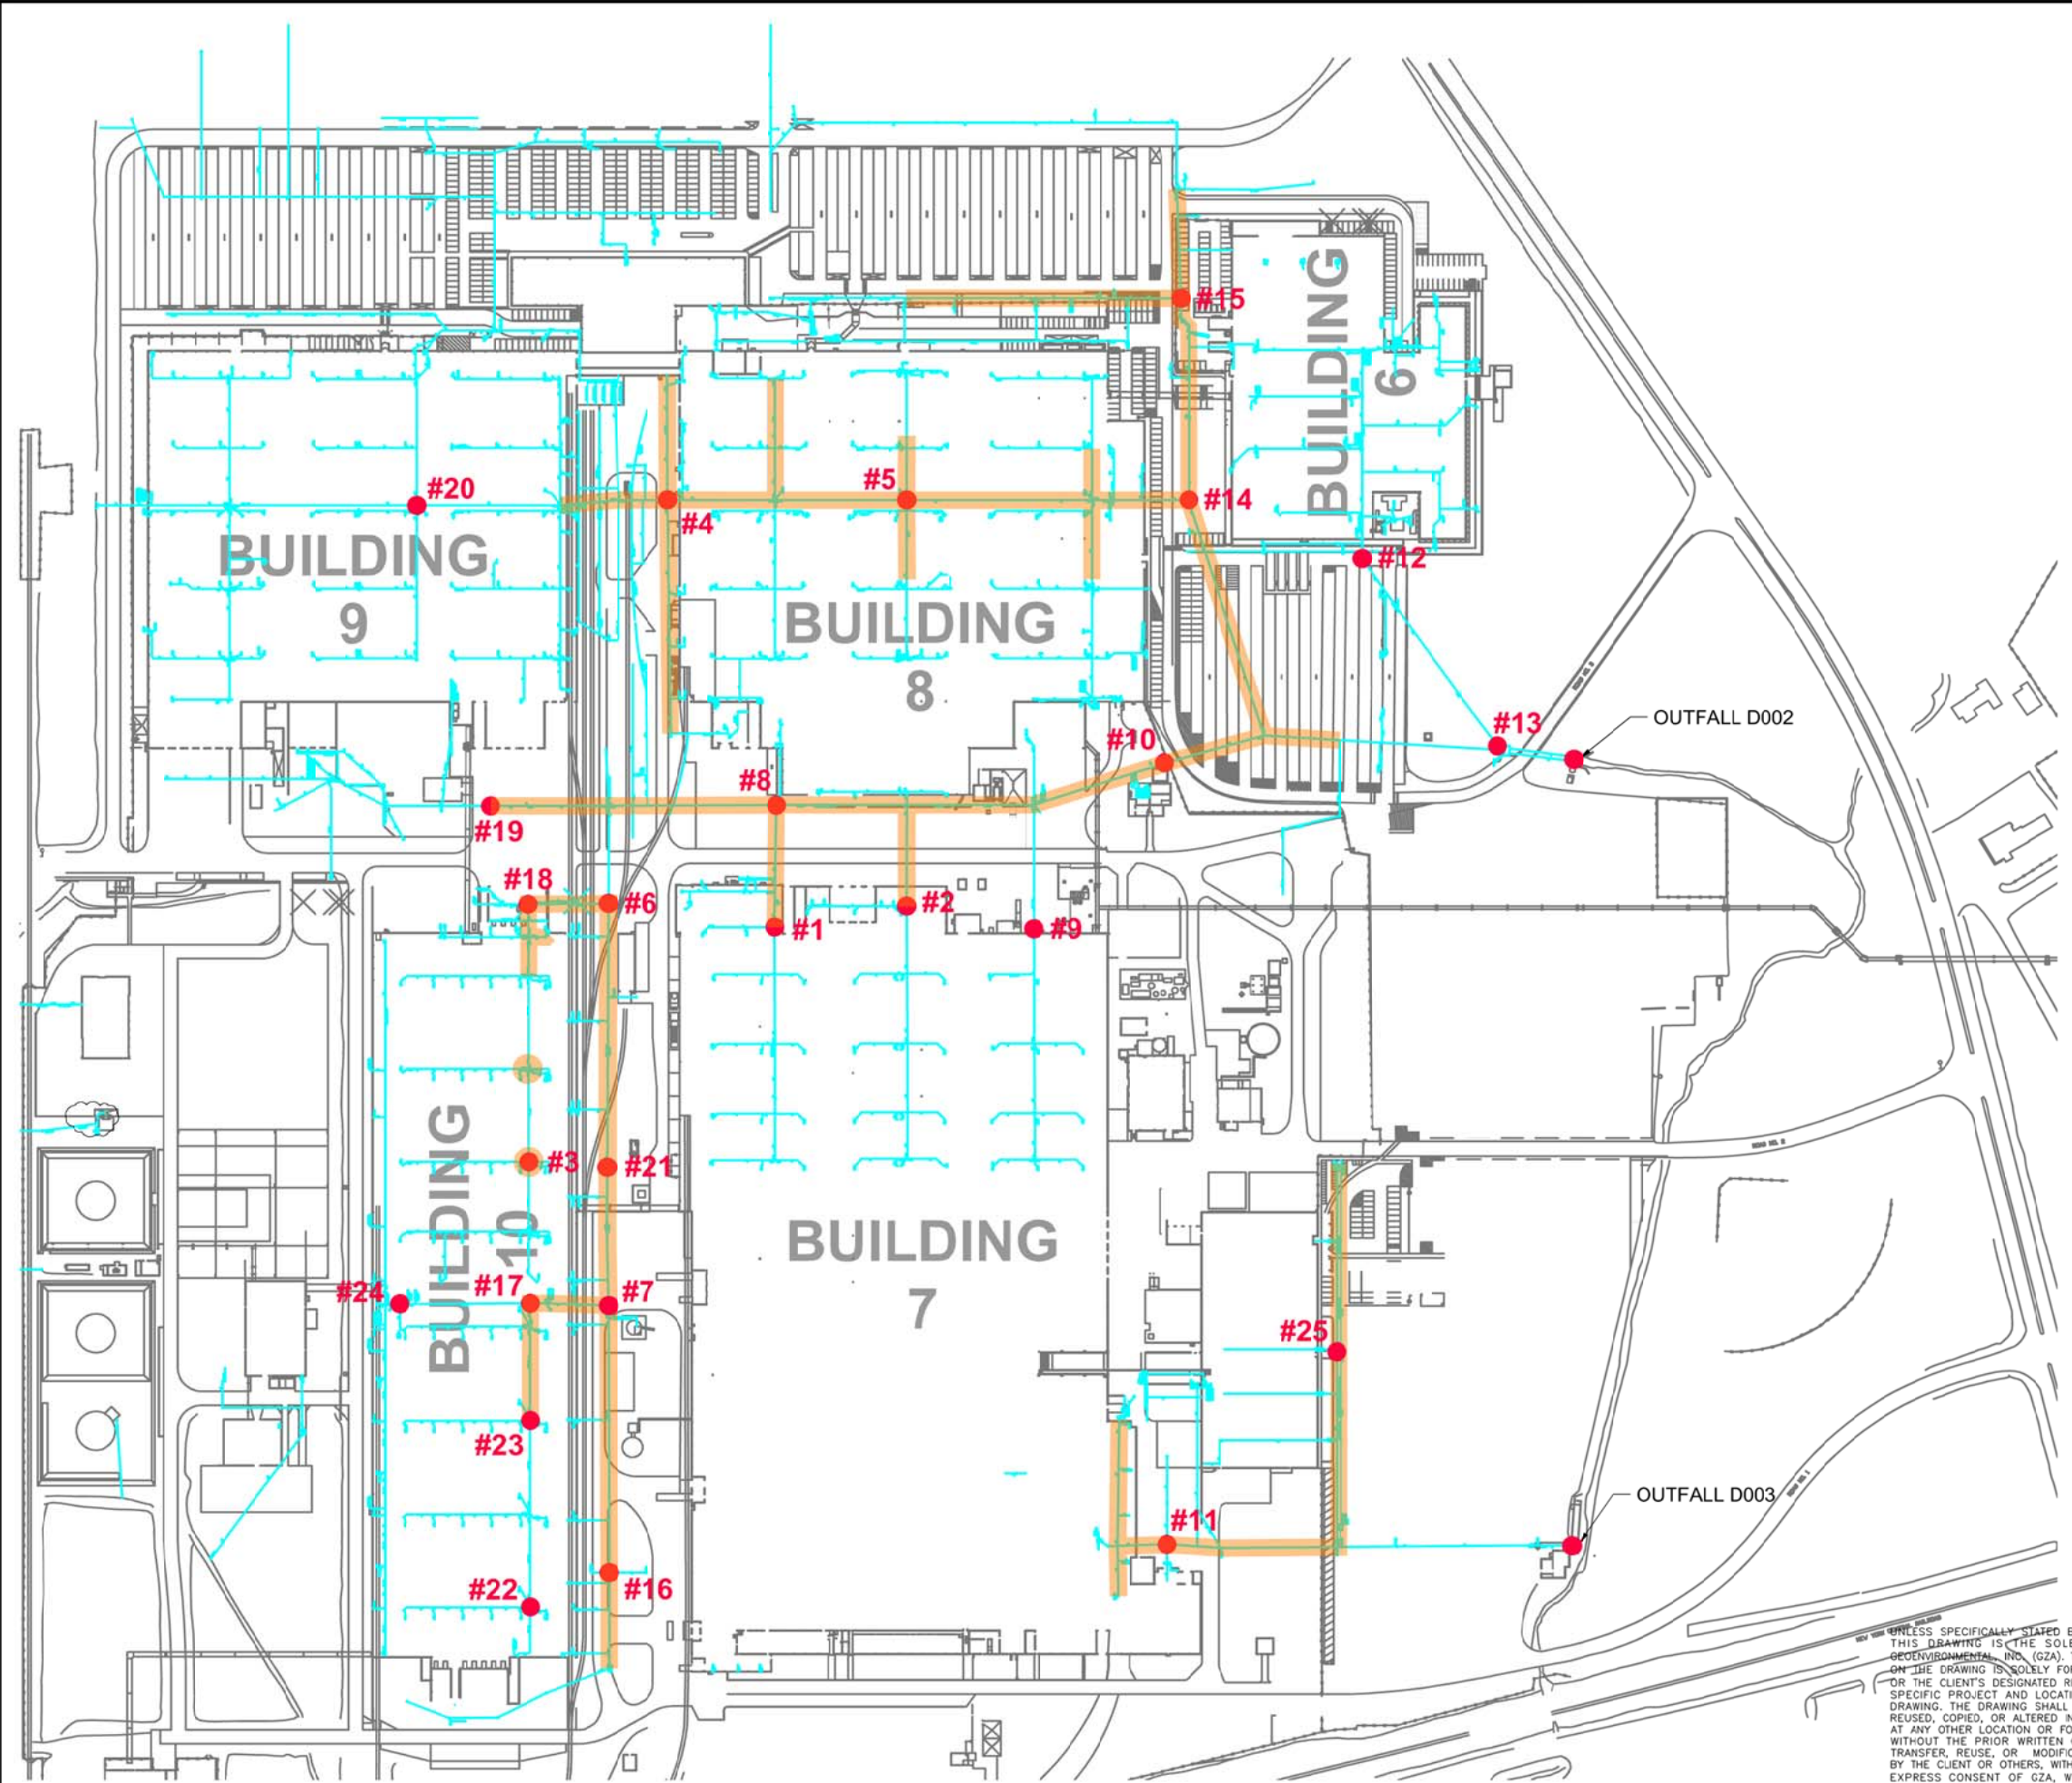
NO.	ISSUE/DESCRIPTION	BY	DATE
<b>LOCKPORT FACILITY</b> 200 UPPER MOUNTAIN ROAD LOCKPORT, NEW YORK			
<b>STORMWATER LOCATIONS AND STORM SEWERS AT OR BELOW GROUNDWATER</b>			
PREPARED BY:

The storm sewer sampling discussed in this report occurred in three (3) events. A total of 26 different storm sewer structures were sampled as shown on Figure 3. The sampling events were not conducted after significant storm water runoff was generated or during snow melt. Water at Outfalls D002 and D003, at the time of the sampling events, was being diverted to the Lockport POTW under low-flow conditions.

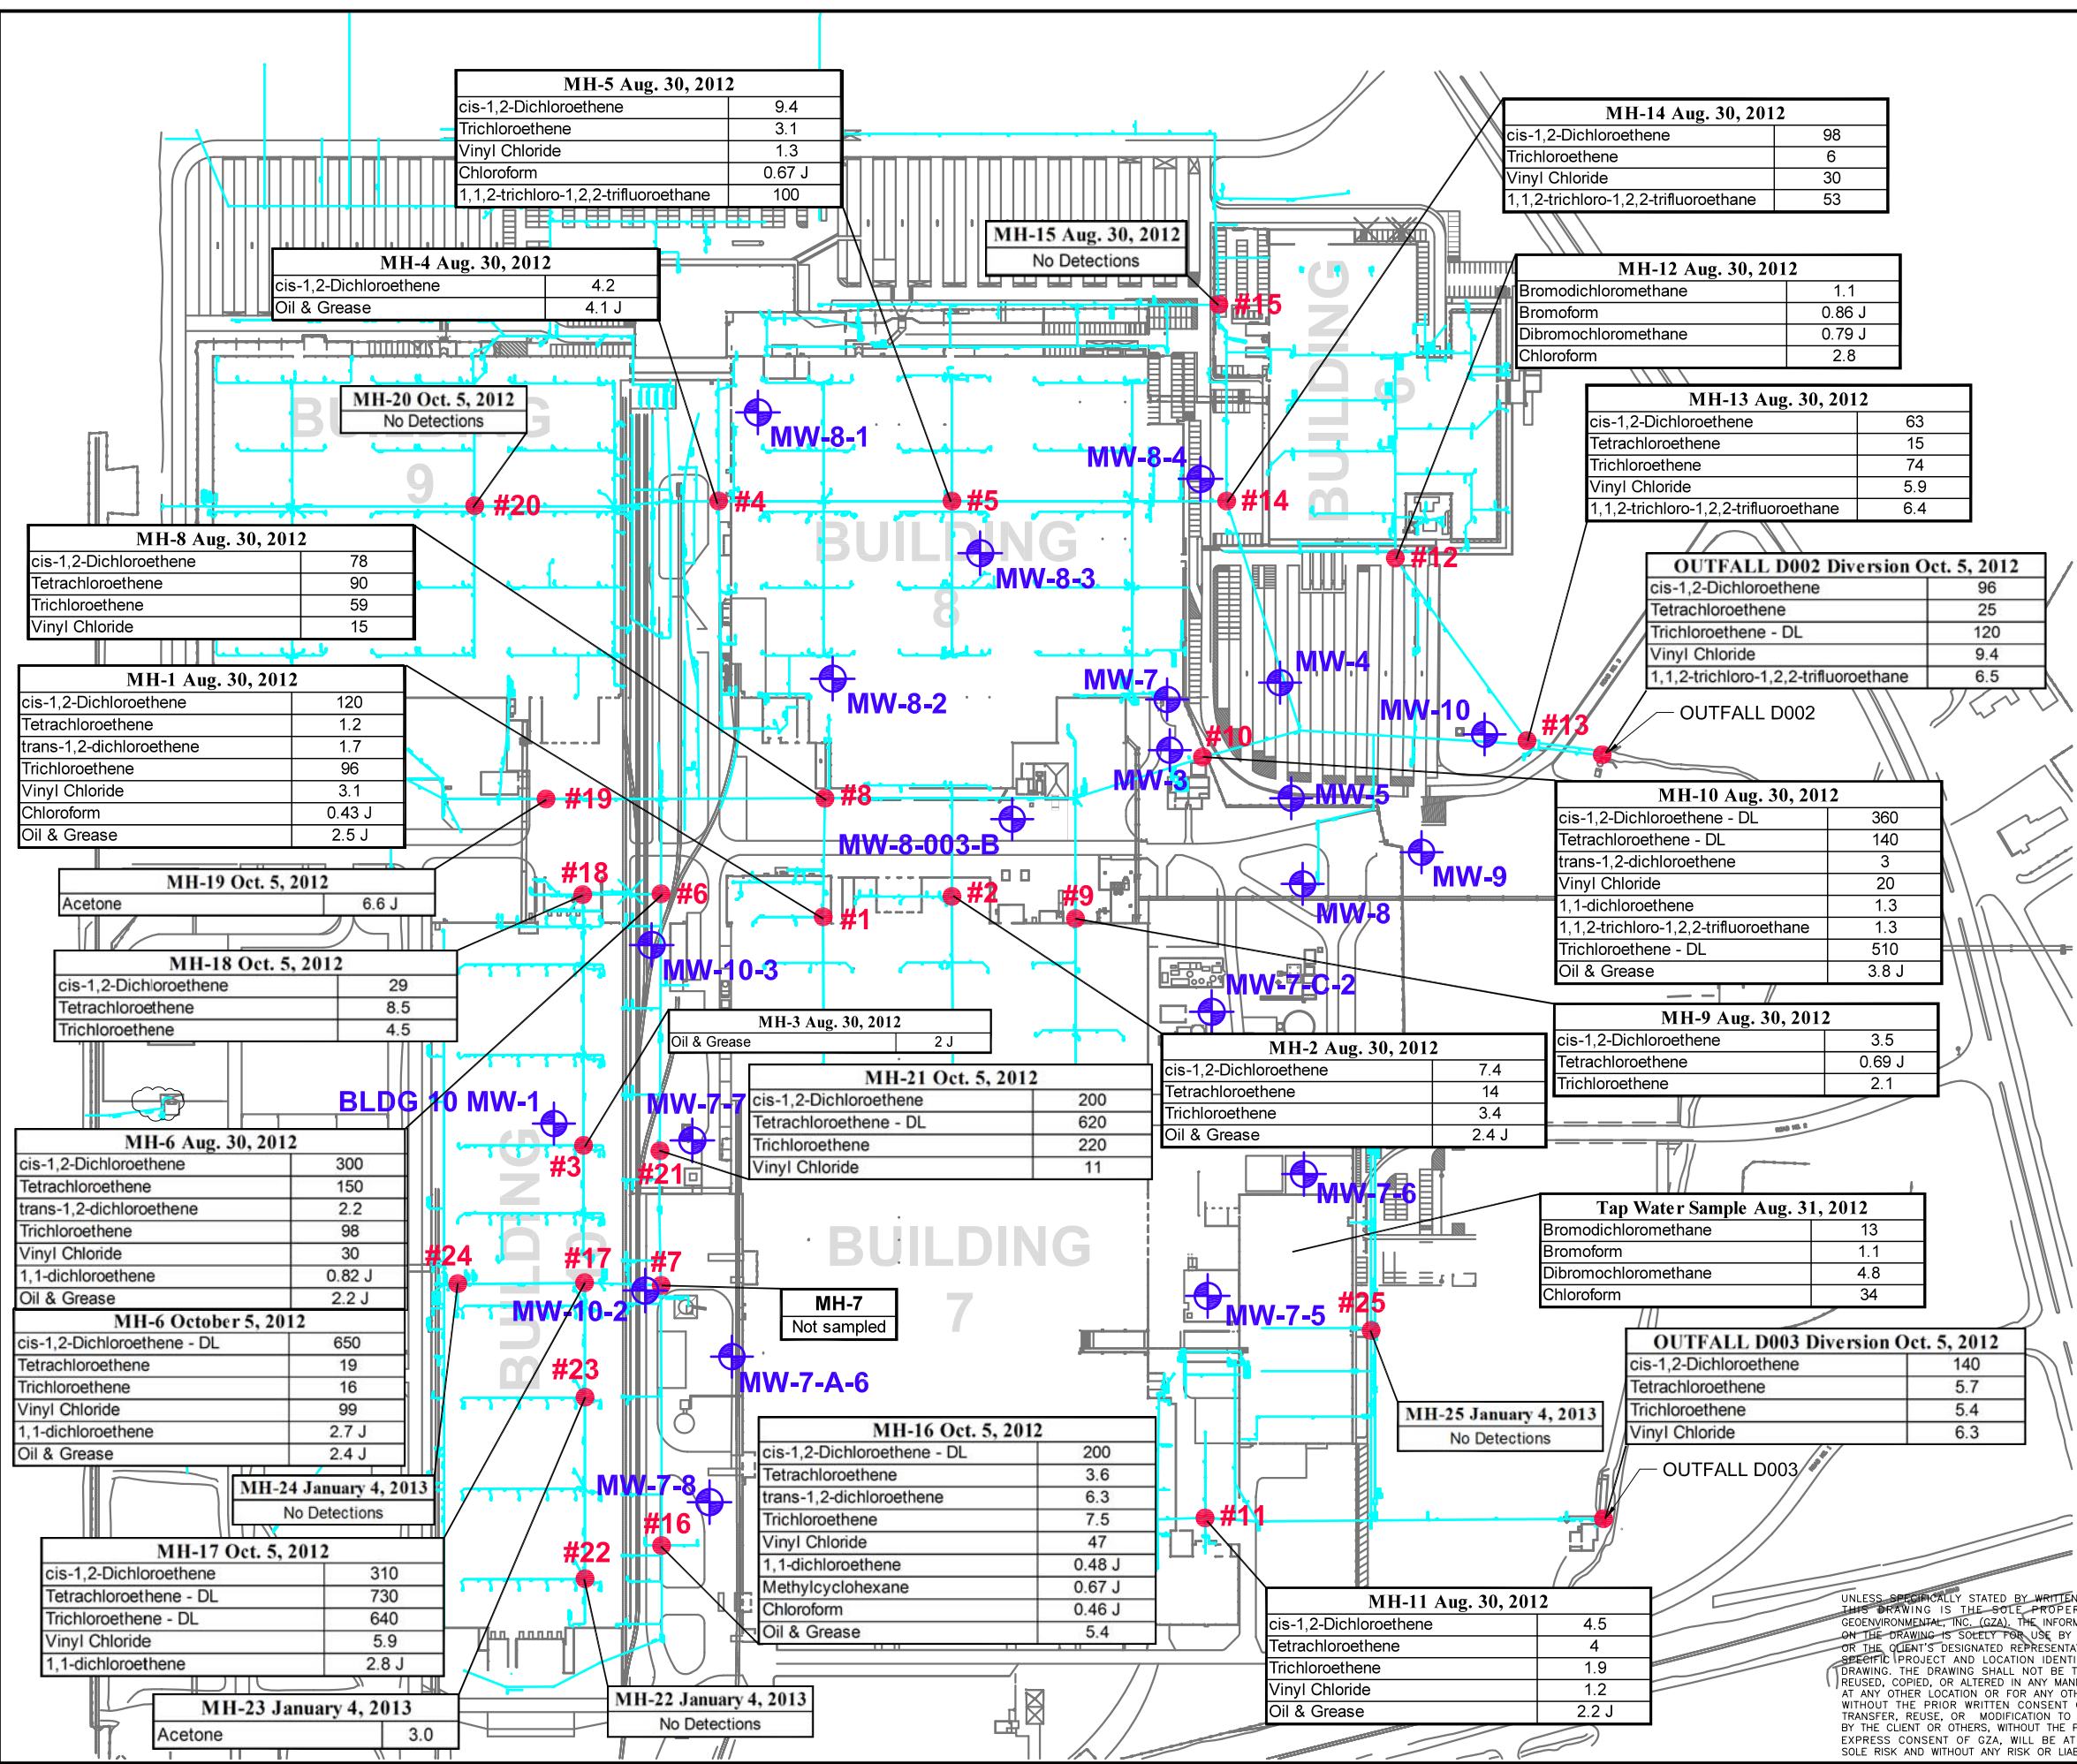
COCs were detected in 17 of the 26 storm sewer locations sampled as part of the storm sewer investigation. The analytical results are summarized on Figure 4. Figure 5 identifies the locations where COCs were detected in the storm sewer locations sampled.

The highest total COC concentrations, those greater than 500 ppb, were detected at four (4) sampling locations.

- MH-6 (581 ppb), MH-17 (1,689) and MH-21 (1,051) are associated with the storm sewer servicing Building 10 and the area between Buildings 7 and 10. Elevated concentrations of COCs have been detected in the monitoring well inside Building 10 (MW-10-1) and five (5) wells located between Building 7 and 10 (MW-7-A-6, MW-7-7 MW-7-8, MW-10-2 and MW-10-3). There is a potential that the elevated COCs detected at MH-6, MH-17 and MH-21 is due to groundwater infiltration and should be further evaluated. We note that there was no flow into MH-17 at the time of the sampling. The detections of the COCs in MH-17 may be due to impacted sediment in the bottom of the structure or infiltration into the manhole itself.

- MH-10 (1,033 ppb) is located along the main west-east orientated storm sewer line running through the GMCH facility located near the southeast corner of Building 8. Storm water from Building 10, northern portion of Building 7, southern portion of Building 8 and exterior storm water runoff from between the main buildings flow through MH-10.

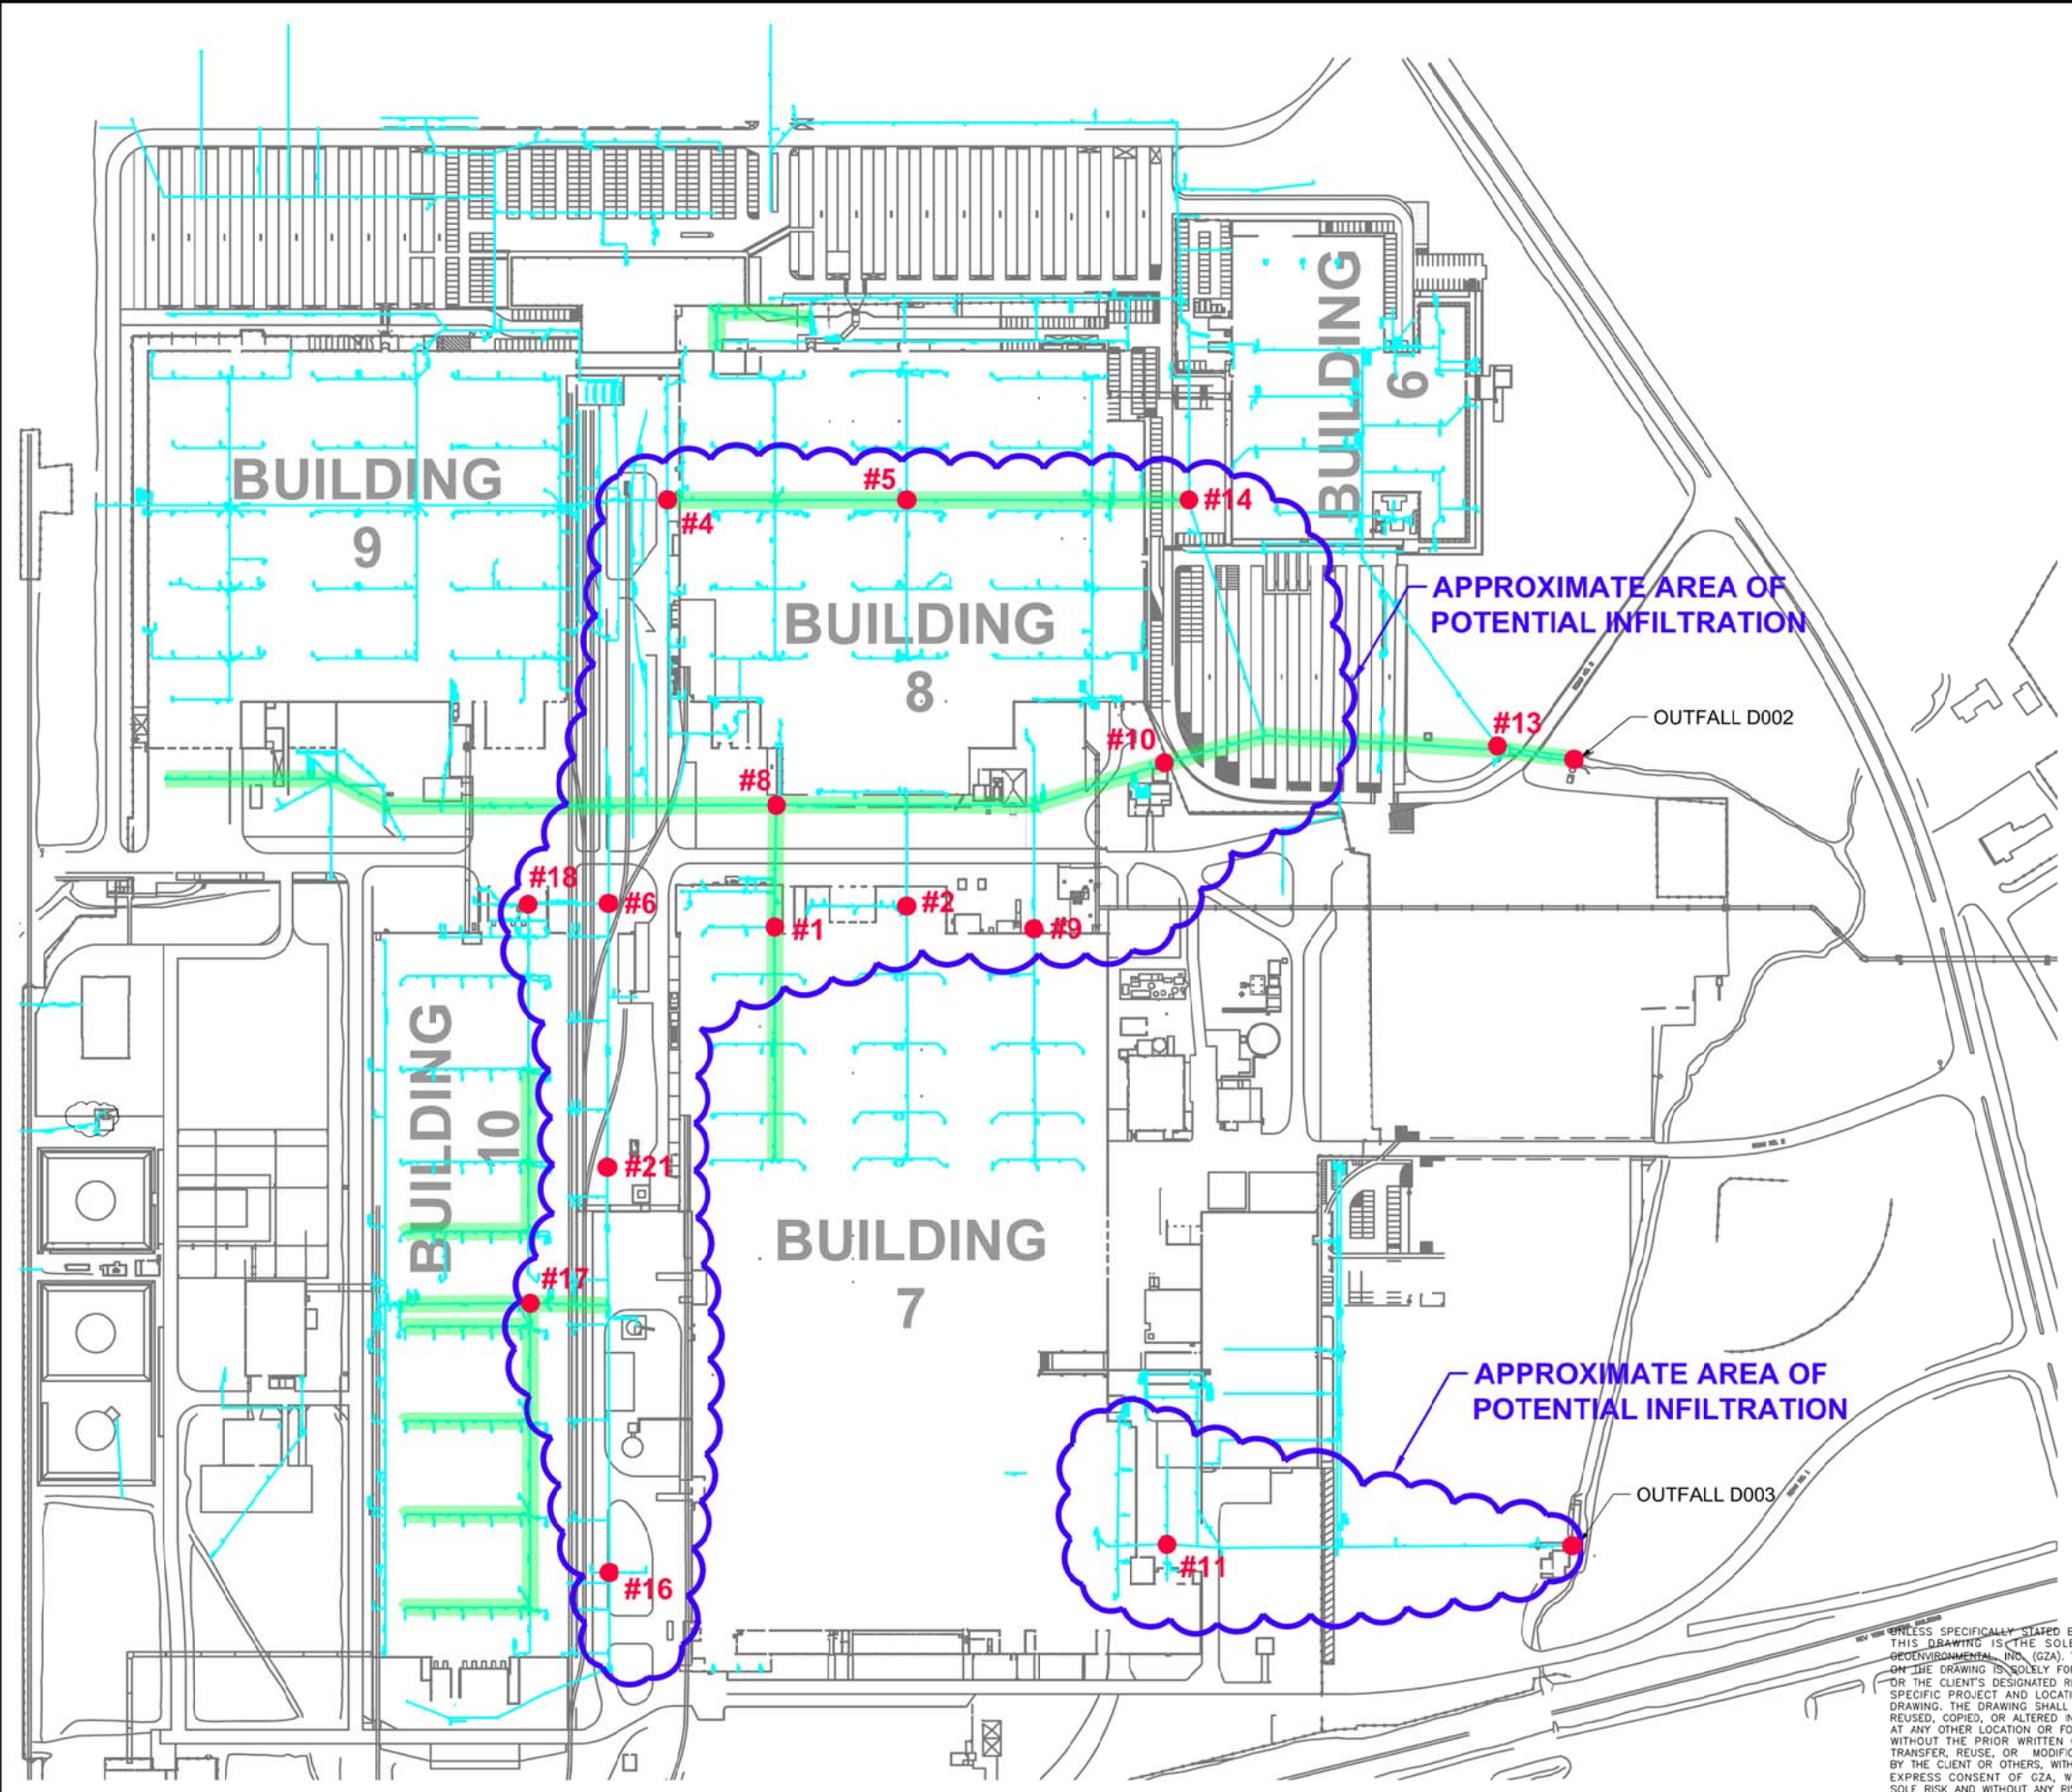
Although not part of the work plan, GMCH provided GZA with storm sewer videos for review. The videos were from storm sewer inspections completed between May 1994 and May 2002 by various contractors. Figure 5 identifies the approximate location of the storm sewer lines that were video inspected (shown in green). GZA reviewed the videos to assess the conditions of the storm sewers at the time of the video and if groundwater infiltration is potentially occurring. The quality of the videos reviewed varied. Review of the videos identified the following.

- Grout at pipe connections was in poor condition or missing.
- Pipe joint separation.
- Infiltration from pipe bedding from pipe lateral crossing storm sewer.
- Infiltration at section of missing pipe wall.
- Sediment or standing water within pipes.
- Infiltration into manhole from pipe bedding beneath pipe.
- Longitudinal cracks in pipes.

Based on the storm sewer sampling results and the groundwater elevations in the vicinity of the structures sampled, groundwater infiltration is likely occurring at some locations. The areas of potential groundwater infiltration are shown on Figure 5. Existing storm sewer video review indicated infiltration is potentially occurring at pipe joints, missing pipe wall sections, or cracks in the pipes within the storm sewer system.

We recommend conducting additional investigations. These additional investigations will include:

- storm sewer sample collection during high-flow conditions; and
- detailed investigation of the storm sewer system associated with Building 10 and the area between Buildings 7 and 10.
