FRONTIER TECHNICAL ASSOCIATES INC.

**TANK CLOSURE REPORT
FOR
UNDERGROUND STORAGE TANK
AT
EKONOL FACILITY
SAINT-GOBAIN PERFORMANCE PLASTICS**

**July 18, 2000
ET-778-03.**

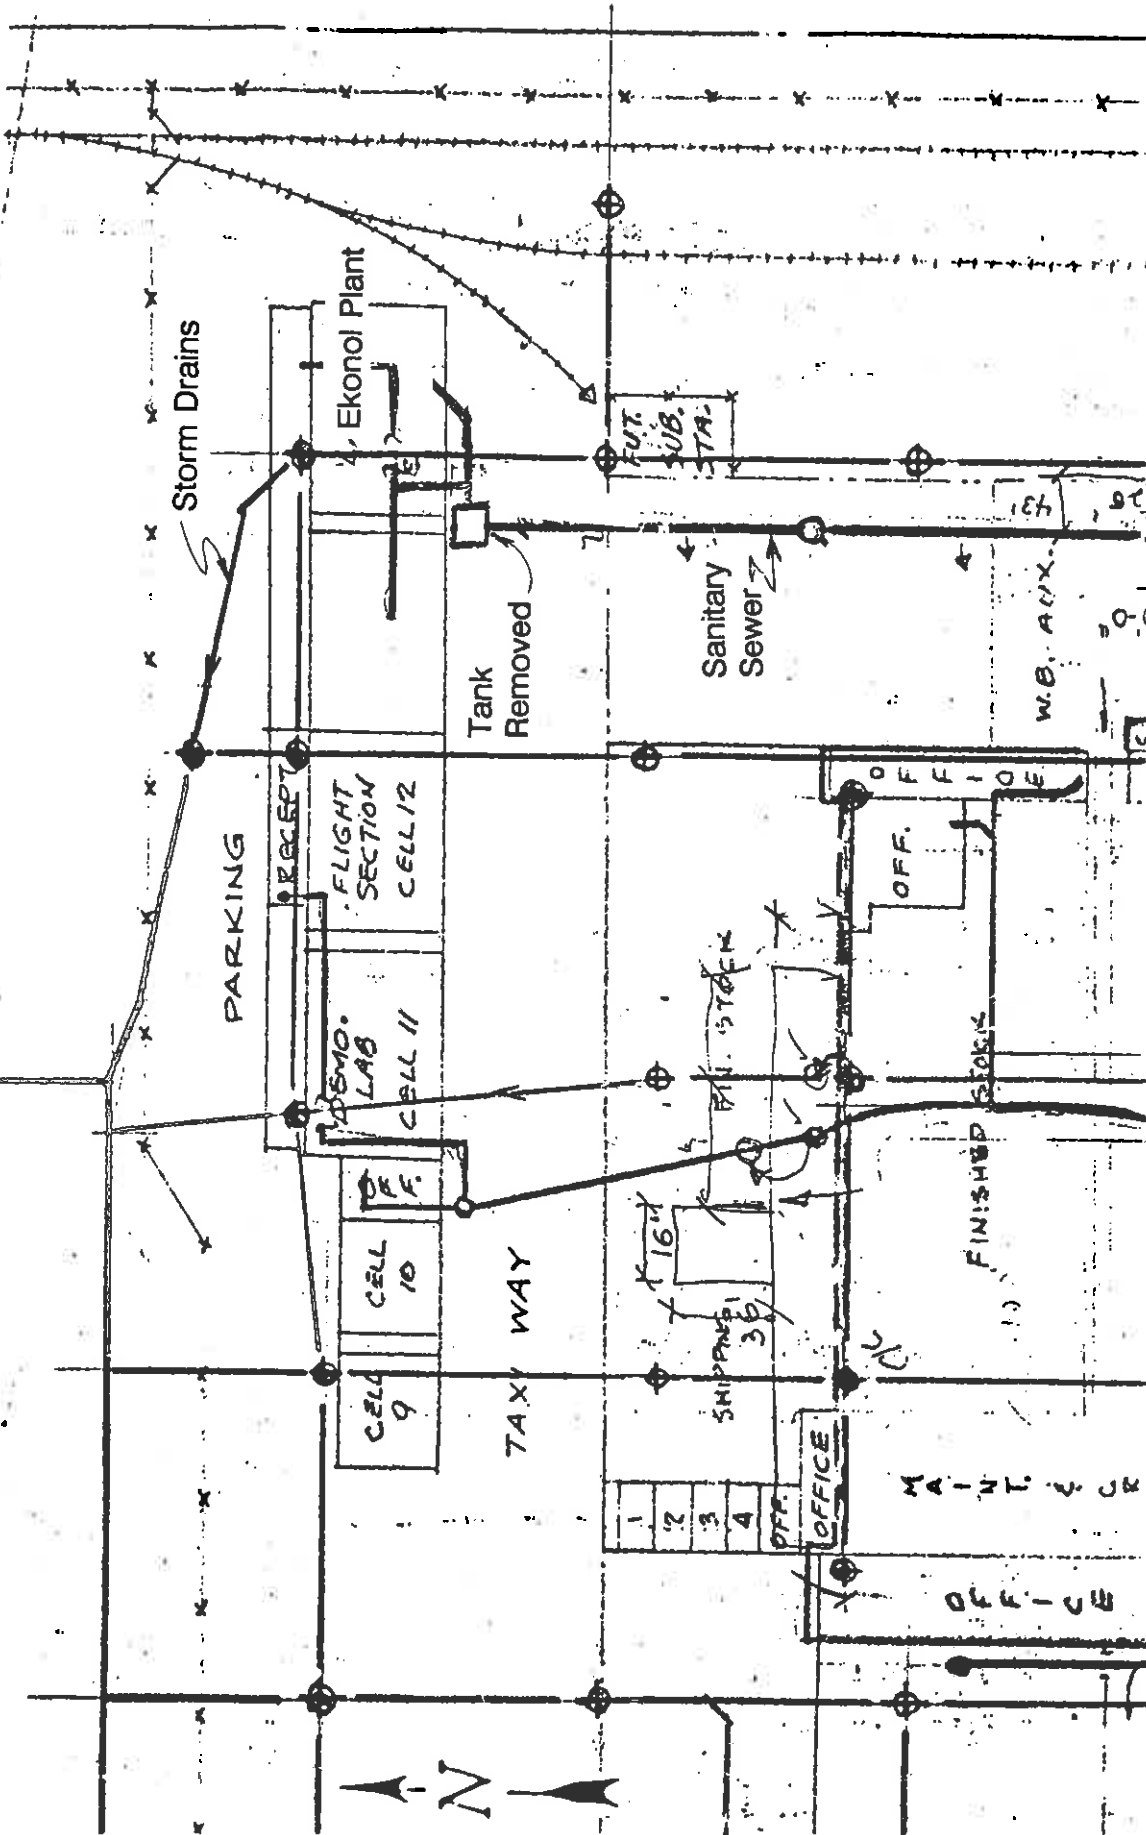
FIGURE 2

HISTORICAL DRAWING OF TANK LOCATION AND PLUMBING
 EKONOL FACILITY

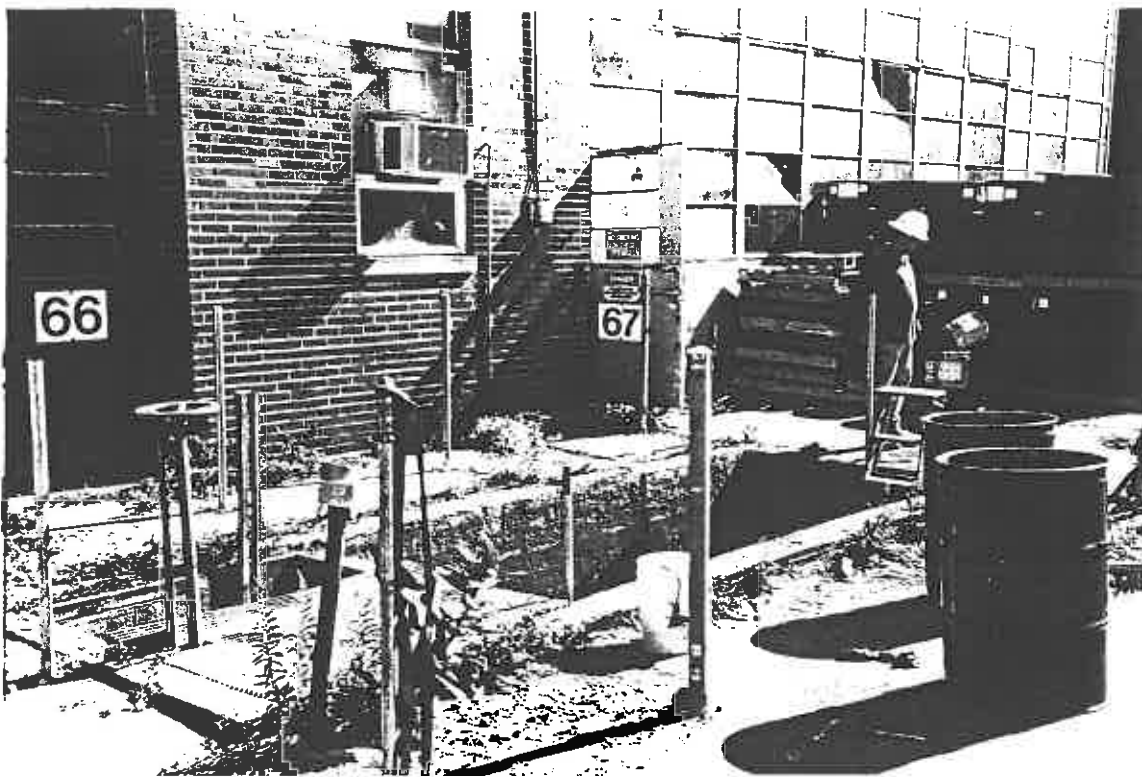
Tank Before Removal

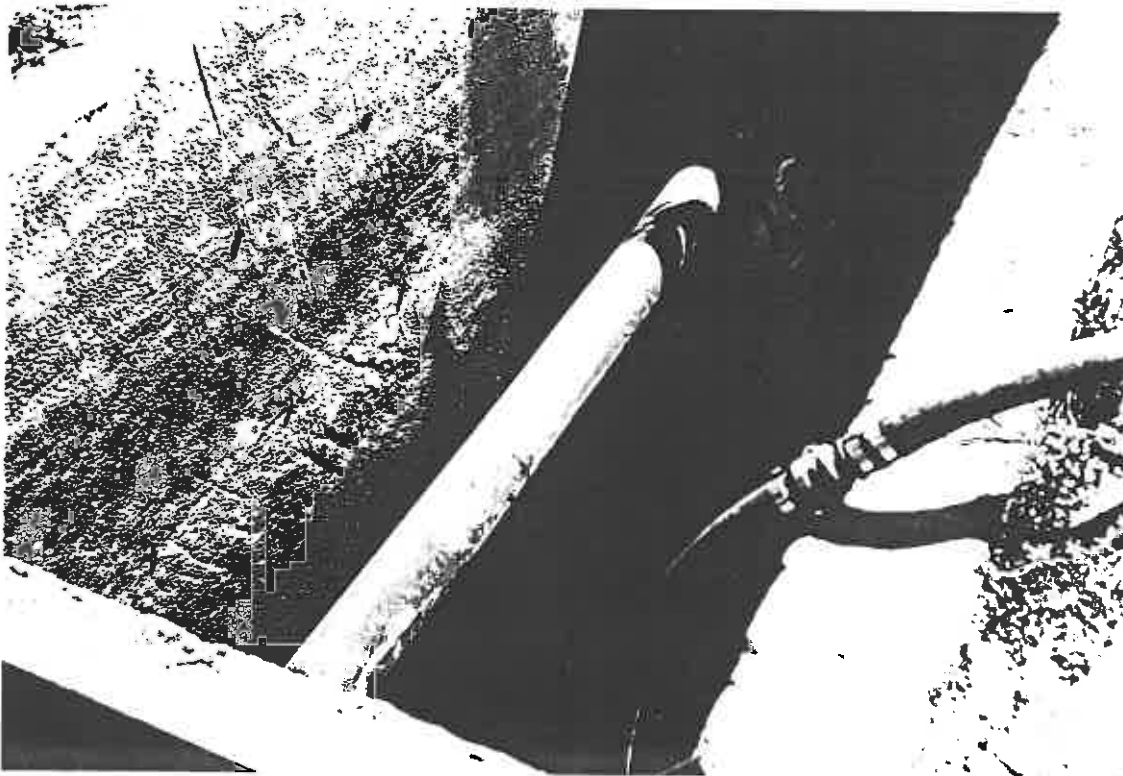
Interior of Tank During Cleaning

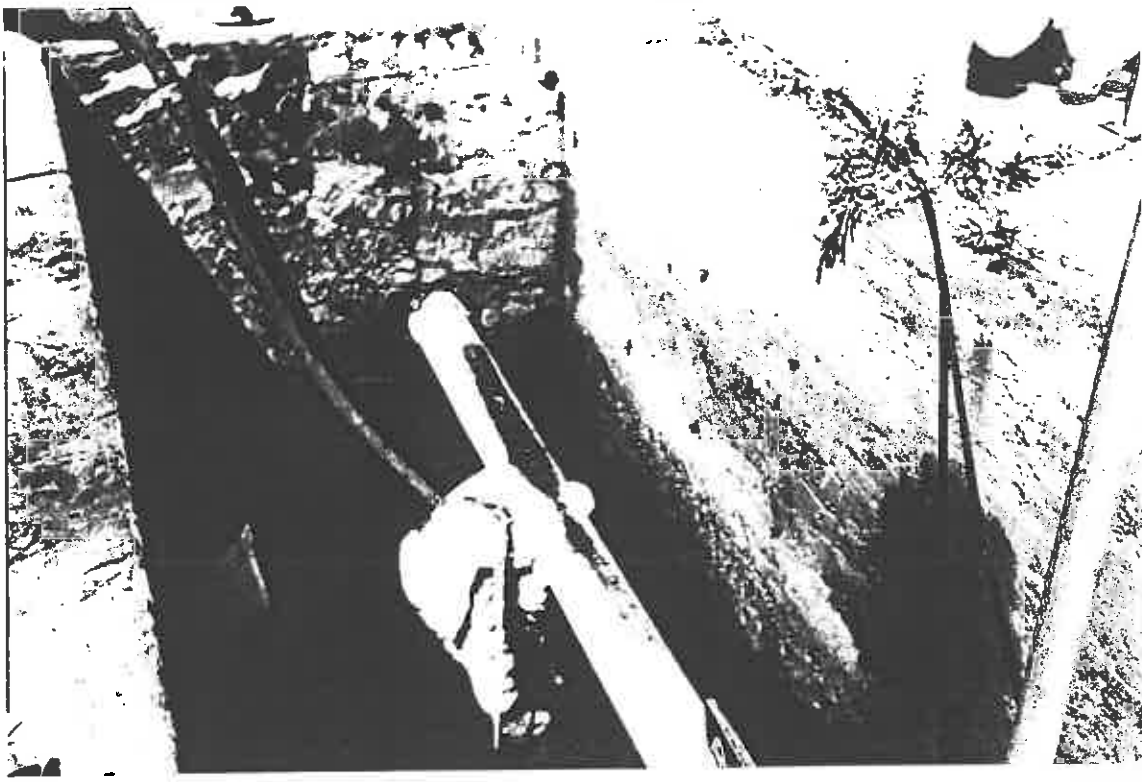
Interior of Tank During Cleaning

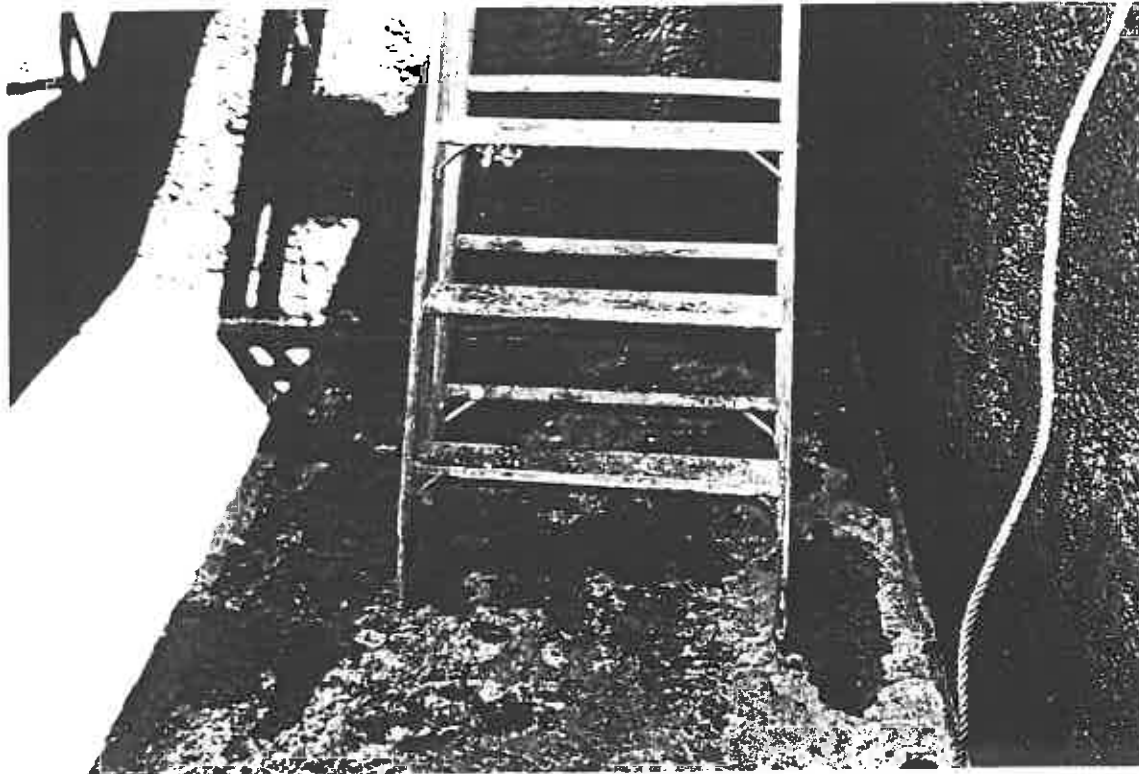
Tank Bottom After Cleaning

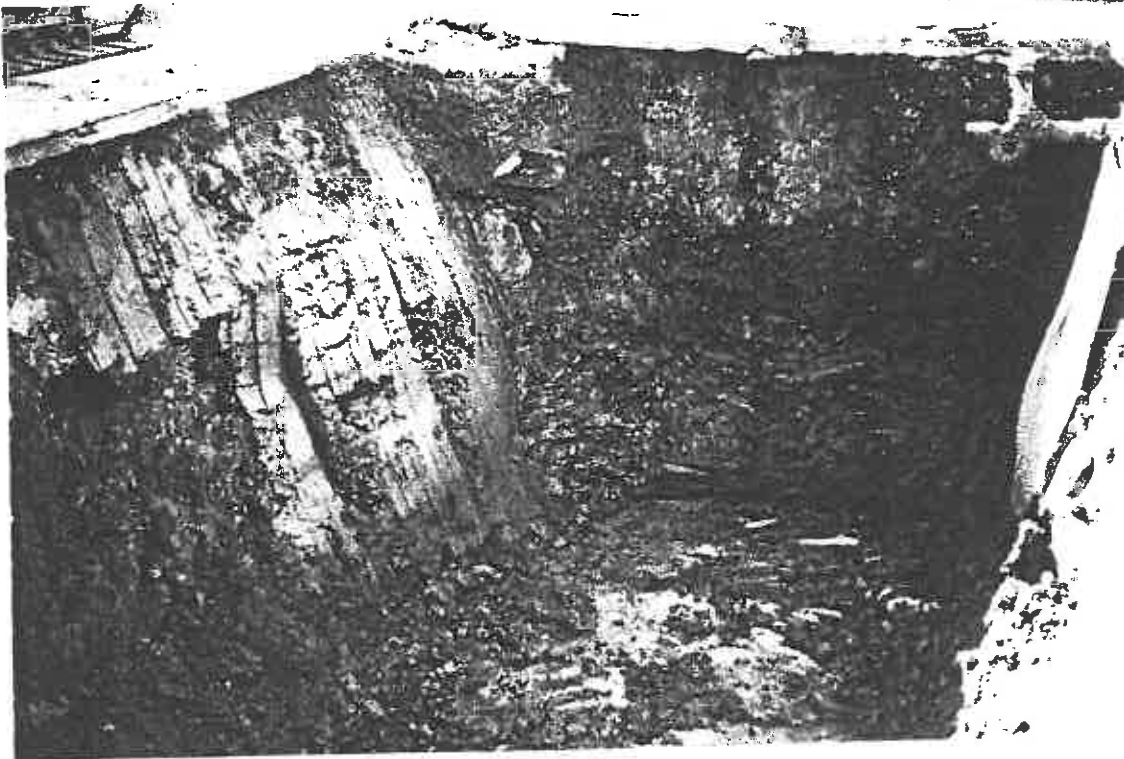
Southwest Corner of Pit (Note Clayey Soil)

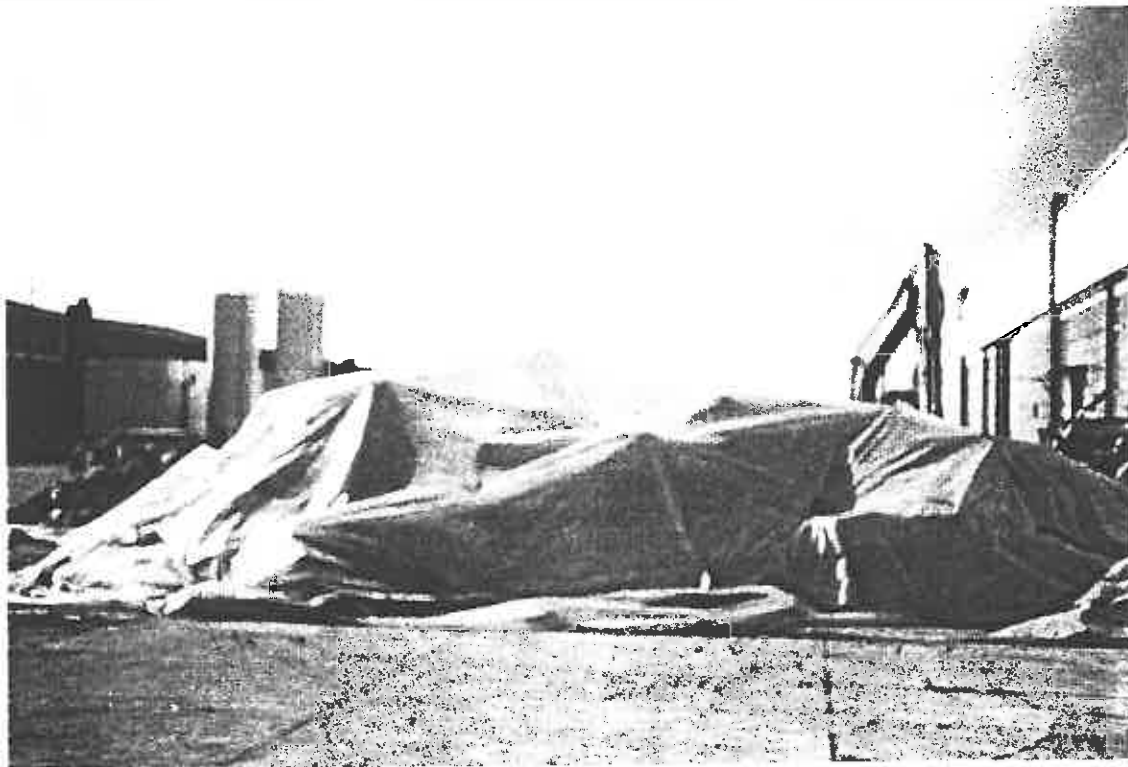
Excavated Soil Pile

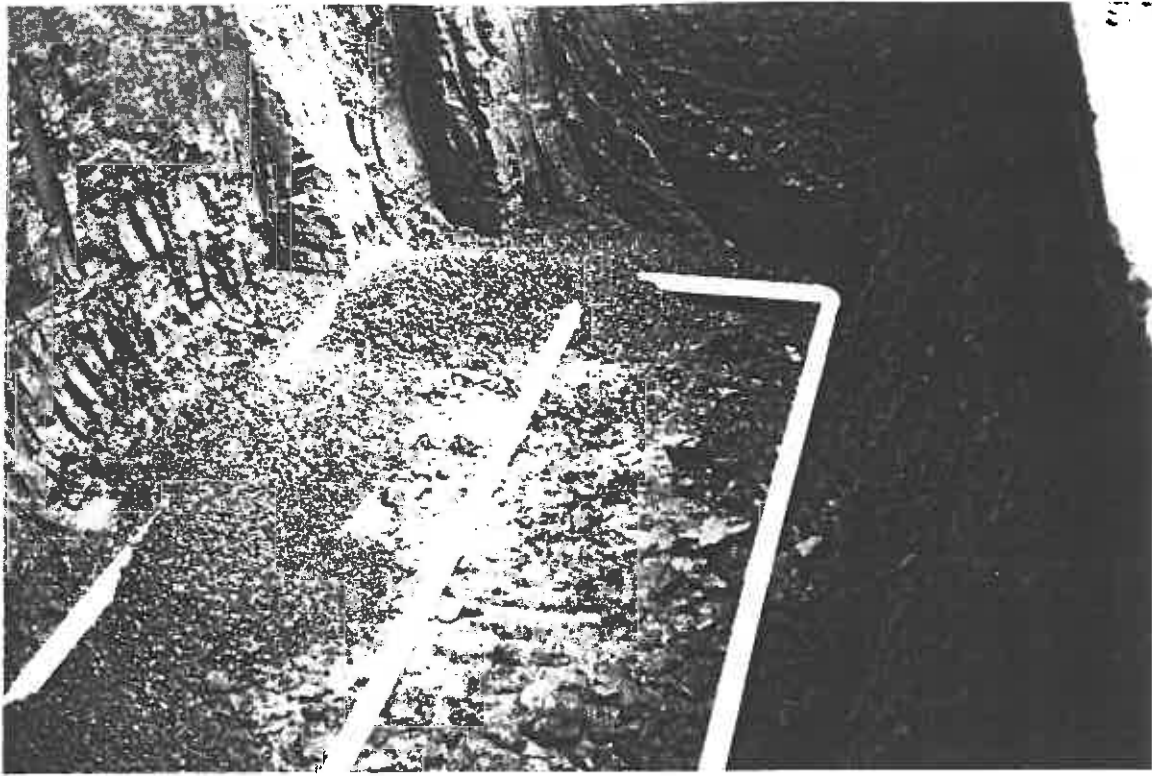
Groundwater Collection Pipes in Pit

Since the extent of the contamination was being determined and the excavation needed to be backfilled, two actions were taken to facilitate any further remediation required. The first action was to place three interconnected perforated pipes along the bottom of the pit with a riser pipe to the surface. This pipe will allow collection, testing and removal of the accumulated groundwater. The excavation was backfilled with No. 2 DOT Stone to provide a permeable zone. Approximately 3.5' above the groundwater collection pipe, a second perforated pipe was placed in the No. 2 DOT stone. This pipe

was placed to collect any soil vapors and to provide a means to remediate any residual contamination using soil vapor extraction. A sketch of the backfill and potential remedial piping is attached. Run-of-Crusher material was used to bring the excavation to grade. The excavation was capped with a concrete pad and graded to the elevation of the surrounding concrete pad.

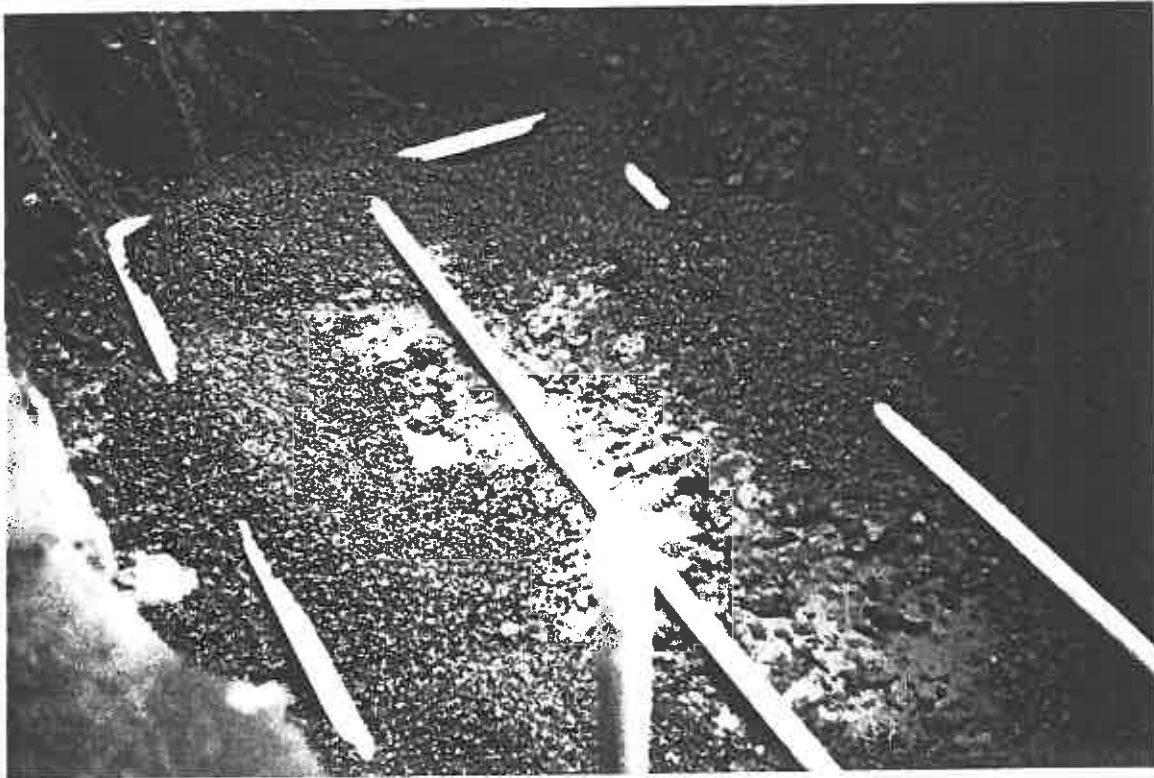
Groundwater Collection Pipes in Pit
