Re: RFP-OCP01-10, Remediation of Above Ground & Underground Storage Tanks at Glenmere Lake Property  
Amendment A

# PRE-DEMOLITION SURVEYS FOR ASBESTOS-CONTAINING MATERIALS

**“Glenmere Lake Properties – Eight (8) Structures”  
Glenmere Avenue  
Florida, New York 10921**

**Project #Q08-5048**

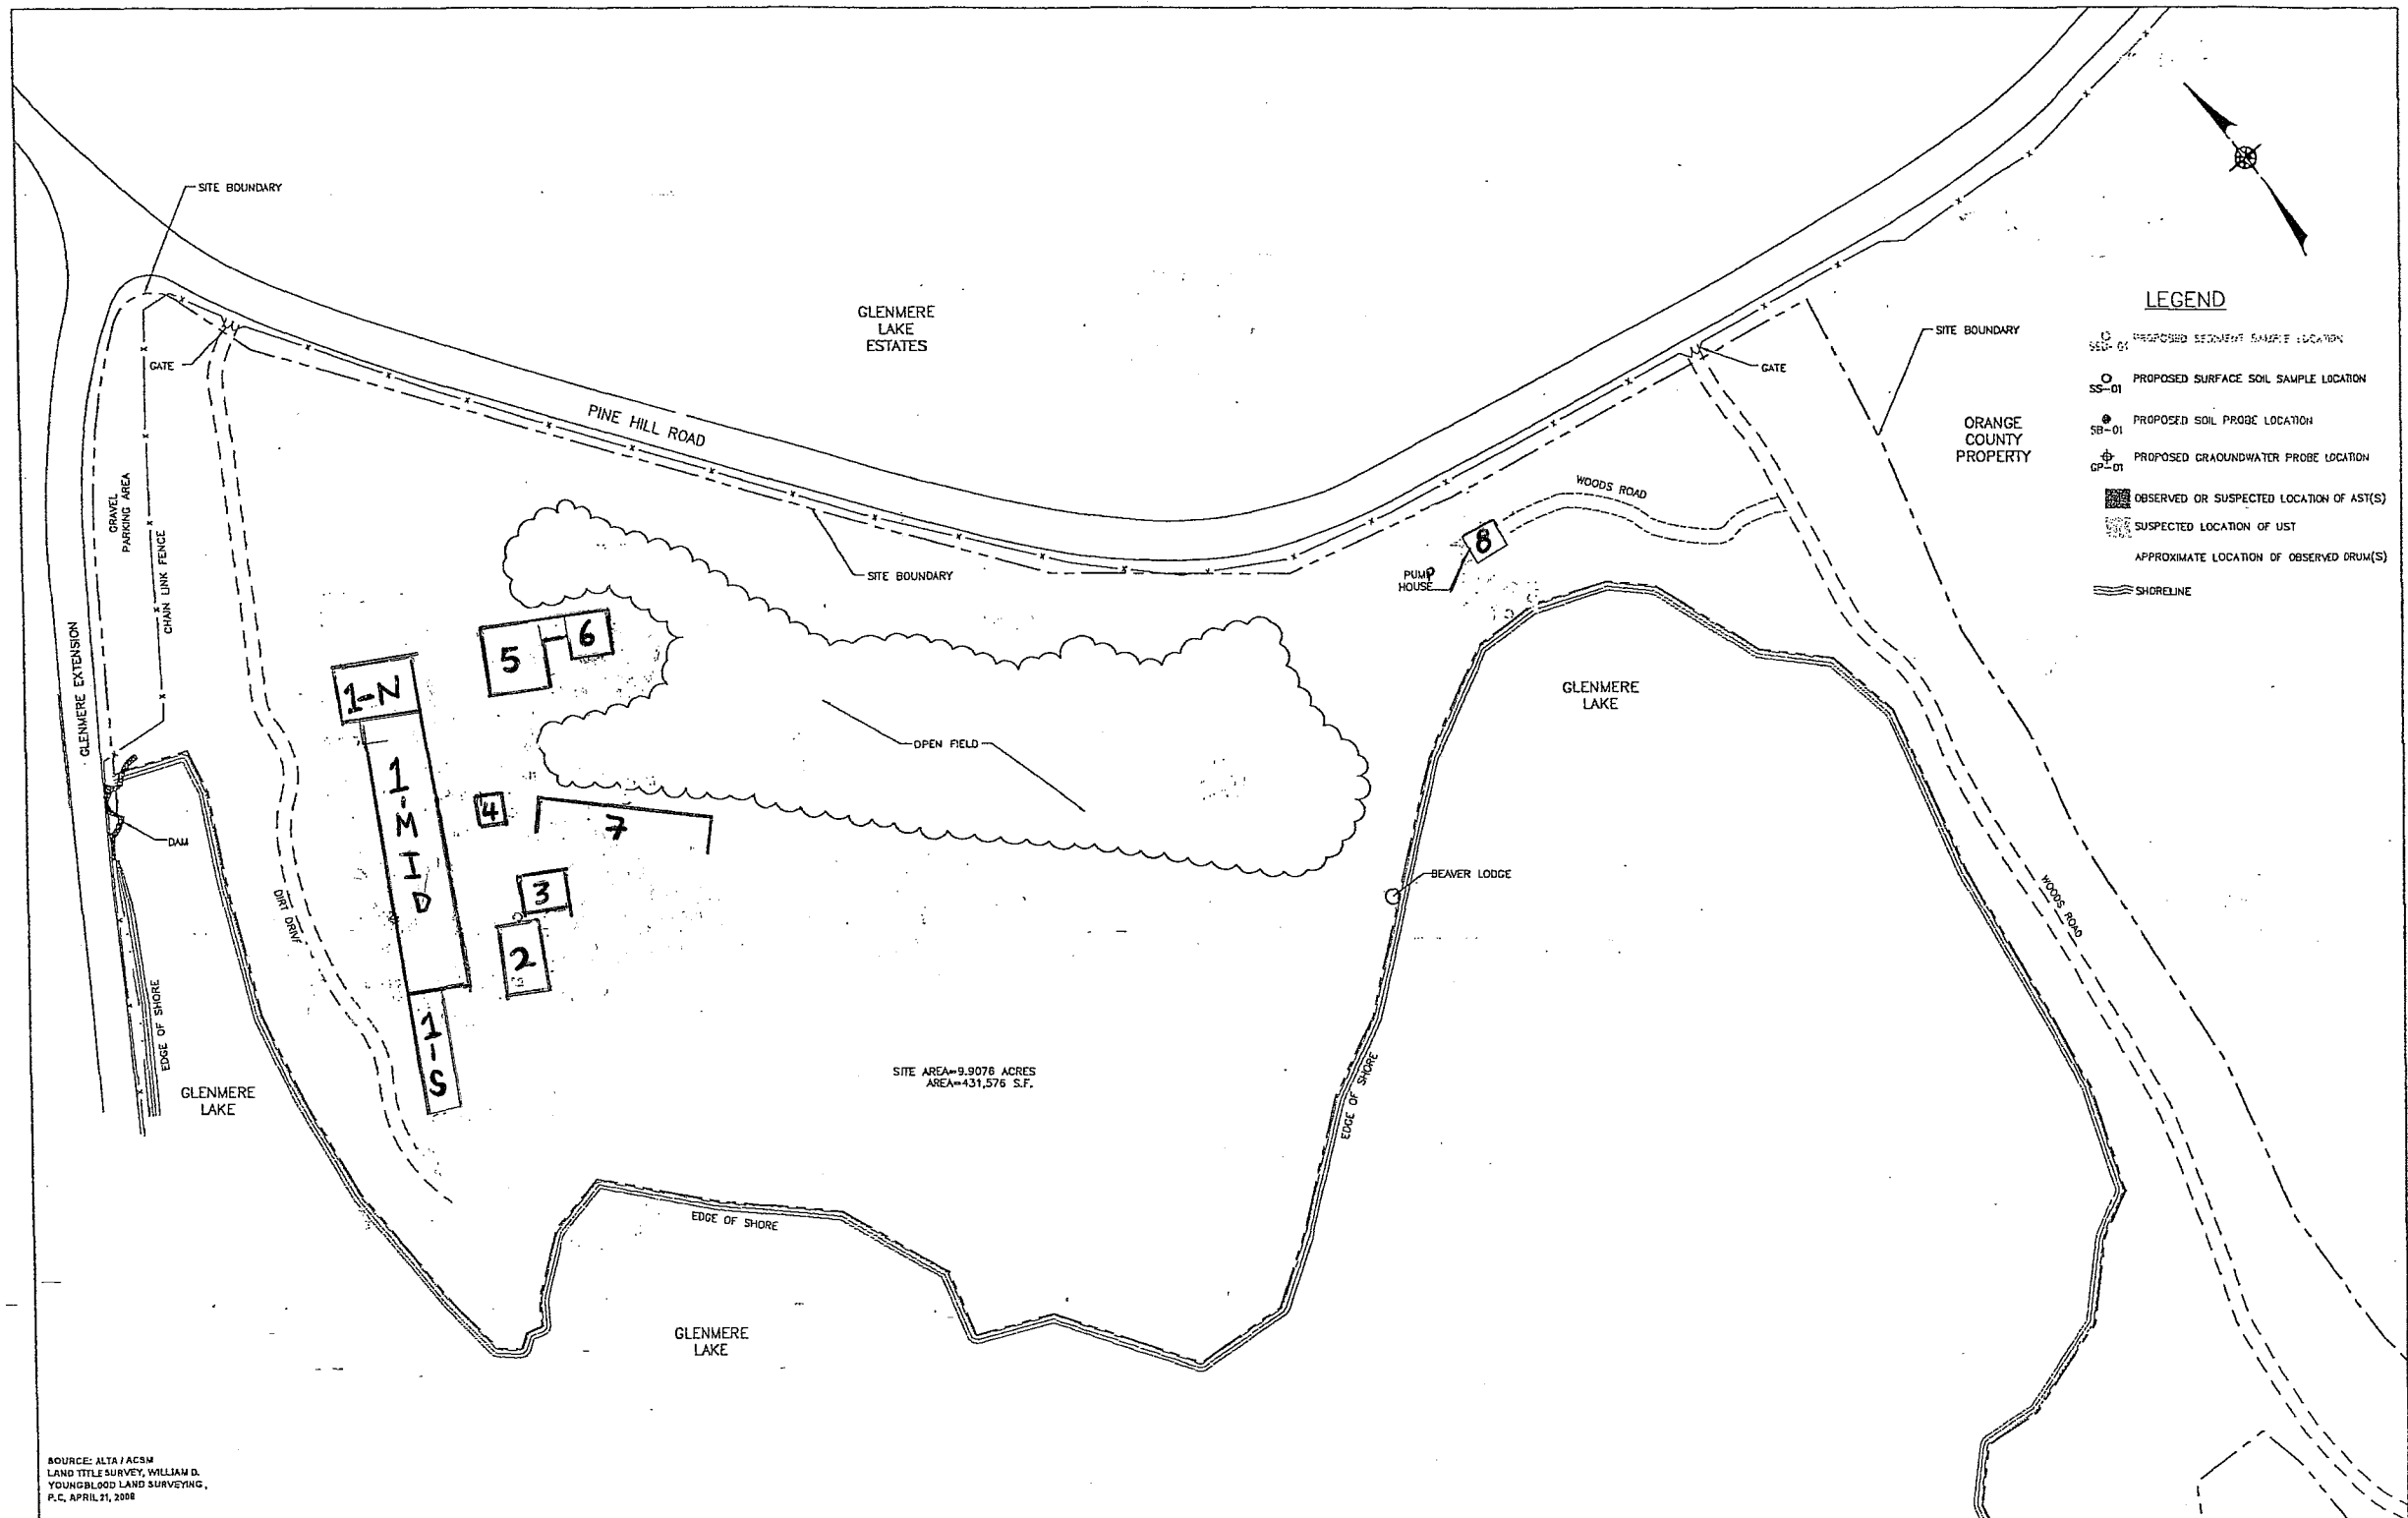
**SAMPLE LOCATION MAP**

Throughout	Entire Structure w/intact ACM Stucco Layers -AND- Misc. ACM Debris	35,000 ft <sup>3</sup> (building)	Yes	Significantly Damaged
------------	--	--------------------------------------	-----	--------------------------

Throughout	Entire Structure w/intact ACM Stucco Layers, ACM Ceiling/Wall Plasters, ACM Tank/Boiler Insulation -AND- Misc. ACM Debris	48,000 ft <sup>3</sup> (building)	Yes	Significantly Damaged
------------	---	--------------------------------------	-----	--------------------------

Throughout	Entire Structure w/intact ACM Stucco Layers, ACM Ceiling/Wall Plasters, ACM Transite Shingles -AND- Misc. ACM Debris	52,500 ft <sup>3</sup> (building)	Yes	Significantly Damaged
------------	--	--------------------------------------	-----	--------------------------

Throughout	Entire Structure w/intact ACM Stucco Layers -AND- Misc. ACM Debris	45,000 ft <sup>3</sup> (building)	Yes	Significantly Damaged
------------	--	--------------------------------------	-----	--------------------------

Throughout	Entire Structure w/intact ACM Stucco Layers, ACM Tank/Boiler Insulation -AND- Misc. ACM Debris	25,000 ft <sup>3</sup> (building)	Yes	Significantly Damaged
------------	---	--------------------------------------	-----	--------------------------

On Shop Table	ACM Rope Gaskets	5 SF (total)	Yes	Good
---------------	------------------	-----------------	-----	------

**NOTE:** *No Access to Interiors (structurally unsound). Therefore, entire building/structure must be removed as Asbestos-containing Material(s) as per Industrial Code Rule 56 (ICR-56) and/or approved NYS-DOL Site-Specific Variance(s).*
