Advanced Cleanup Technologies, Inc.

PHASE I / PHASE II ENVIRONMENTAL SITE ASSESSMENT

161 Sweet Hollow Road
Old Bethpage, New York

September 16, 1994

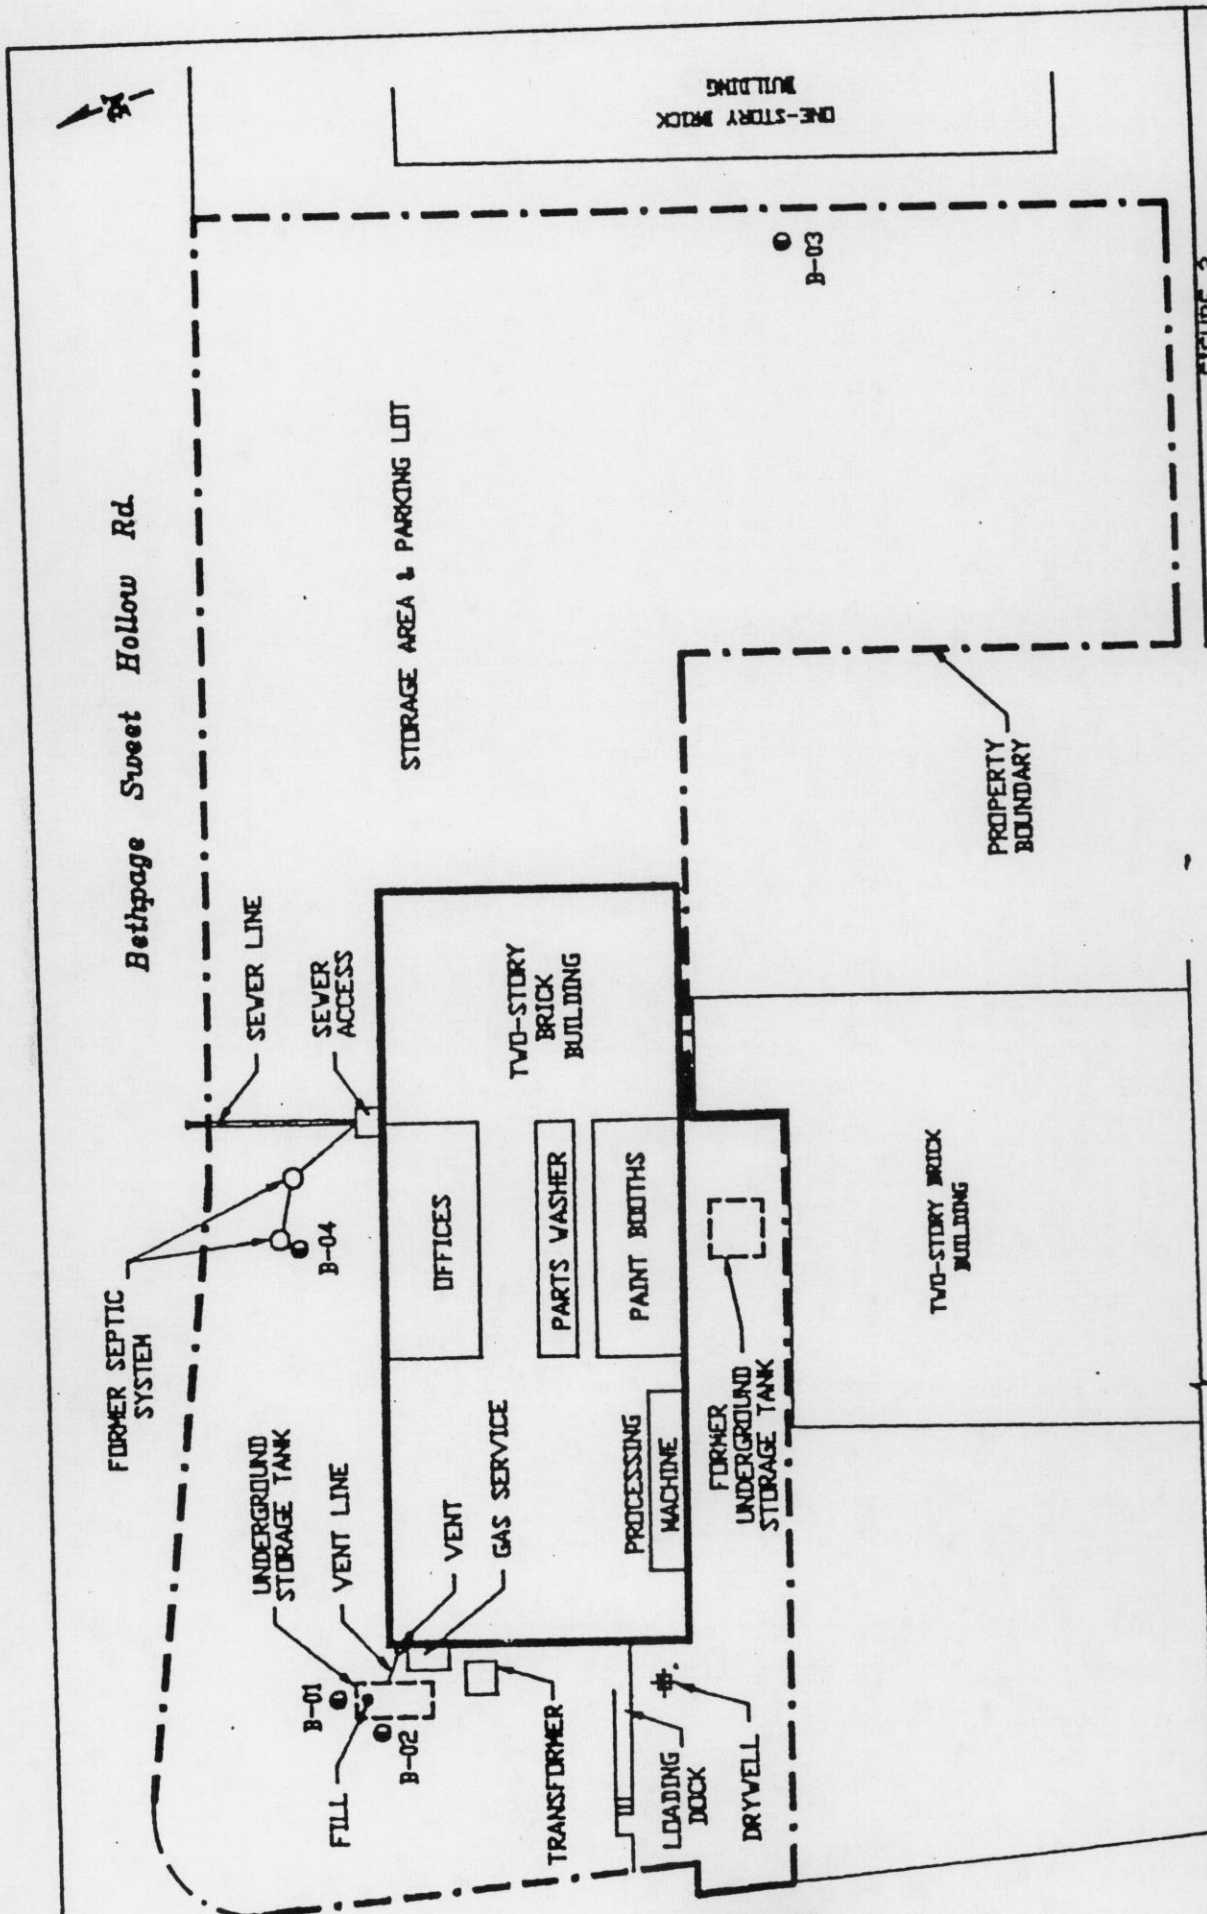
FIGURE 2

In order to assess the soil quality in the vicinity of the 1,000 gallon UST, soil borings B-01 and B-02 were installed in the vicinity of the tank. Figure 2 provides the location of each sampling point. Prior to the subsurface sampling, a Ground-Penetrating Radar (GPR) survey was conducted in the vicinity of the UST in order to delineate the boundaries of the tank and any subsurface piping associated with the tank.

As Table 1 shows, trace levels of petroleum contamination were detected in both B-01 and B-02. Because the samples from each boring were composited, this petroleum contamination should be considered an average concentration over the sampling depth of 5 feet to 22 feet.

While New York State has no specific remedial criteria for petroleum contaminated soils, this limited contamination is well below accepted clean up criteria (1,000 ppm TPH in New Jersey and 500 ppm in Massachusetts). Therefore, a limited amount of soil contamination may be encountered if the tank was to be removed. However, that contamination will not require remediation under accepted cleanup criteria.

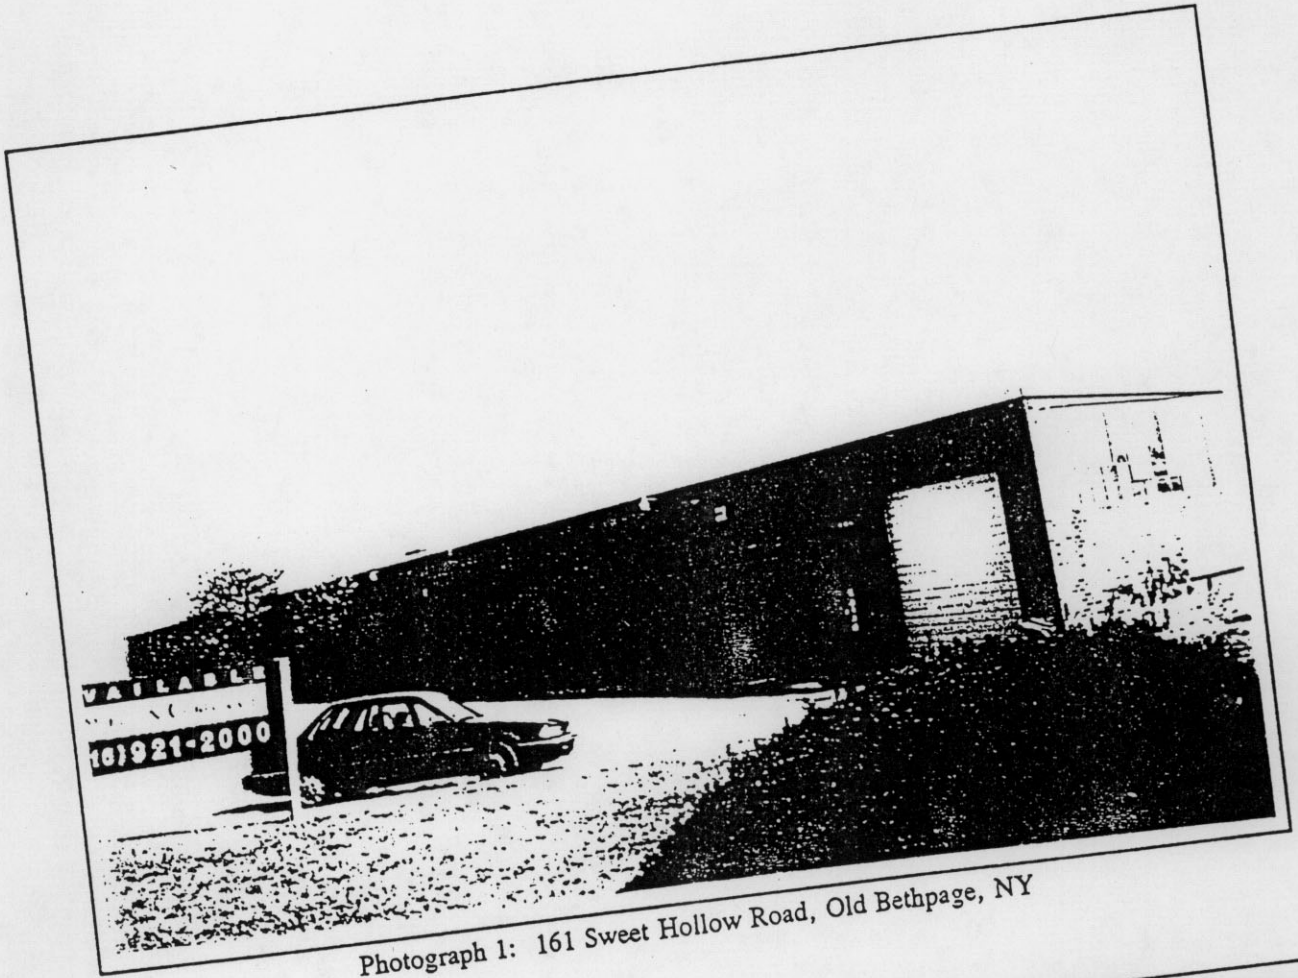
The subject property consists of a 2 story brick and concrete manufacturing building which is situated on a plot of land approximately 85,500 square feet in size (Photograph #1). A diagram of the site is provided as Figure 2. The building was unoccupied during the inspection. The building is constructed on a concrete slab and has no basement.

Photograph 1: 161 Sweet Hollow Road, Old Bethpage, NY

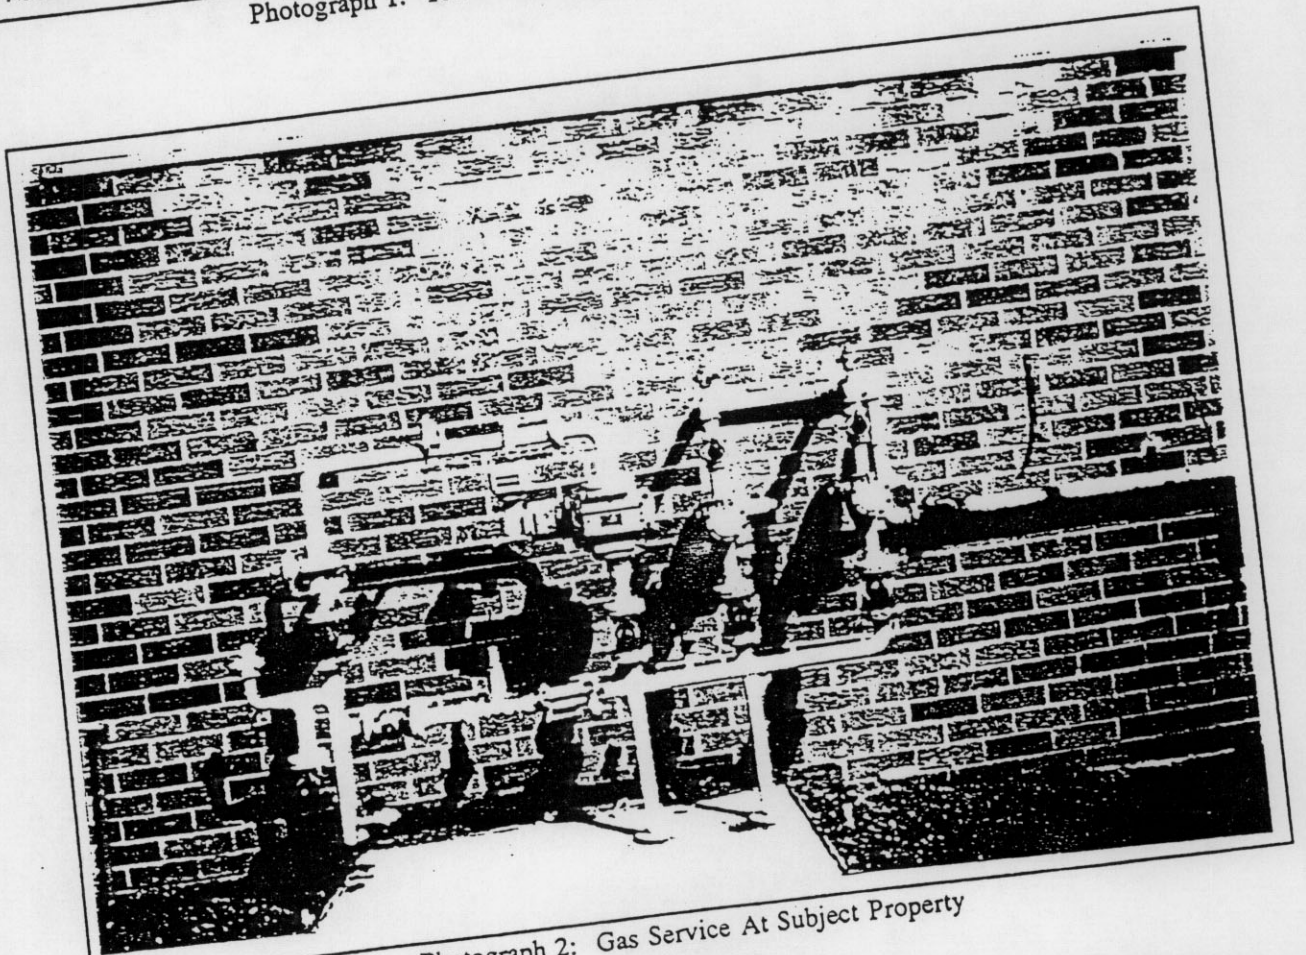
The building is supplied heat by several gas fired, forced air heaters which are suspended from the ceiling. The gas meters are located at the northeast corner of the building (Photograph

Photograph 2: Gas Service At Subject Property

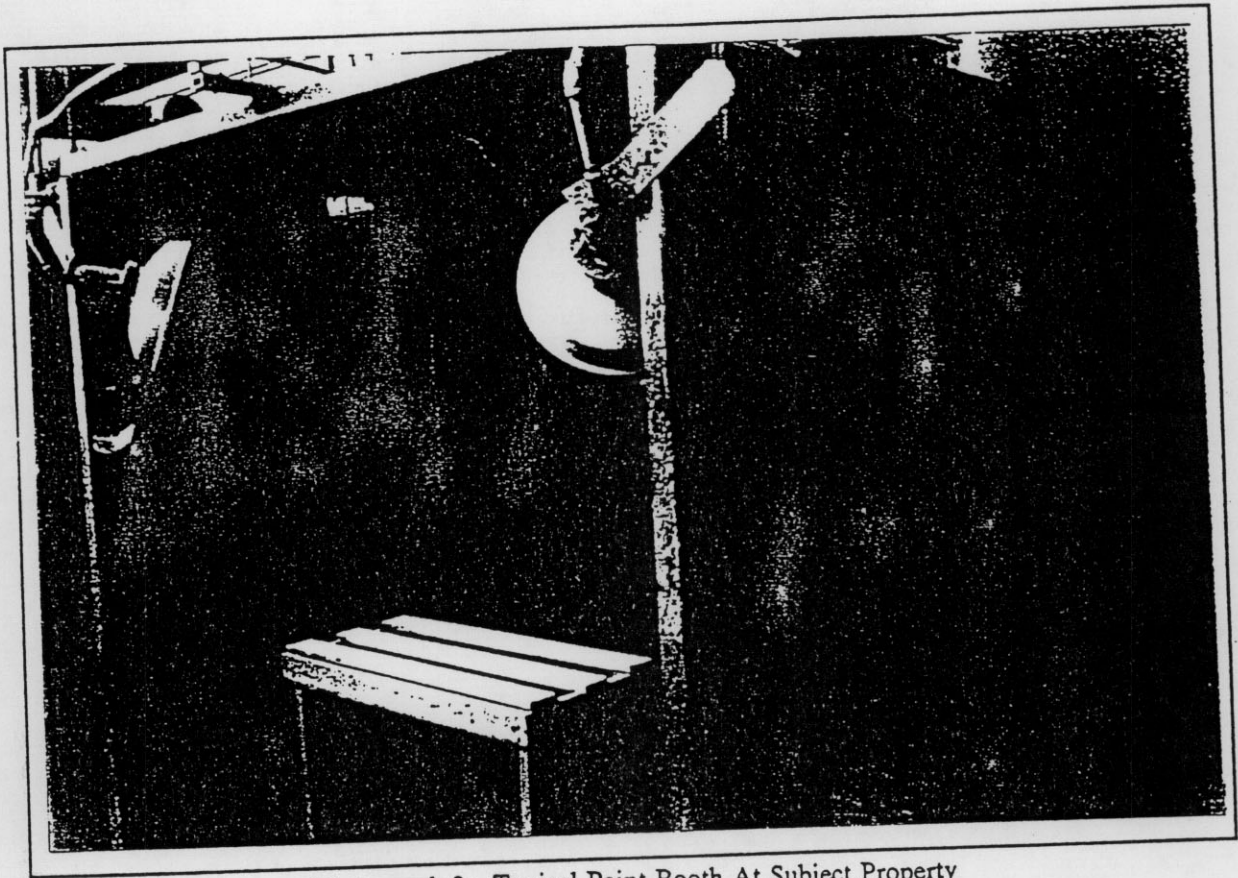
The spray booths are located along the southern wall of the building (Photograph #3). The spray booths were observed to be coated with several layers of both paint and a hard powder substance. No floor drains were observed in the paint booths or in the vicinity of the paint booths. The estimated cost to remove and dispose of the spray booths would be approximately \$2,500.

Photograph 3: Typical Paint Booth At Subject Property

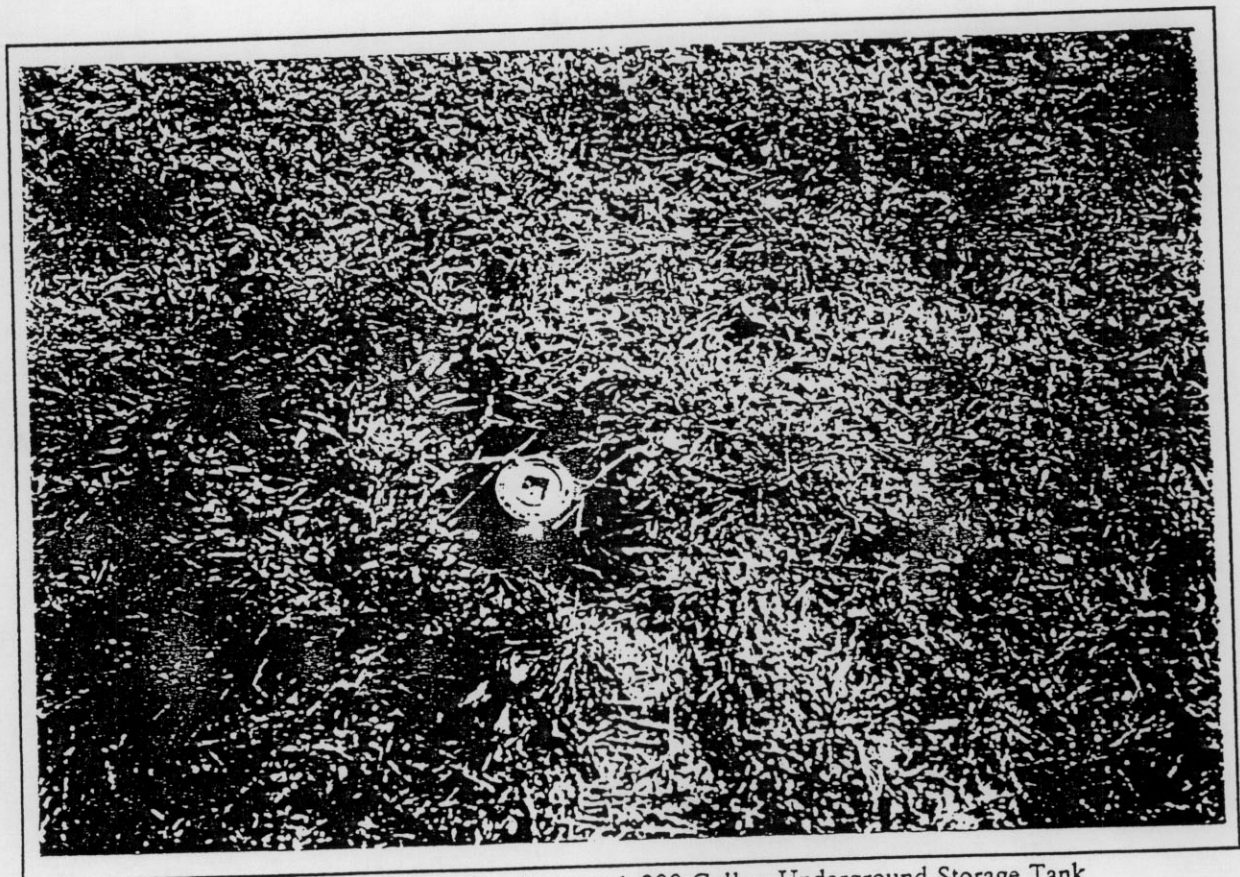
Photograph 4: Fill Pipe For Current 1,000 Gallon Underground Storage Tank

No aboveground storage tanks were observed at the property. One vent pipe and 1 fill pipe were observed at the northwest portion of the property (Photographs #4 and #5). According to Mr. Marchhart, there is a 1,000 gallon underground storage tank (UST) containing diesel fuel in this area. Mr. Marchhart stated that when he purchased the property, the UST was present but had never been utilized. The Nassau County Fire Marshal's (NCFM) office is the regulatory agency which maintains the registrations for USTs in Nassau County. The NCFM's office does not have a file pertaining to the subject property.

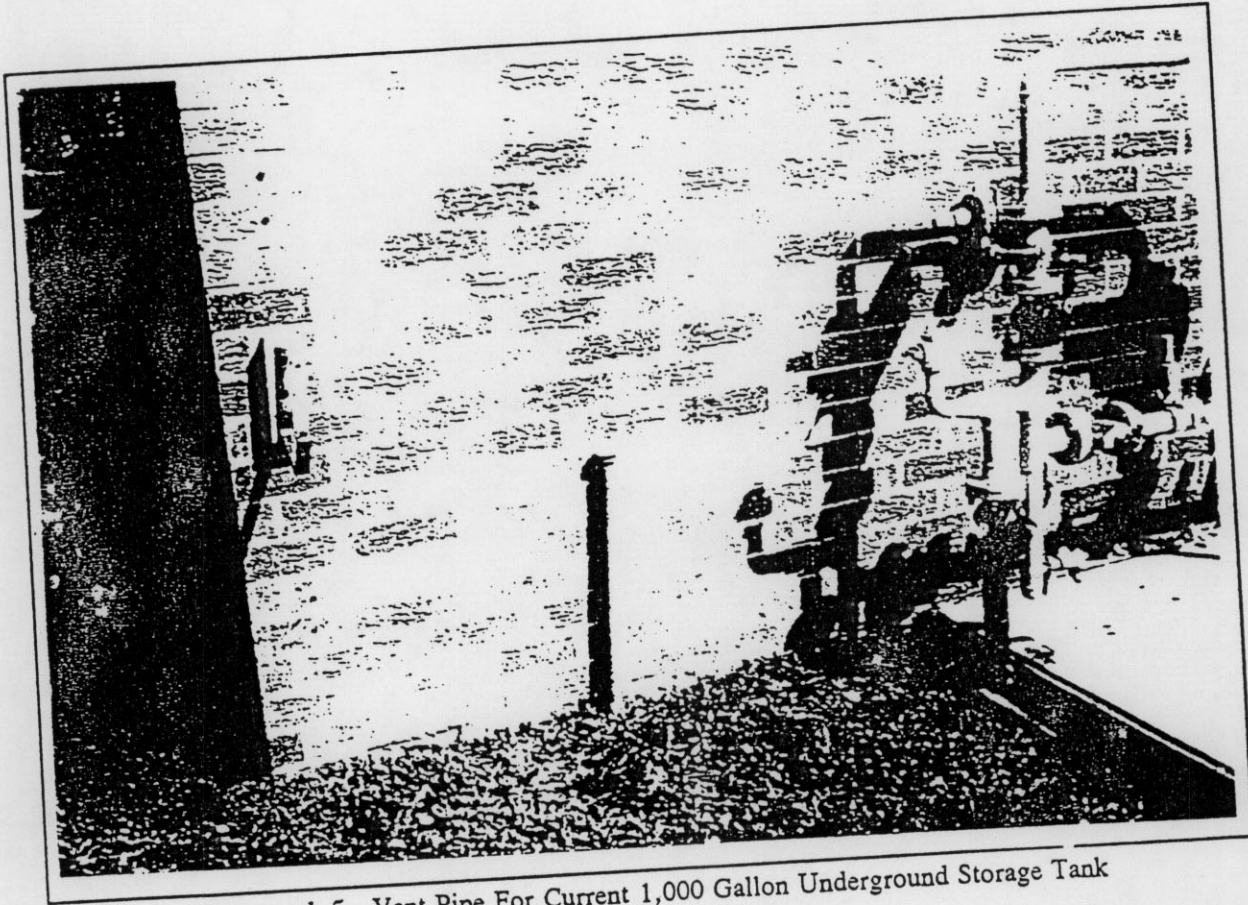
Photograph 5: Vent Pipe For Current 1,000 Gallon Underground Storage Tank

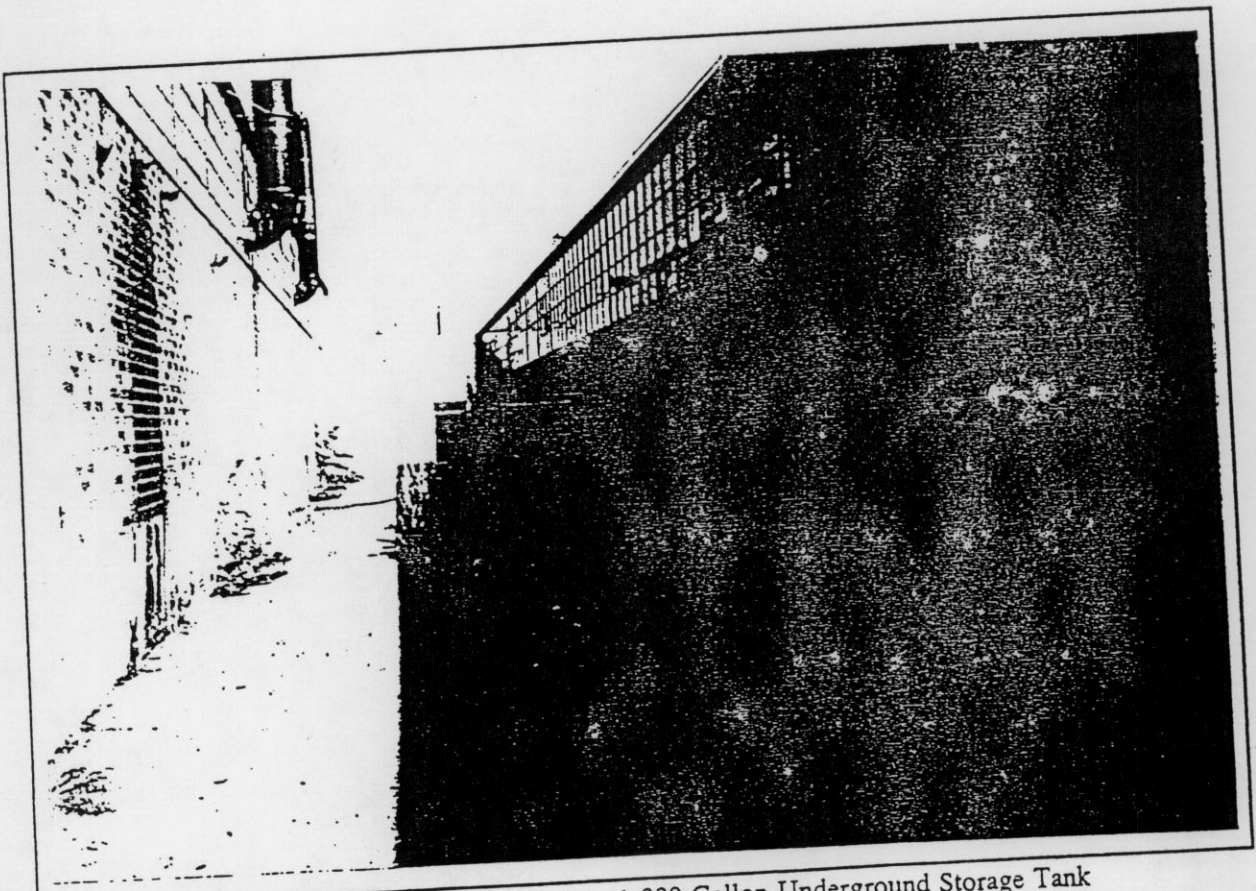
1,000 Gallon Underground Storage Tank

A review of the NCDOH file pertaining to the subject property indicated that a UST was removed from the property during 1987. Photograph #6 provides the location of the former tank. A 1,000 gallon fuel oil tank located adjacent to the southern wall of the building was fit tested on July 27, 1987. The system reportedly failed the fit test. The New York State Department of Environmental Conservation (NYSDEC) was notified of the failure and requested that either the tank be excavated and contaminated soil be removed, segregate all parts of the

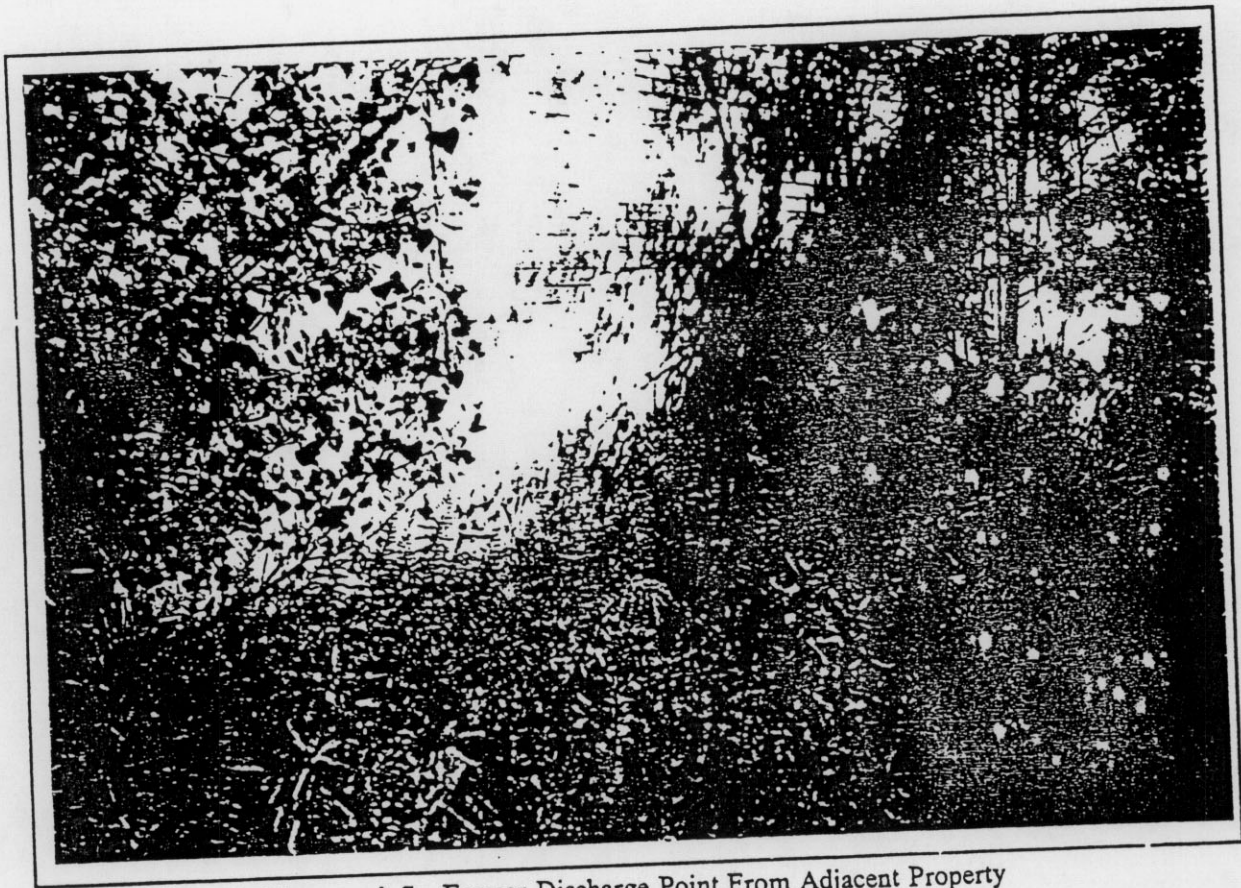
A visual inspection of the property was conducted for evidence of potential hazardous material contamination. An area of stressed vegetation was observed along the eastern property boundary. A small diameter PVC pipe originating from the adjacent building was plugged and was observed to be immediately above the stressed area (Photograph #7).

According to Mr. Marchhart, the company east of the subject property previously discharged what was described as a "milky-white substance" through the small diameter pipe onto the subject property. Mr. Marchhart inquired with the property owner as to the contents of the substance. The property owner stated that the substance is silica-containing water which is used as an abrasion lubricant in the manufacturing of glass and mirrors.

Photograph 7: Former Discharge Point From Adjacent Property

As Table 2 shows, none of the RCRA Metals detected in boring B-03 were above the recommended soil cleanup levels set forth by the NYSDEC. This indicates that the discharge from the adjacent property has not impacted soils at the subject property. The stressed area is likely the result of the previous constant flow of liquid from the pipe.

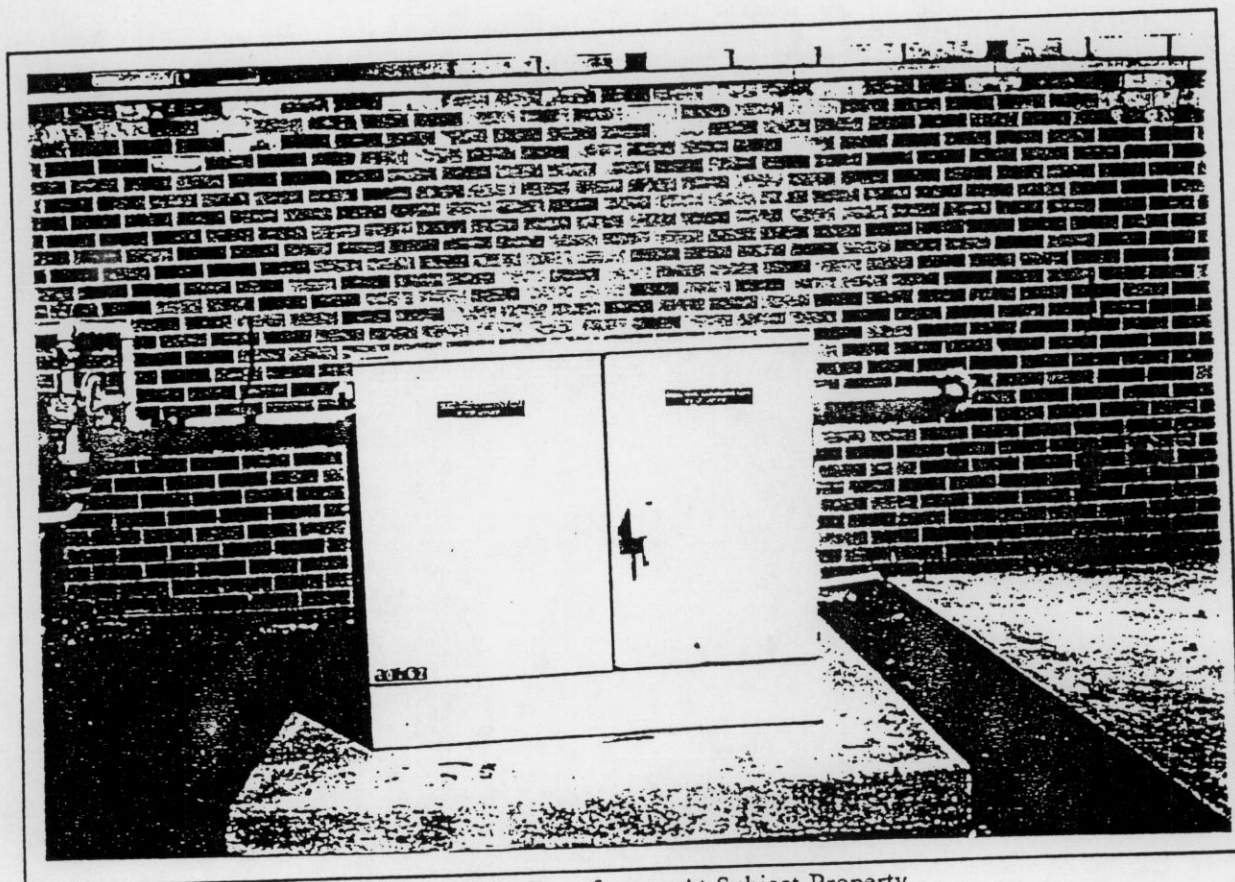
Photograph 8: Transformer At Subject Property

One electrical transformer is located at the property (Photograph #8). Figure 2 provides the location of the transformer. No stains or odors were detected in the vicinity of the transformer. An environmental engineer for the Long Island Lighting Company (LILCO) states that LILCO transformers do not contain PCBs. No other equipment which could contain PCB's such as elevators or hydraulic lifts, were observed at the property.
