Subject: **Summary of Findings**
Former Manual Screen Wash Area
Champion Products Facility
Perry, New York
DEC Site No: V00018-9
Delta Project No: S098-009

The purpose of this letter is to present the findings of the investigation in the former manual screen wash area. The scope of work, as outlined in a letter submitted to the New York Department of Environmental Conservation (Department) on June 4, 1999, was completed on June 30, 1999. Investigation of the former manual screen wash area was initiated as part of the investigation Champion Products Company is performing in anticipation of entering into a Voluntary Cleanup Agreement with the Department.

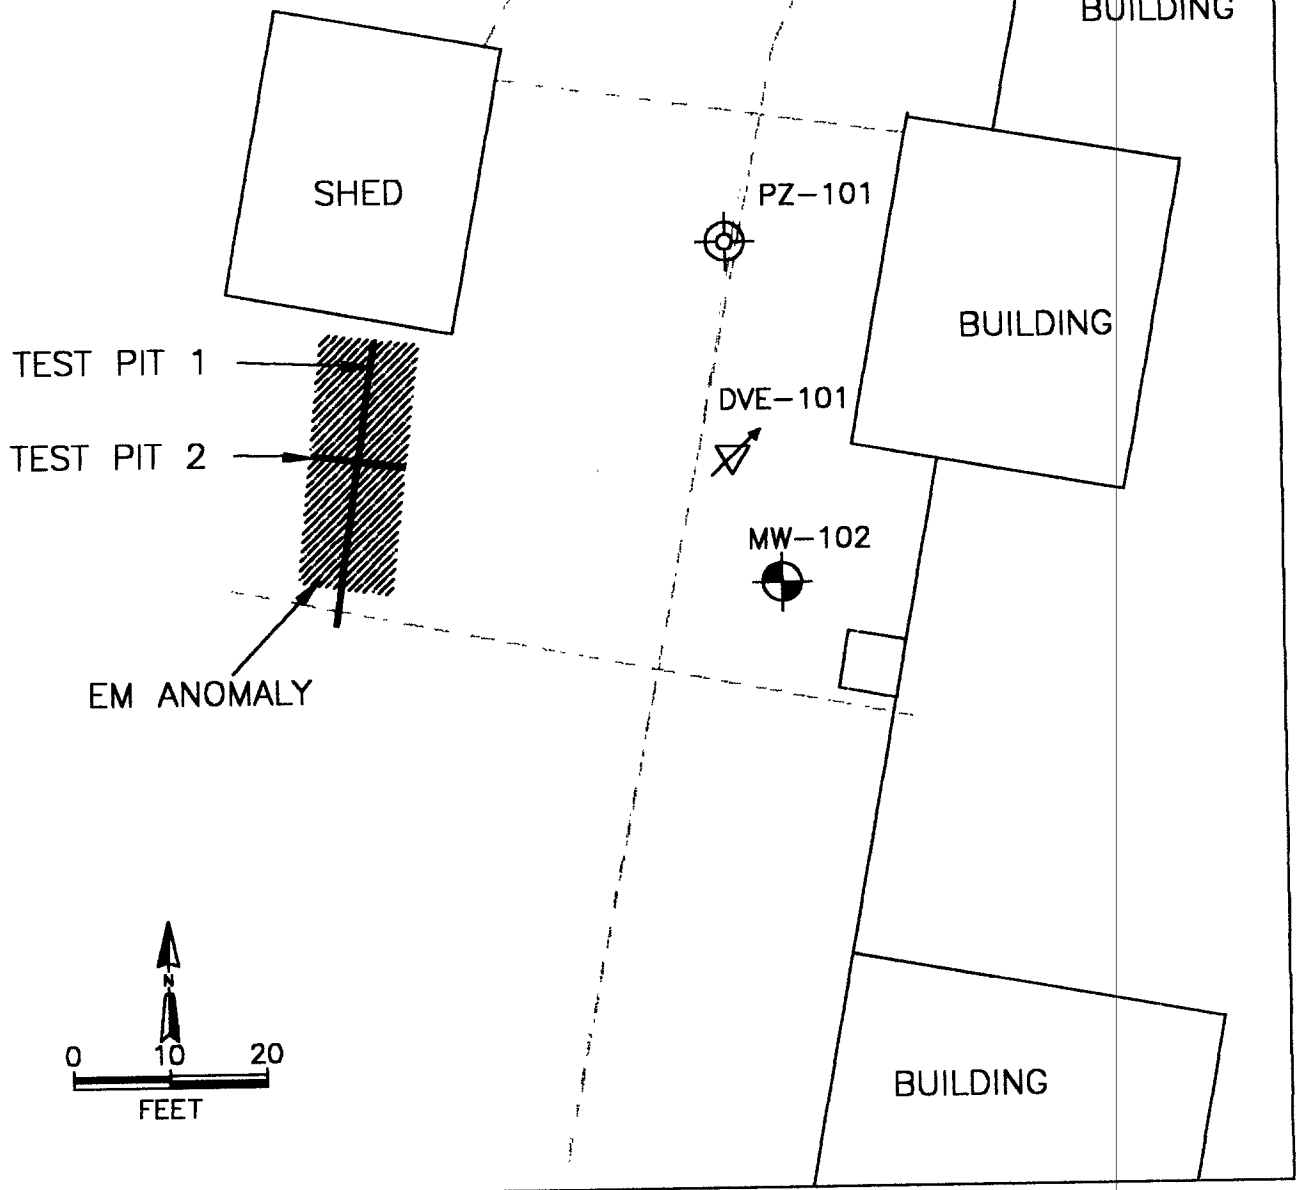
PROJECT NO.:
S098-009
FIGURE NO.:
1

Results of the geophysical survey performed in the former screen wash area indicated a large, apparently metal-rich target with a roughly rectangular shape just south of the equipment shed, as shown one Figure 1. GPR results indicated that the magnetic anomaly did not produce high amplitude, parabolic-shaped reflections of the type commonly associated with cylindrical UST's, however, the magnetic anomaly could have represented a flat-topped concrete vault. A copy of the Enviroscan Geophysical Survey is enclosed.

On June 30, 1999, Delta advanced two test pits in the area identified by the geophysical survey, as shown in Figure 1. Mr. Maurice Moore of the Department was present to observe this activity.

Test Pit 1 was advanced to a depth of 7 feet below ground surface (bgs), was excavated in a north/south direction and was approximately 25 feet in length. Soil encountered during the excavation appeared to be undisturbed and consisted of native material (silts and clays). Backfill material, distribution lines or any evidence that would indicate a possible tank and/or vault (i.e., fragments of concrete or steel) were not identified. Test Pit 2 was advanced to a depth of 7 feet bgs, was excavated in a east/west direction and was approximately 10 feet in length. No evidence was found that would indicate a tank or vault presently or previously existed in this area.

- The geophysical survey indicated a magnetic anomaly in the area south of the equipment shed.
- The two test pits advanced in the location of the magnetic anomaly showed no evidence of a tank or vault presently or previously being located in this area.
- Based on the results of the geophysical survey, a process tank or vault is not located in the area of the former manual screen wash area.

- The source of the magnetic anomaly found in the former manual screen wash area is unknown.

Based on the above findings, Delta recommends that no additional investigation is needed in the former manual screen wash area. As proposed in the Draft Remediation Workplan, dual phase vapor extraction will be performed in this area to remove volatile organic compounds from the subsurface.
