July 14, 2023
Project 2203514

**Re: Quarterly and Annual Inspections: Methane Monitoring System and Sub-Slab
Depressurization System
Empire Outlets
55 Richmond Terrace, Staten Island, New York**

**Appendix B – Photo Log
Annual Inspection Report
Empire Outlets
55 Richmond Terrace, Staten Island, New York**

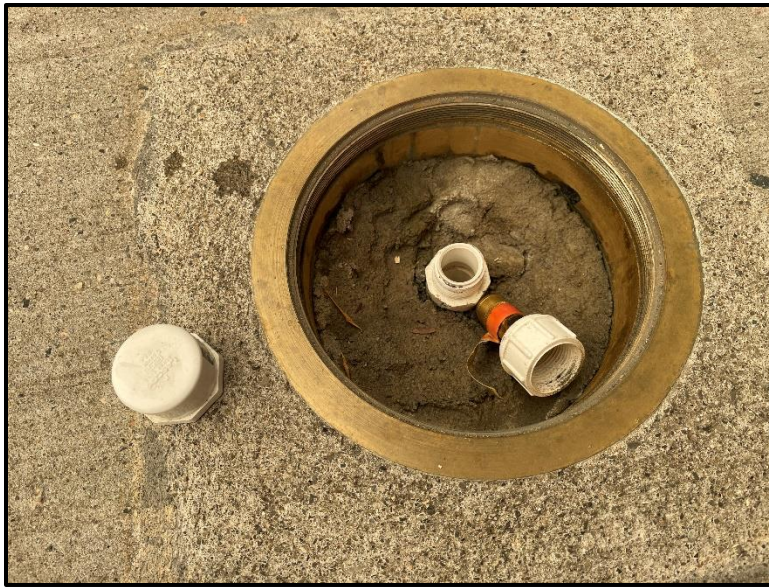
Photo 1. June 7, 2023

All accessible parts of the SSDS were visually inspected on June 6, 2023. Six vapor monitoring points (MP-1 through MP-6) were opened and found to be in good condition. The headspace of each monitoring point was screened with a multi-gas meter, with the exception of MP-2, which requires a quick connect fitting that was not available during this inspection. The multi-gas meter used was a Rae Systems MultiRAE, serial number MBB3Z021P4. No field detections of VOCs or methane were observed in any of the monitoring points. Soil vapor screening data is recorded on the SSDS Inspection Form, included in Appendix A. Photos documenting the condition of the monitoring points are included in Appendix B.

SSDS inspection: vapor monitoring point MP-1.

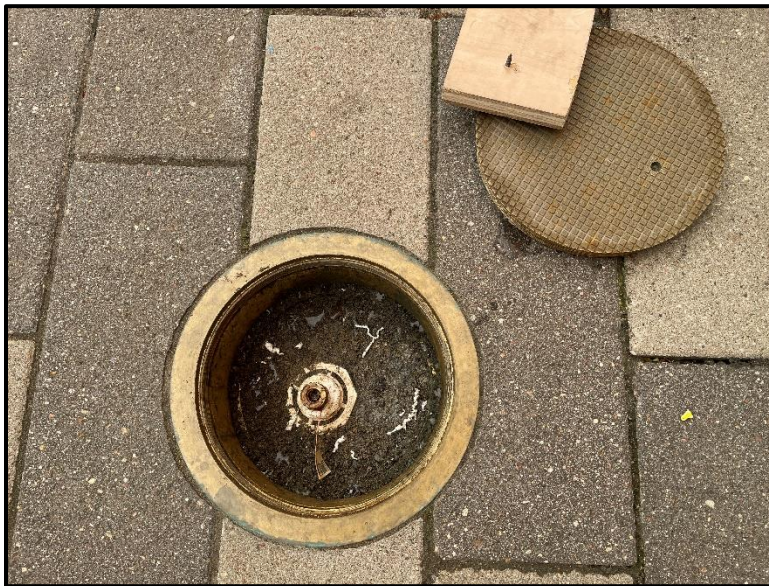
Photo 2. June 7, 2023

SSDS inspection: vapor monitoring point MP-2.

- GEI will order the appropriate quick connect fitting to enable multi-gas meter readings to be taken from SSDS monitoring point MP-2 during future inspections.
- The system installer (Donovan Electric) will consult with their supplier and/or the manufacturer (Honeywell) regarding the two detectors that failed to connect to the Bluetooth app and the five detectors that failed span calibration. These seven detectors will be repaired, replaced, or reconfigured, as necessary, to restore functionality.
- Following restoration of the above-mentioned seven methane detectors, GEI will bump test the detectors to confirm functionality. Field calibration will be performed by GEI if bump test readings are found to be out of range.

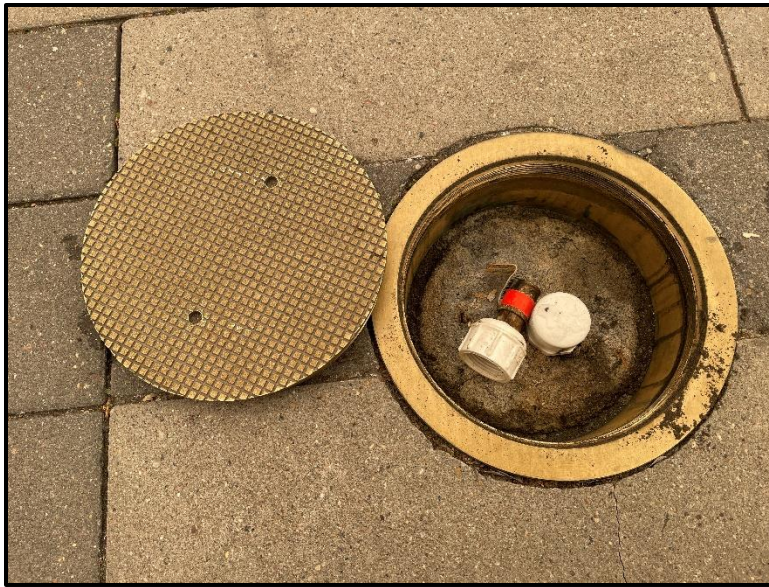
Photo 3. June 7, 2023

SSDS inspection: vapor monitoring point MP-3.

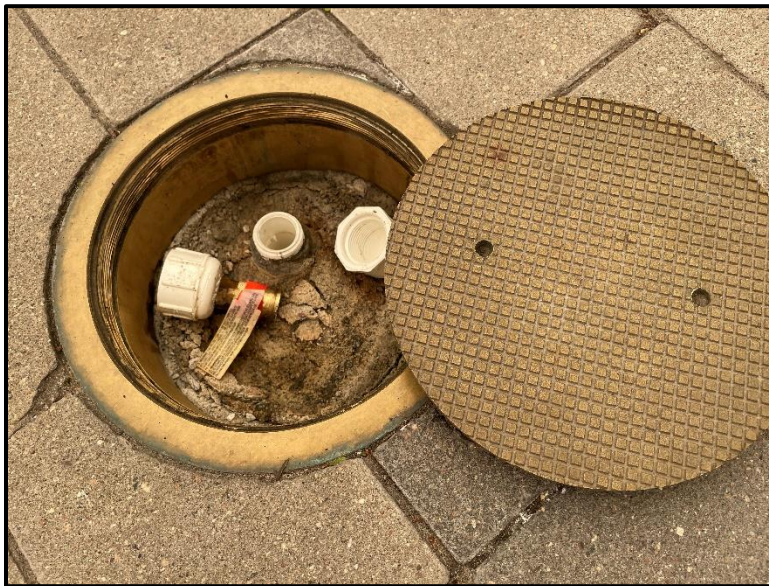
Photo 4. June 7, 2023

SSDS inspection: vapor monitoring point MP-4.

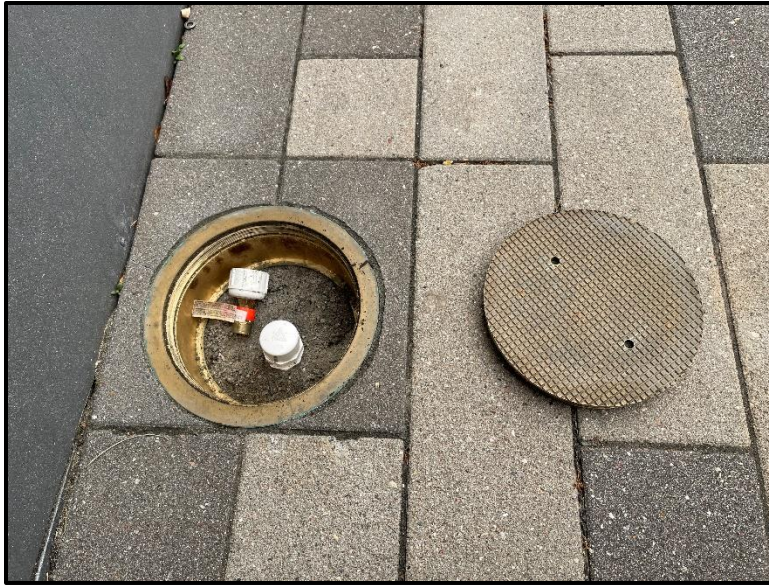
Photo 5. June 7, 2023

SSDS inspection: vapor monitoring point MP-5.

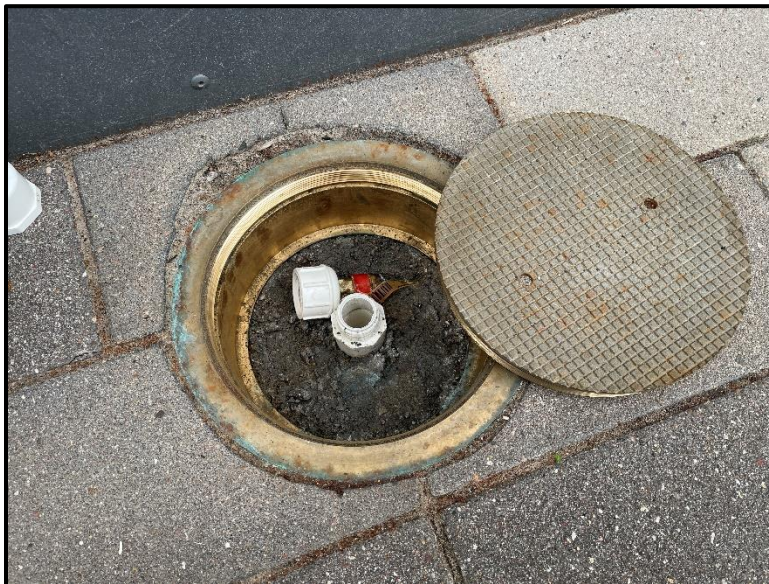
Photo 6. June 7, 2023

SSDS inspection: vapor monitoring point MP-6.

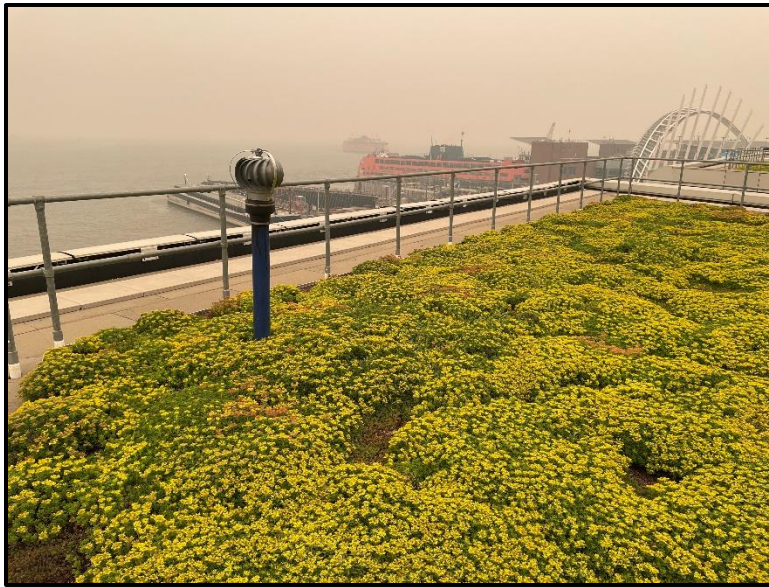
Photo 7. June 7, 2023

Six SSDS roof vents (VR-1 through VR-6) were visually inspected and found to be in good condition. Photos documenting the condition of the roof vents are included in Appendix B.

SSDS inspection: roof vent VR-1 with surrounding rooftop.

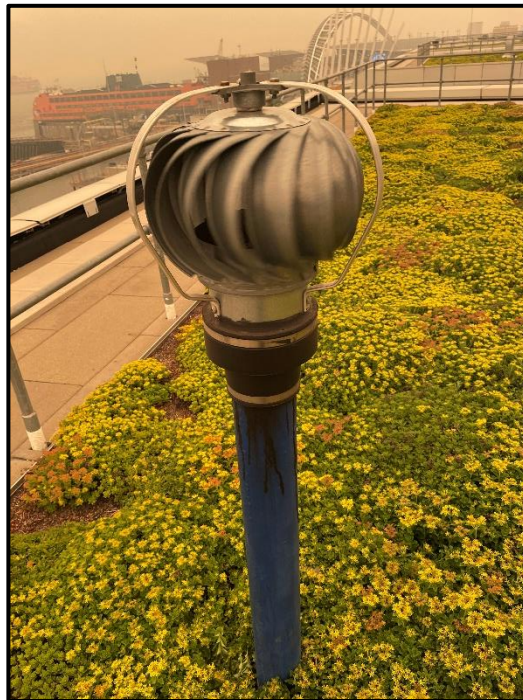
Photo 8. June 7, 2023

SSDS inspection: roof vent VR-1.

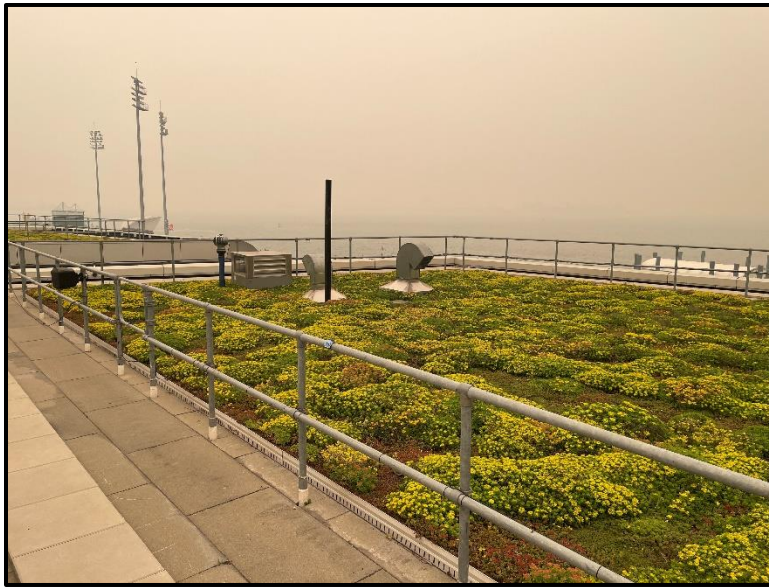
Photo 9. June 7, 2023

SSDS inspection: roof vent VR-2 and surrounding rooftop.

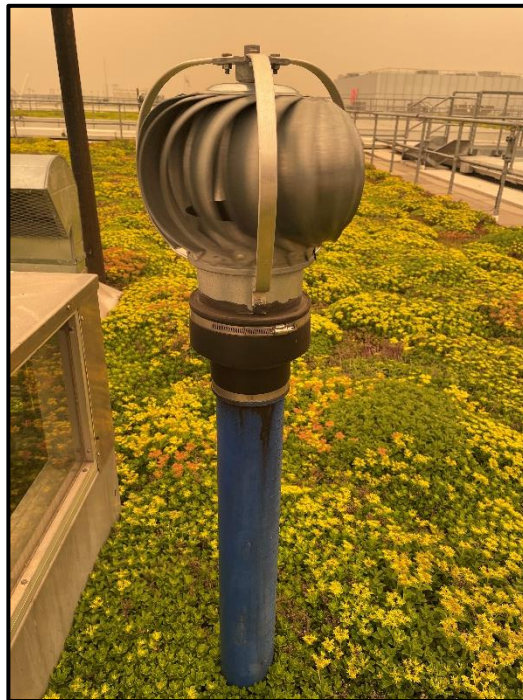
Photo 10. June 7, 2023

SSDS inspection: roof vent VR-2.

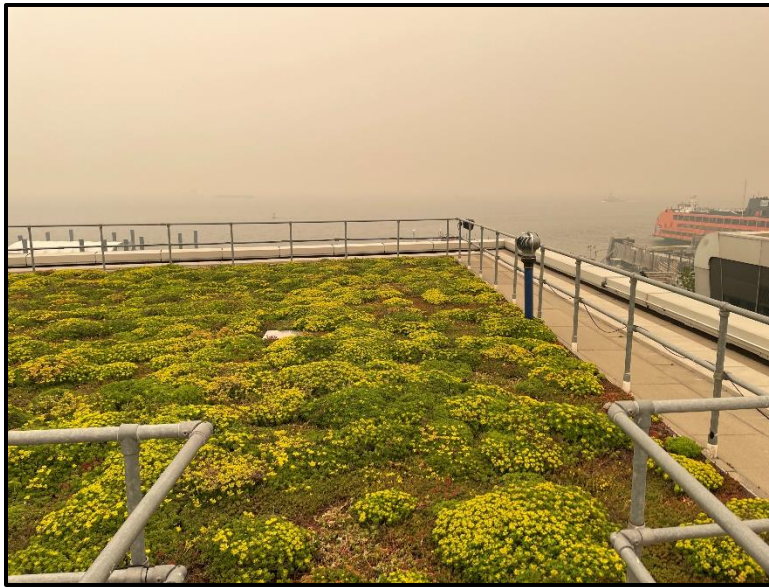
Photo 11. June 7, 2023

SSDS inspection: roof vent VR-3 and surrounding rooftop.

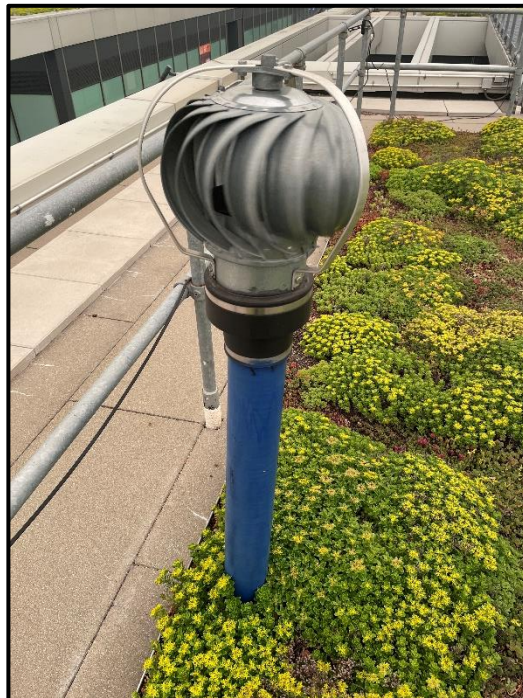
Photo 12. June 7, 2023

SSDS inspection: roof vent VR-3.

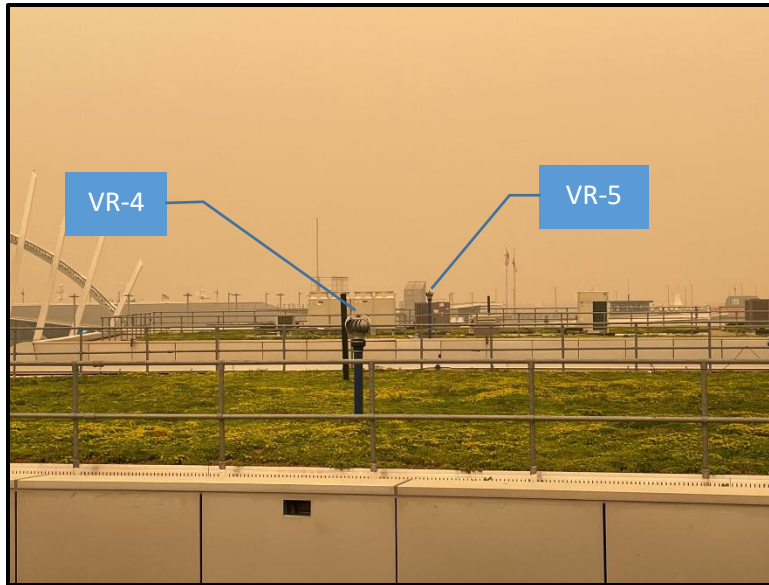
Photo 13. June 7, 2023

SSDS inspection: roof vents VR-4 and VR-5.

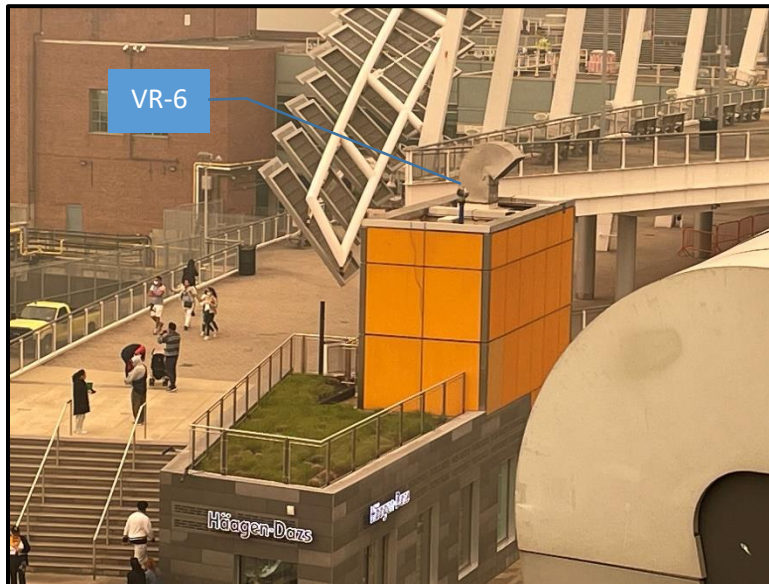
Photo 14. June 7, 2023

SSDS inspection: roof vent VR-6.
