**Re: OM&M Report (Routine Maintenance) for SSD Systems Installed at
40 Marbledale Road, Tuckahoe, Westchester County
Weissman Holdings, Inc. (formerly Kings Electronics Co., Inc.)
Site # V 00237-3**

**OM&M Report Summarizing Routine Maintenance of SSD Systems
40 Marbledale Road, Tuckahoe, Westchester County
NYSDEC Site # V 00237-3
May 21, 2009**

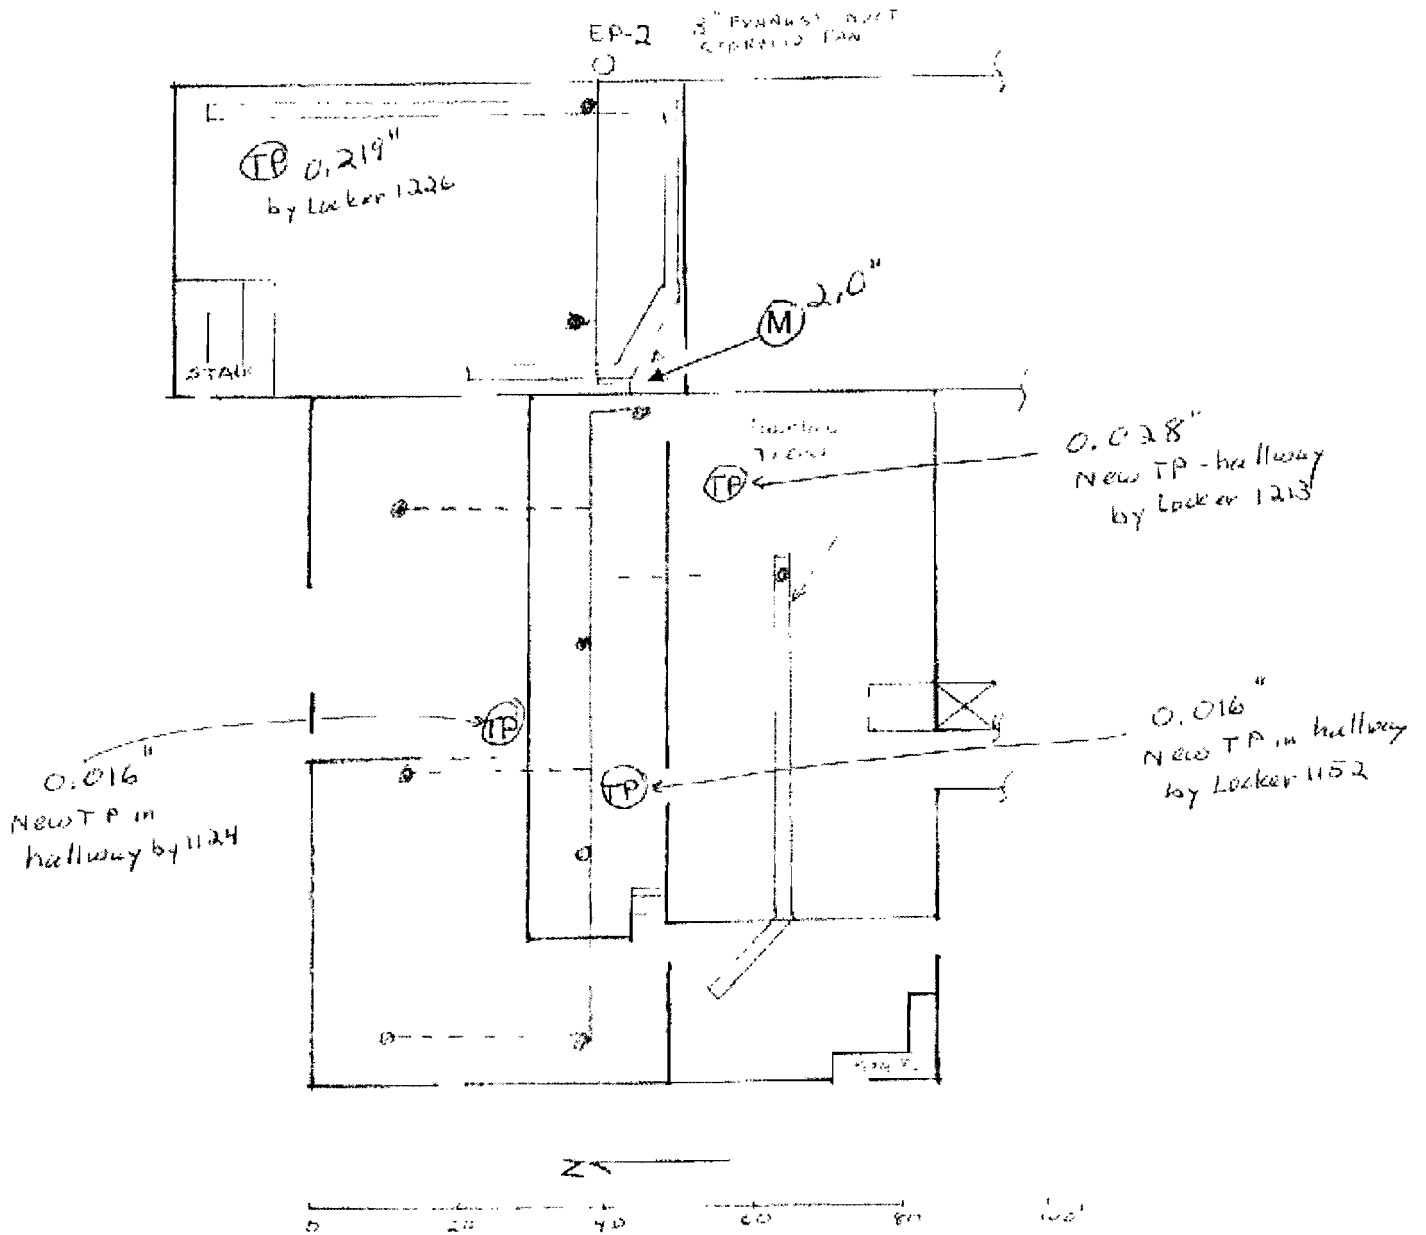
Pressure Field Extension (TP) and Manometer (M) Vacuum - wei
 System 2, Buildings 3 and 4

Conduct appropriate pressure field extension testing of SSD System.	✓	Original TP in Bldg 4, Three new TPs in Bldg 3

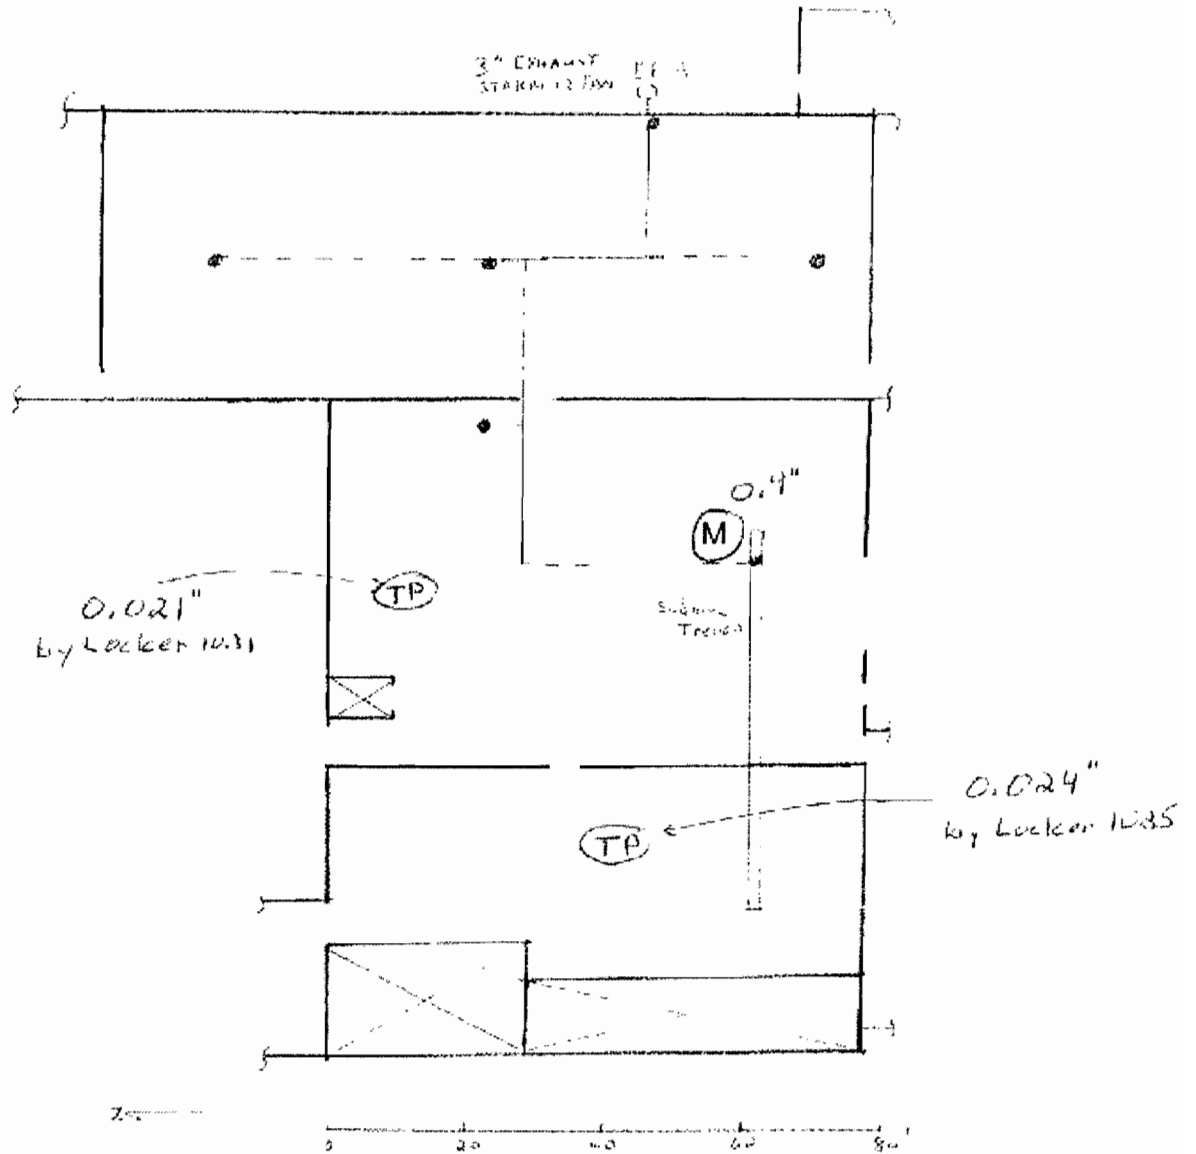
Pressure Field Extension (TP) and Manometer (M) Vacuum - wci
 System 3, Buildings 2 and 4.

Conduct appropriate pressure field extension testing of SSD System.	✓	<i>Original TPs</i>
