June 7th, 2011

This is the Periodic Review Report for Site No. V00314, previously known as "Outokumpu American Brass (OAB) Facility" but now operating under the name Luvata Buffalo, Inc, located @ Military and Sayre St. Buffalo, NY 14207.

Enclosure 1
NEW YORK STATE DEPARTMENT OF ENVIR
Site Management Periodic Review
Institutional and Engineering Contr

Reporting Period: June 30, 2009 to June 03, 2011

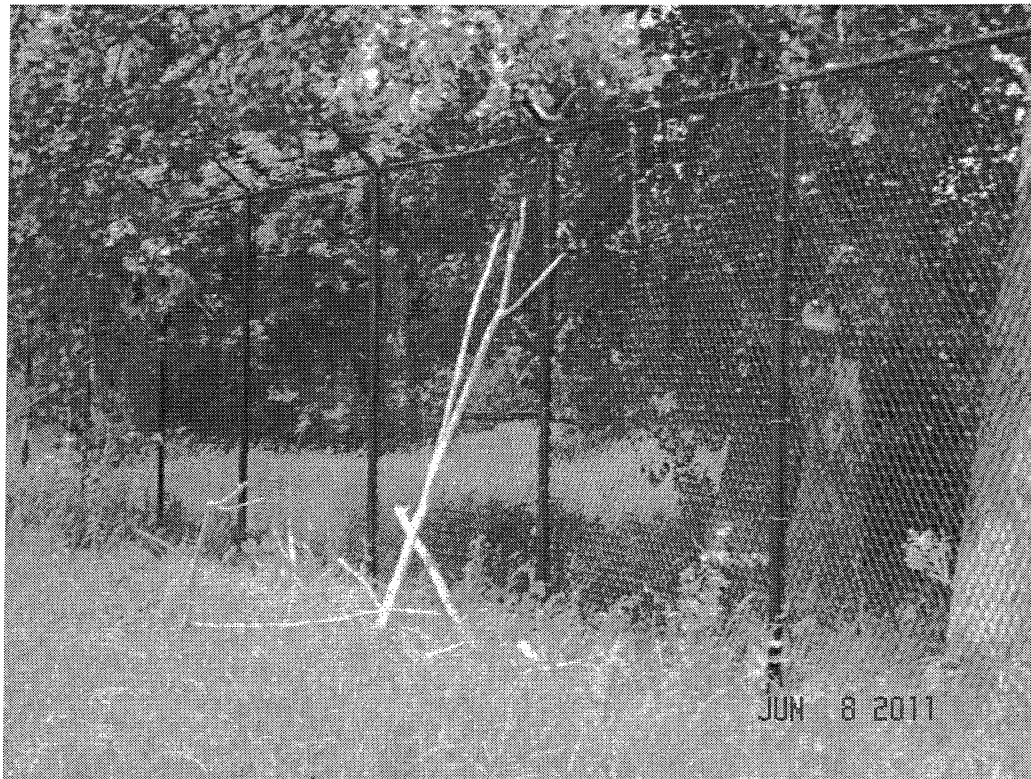
Area J, North West corner near railroad tracks. The fence is shown to be in good to excellent shape with minimal intrusion of vegetation or debris. The trees on the fence are dead branches.

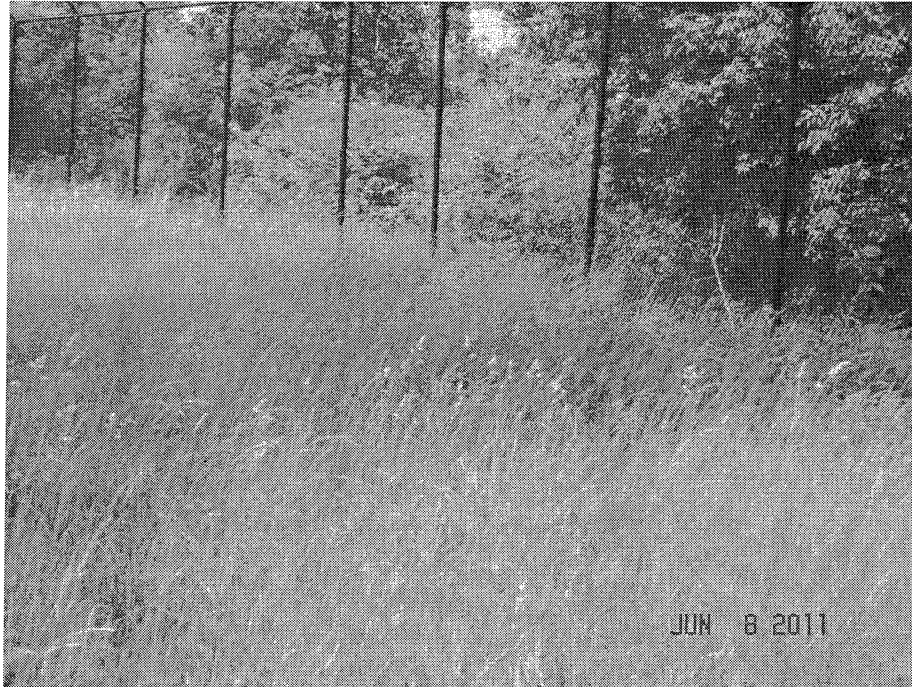
Area J, North West area, healthy vegetation, no footpaths present, fence in excellent condition.

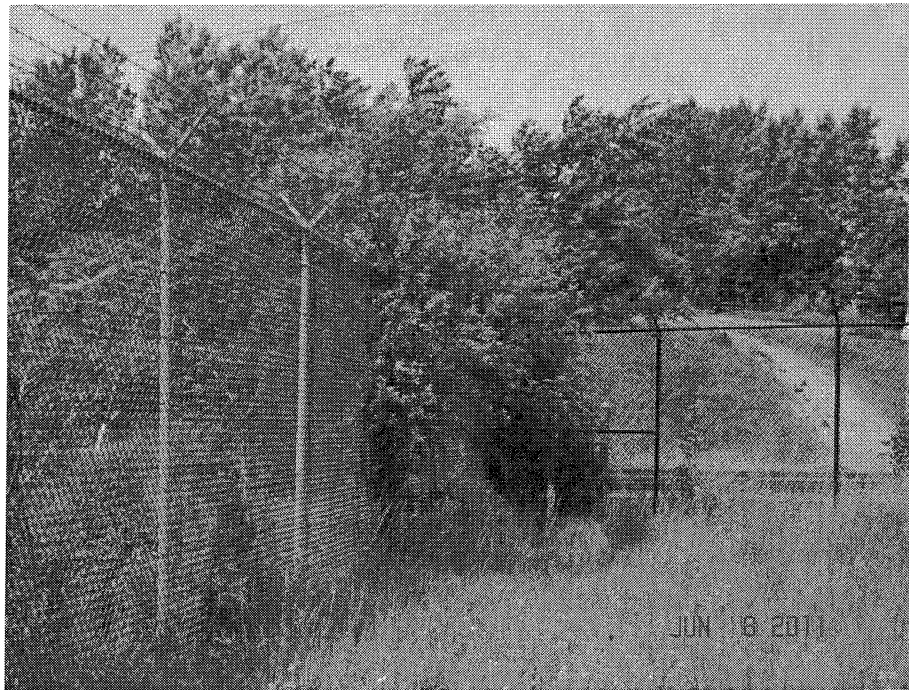
Area J, North West corner, next to railroad tracks. This photo shows necessity of minor landscaping maintenance to ensure the strength and effectiveness of fence.

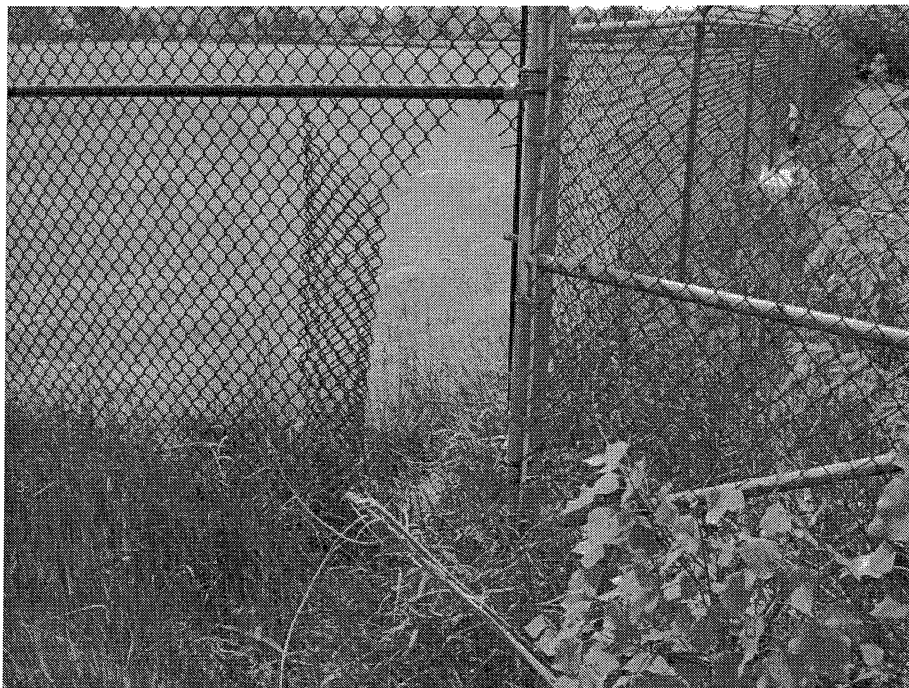
Area J, South West corner, behind baseball field. This photo shows a fence that has been cut allowing access to Area J. The fences are inspected weekly by

security and this repair immediately turned over to maintenance and documented with a work order and also is recorded in Table 4 in the spreadsheet.

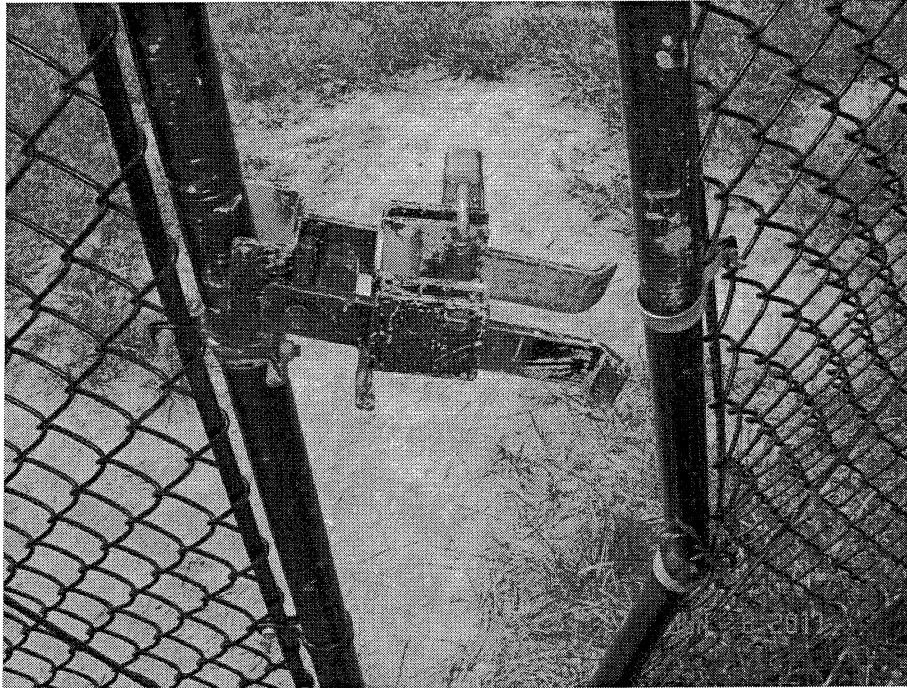
Area J, South West area, behind baseball fields, this photo shows the gate has been damaged by landscaping equipment. As with other damage the fences are inspected weekly by maintenance and this damage has been turned over to maintenance for repair and has been logged in Table 4 in the spreadsheet.
SUPPORTING DOCUMENTATION

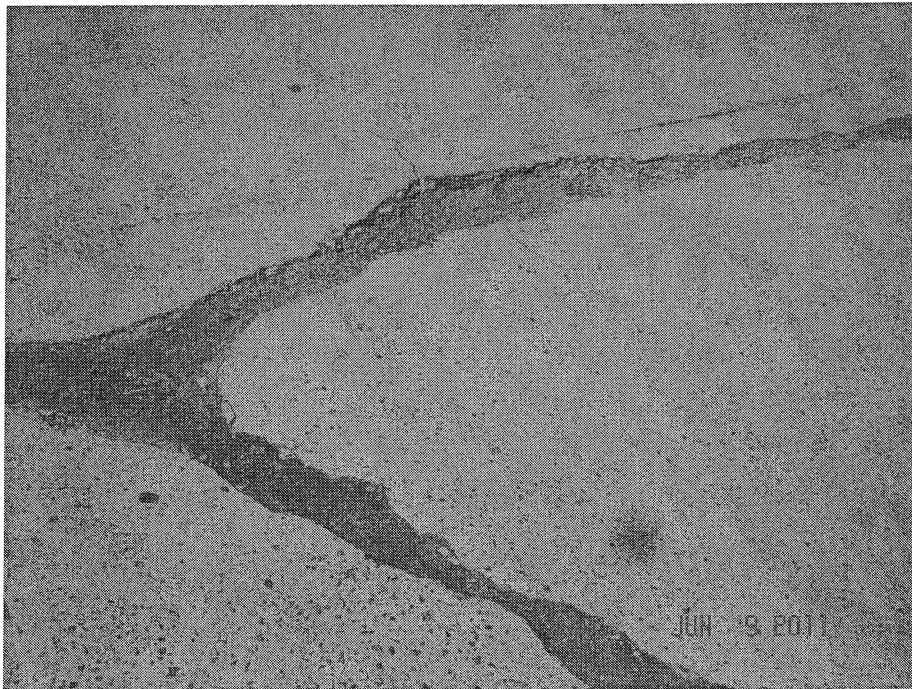
Area A, cracks and gaps in concrete, seasonal repair.

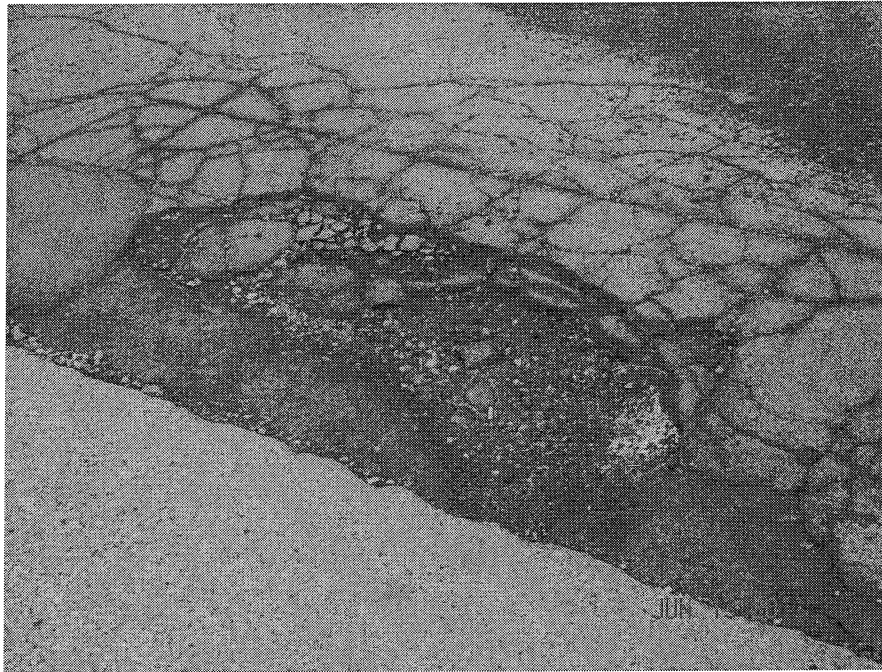
Area A, pothole in asphalt, seasonal repair.

Inspect For	Inspection Item Identified	Action Required	Comment
Deterioration	NO	NO	
Obstruction/ Debris	NO	NO	
Potholes	YES	YES	A work order was filed to fill potholes, this work will be completed as weather allows. See attached photos
Drainage/ Puddles	NO	NO	
Stormwater Structures, Other	NO	NO	
Other	NO	NO

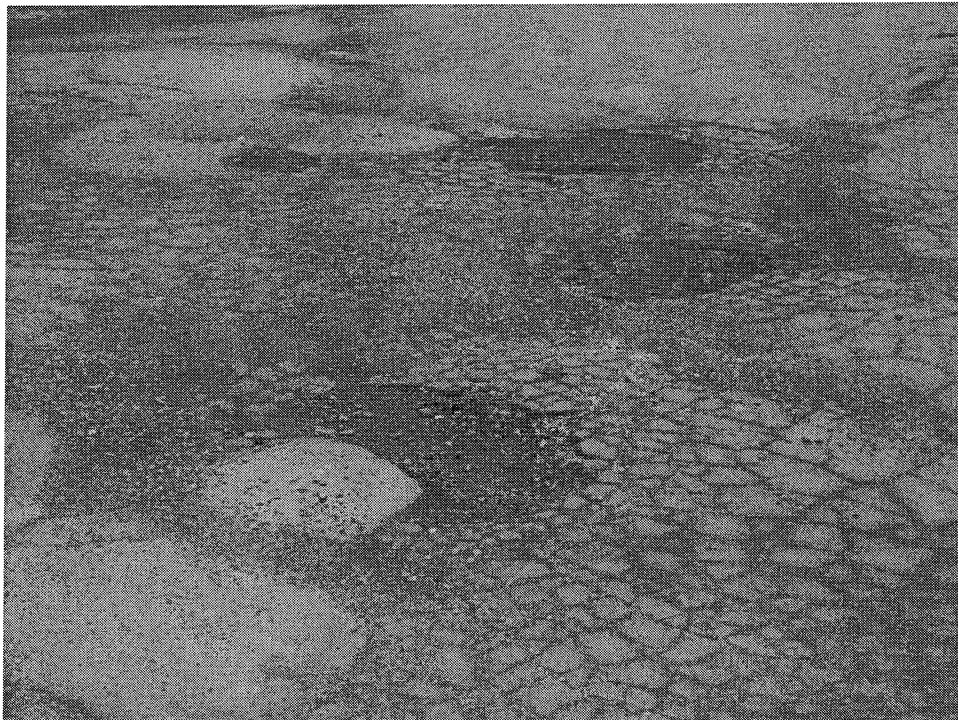
Area A, potholes in asphalt, seasonal repair.
