Roberta Kloda  
Aurubis Buffalo, Inc.  
P.O. Box 981  
Buffalo, NY 14240  
(716) 879-6905  
R.Kloda@aurubis.com  
July 22, 2013

This is the Periodic Review Report for Site No. V00314, previously known as "Outokumpu American Brass (OAB) Facility" but now operating under the name Aurubis Buffalo, Inc, located @ Military and Sayre St. Buffalo, NY 14207.

#### I. INTRODUCTION

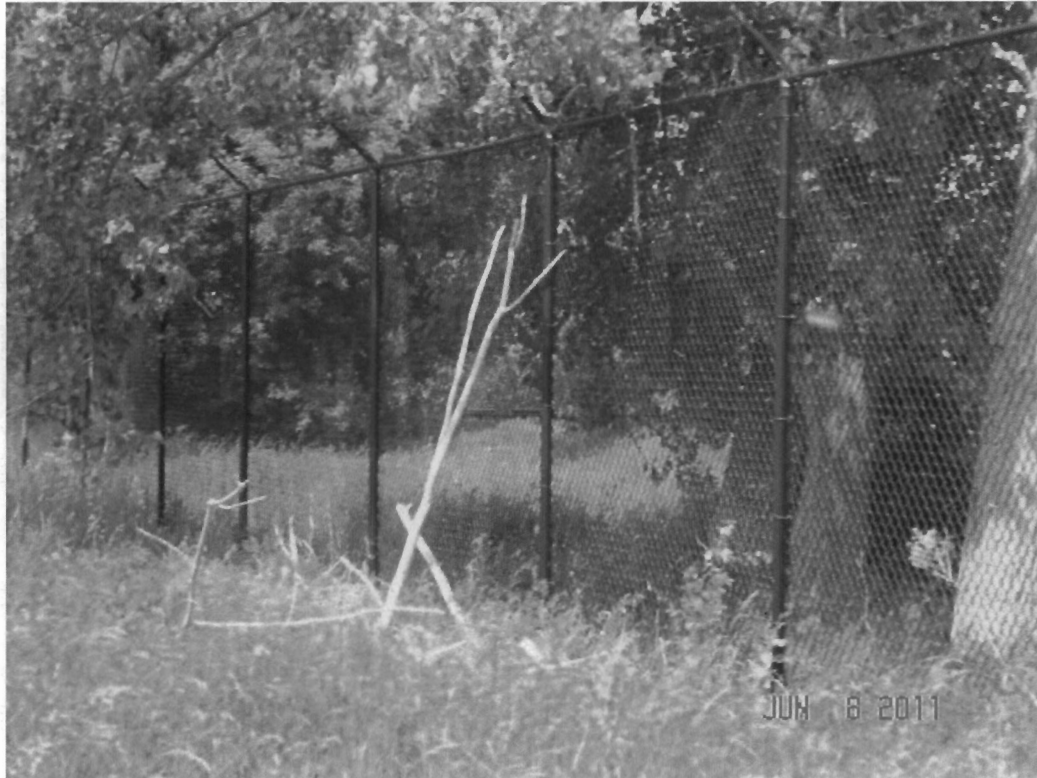
Area J, North West corner near railroad tracks. The fence is shown to be in good to excellent shape with minimal intrusion of vegetation or debris. The trees on the fence are dead branches.

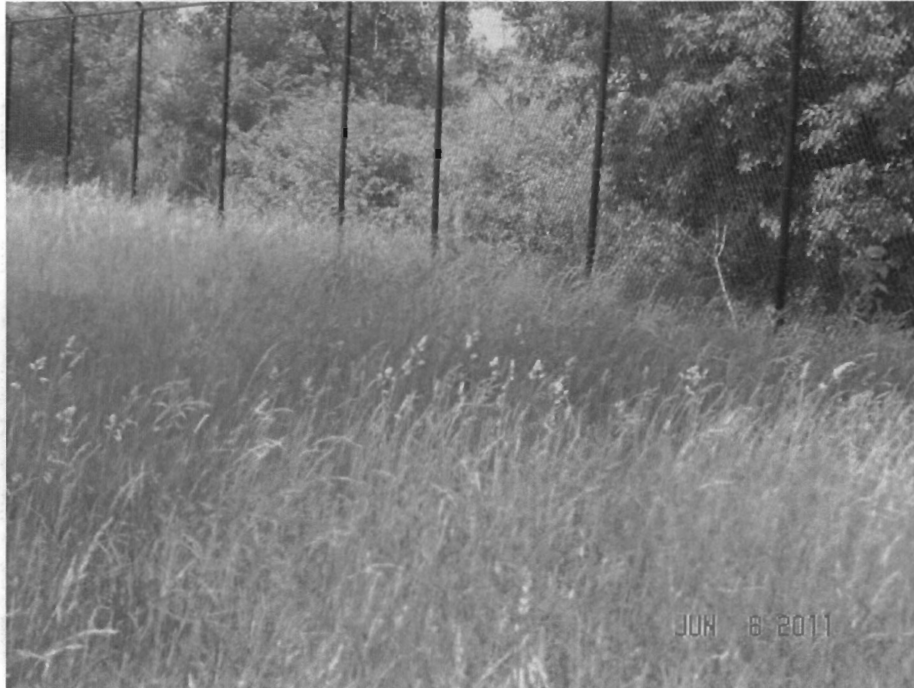
Area J, North West area, healthy vegetation, no footpaths present, fence in excellent condition.

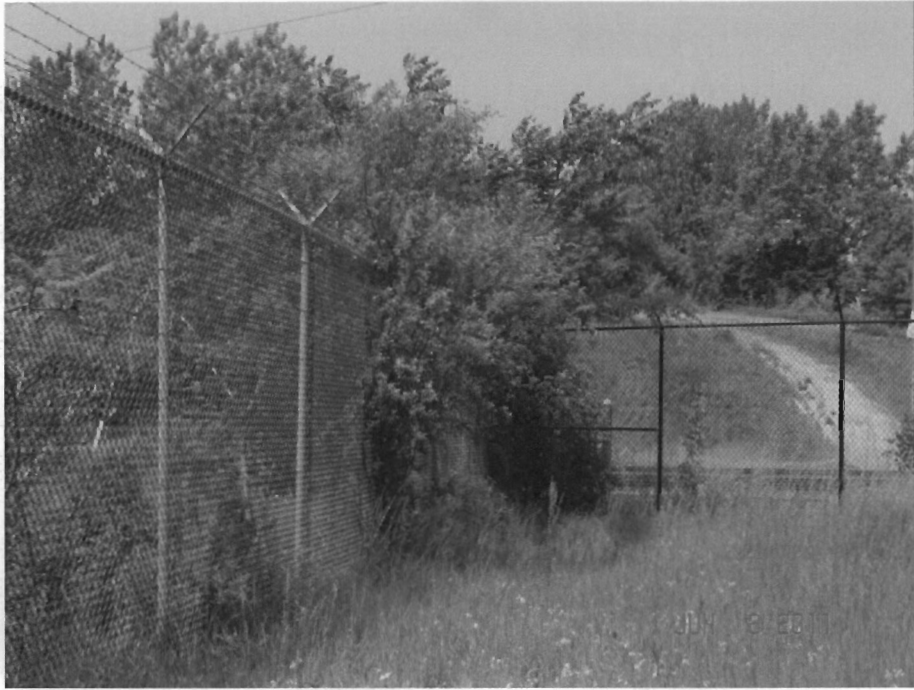
Area J, North West corner, next to railroad tracks. This photo shows necessity of minor landscaping maintenance to ensure the strength and effectiveness of fence.

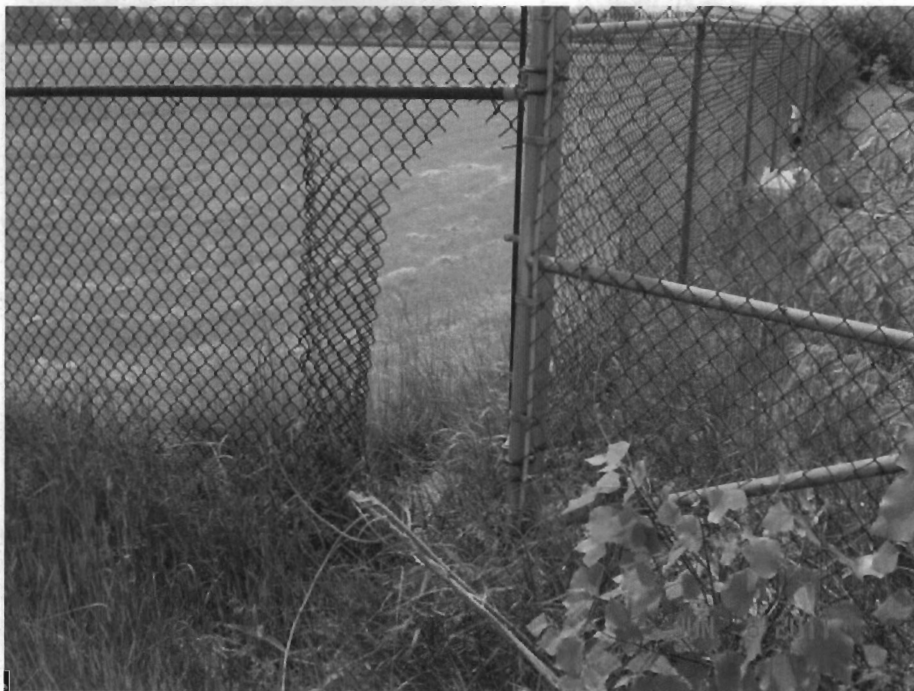
Area J, South West corner, behind baseball field. This photo shows a fence that has been cut allowing access to Area J. The fences are inspected weekly by

security and this repair immediately turned over to maintenance and documented with a work order and also is recorded in Table 4 in the spreadsheet.

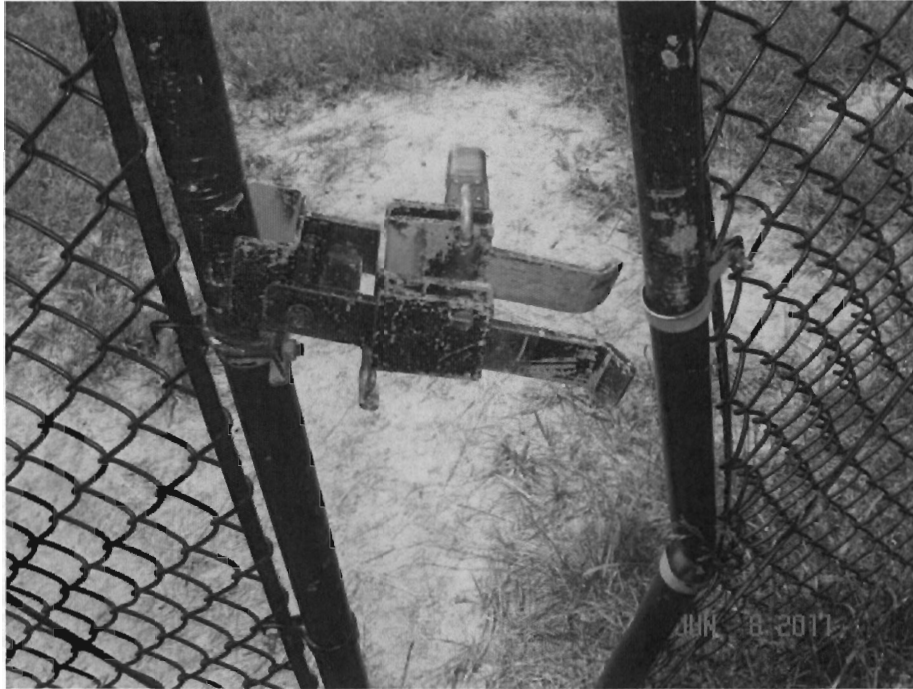
Area J, South West area, behind baseball fields, this photo shows the gate has been damaged by landscaping equipment. As with other damage the fences are inspected weekly by maintenance and this damage has been turned over to maintenance for repair and has been logged in Table 4 in the spreadsheet.

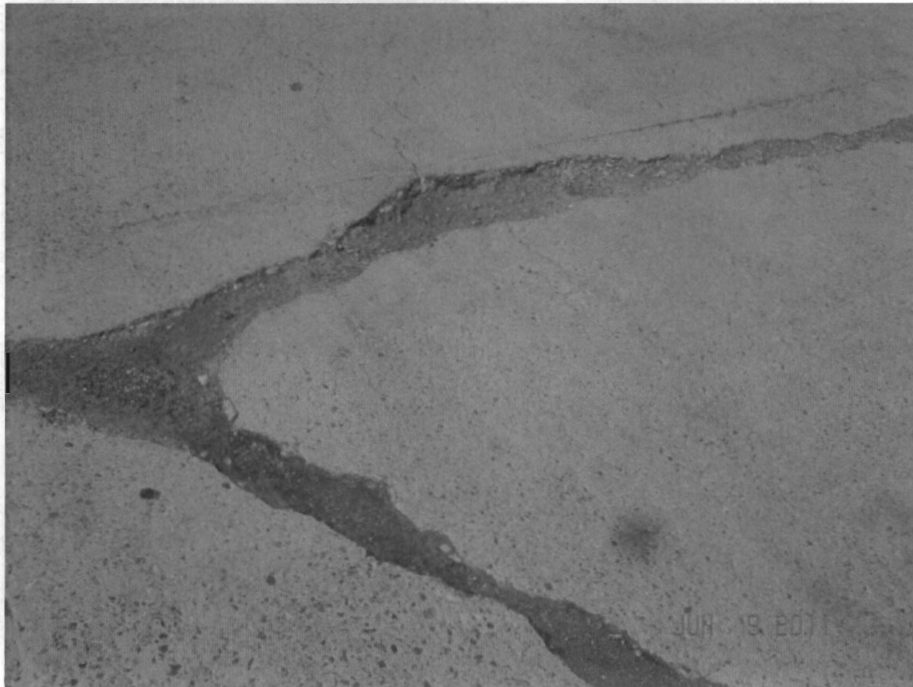
Area A, cracks and gaps in concrete, seasonal repair.

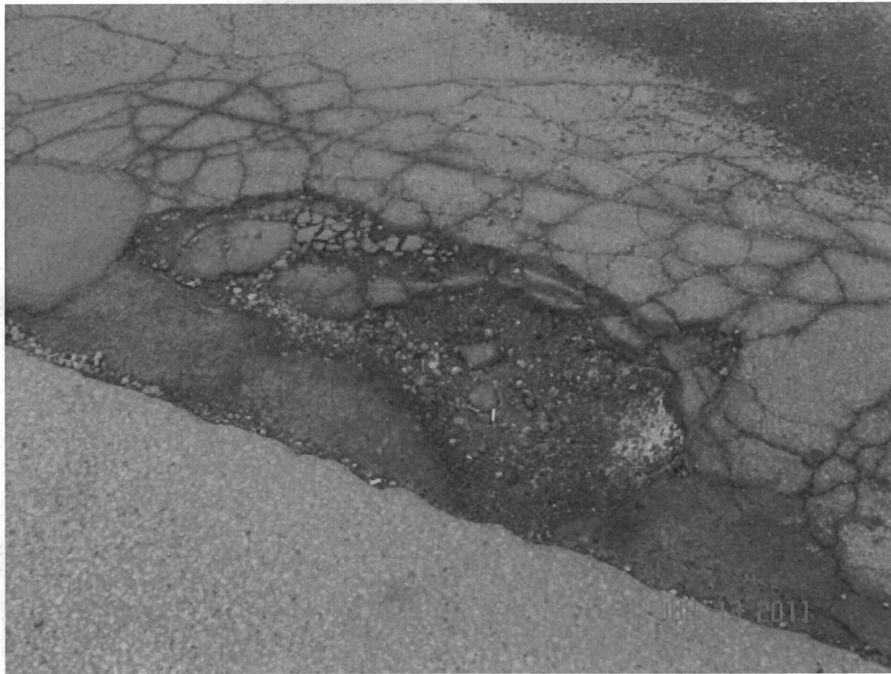
Area A, pothole in asphalt, seasonal repair.

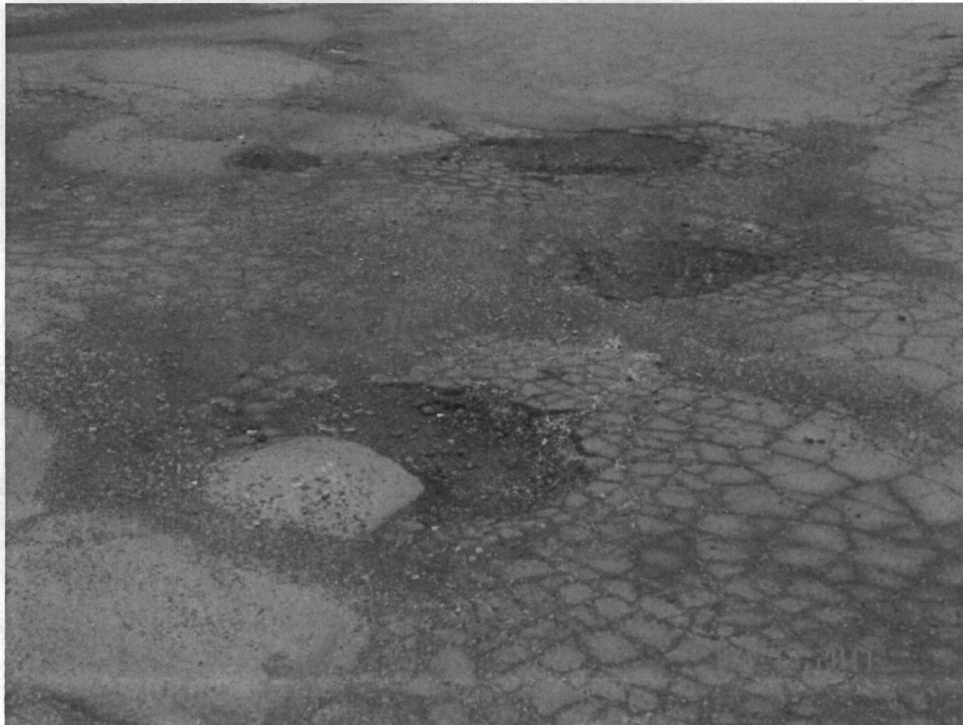
Area A, potholes in asphalt, seasonal repair.
