**Residential Backyards 57-40, 57-42, and 57-48
57th Drive**

QUEENS, NEW YORK

Off-site Final Engineering Report

MAY 2009

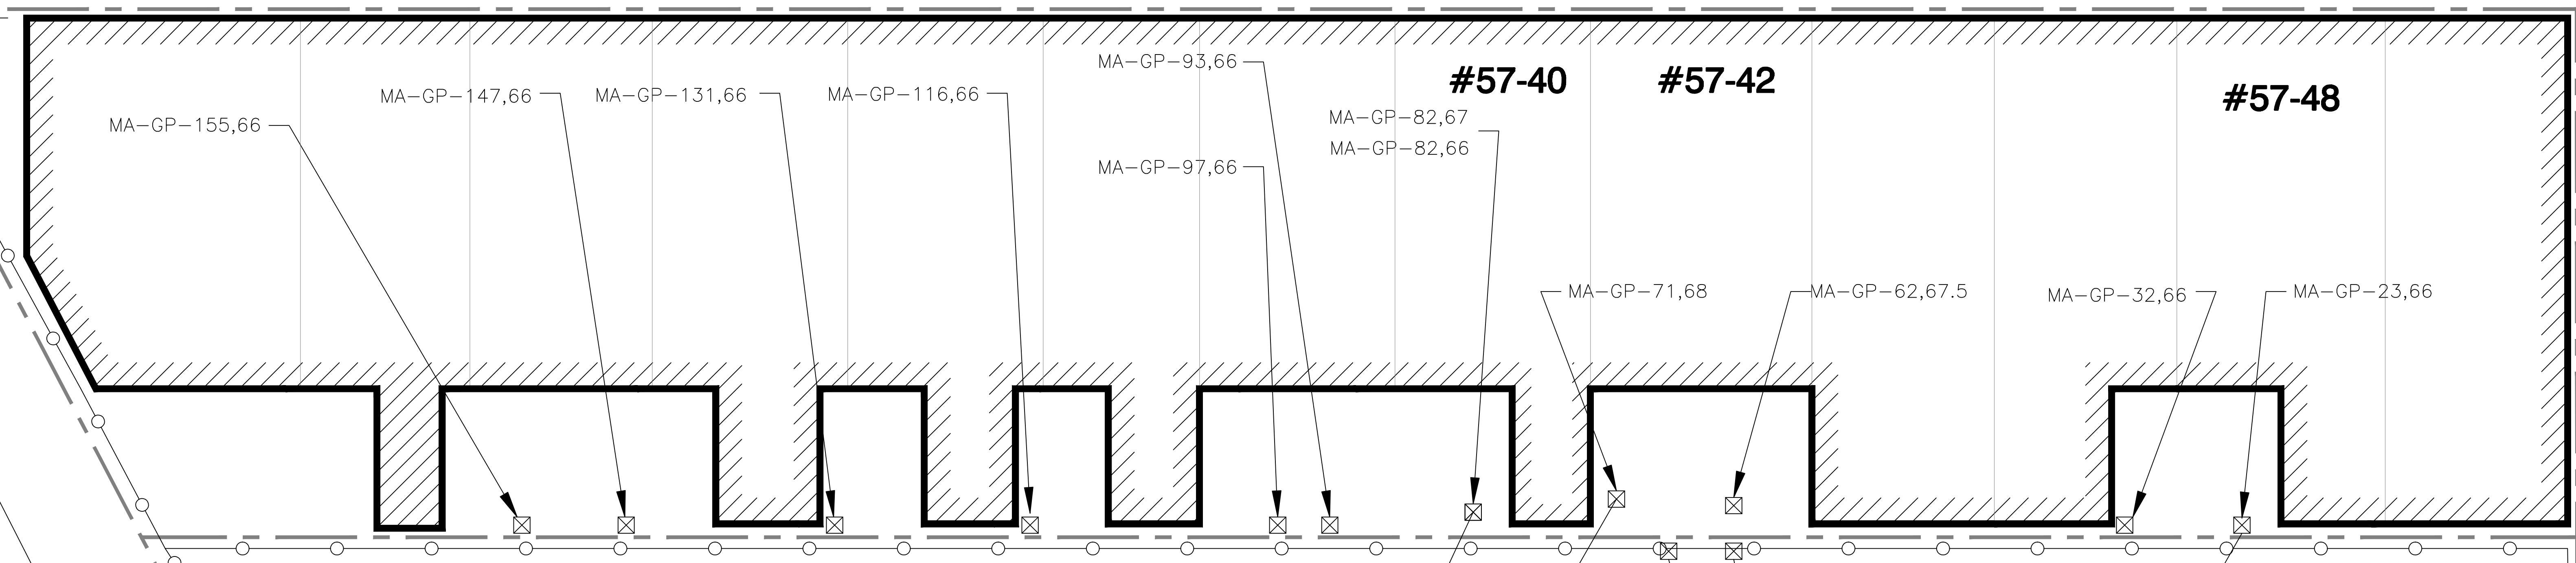
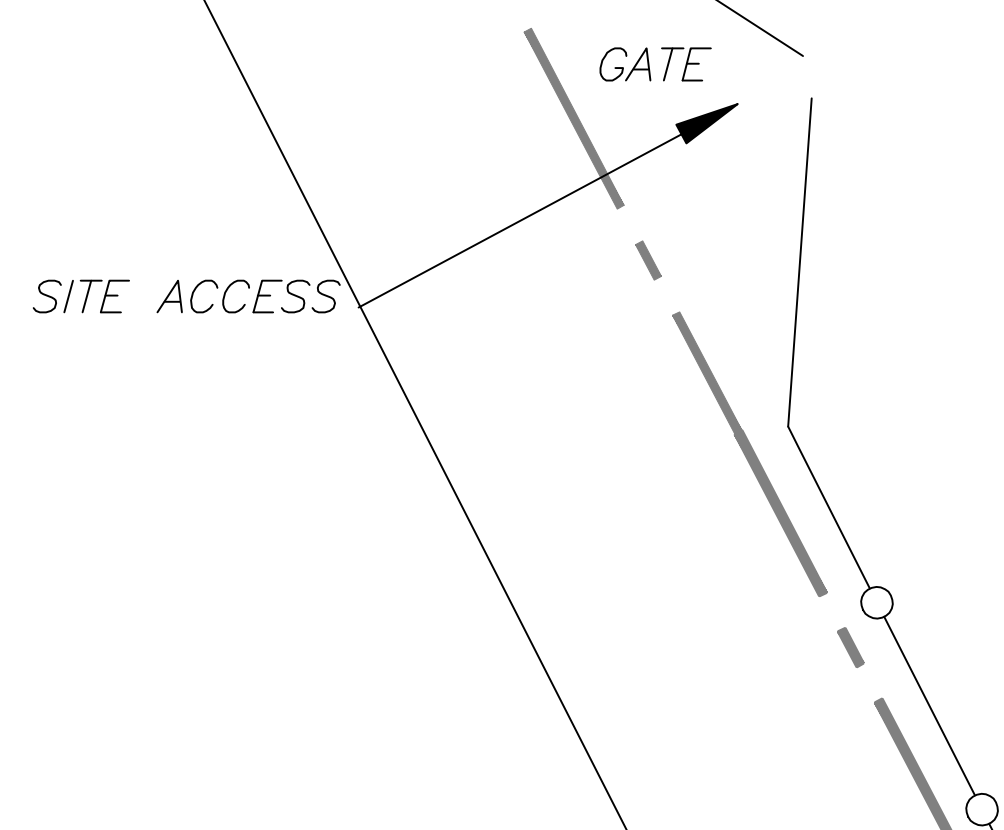
Analytical soil data generated during the remedial investigation noted above are presented in Tables 1-1 to 1-3. The soil data indicated that elevated concentrations of polychlorinated biphenyls (PCBs), specifically PCB Aroclor-1260, were present in the shallow subsurface soils (from ground surface to two-feet below ground surface) in the backyards of three residential properties located at 57-40, 57-42, and 57-48 57th Drive and underneath the concrete fence footer behind 57-42 57th Drive as shown on Figure 5.

MA-GP-82,67		
SAMPLE DEPTH (ft bgs)	CONCENTRATION (ppm)	NYSDEC RSCO (ppm)
0-2	1.170	1.0

MA-GP-71,68		
SAMPLE DEPTH (ft bgs)	CONCENTRATION (ppm)	NYSDEC RSCO (ppm)
0-2	1.040	1.0

MA-GP-62,64		
SAMPLE DEPTH (ft bgs)	CONCENTRATION (ppm)	NYSDEC RSCO (ppm)
6	334	1.0

MA-GP-67,64		
SAMPLE DEPTH (ft bgs)	CONCENTRATION (ppm)	NYSDEC RSCO (ppm)
5	762	1.0
